NATIONAL REGISTER OF HISTORIC PLACES  
INVENTORY -- NOMINATION FORM

HISTORIC  
Double Trouble  
AND/OR COMMON  
Double Trouble Historic District

DOUBLE TROUBLE  
HISTORIC DISTRICT

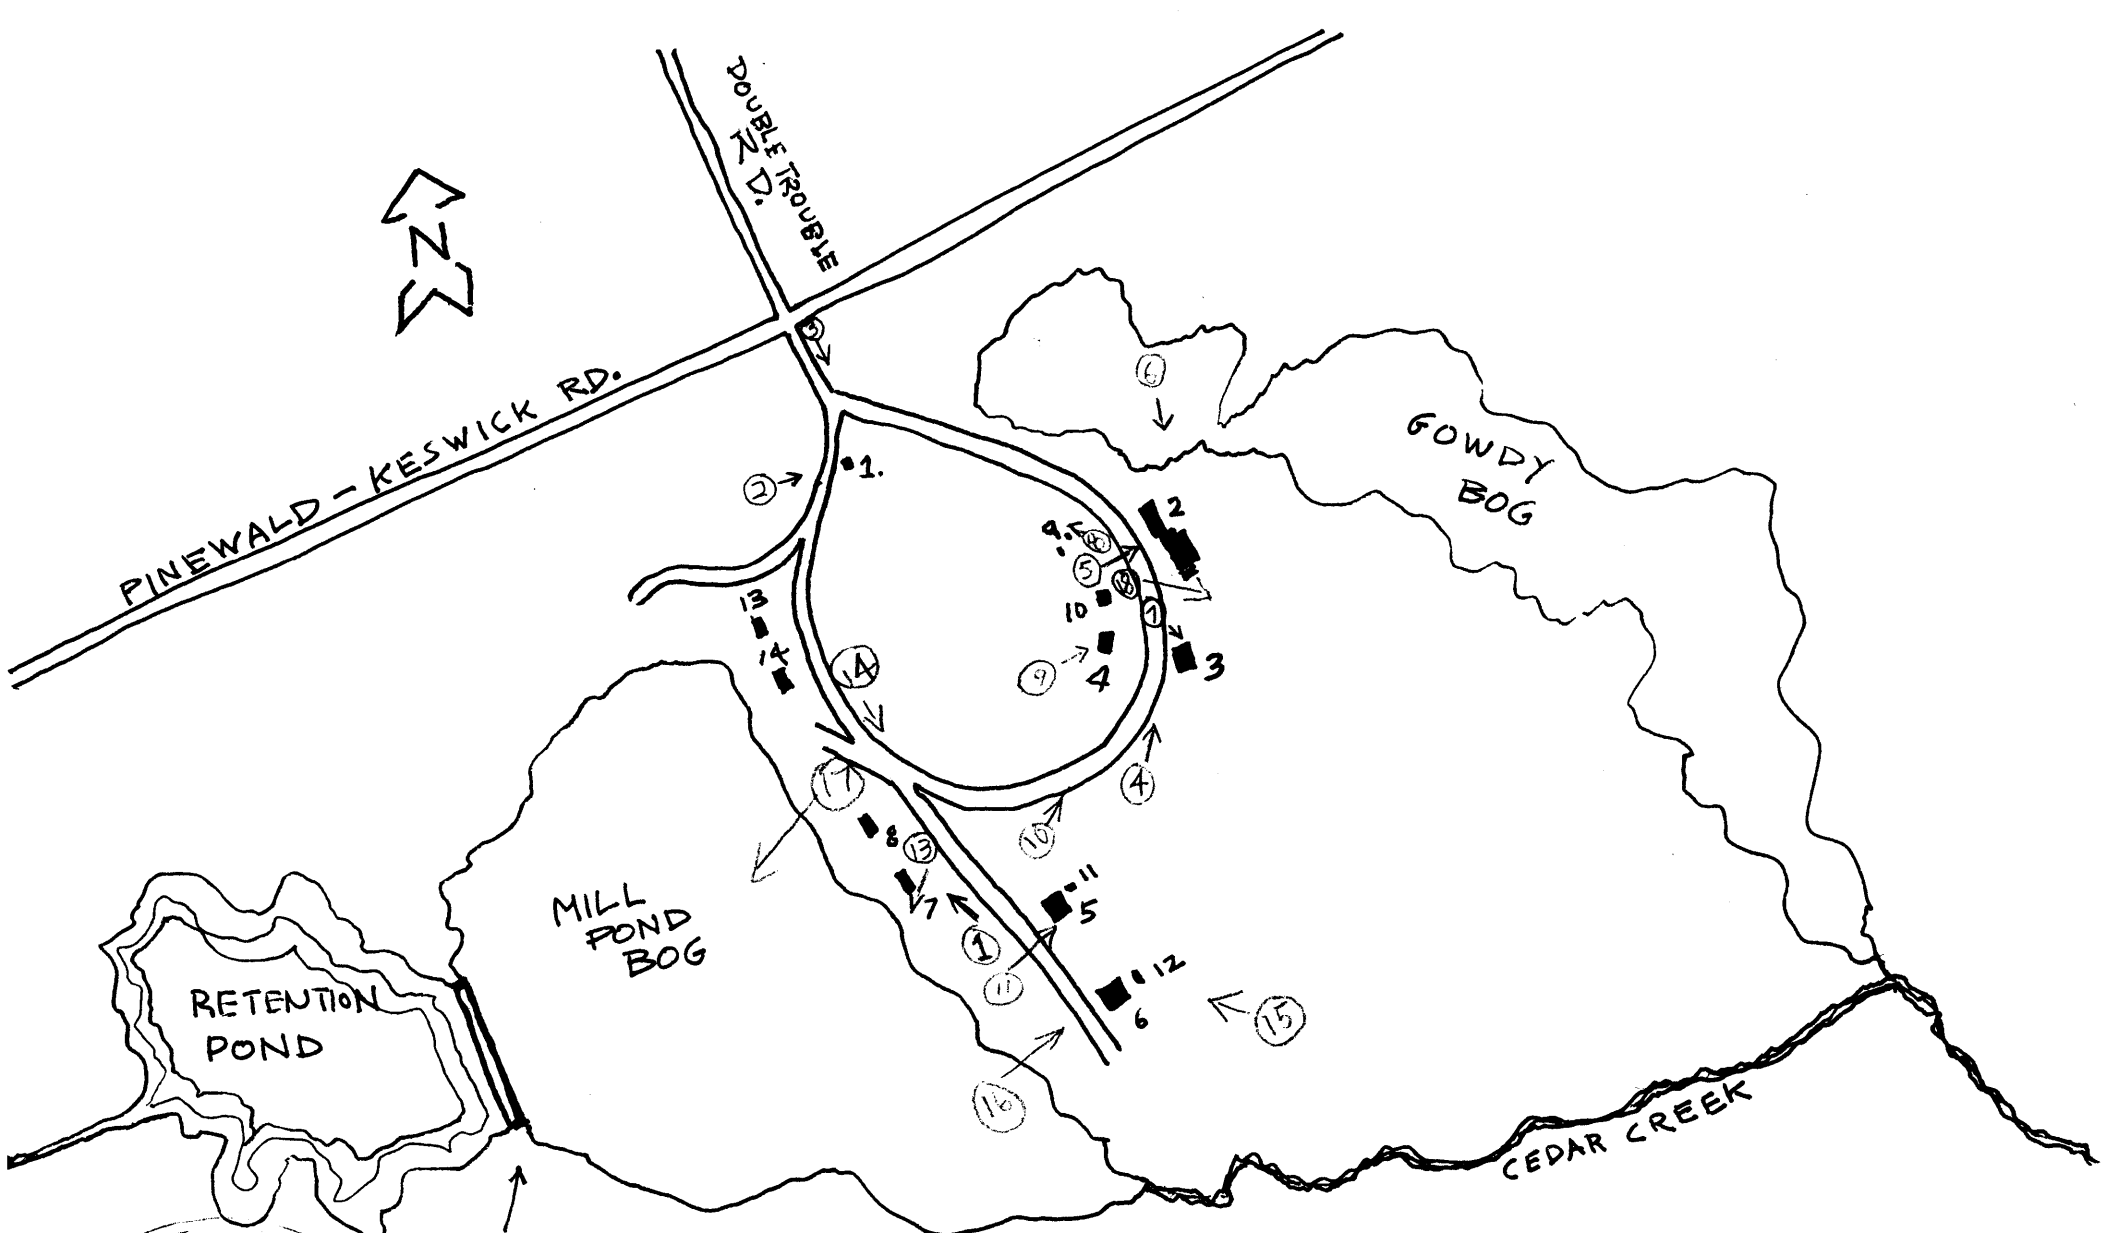
1. Schoolhouse
2. Cranberry Sorting and Packing House (Tin sided)
3. General Store
4. Foreman's House
5. Communal House
6. Saw Mill (Tin sided)
7. Picker's Cottage
8. Picker's Cottage
9. Pair Wooden Outhouses
10. Frame Salt Storage Shed (Tin sided)
11. Frame Cook House (Tin sided)
12. Frame Wood Storage Shed
13. Picker's Cottage
14. Picker's Cottage
15. Earth Dam

Earth Dam 15

Double Trouble Historic District consists of approximately 200 acres of cranberry bog, and a village nucleus of service buildings including a cranberry packing and sorting house, a saw mill, a general store, a school house, a schoolmaster's house, a caretaker's cottage and 4 pickers' cottages. The village is set upon an area of relatively high ground between 2 great bogs, Gowdy Bog to the east and Mill Pond Bog to the west. At the edges of the village the land falls away sharply and open bog land stretches outward to cover many acres. This bog vista is terminated by the surrounding pine forests which appear to the viewer as dark green lines off in the distance. The village area is entered on the north side from the Keswick-Barber Road.

Its buildings are disposed about a circular gravel driveway with 2 spurs on the west side, one of which proceeds south, and one of which proceeds west. The functional focus of Double Trouble village occurs on the east side of the circle. The main building in this group is the cranberry sorting and packing house, a 5 bay pitched roof, frame building with sheet metal siding, and a 3 bay front porch. There is also a 1 story 4 bay frame support building in front. The packing and sorting house contains 3 Hayden Cranberry separators, which are almost completely intact. Each machine is essentially a system of conveyor belts, bins, and rollers to facilitate manual sorting. The belts and cogs have wheels which feature characteristically early 20th Century serpentine spokes.
