KENTUCKY HISTORIC RESOURCES
Individual Inventory Form

Resource # SH 254
SHELBY County

1. Name of Resource:
L.C. FRY FARM

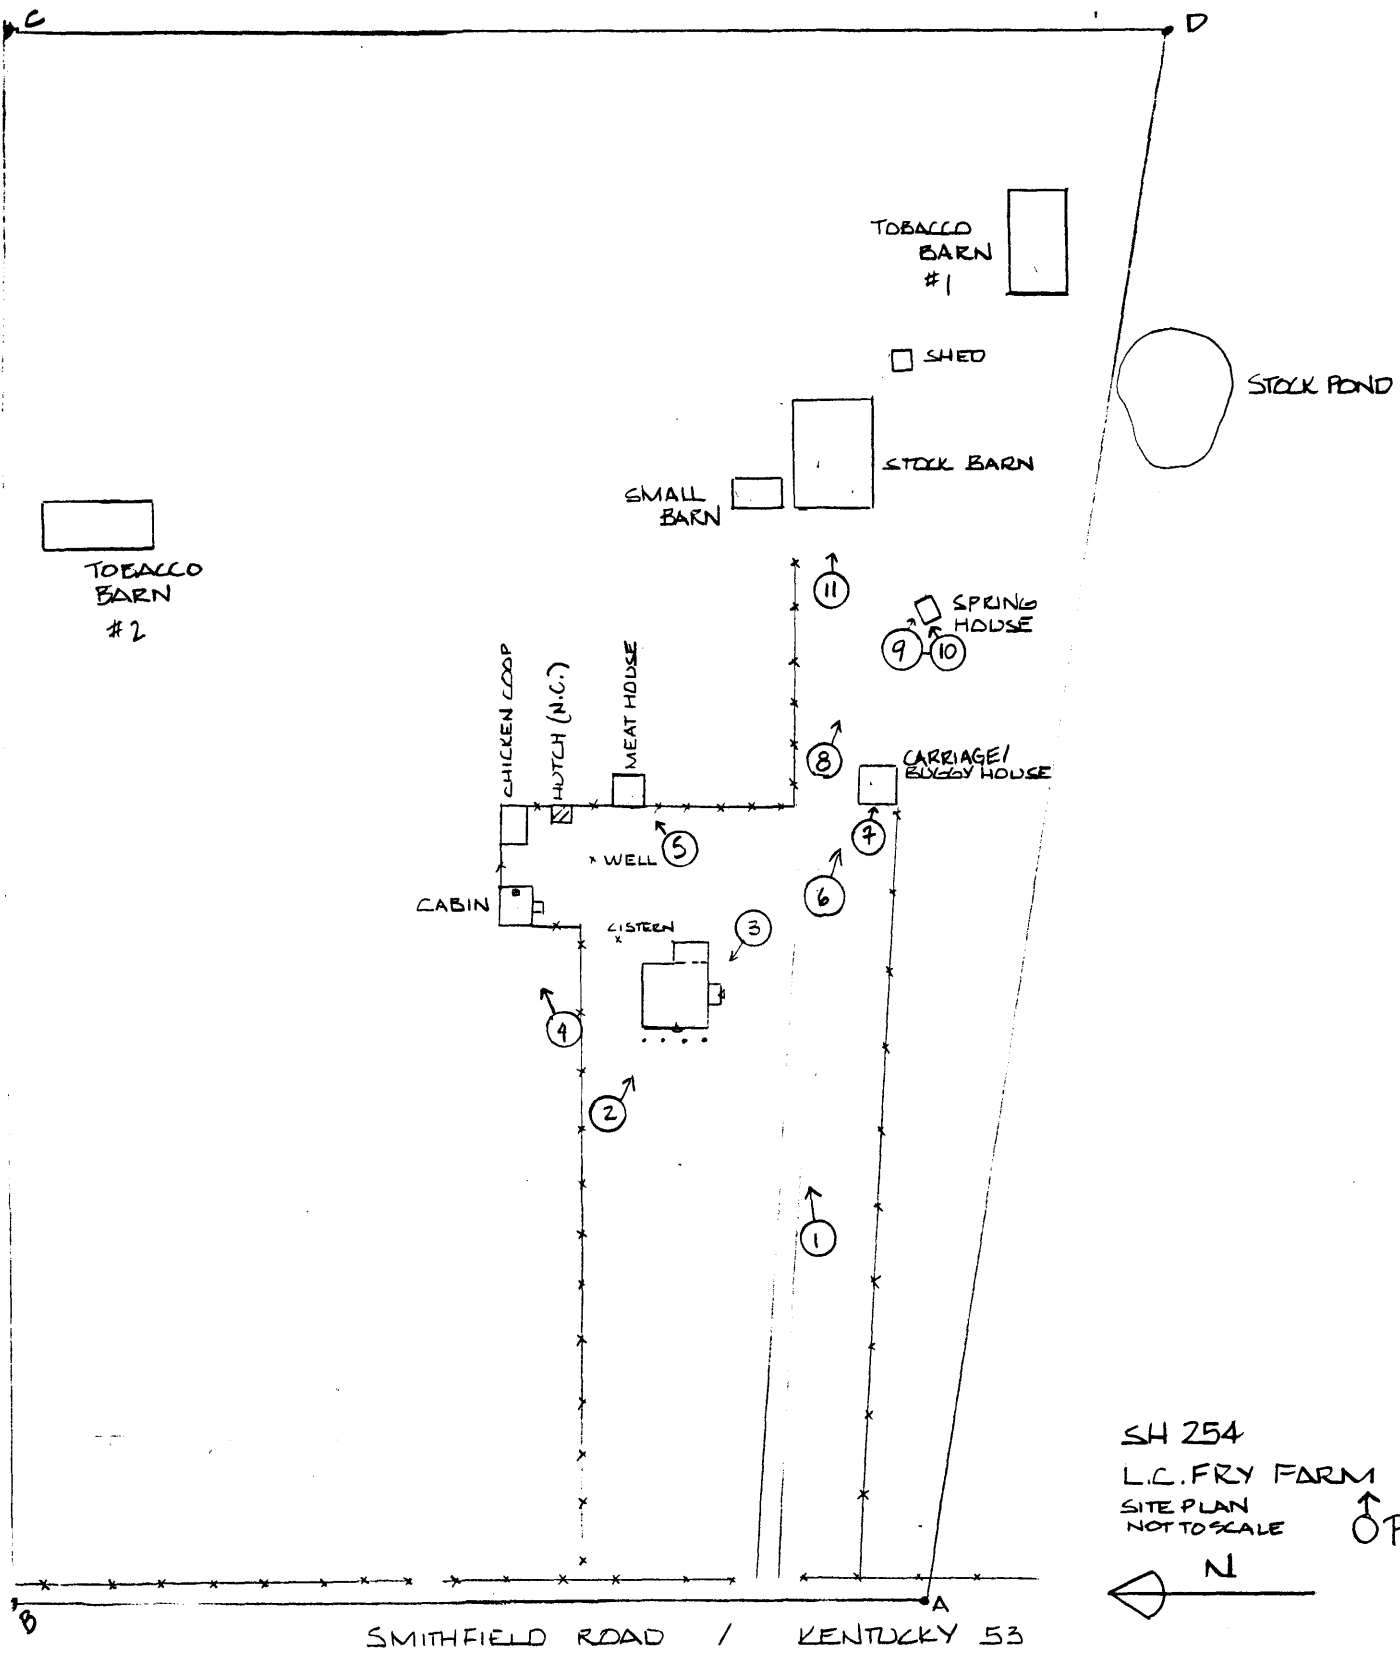
The property boundaries includes thirteen buildings and features. Nine buildings and two structures are contributing and one building is non-contributing.

house	C	stock barn	C
tenant cabin	C	tobacco barn (1)	C
chicken house	C	small barn	C
rabbit hutch	NC	tobacco barn (2)	C
meat house	C	cistern	C
spring house	C	well	C
buggy house	C
