**Structure/Site Information Form**

Original Owner: Cox, Silas, House Construction Date: c. 1901 Demolition Date:  
 Original Use: Residence Present Use:  
 Building Condition: Integrity: Preliminary Evaluation: Final Register Status:  
 Excellent  Site  Unaltered  Significant  Not of the  National Landmark  District  
 Good  Ruins  Minor Alterations  Contributory Historic Period  National Register  Multi-Resource  
 Deteriorated  Major Alterations  Not Contributory  State Register  Thematic

100 S. 400 E. Site #16  
Beaver, Utah  
Ground Plan  
recorded by Tom Carter May 83  
USHS

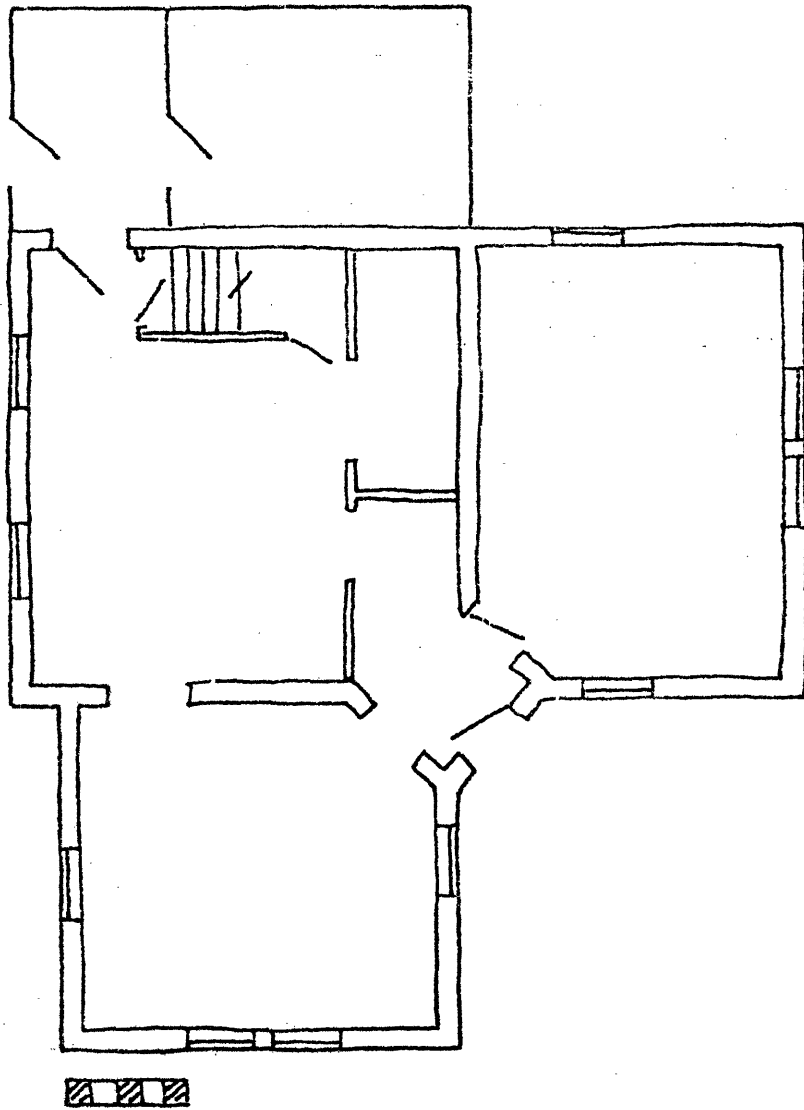
The Silas Cox House is a one-and-a-half story brick house which was built in 1901. It is an "L" plan house with an unusual entrance inset at the junction of the two wings. The house has a gable roof and a boxed cornice with a frieze. Eclectic Victorian trim ornaments the house and decorative elements are provided by the window and door openings, a pedimented dormer over the door, and corbelled chimney caps. The house is distinguished by its unusual entrance orientation. In excellent condition, the house appears to have no major alterations.

The main door, set in the corner at a 45 degree angle to the perpendicular side wings, has had an aluminum screen door and awning added. Wall space separates the segmentally arched door head from a gabled dormer set at the juncture of the cross-gables which emphasizes the location of the entrance. One-over-one double hung sash windows flank the door. All the windows on the house have projecting sills and segmental heads of radiating brick voussoirs, with header extrados and side pendants.
