NATIONAL REGISTER OF HISTORIC PLACES
REGISTRATION FORM

historic name Kaumakapili Church

Section 7 Page 1 Kaumakapili Church
Honolulu, Hawaii

Narrative Description

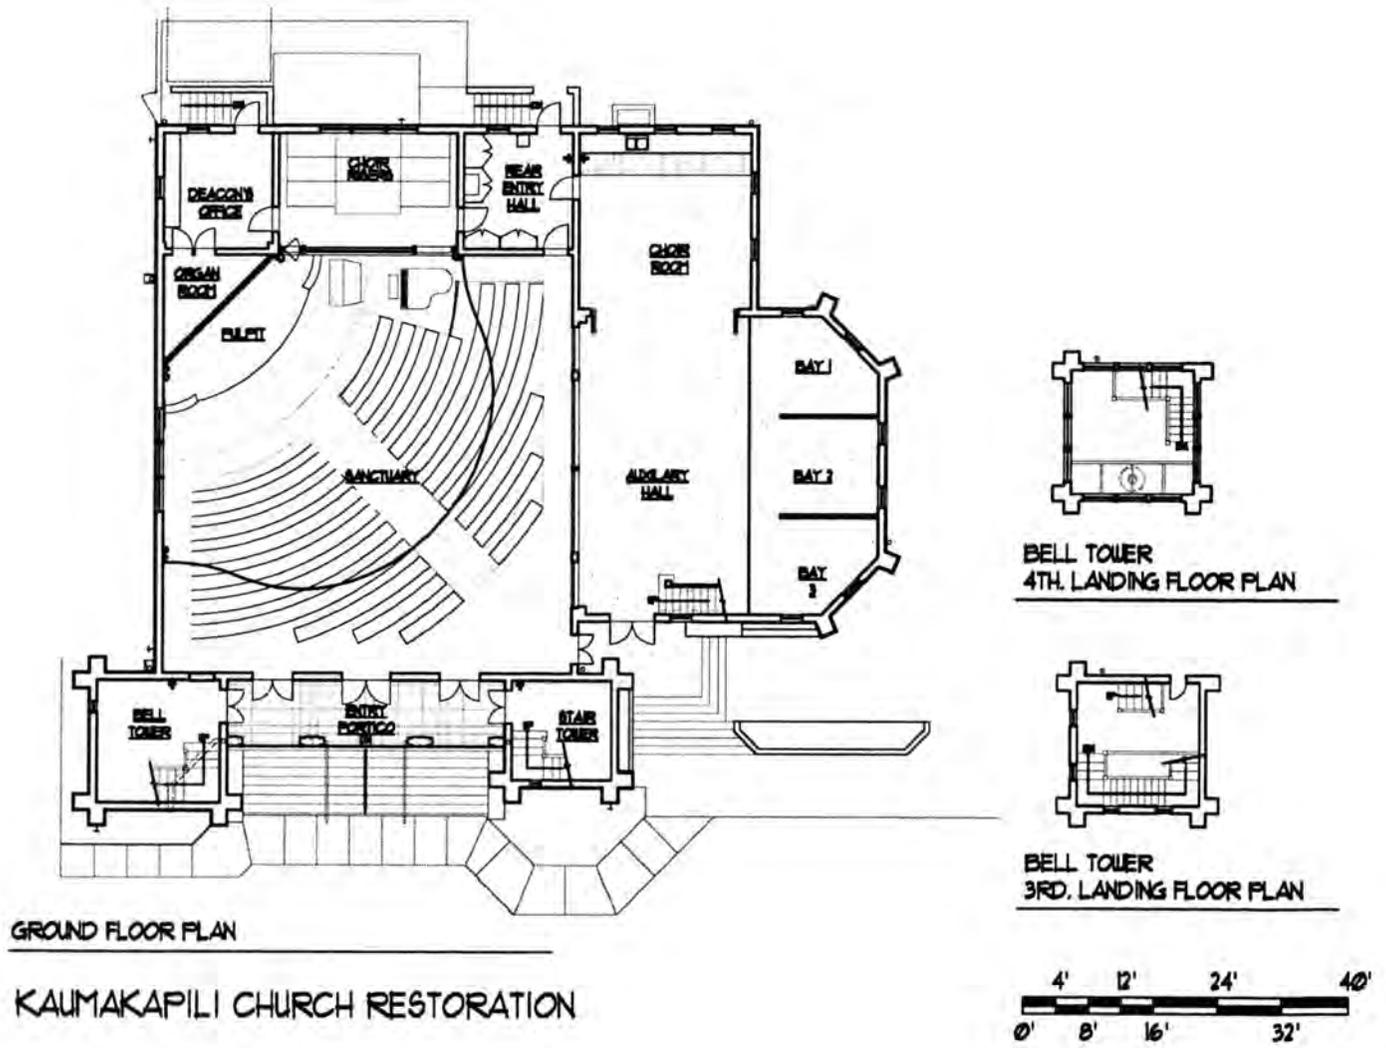
Figure 3: Kaumakapili Church, Ground Floor Plan

GROUND FLOOR PLAN

The building is asymmetrical in plan and consists of the vaulted Sanctuary with an arched entry portico flanked by two false-buttressed towers, and a pentagonal-shaped two-story Auxiliary Hall on the east side of the structure. A single-story suite of rooms containing support spaces, including the rear entry hall, the Deacon's Office and the Choir Meeting Room abuts the rear elevation of the building. The four-story Bell Tower on the west side of the front elevation provides access to the interior balcony, as well as supporting the bell at its uppermost level. The three-story Stair Tower on the east side also provides access to the balcony, as well as visually balancing the Church façade.

The pentagonal-shaped Auxiliary Hall is a two-story space with a mezzanine that has three end bays on each level. These bays could be used as small meeting rooms or classrooms. The mezzanine is accessed by a stair with railings, pickets and newel posts crafted of wood with a dark stain.

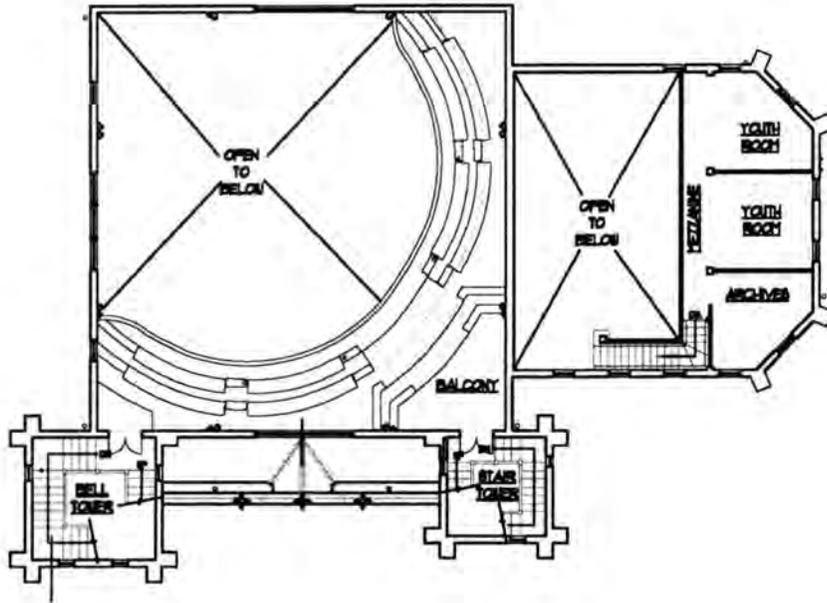
Figure 4: Kaumakapili Church, Upper Floor Plan

SECOND FLOOR PLAN

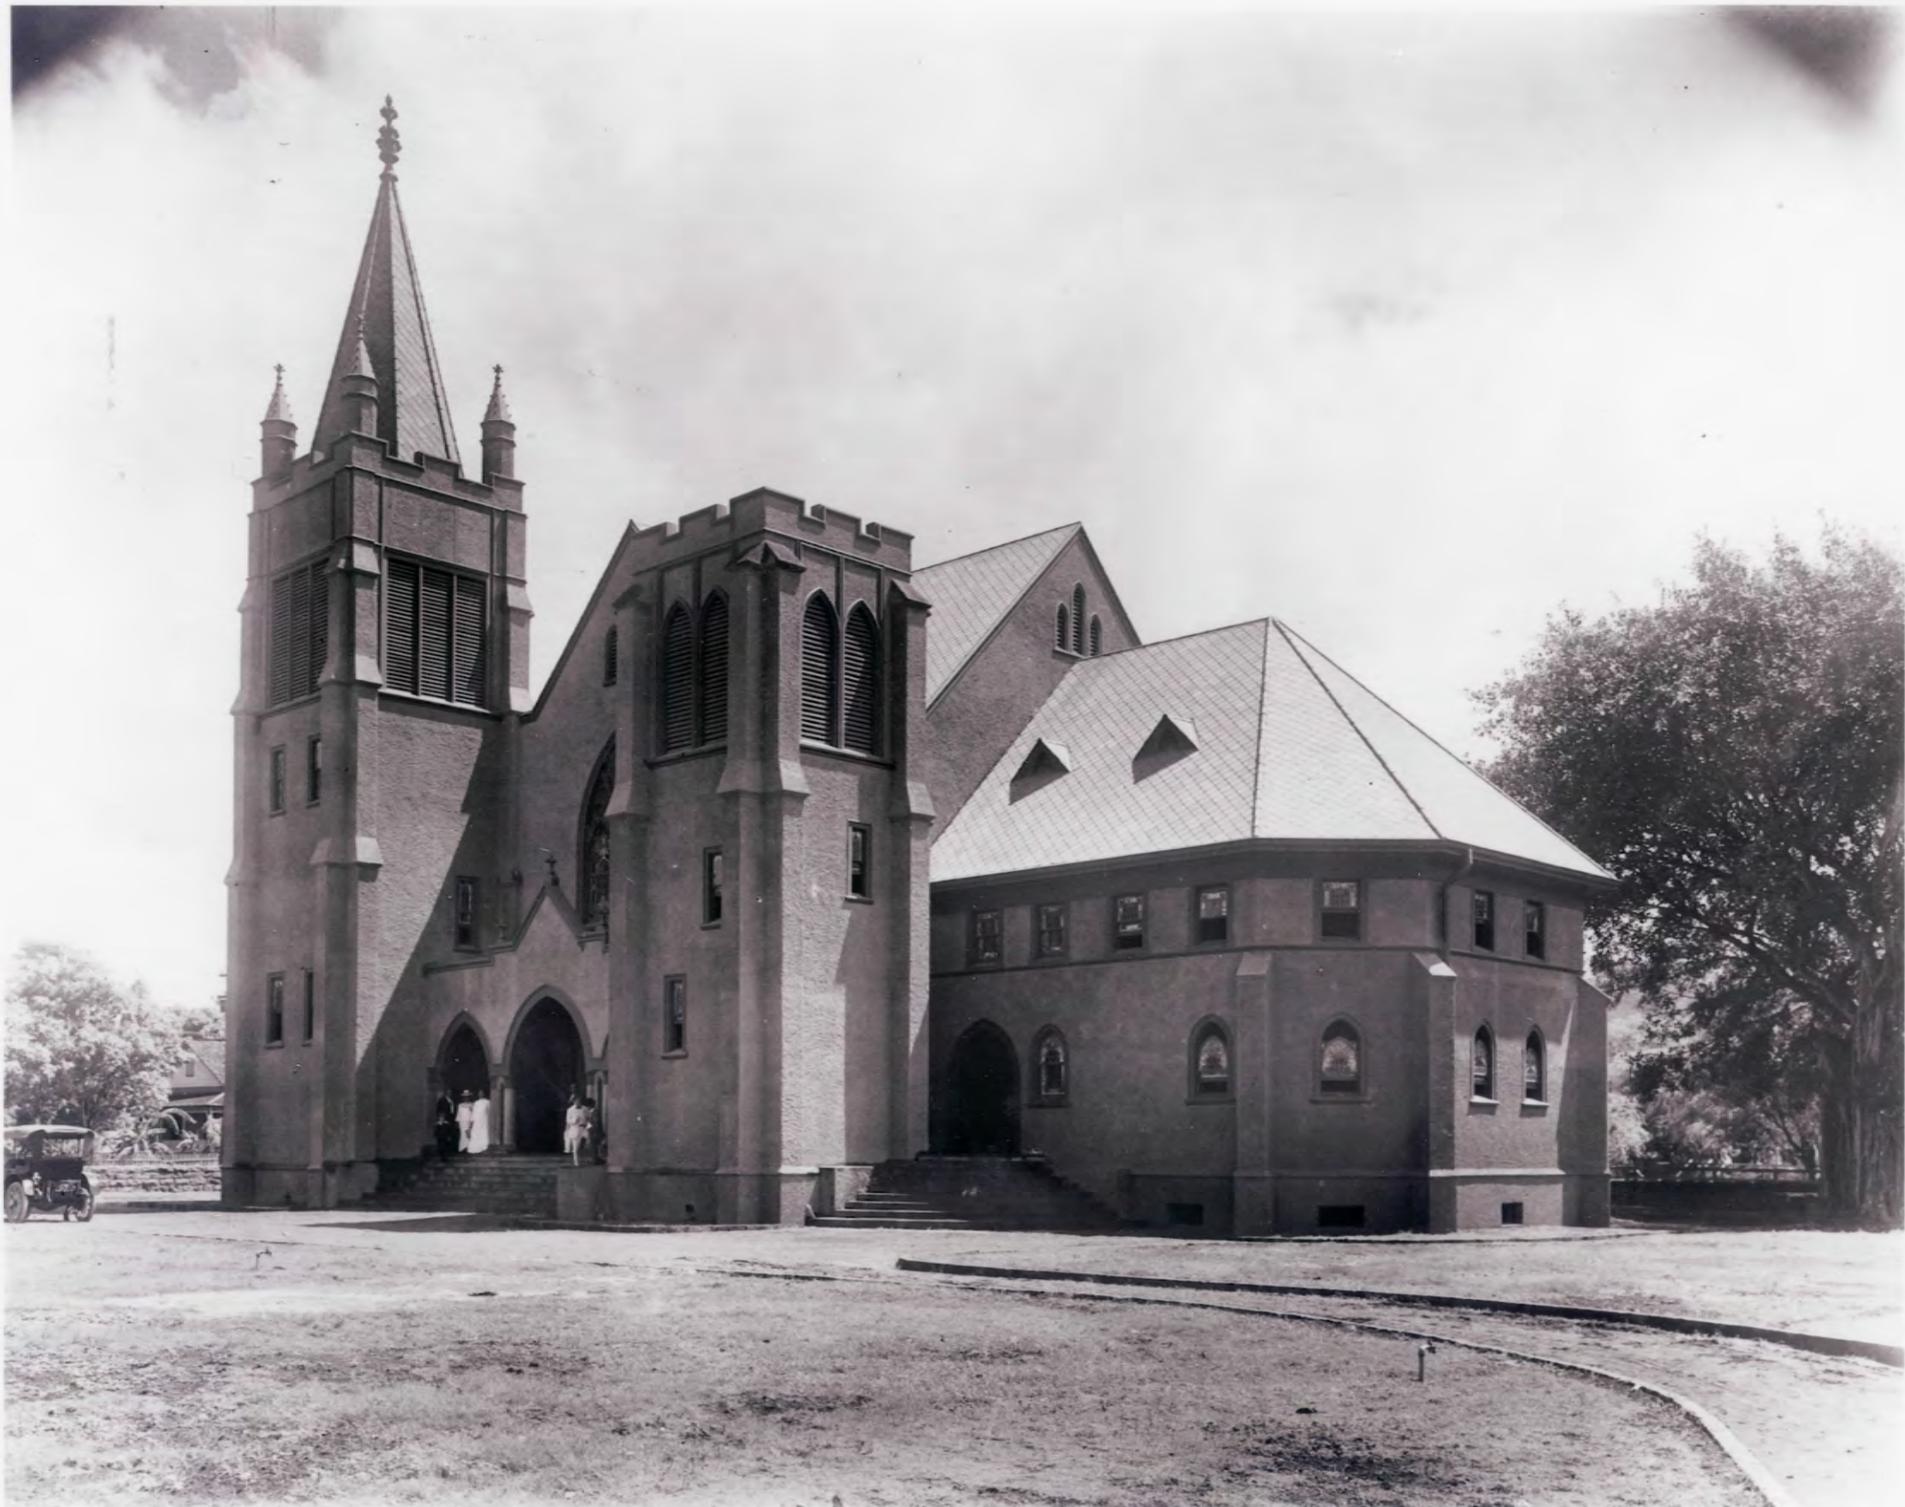
Kaunakapili Church
Honolulu County, Hawaii
Photographer unknown
ca. 1911
Kaunakapili Church Photo Collection
Kaunakapili Church
Photo No. 1

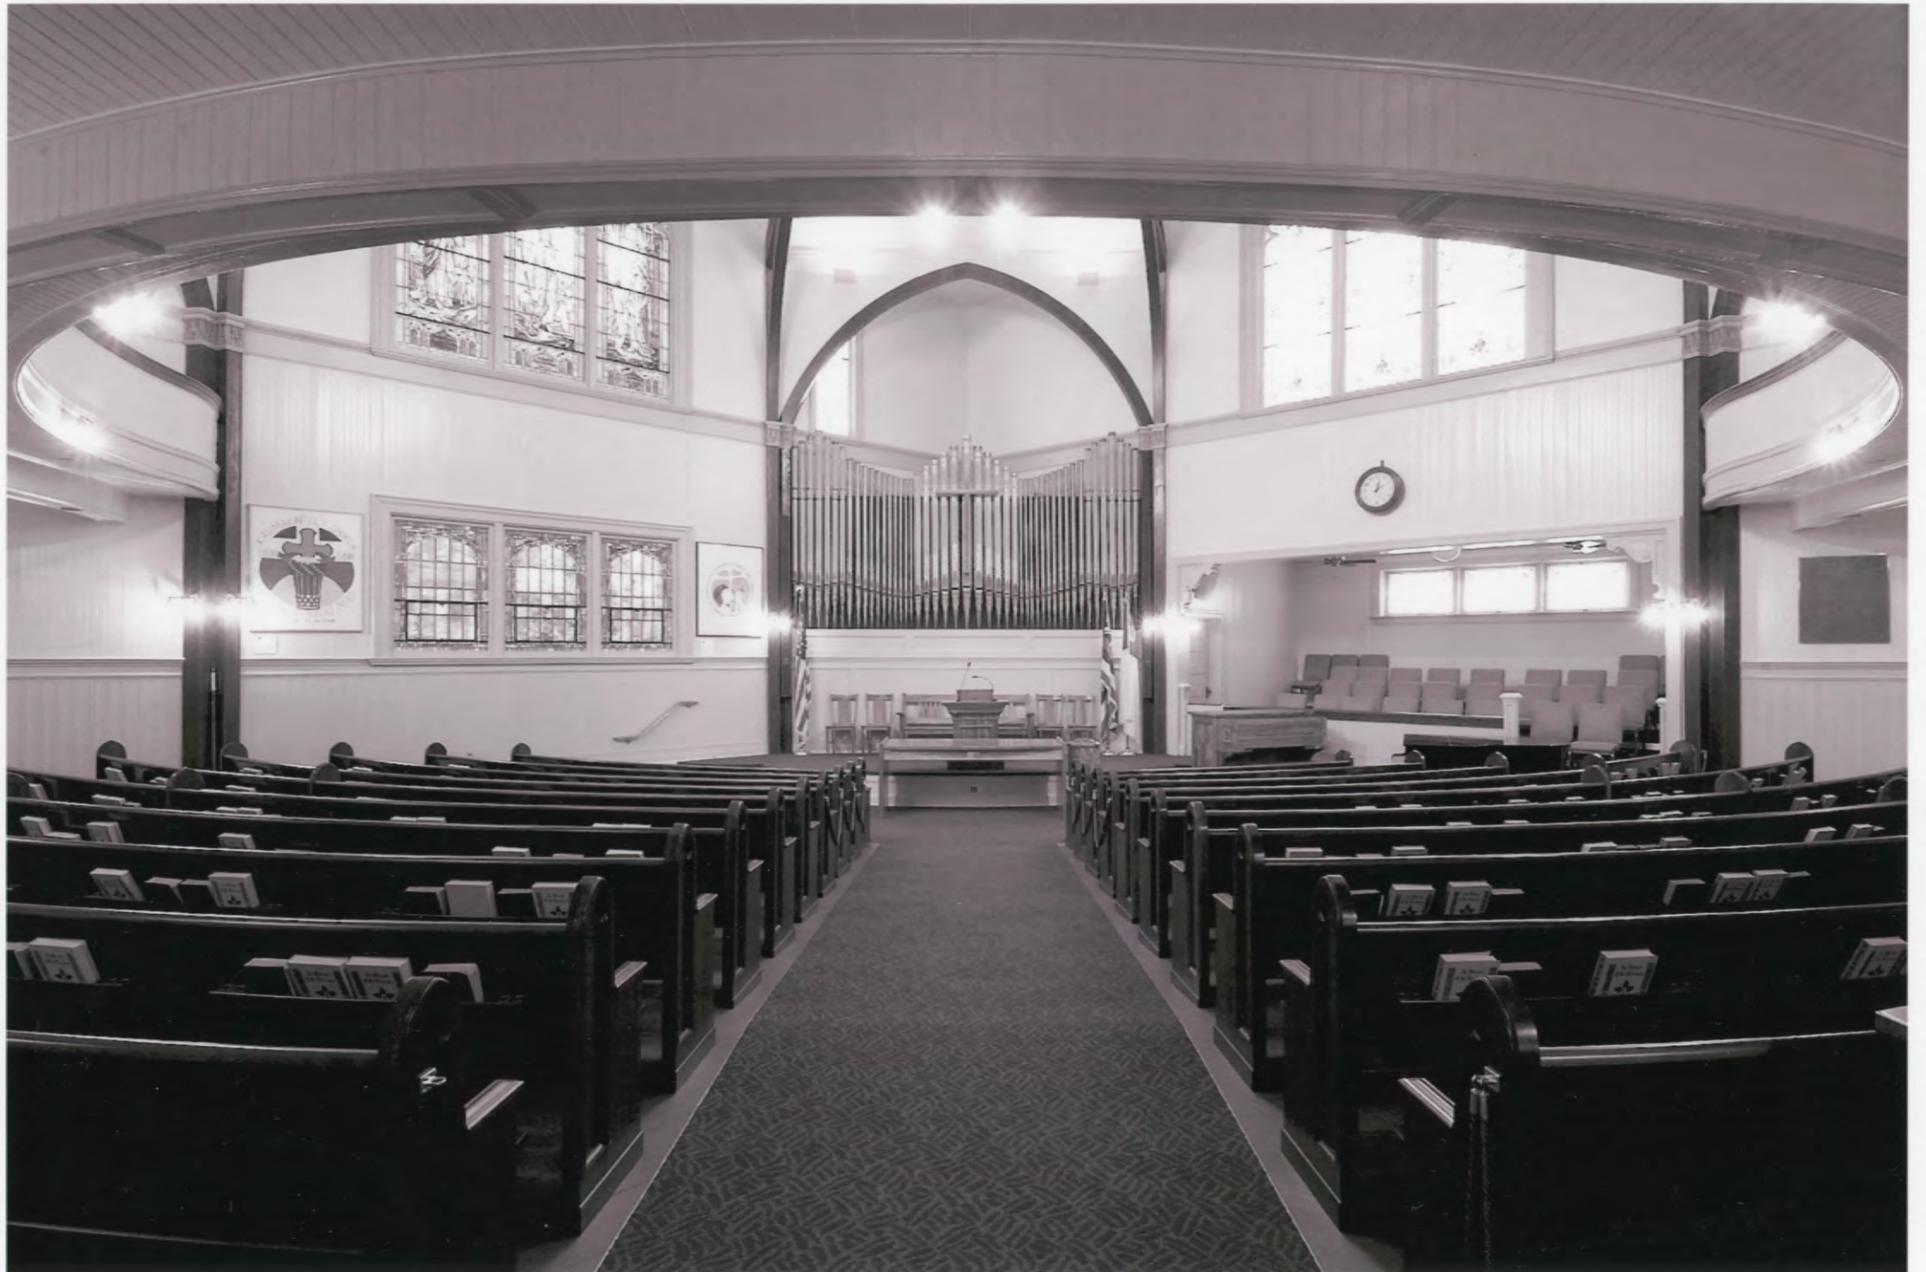
Kaunakapili Church
Honolulu County, Hawaii
David Franzen
2004
Franzen Photography
Sanctuary
Photo No. 2

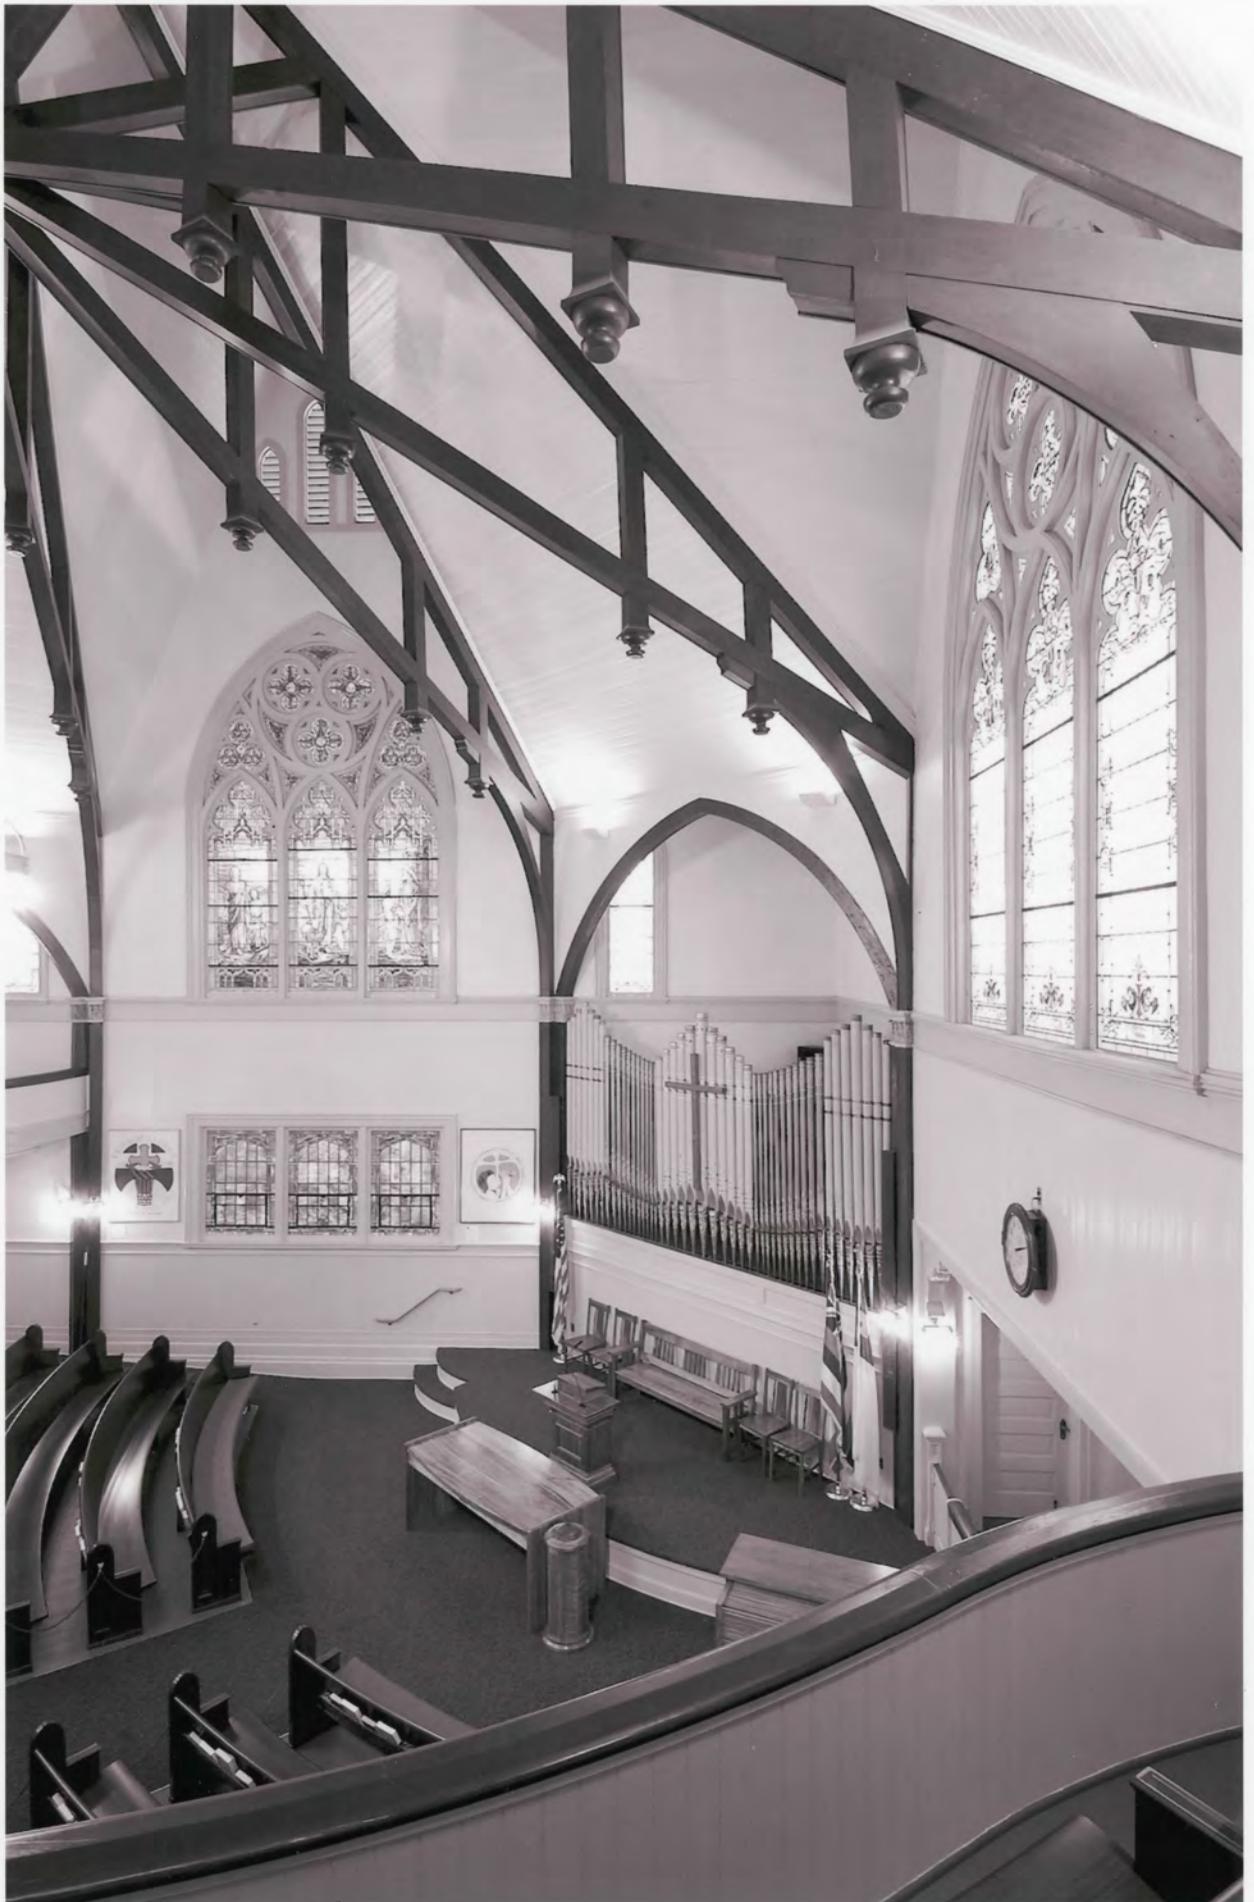
Kaumakapili Church
Honolulu County, Hawaii
David Franzen
2004
Franzen Photography
Sanctuary from balcony
Photo No. 3

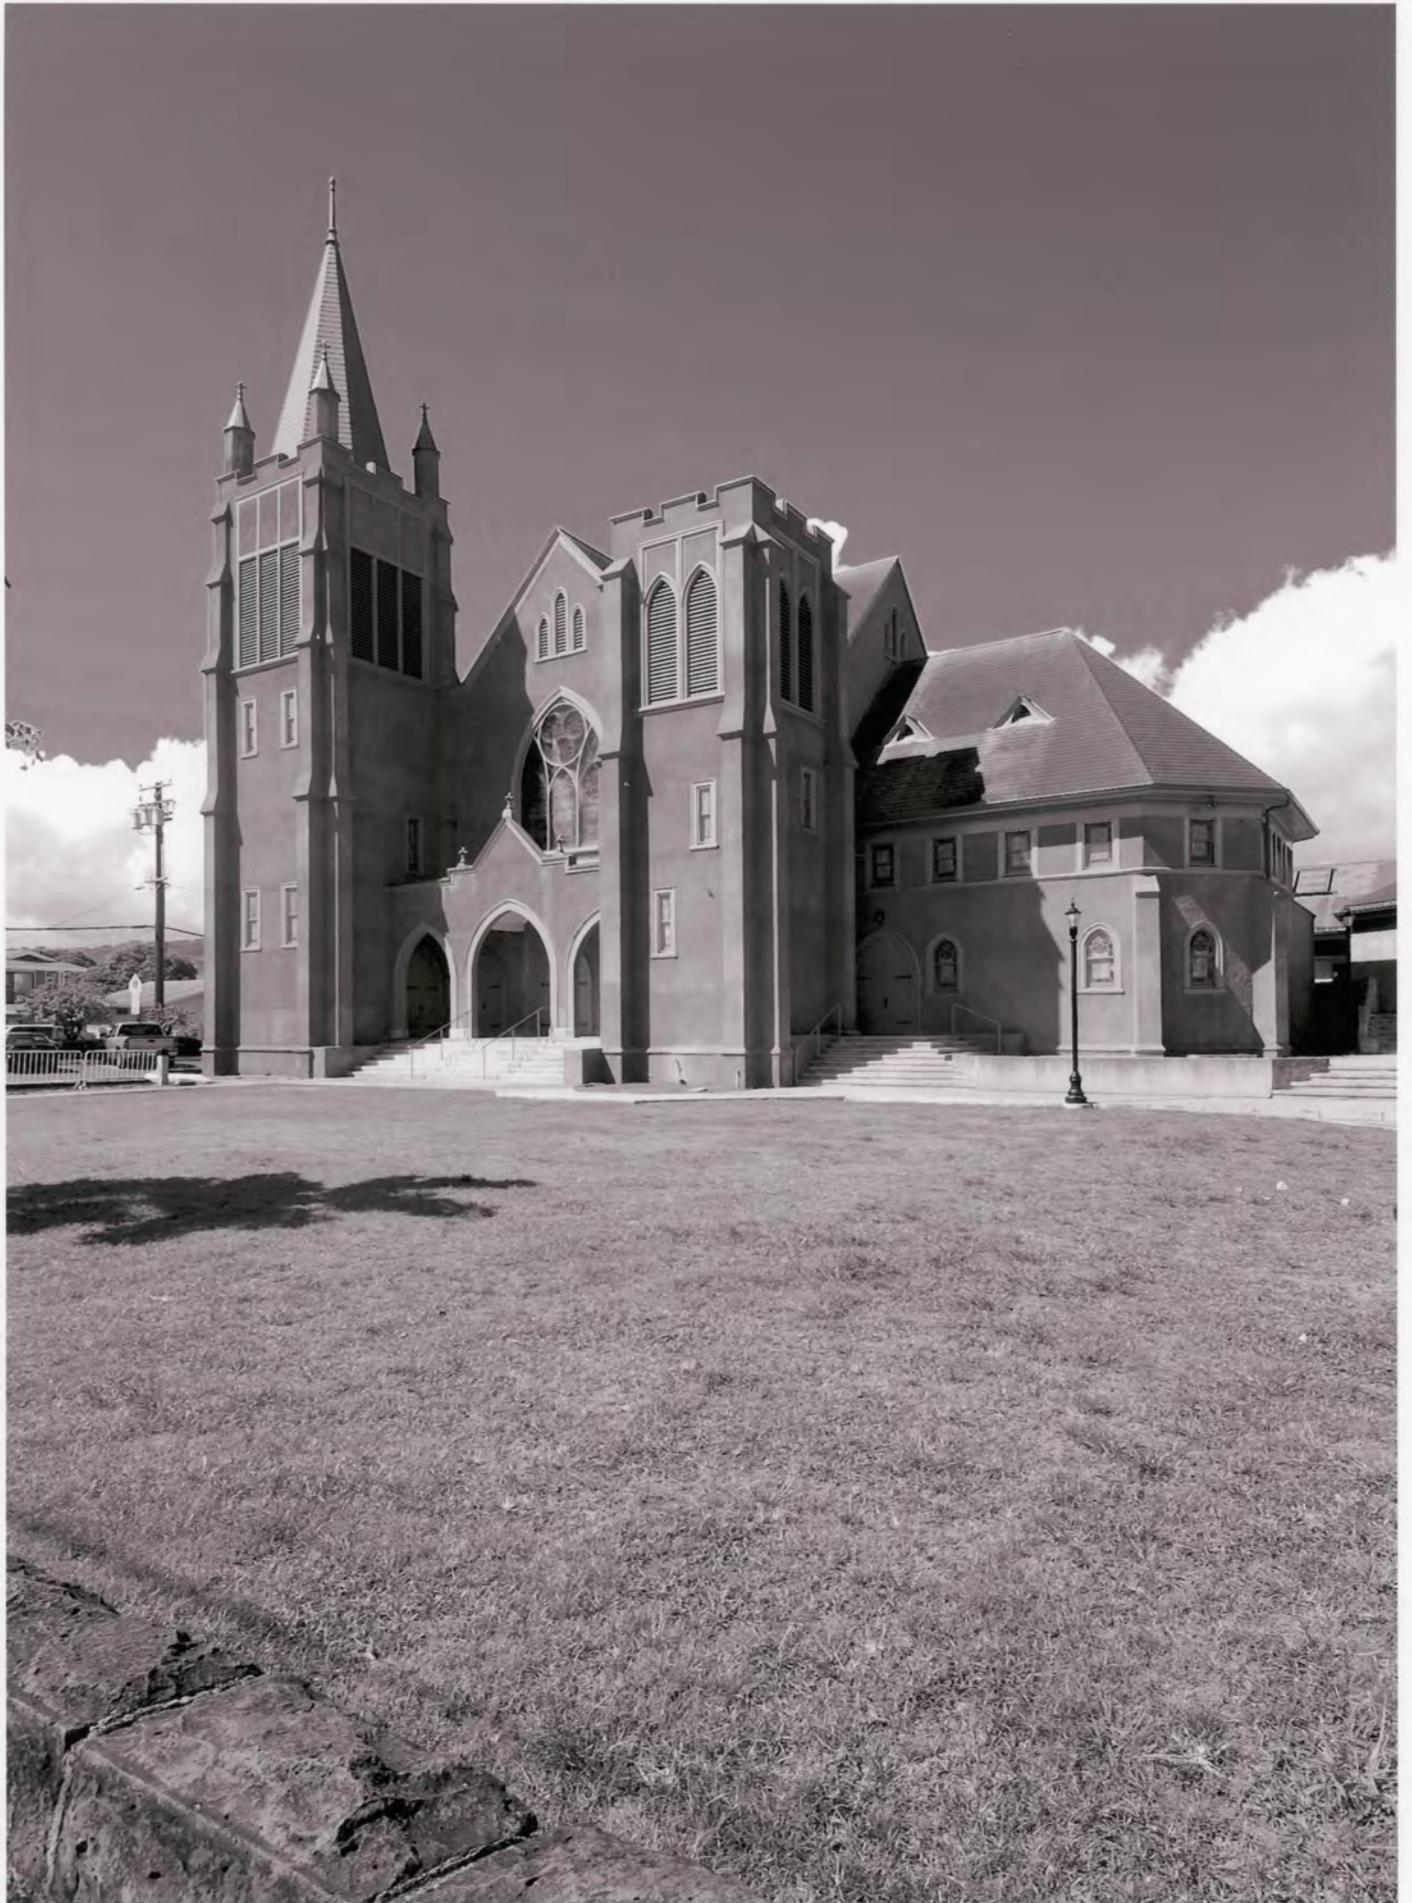
Kaunakapili Church
Honolulu County, Hawaii
David Franzen
2004
Franzen Photography
Exterior of Church
camera facing north
Photo No. 4

The Gothic Revival-style church is the most prominent feature of the urban Kalihi-Pālama neighborhood. The bell tower steeple with its bronze finial stands 96 feet above the surrounding properties. The campus features an expanse of grass lawn at the front of the building bordered by two paved parking lots and is surrounded by a low dressed-basalt wall with piers at the walk and driveway openings. The wall is a good example of local craftsmanship using a vernacular material (dressed basalt blocks or "lava rock").
