IDENTIFICATION SECTION

Site No.: 39-E-2 Morse House  
Site Name: Historic  
Common Morse House  
Field Recorder: RA/AV  
Date Recorded: 7/22/86  
Owner's Name: Chauncey B. Morse  
Street: 404 E. Main St.  
City/Town: Grandview  
County: Yakima  
Zip Code: 98930

# HISTORIC PROPERTY INVENTORY FORM

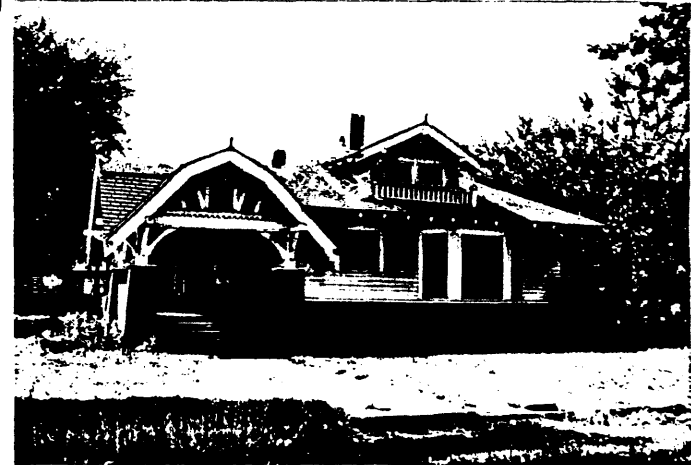
Photography Neg. No.: 5-28  
(Roll No. + Frame No.)  
View: North  
Date: 7/22/86

The Morse House is a wood frame bungalow composed of a hipped roof cube with a projecting front porch sheltered by a cross gambrel roof. The house rests on a brick foundation. The lower wall is brick, with battered brick piers at each corner. The upper walls are sided with clapboard except in the porch gable ends, which are sheathed with an unusual horizontal siding with stickwork applied in a radiating fashion. A first story bay window, with double hung sash and leaded glass, projects from the north facade. Gable roof dormers project from the north and south slopes of the roof. The dormers have exposed rafters, carved brackets, and multi-light fixed windows. The front porch is covered by a cross gambrel roof, supported by battered brick piers and heavy wood braces. Across the exterior, rafter tails are exposed. Carved finials top the gable peaks and a simple chimney stack straddles the roof ridge. A decorative metal ridge roll caps the roof. The

exterior doors have carved woodwork and a glazed upper panel. The well-preserved interiors include fir trim (baseboards, window and doors surrounds), a sliding door between living and dining areas, and two modest chandeliers.
