KENTUCKY HISTORIC RESOURCES
Individual Inventory Form

Resource # 50
Shelby County

1. Name of Resource: Swindler House
2. Original Owner: Unknown
3. Other Names: None
4. Prehistoric Site Building Object
Historic Site Structure Other
5. Location: West side of Mulberry-Eminence
Pike, 1/2 mile north of Stoney
Point Rd.

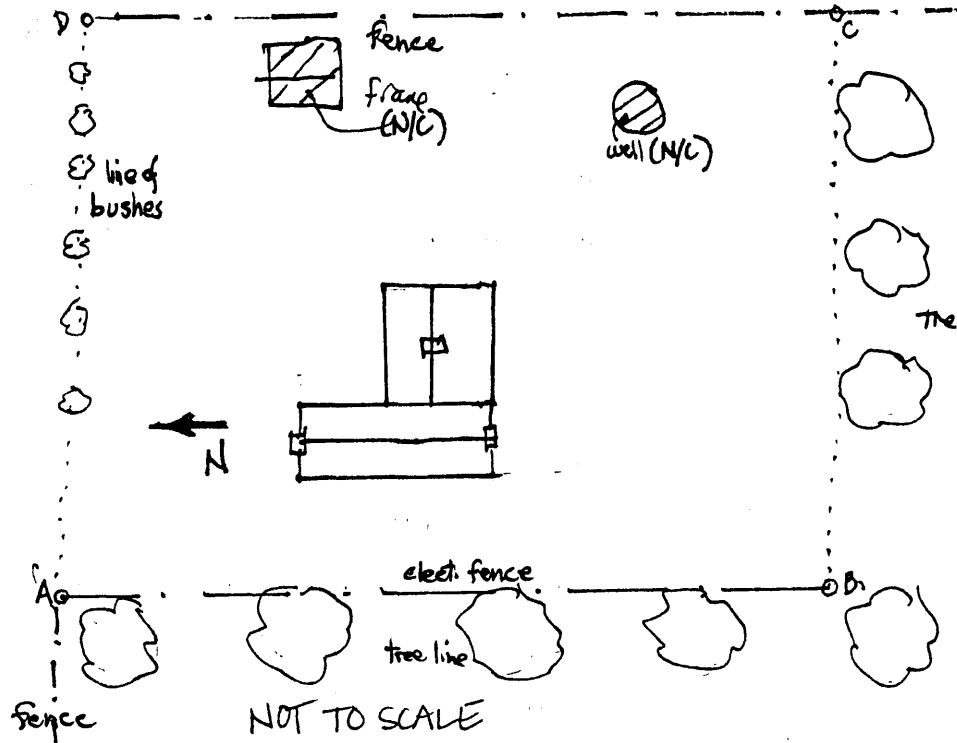
44. Site Plan (and boundary description and justification for N.R. sites):

Beginning at A, south 90' along a fence to B, thence west 100' along a line of trees to C, thence north 90' along a line of trees to D, thence east 100' along a row of bushes to the point of origin. The boundaries were chosen to encompass the house and its domestic space which is enclosed by fences, trees, and shrubs and contains one non-contributing frame out building of modern date.

Point A is the intersection of an electric fence line with a line of shrubbery, at the northwestern corner of the yard, and is 36 ft. northwest of the northwestern corner of the main block of the dwelling.

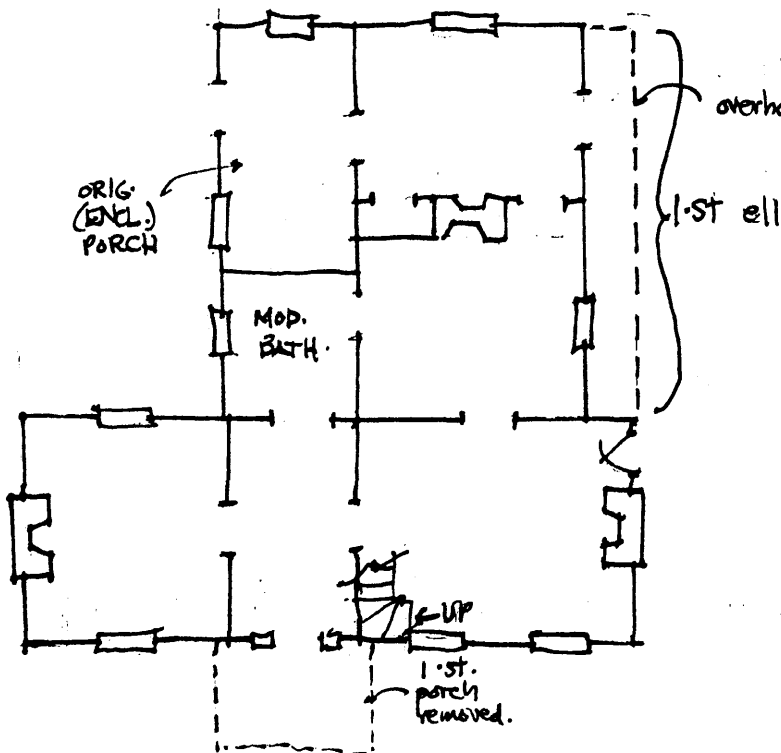
45. Description and House Plan:

2-story, 4-bay, brick, center-passage, single-pile plan, Flemish bond principal (west) facade, common bond on sides and rear, partially exterior end chimneys, 1-story ? wing removed from south gable end, 1-story, 2-room slightly offset brick ell, no arches over windows, original sash replaced on first floor with 2/2 sash, box cornice, 4-pane sidelights flank 9-panel front door, porch enclosed on north side of ell.

Enclosed stair removed from north side of passage, enclosed stair in northwest corner of south room opens into south room, chair rails, ceiling lowered, federal moldings, mantels contain central tablet with sunburst and reeded pilasters in both north and south rooms, modern kitchen in east room of ell.
