**HISTORIC RESOURCES INVENTORY
BUILDING AND STRUCTURES**

**STATE OF CONNECTICUT
CONNECTICUT HISTORICAL COMMISSION**

1. BUILDING NAME (Common)		(Historic)	
Eliphalet Howd House			
2. TOWN/CITY		VILLAGE	COUNTY
Branford			New Haven
3. STREET AND NUMBER (and/or location)			
675 East Main Street Map J4, Block 2, Lot 4

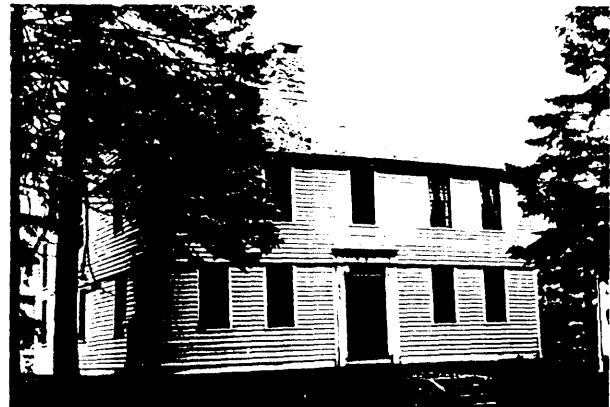
North & East Elev.

Constructed on a nearly-square plan with its ridge parallel to the street, this structure has a steeply-pitched roof (45° or 12:12) with a stone center chimney which straddles the ridge. The house has a five-bay, nine window facade with twelve-over-twelve sash. It has hewn overhangs of both the second floor and the attic story. The entry has a pair of paneled doors with a glazed transom, flanked by pilasters and capped by a decorated frieze and projecting cornice. The gable ends have five windows, suggesting a five-room plan. The exterior is finished with clapboards on all sides; the box cornice at the street facade features a row of dentil moldings.
