NATIONAL REGISTER OF HISTORIC PLACES NOMINATION, GLACIER NATIONAL PARK

STRUCTURE NAME: Walton Ranger Station/Residence      STRUCTURE NUMBER: 126

### National Register of Historic Places Continuation Sheet

Walton Ranger Station Historic District (addendum), Flathead County, MT.

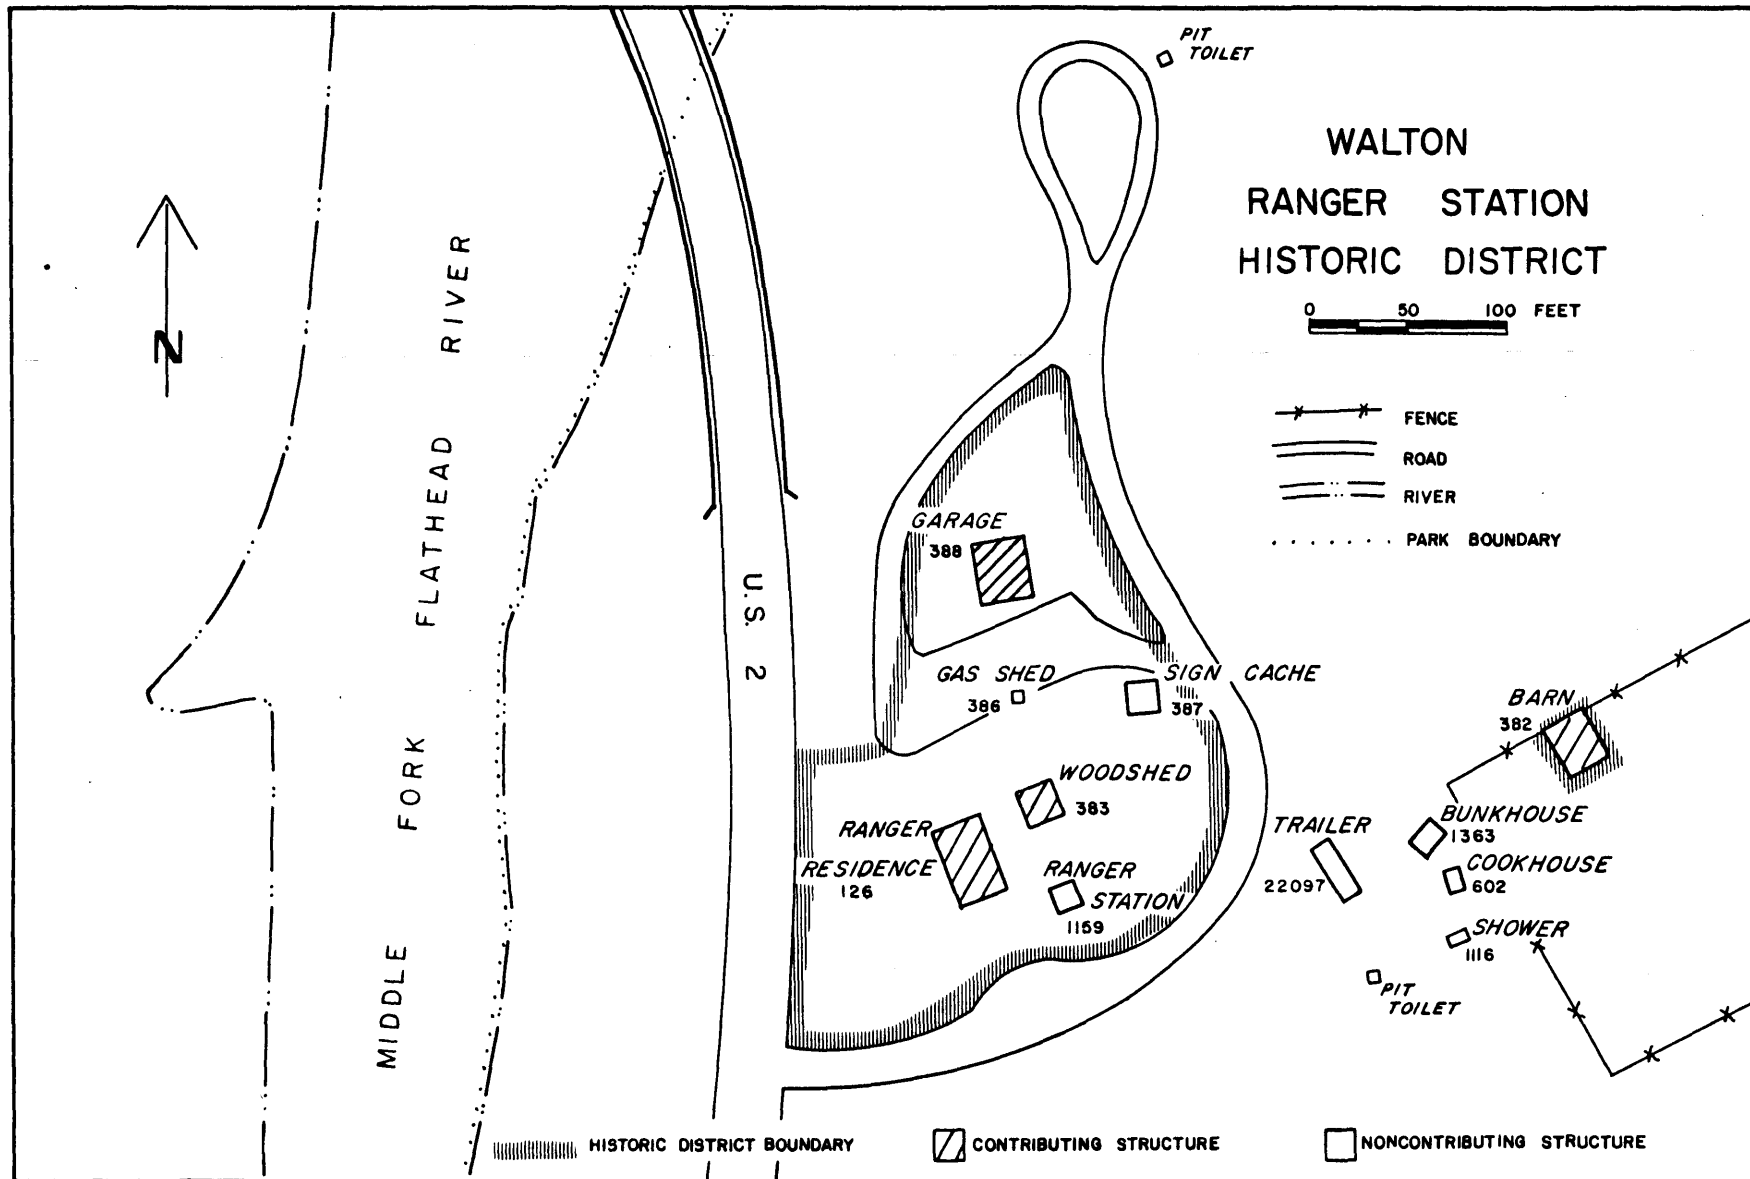
The following buildings are listed in the National Register of Historic Places as contributors to the Walton Ranger Station Historic District. Additional documentation is provided below for the purpose of describing and evaluating building interiors for integrity and significance. Changes to the historic district since nomination are also addressed below and on the attached modified site map.

This small building, evaluated as noncontributing in 1986, was removed from the historic district at an unknown date. A modified site map is attached.
