KENTUCKY HISTORIC RESOURCES  
Individual Inventory Form

Resource # 60  
Shelby County

1. Name of Resource:  
Bird Octagonal Mule Barn

34. Prepared by: C. Worsham

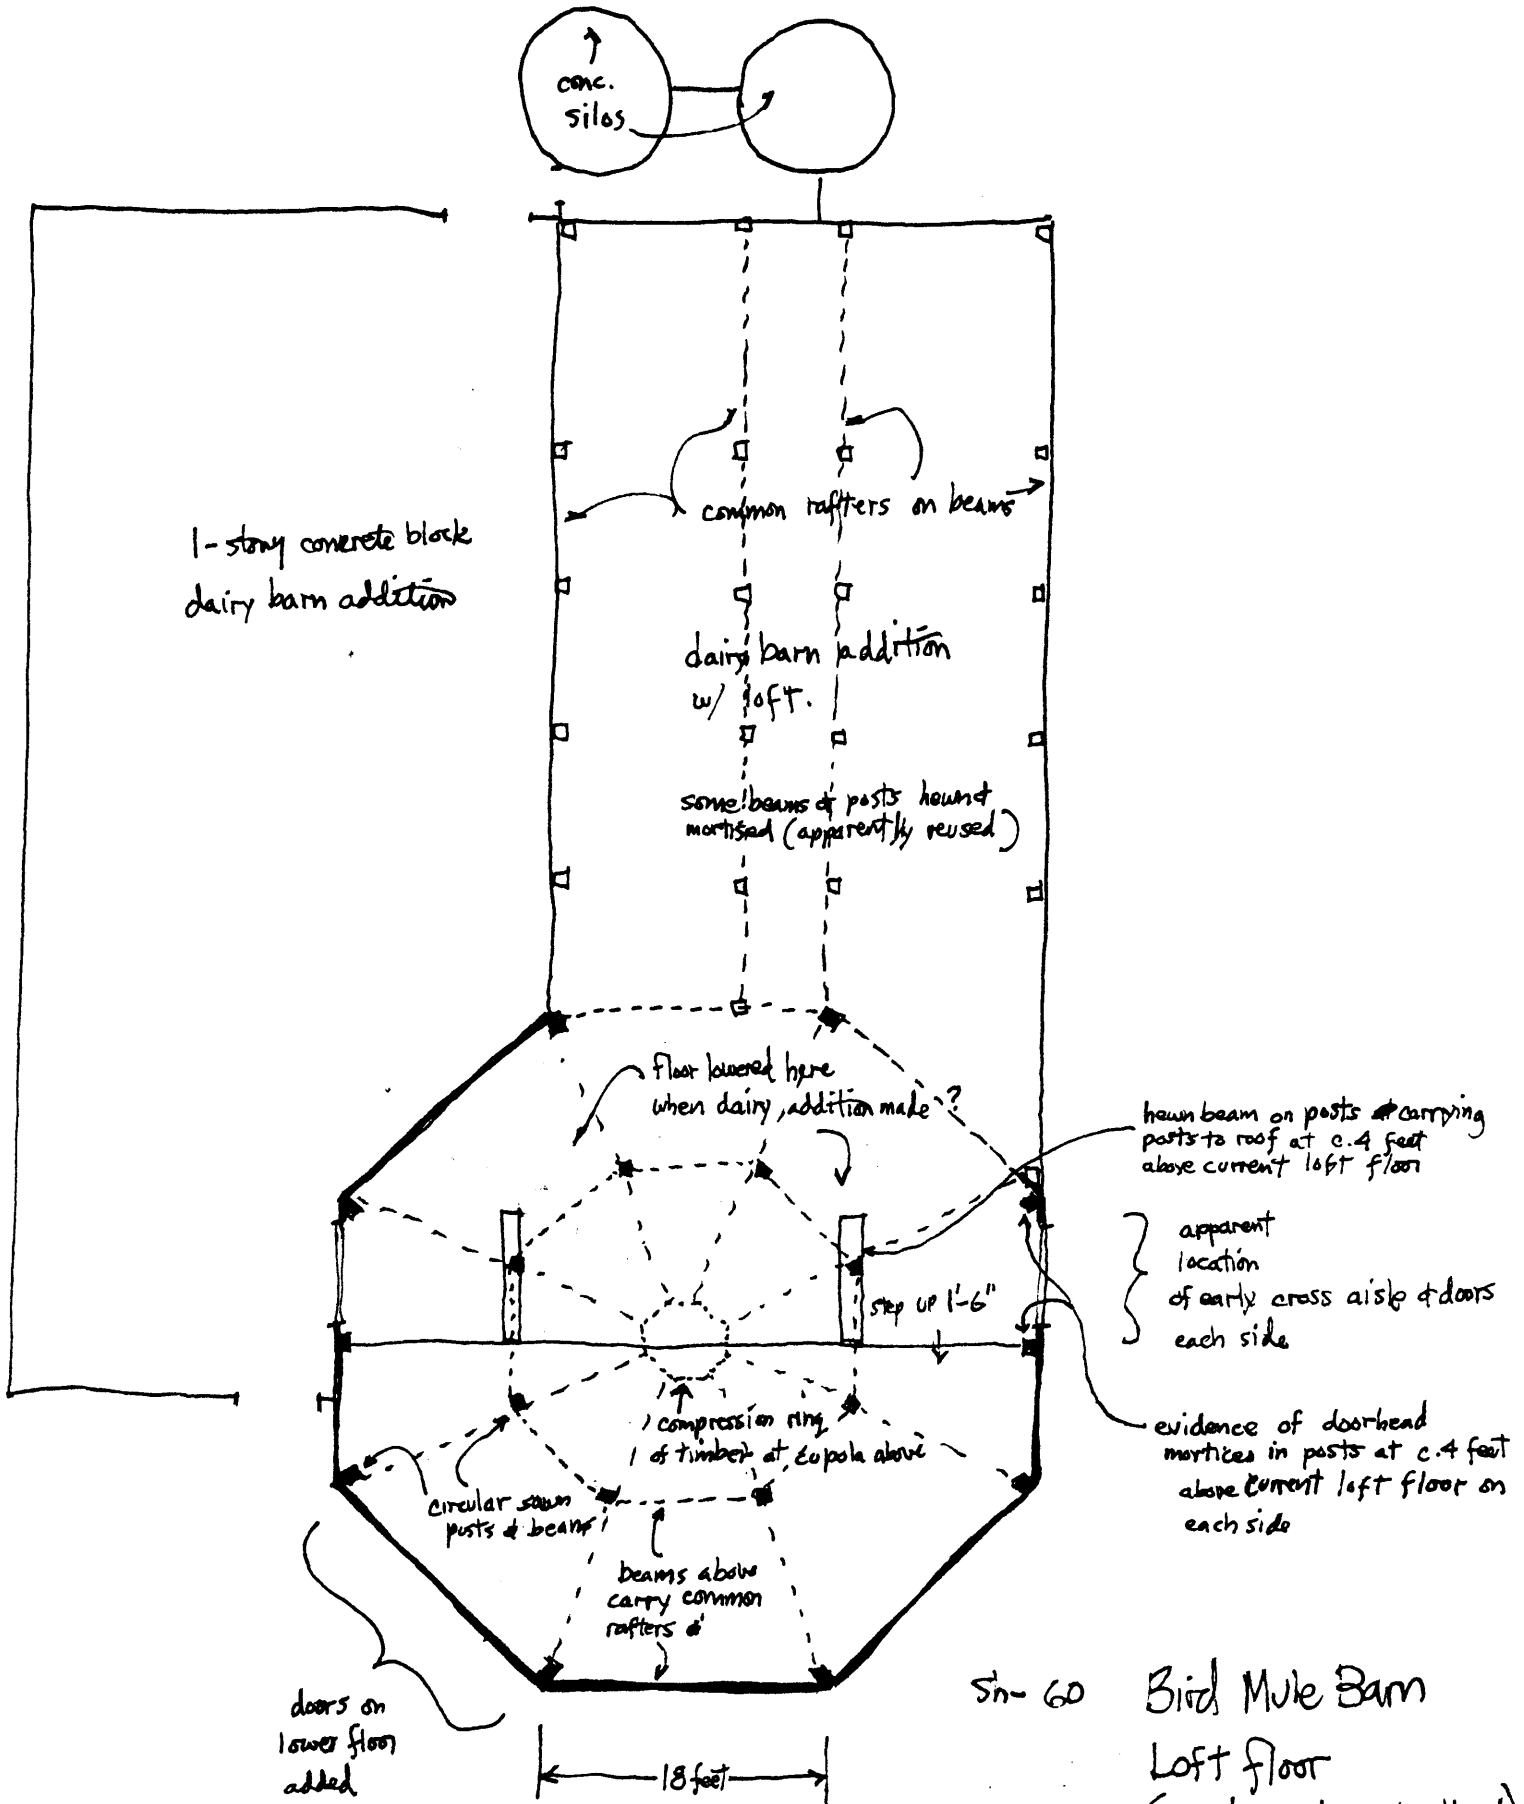
Sh- 60 Bird Mule Barn  
Loft floor  
(ground level much altered)  
Shelby County, Kentucky  
NOT TO SCALE

Octagonal frame barn. Ground floor now altered beyond interpretation. Loft area well preserved. Inner octagon of posts provides intermediate support for a common-rafter roof. Cupola in center carried on a compression ring. Evidence of ca. 9 foot-wide aisle includes change in loft floor level and beams spanning its location to carry posts above which would have impeded movement through it (see plan). Similar in several respects to dairy barns reported in New York State, showing influence of late nineteenth-century publications of agricultural societies and promoters of octagonal barns as economical and efficient forms to build and operate.\* It may have had a combination of a central plan with a transverse aisle. Scalloped vergeboards around barn above vertical-board siding on barn and central cupola. Asphalt shingle roof. Rectangular frame dairy barn addition to north with connected silos. Concrete block dairy barn extension to west.

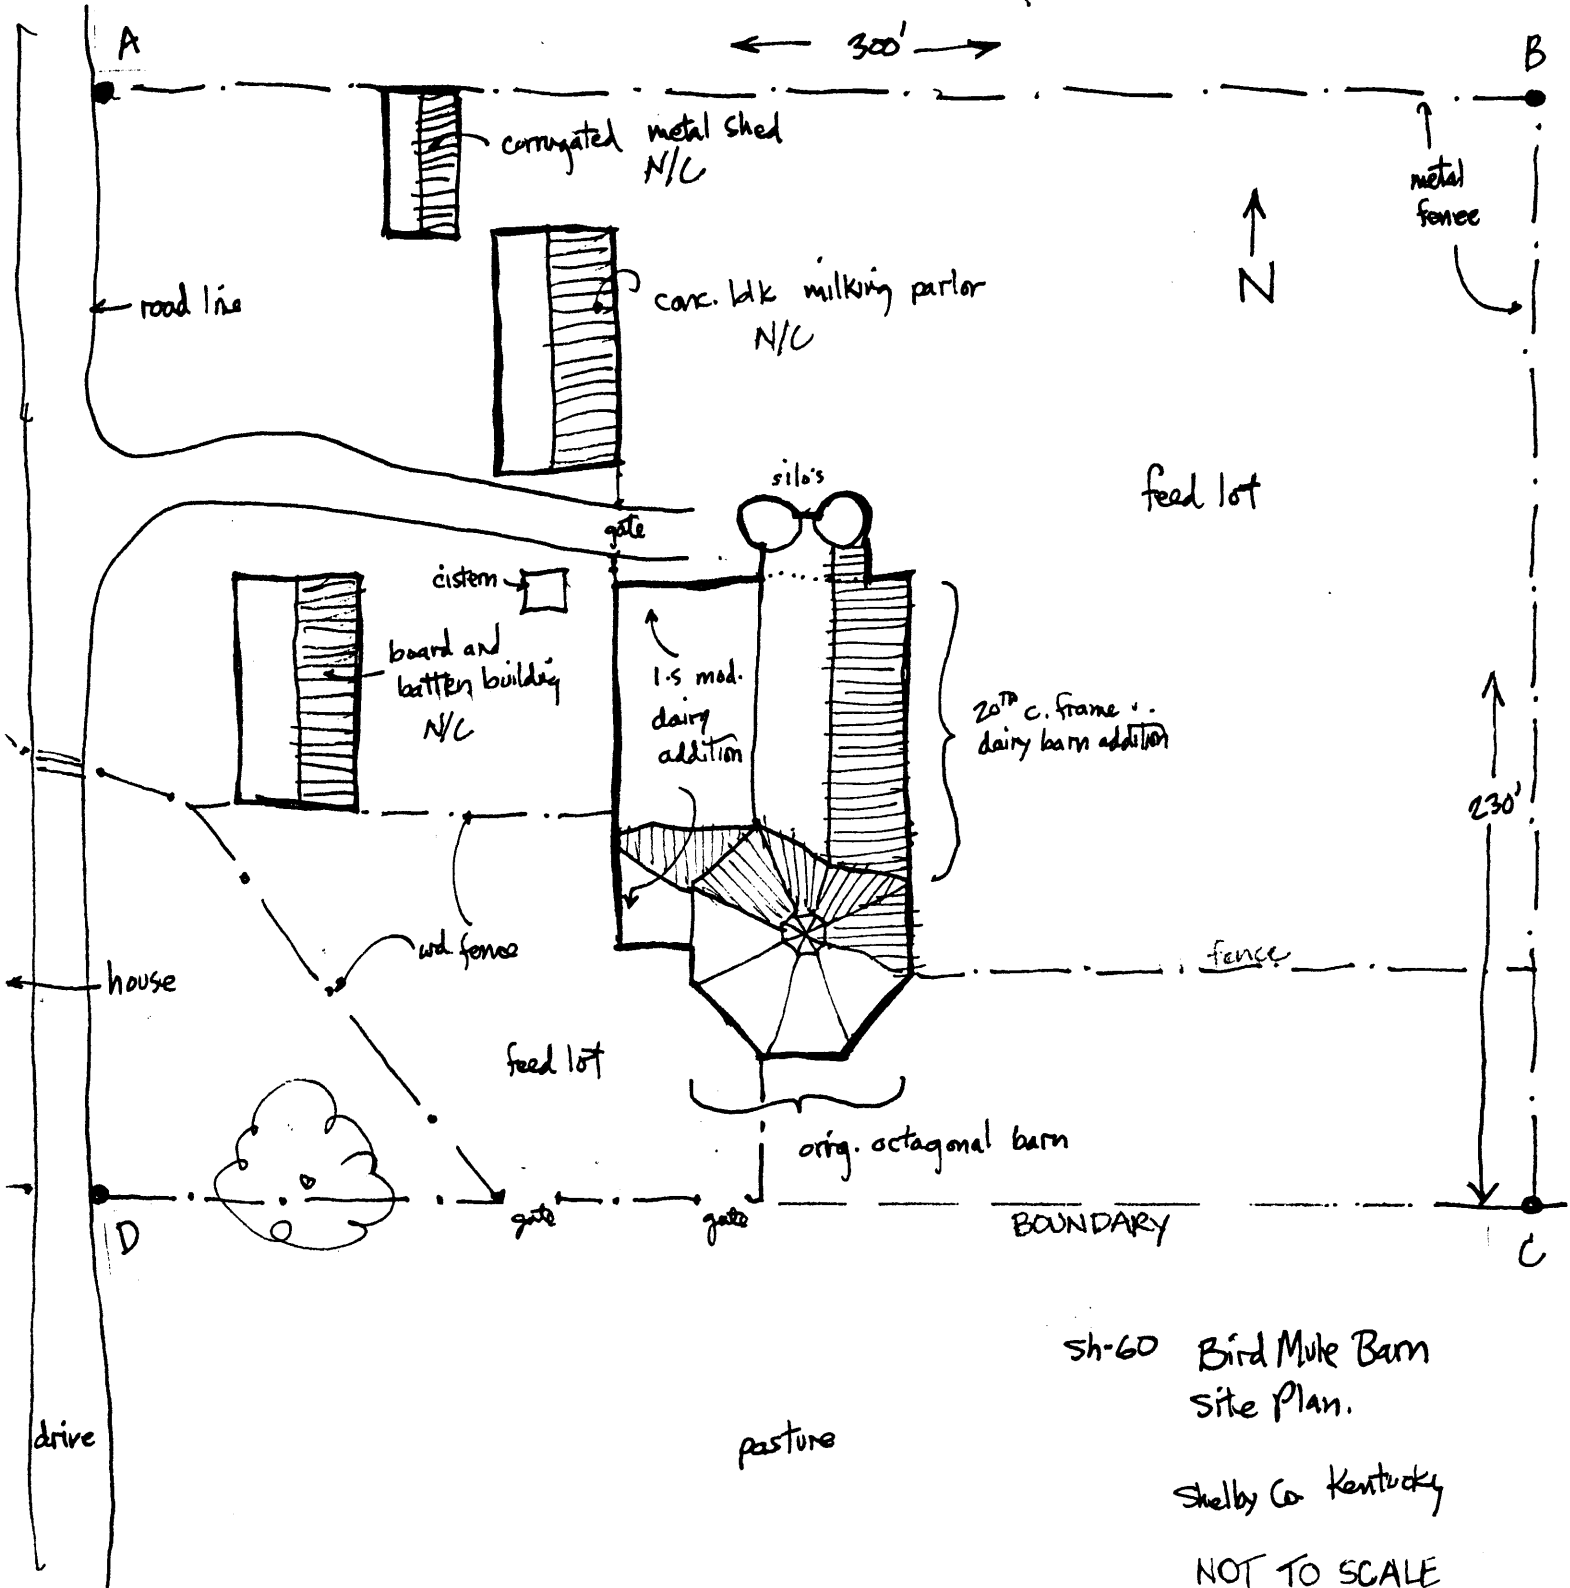
Sh-60 Bird Mule Barn  
Site Plan.

Beginning at Point A, at the intersection of the eastern edge of the main farm road and the fence defining the northern extent of the barn-associated lot, 300 ft. eastward along fence to intersection with another fence at B; 230 ft. southward to C; 300 ft. westward along a fence and a line corresponding to an extension of the fence to the eastern edge of the main farm drive at D; 230 ft. northward along said edge of said drive to point of origin.

The boundaries were drawn to include the barn and its setting of adjacent feed lots as defined by fences. The area also includes a concrete block milking parlor, a corrugated metal shed, and a frame board-and-batten building, all of which, though modern, relate directly to the current operation of the barn. Although they are non-contributing, these buildings could not be excluded from the boundaries without disrupting the relationship of the barn to the barn lot.
