Property Name: Double Arrow Lookout

National Register of Historic Places Registration Form

L-4 Fire Lookouts in the USFS Northern Region (Region 1), 1932-1967

Other: "Readicut" L-4 Lookout House

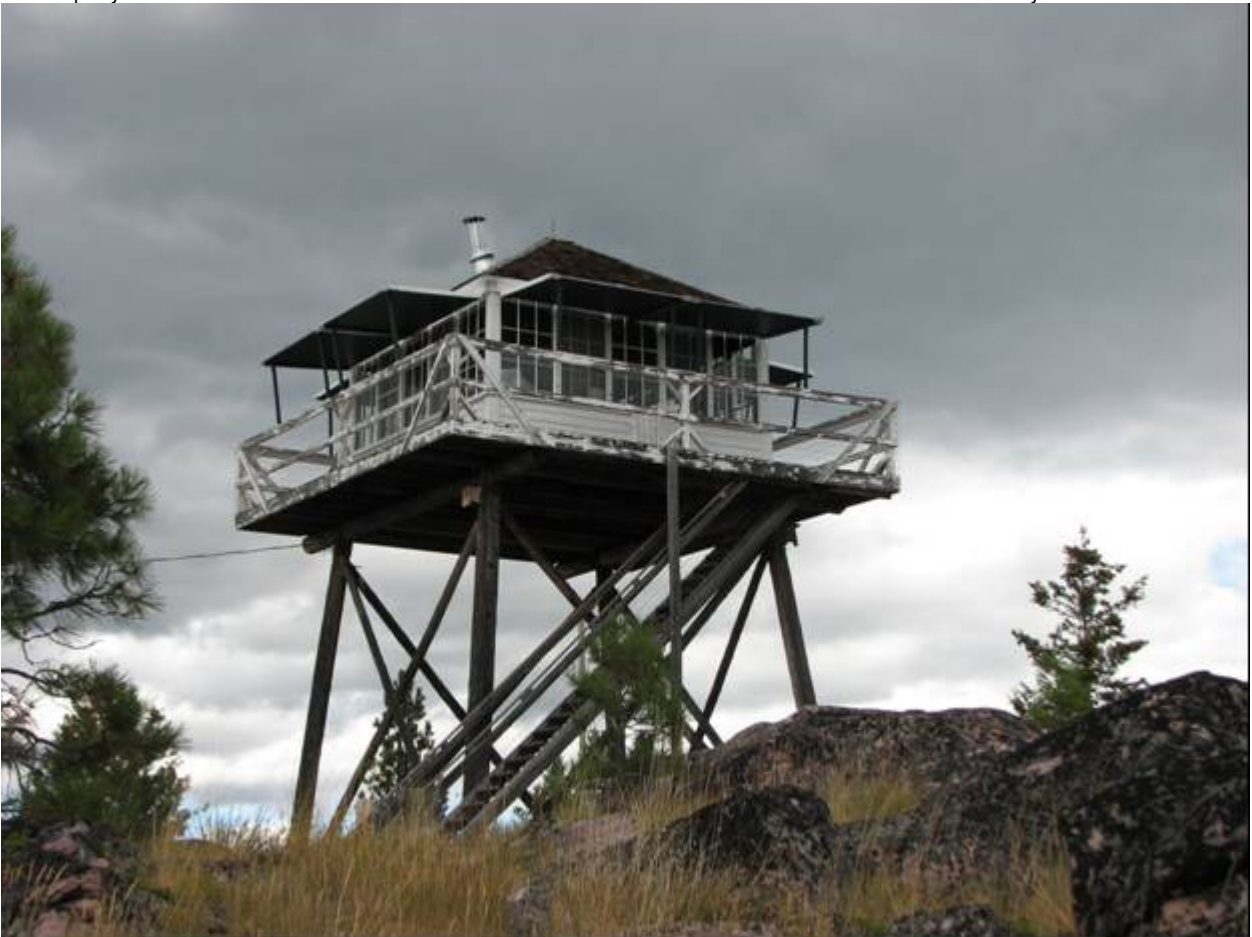
MT_MissoulaCounty_DoubleArrowLookout_0001. Looking northeast to the west and south walls of the Double Arrow Lookout.

Double Arrow Lookout (one contributing building). The Double Arrow Lookout is a 14 ft. by 14 ft. wood frame building with a pyramidal roof built atop a 20 foot-high, log tower. Simple drop wood siding covers the lower portion of the exterior walls, and the roof is covered with sawn cedar shingles.¹ A new stainless steel stove pipe extends above the west slope of the roof. The entry into the lookout house is located at the south end of the wall that faces east-northeast, and contains a wood door with six lights above a narrow panel. A ribbon of four, nine-light windows occupy the area above the lower wall north of the door. The remaining three walls each contain a ribbon of five, nine-light window units, two of which slide sideways allowing ventilation. Openings for the sliding sashes have been fitted with removable, wood-frame screens that can be attached to the exterior of the building.

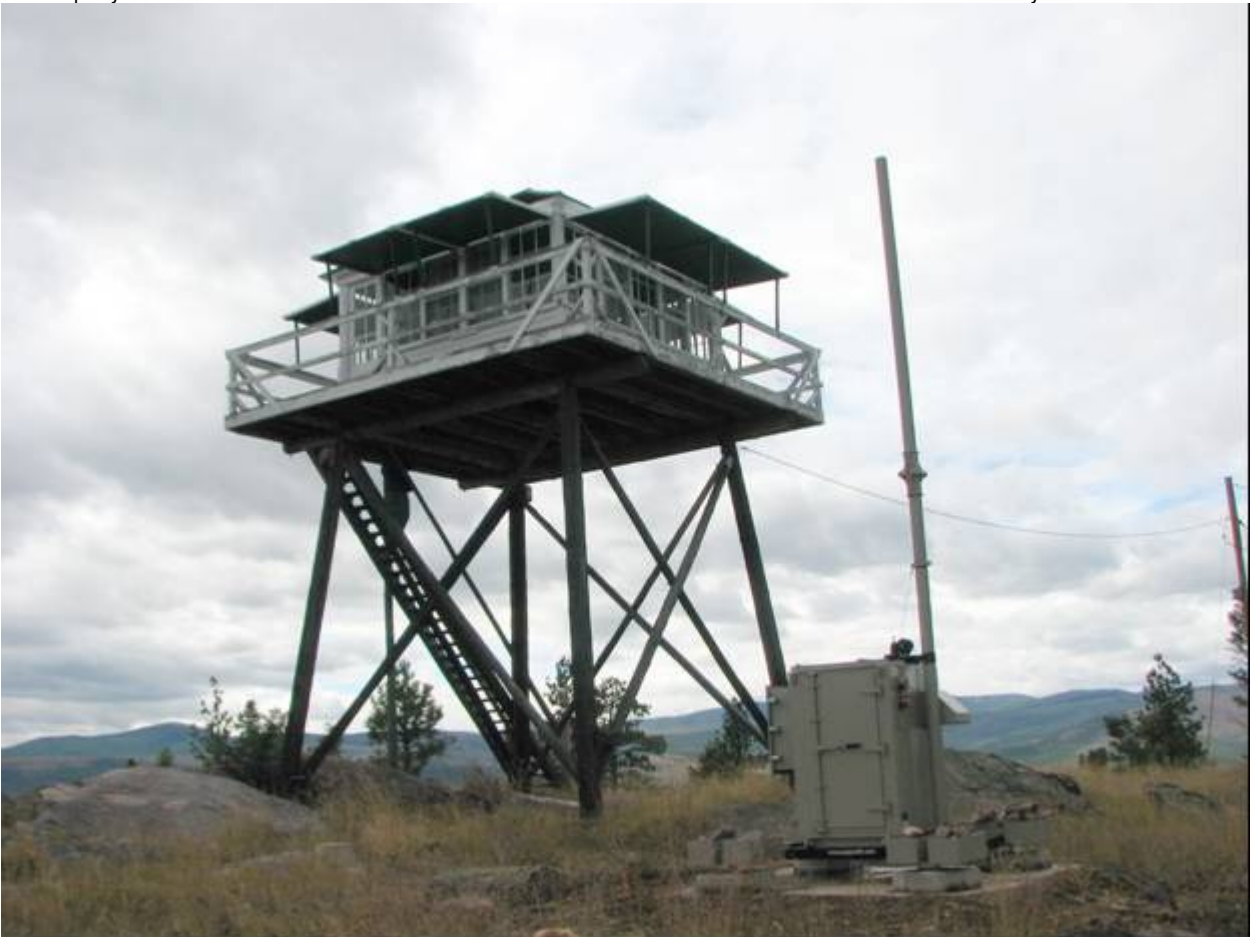
MT_MissoulaCounty_DoubleArrowLookout_0002. Looking south-southwest to the east (front) and north walls of the Double Arrow Lookout. Radio relay equipment in foreground.

Radio Equipment Box (one noncontributing structure). The steel radio equipment box stands about 4 ft. tall and measures about 2 ½ ft. square. It rests on four small concrete blocks

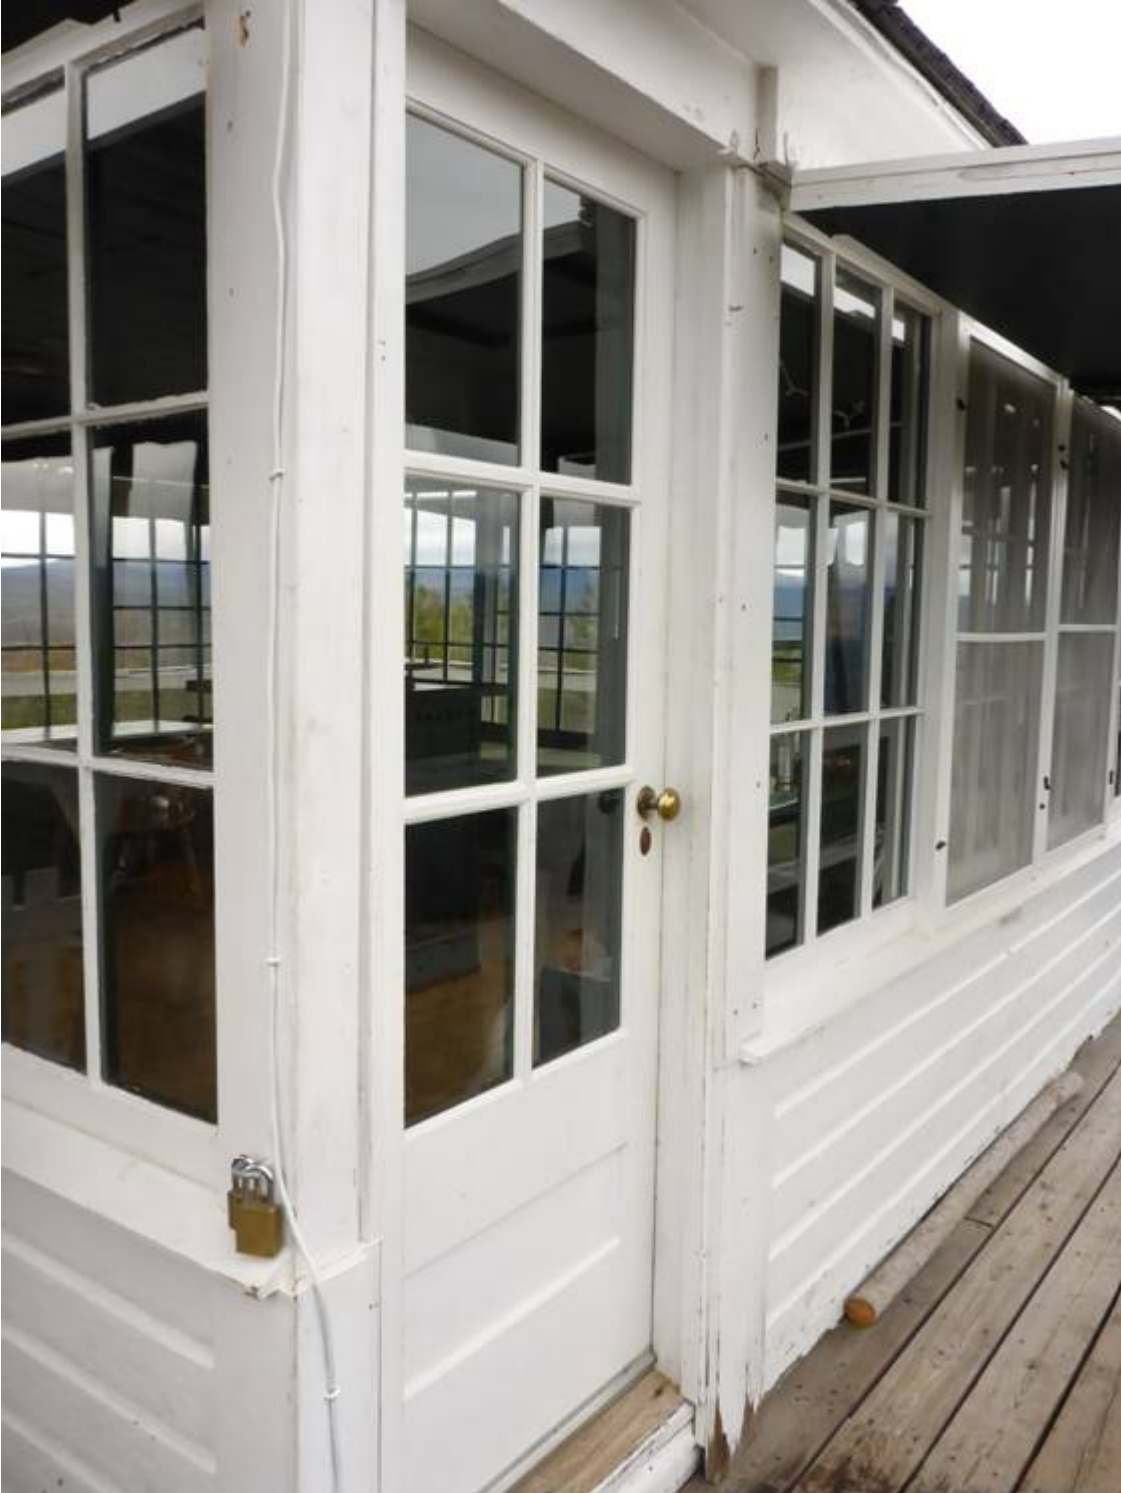
MT_MissoulaCounty_DoubleArrowLookout_0003. Detail of the door, located at the south end of the east wall.

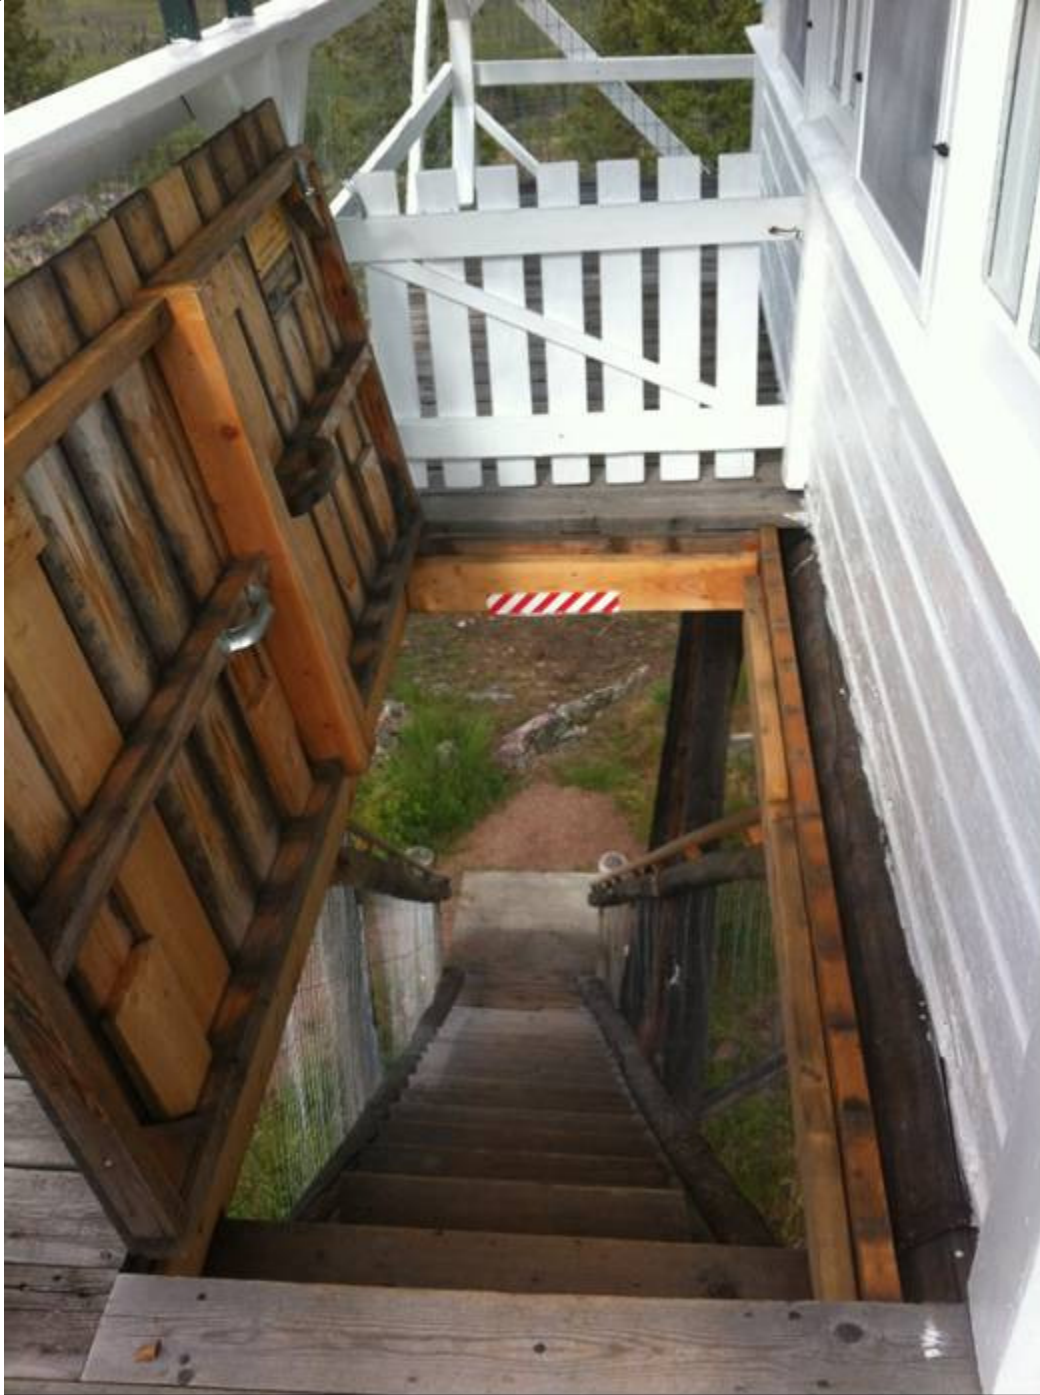
MT_MissoulaCounty_DoubleArrowLookout_0004. Looking down the stair through the open trapdoor.

The four legs of the cross-braced tower have concrete footings. A single-flight stairway leads from the southwest corner of the tower to a trapdoor in the catwalk. The stairs have log stringers and board treads. Pole handrails are located on both sides of the stairs, and wire mesh has been attached to the stringers and handrails as a safety measure. At the top of the stairs a trapdoor provides access to the catwalk. A low gate with a spring hinge is located across the catwalk at the edge of the trapdoor.² Like the stairs, wire mesh ('hog wire') has been attached to the catwalk railing as a safety measure.

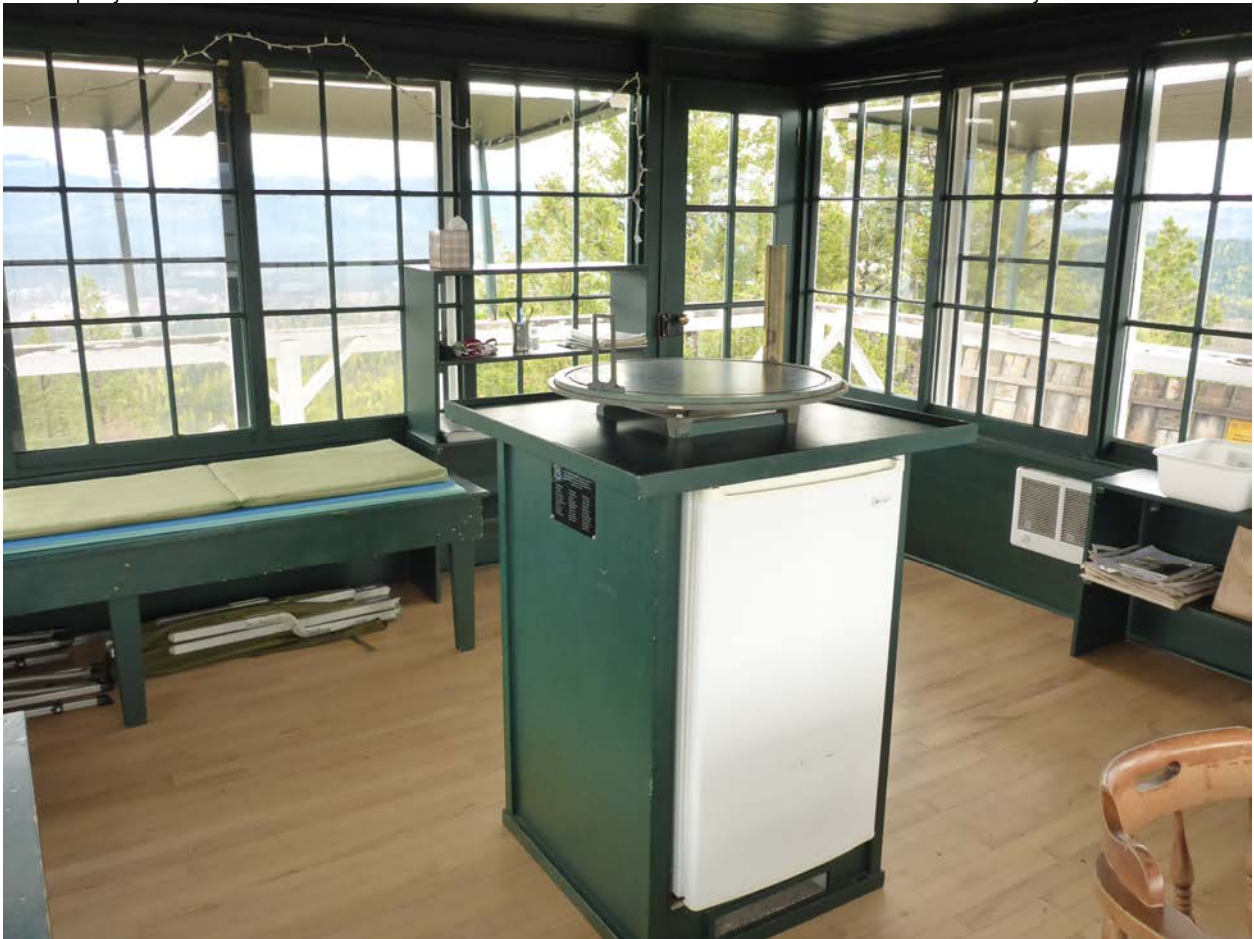
MT_MissoulaCounty_DoubleArrowLookout_0005. Interior of Double Arrow lookout house, view to east-southeast. Cabinet for refrigerator cleverly designed to look like the base for a fire-finder.

The one-room interior, designed to serve as a lookout man's quarters and work space, has few fixed elements. The original maple floor is in good condition. With the adapted reuse of the building as a cabin rental, the wood stove was removed and the building fitted with an electric wall heater. As originally built, a trap door in the ceiling led to a small storage compartment. A ceiling-mounted ladder that used to access the compartment has been removed.

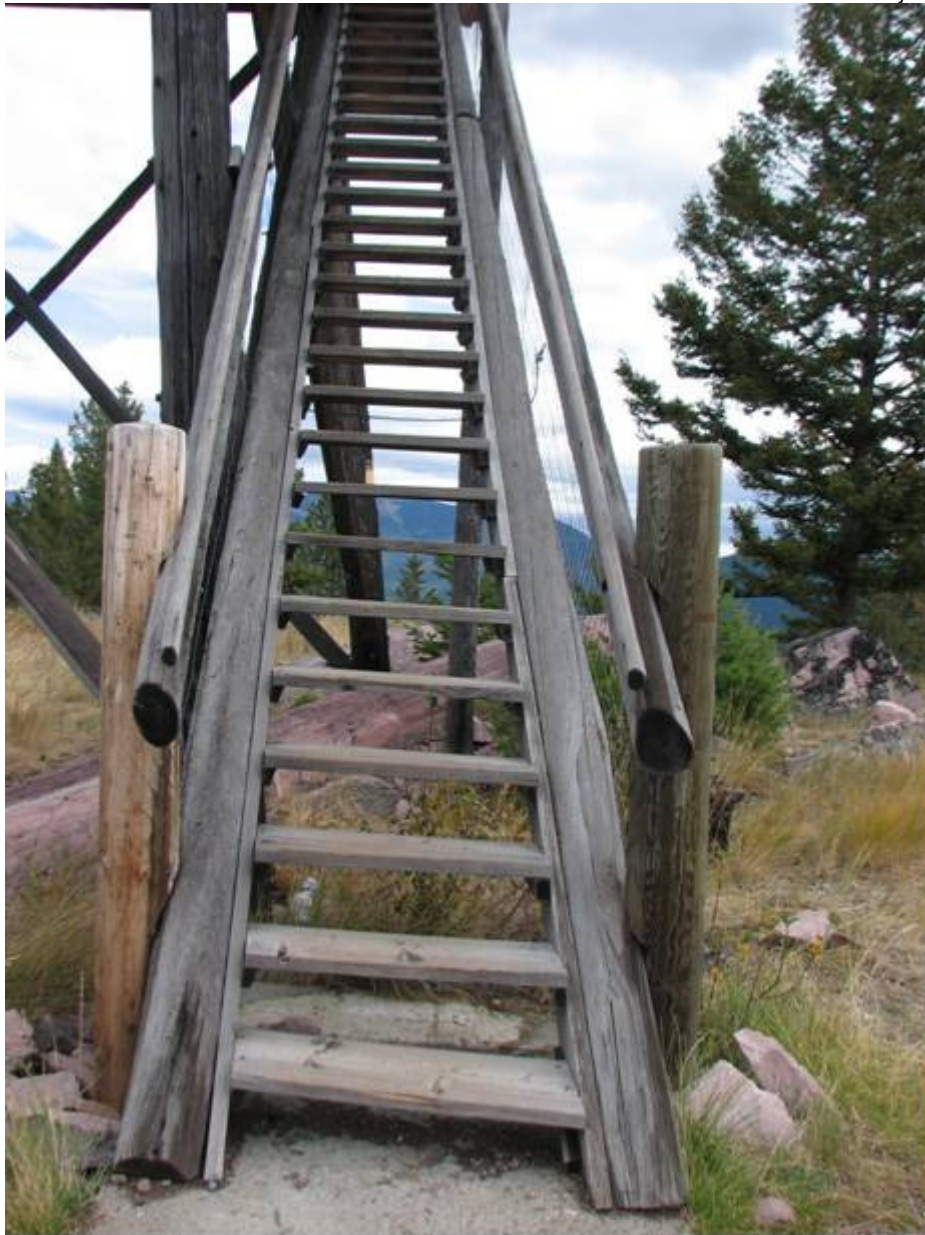
MT_MissoulaCounty_DoubleArrowLookout_0006. Looking east-northeast: detail of the log stairway.

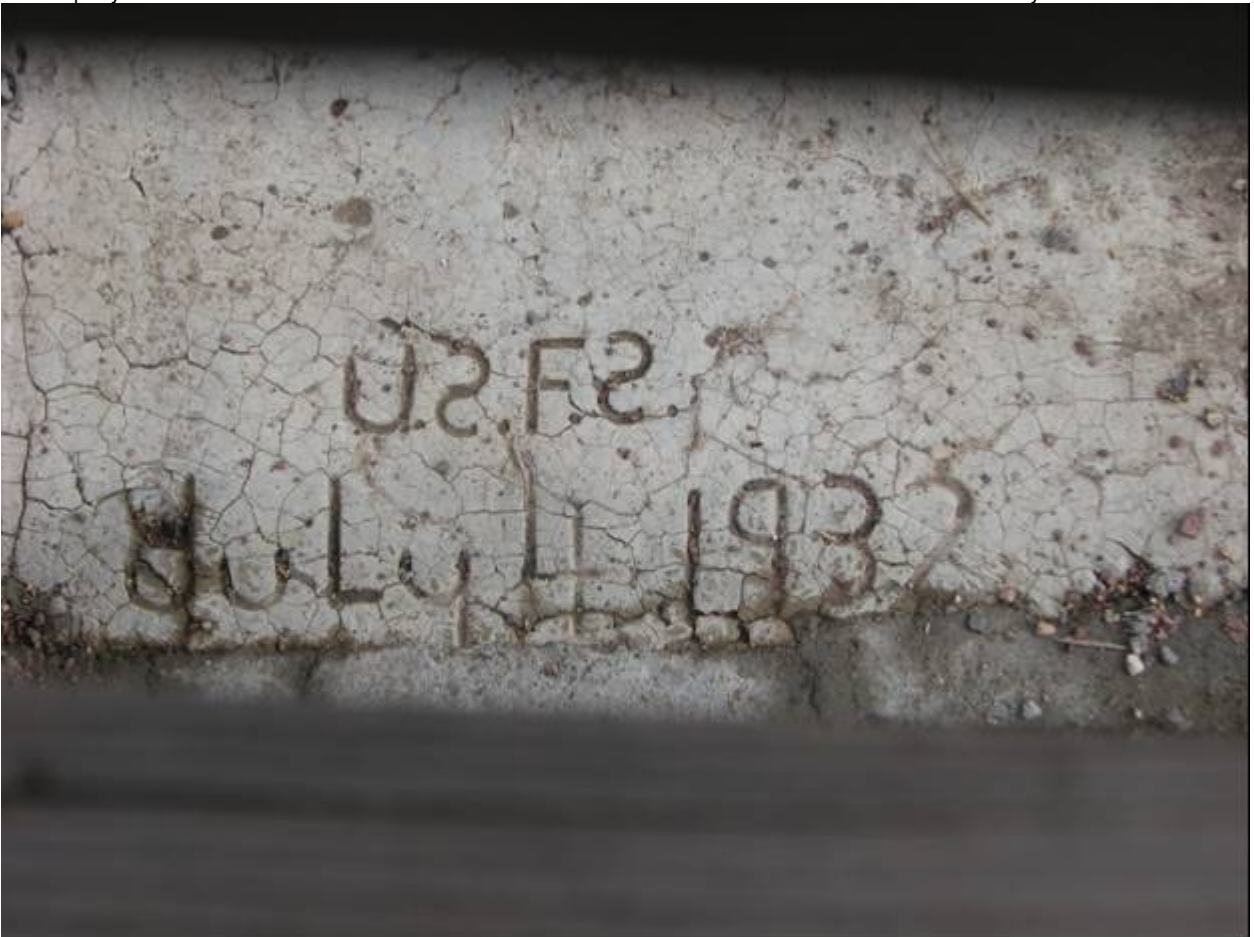
MT_MissoulaCounty_DoubleArrowLookout_0007. Detail of concrete tower base stamped with "USFS / July 4, 1932." Note the two Ss, are inverted.

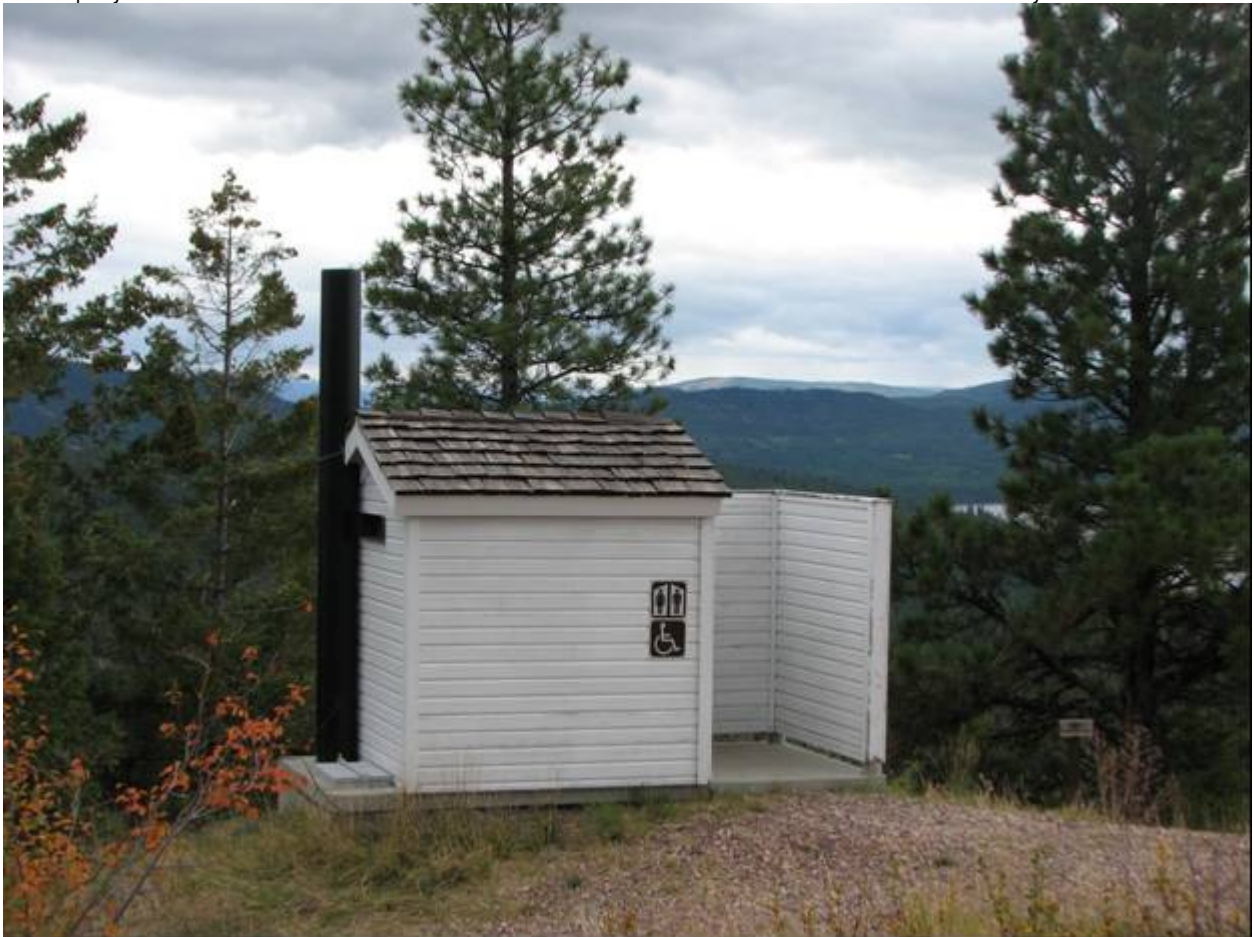
MT_MissoulaCounty_DoubleArrowLookout_0008. Looking south to the modern, noncontributing pit toilet.

Modern pit toilet (one noncontributing building). Built sometime between 1994 and 2012, the modern pit toilet, or SST (sweet smelling toilet), is located about 110 ft. southeast of the lookout tower, on the south side of the lookout spur road. It is a one-story, wood-frame building construction on top of a concrete vault. The exterior walls are covered with simple drop siding with vertical corner board trim. The front gable roof is covered with wood shingles. The entrance in the center of the southwest wall contains a metal door with one opaque light above a vent. The entrance is shielded by a two-sided, wood-frame privacy screen that extends from the front wall of the building. A large metal vent is located adjacent to the rear (northeast) wall.

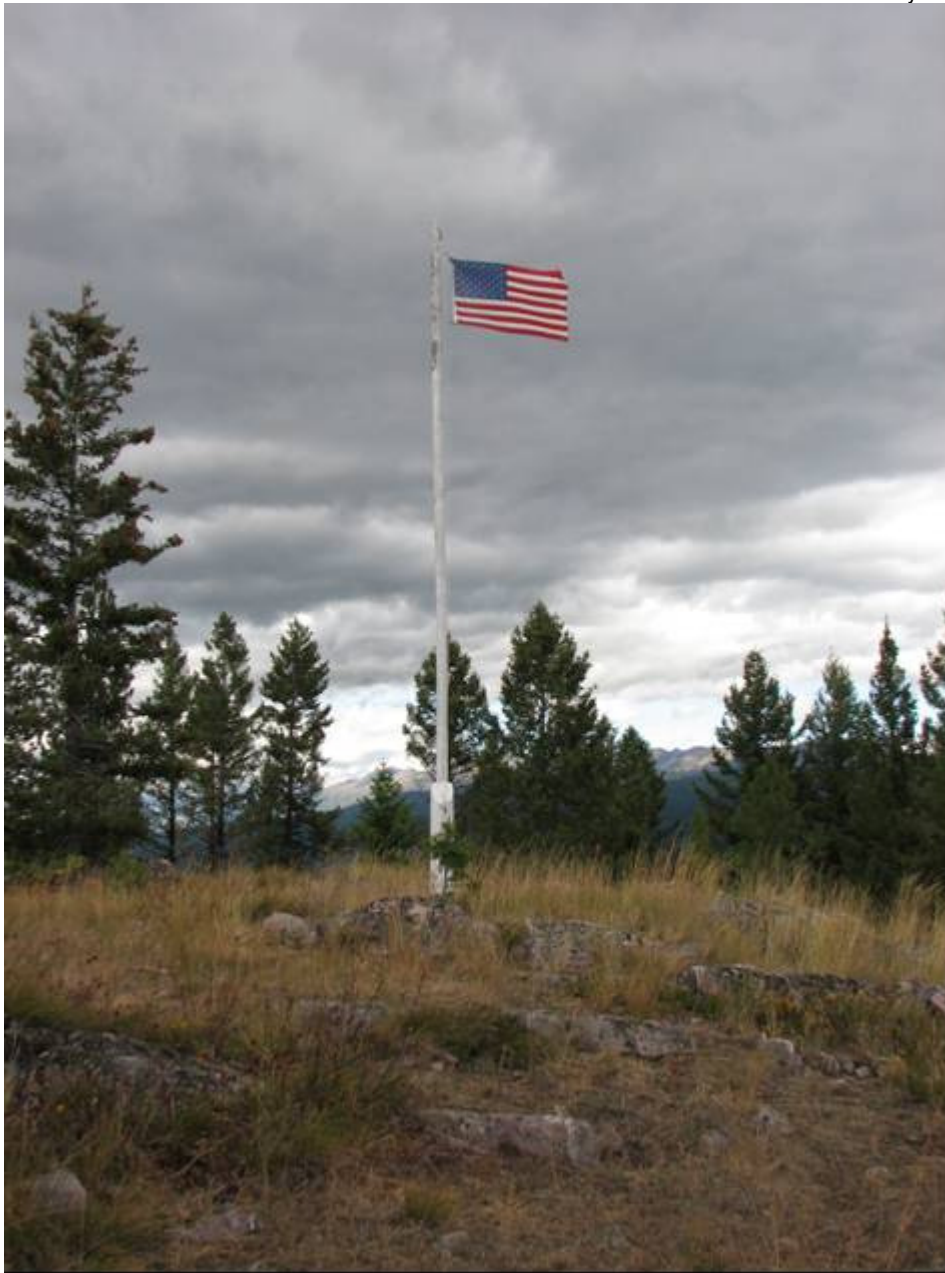
MT_MissoulaCounty_DoubleArrowLookout_0009. Looking southwest to the flagpole.

Flagpole (one contributing object). The flagpole is located about 60 ft. northeast of the lookout tower. It consists of a small diameter peeled tree (about 30 ft. long), bolted between two log supports that are partially buried. The tops of the log supports are beveled.
