1. Name of Resource: Carpenter House 2. Original Owner: Calvin Carpenter

Resource # 169

KENTUCKY HISTORIC RESOURCES								
Individual Inventory Form

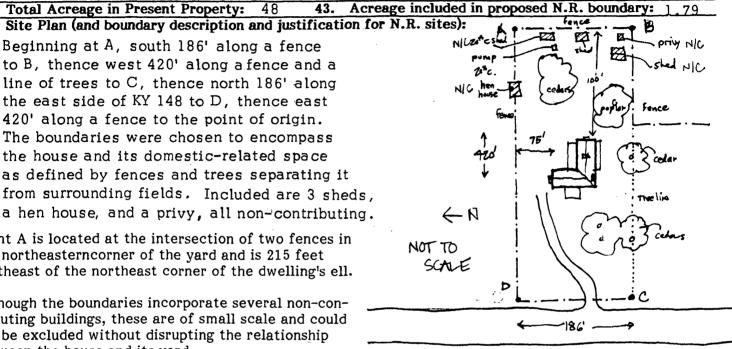
43.

Site Plan (and boundary description and justification for N.R. sites): 44. Beginning at A, south 186' along a fence to B, thence west 420' along a fence and a line of trees to C, thence north 186' along the east side of KY 148 to D, thence east 420' along a fence to the point of origin. The boundaries were chosen to encompass the house and its domestic-related space as defined by fences and trees separating it from surrounding fields. Included are 3 sheds,

Point A is located at the intersection of two fences in the northeasterncorner of the yard and is 215 feet northeast of the northeast corner of the dwelling's ell.

Although the boundaries incorporate several non-contributing buildings, these are of small scale and could not be excluded without disrupting the relationship between the house and its yard.

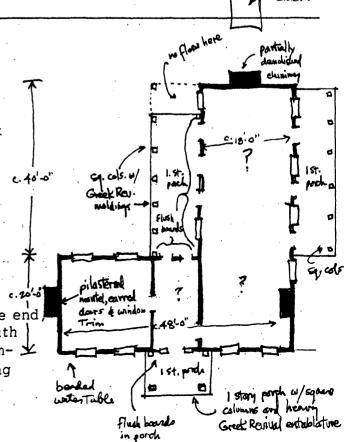
#### 45. Description and House Plan:

2-story, 5-bay, frame, center-passage, singlepile plan, plain narrow weatherboards, 1-story center porch with square columns and heavy Greek entablature, flushboards under porch, wide ceiling boards, pilasters flank 4-panel door and are themselves flanked by painted glass sidelights, panelled aprons, transom also of painted glass, beaded watertable, coursed stone foundation, frieze board with molding which stops short at each end of principal (west) facade, 6/6 sash, ... early blinds, roof hipped where 2-story ell joins main section of house on south end, interior brick . 20% end chimney, exterior brick chimney on north gable end standing seam metal roof, 1-story porch along south side of ell, partially collapsed exterior brick chim- \(\psi\) ney on east end of ell, original 1-story porch along north side of ell has square columns with early

Greek moldings, east bay of porch added (no floor), flushboards under porch.

4-panel doors, earred door and window surrounds, pilastered mantles, woodwork is grained.
