National Register of Historic Places Registration Form

Historic name Marysville Union Pacific Depot
Other names/site number KHRI #117-3560-00014
Name of related Multiple Property Listing Historic Railroad Resources of Kansas

Street & number 000 Hedrix Avenue (at Alston Street) not for publication
City or town Marysville vicinity
State Kansas Code KS County Marshall Code 117 Zip code 66508

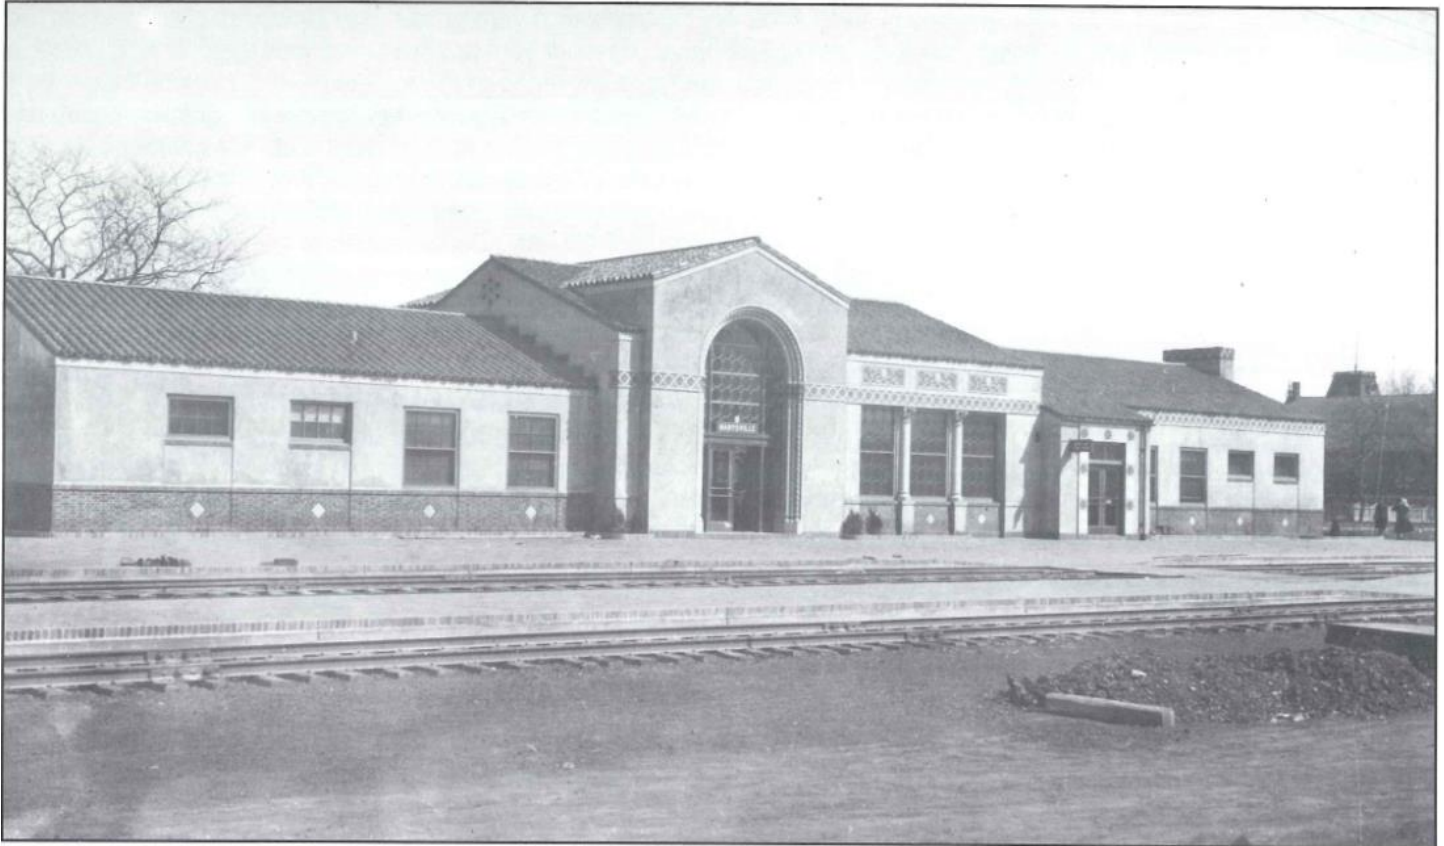
Figure 2. April 4, 1929 image of west elevation, showing half windows at north and south ends.
Source: Schlichter & Link, *Union Pacific's Central Division Hub*, 94.

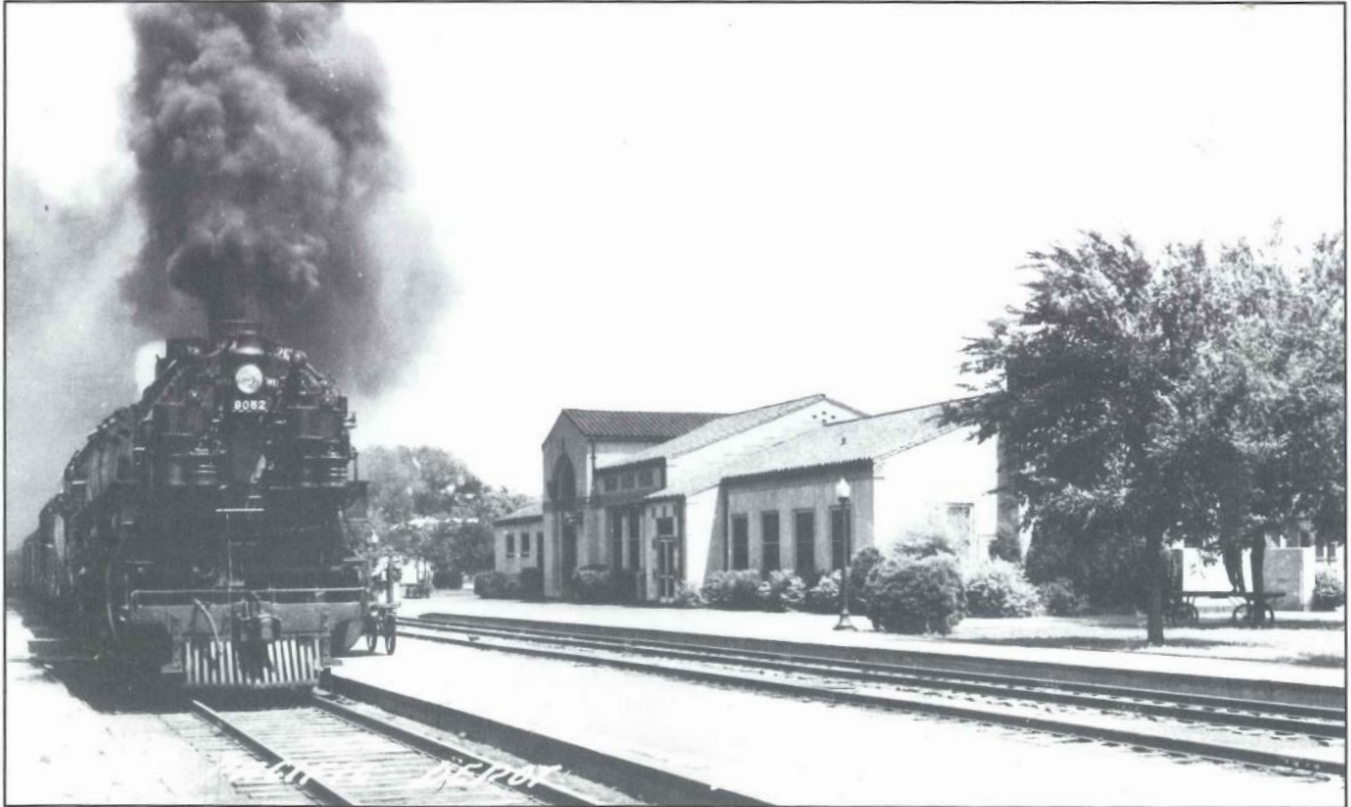
Figure 3. Early 1930s image looking northeast at west elevation.
Source: Schlichter & Link, *Union Pacific's Central Division Hub*, 8.

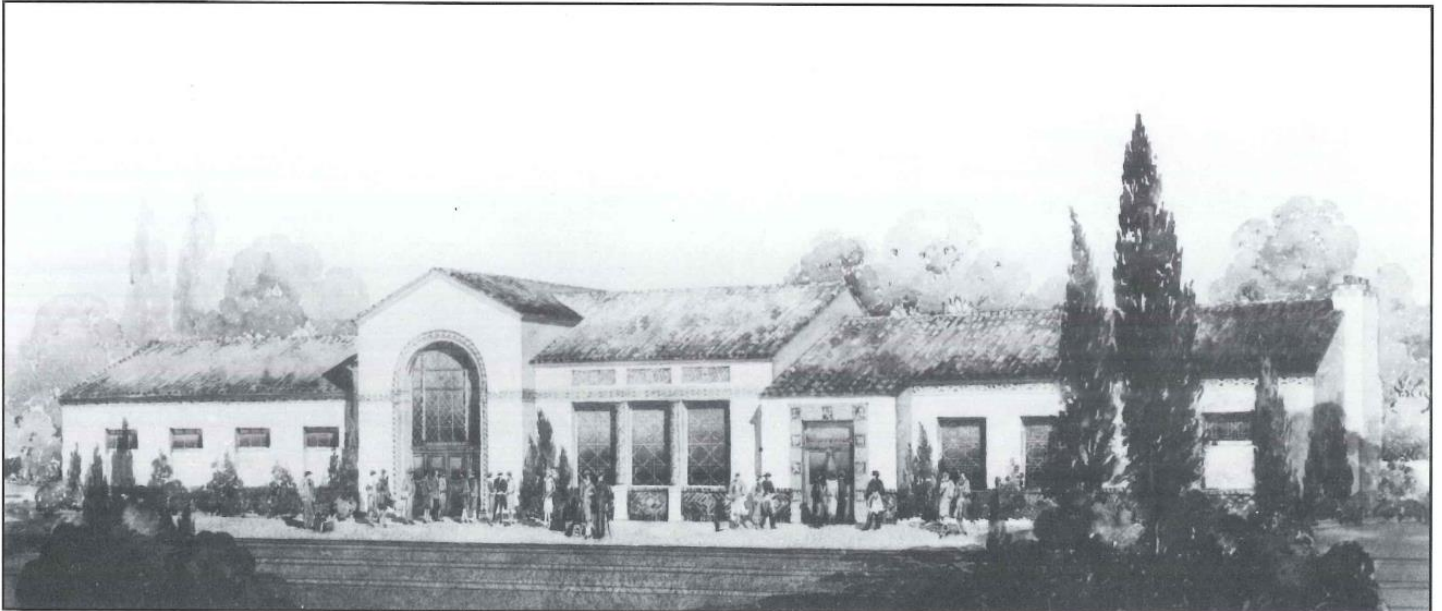
Figure 6. Underwood's design.
Source: Schlichter & Link, *Union Pacific's Central Division Hub*, 93.

A set of plans was drafted by the Union Pacific Chief Engineer and sent to Los Angeles-based architect Gilbert Stanley Underwood (*Figures 5 through 9*). In her book about Underwood, author Joyce Zaitlin writes, "Some of his most pleasing depots were created in the Spanish Revival style, probably influenced by his early apprenticeship with Arthur Benton." Underwood served as a draftsman under the San Bernardino-based architect – considered a "master of the Mission mode" – joining the firm in 1911. Benton's "interest in everything having to do with the Southwest had an enormous impact on the young Underwood."¹⁴ Marysville's depot was designed in the Spanish Revival style and became one of several depots Underwood's firm designed for the Union Pacific. Among others were ones in Gering and Cozad, Nebraska, as well as larger stations in Omaha and Topeka. The Abilene Depot was also designed by Gilbert Stanley Underwood during the same timeframe, and it is also designed in a Spanish Revival style.

Underwood based the design of Marysville's depot on the one in Gering, Nebraska. Initially measuring 42' by 202', Marysville's depot dimensions were reduced to 38' by 160' because the size was determined by UP officials to be larger than necessary to meet the requirements and functionality of the building. Entry into the lobby was through a wide arched doorway designed to be on axis with Alston Street (*Figure 10*), which the city vacated at the request of the railroad. Railroad officials feared that these large doorways, which are hallmarks of the building, might make the waiting room too bright, thus the utilization of translucent glass in the windows. Officials were also quick to demand that the sash not be leaded so as to allow a common glazer to repair them. The impact of the lit windows exposed at night was noted. It was also noted that the Union Pacific shield was not shown, and it was "assumed" that would be incorporated somewhere. That shield eventually flanked the north and south ends of the building and one over each of the three large windows on both track and streetside locations. Estimated cost, including equipment and furnishings, was just over \$220,000.

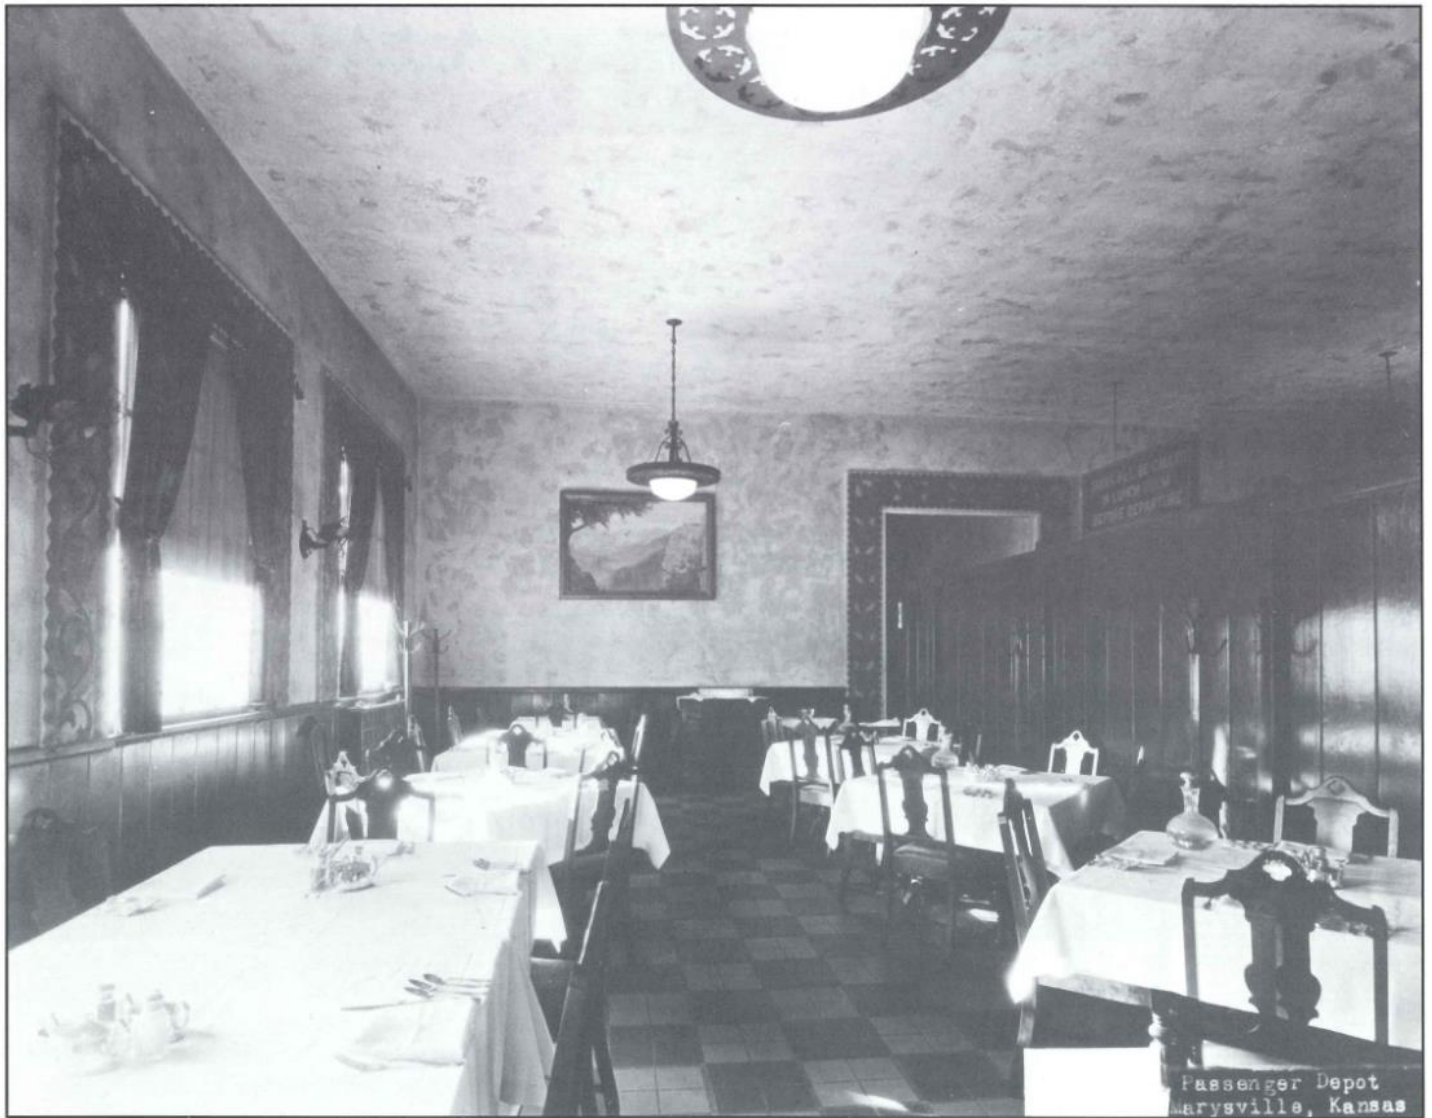
Figure 11. Dining room shortly after the depot's opening
Source: Schlichter & Link, *Union Pacific's Central Division Hub*, 98.

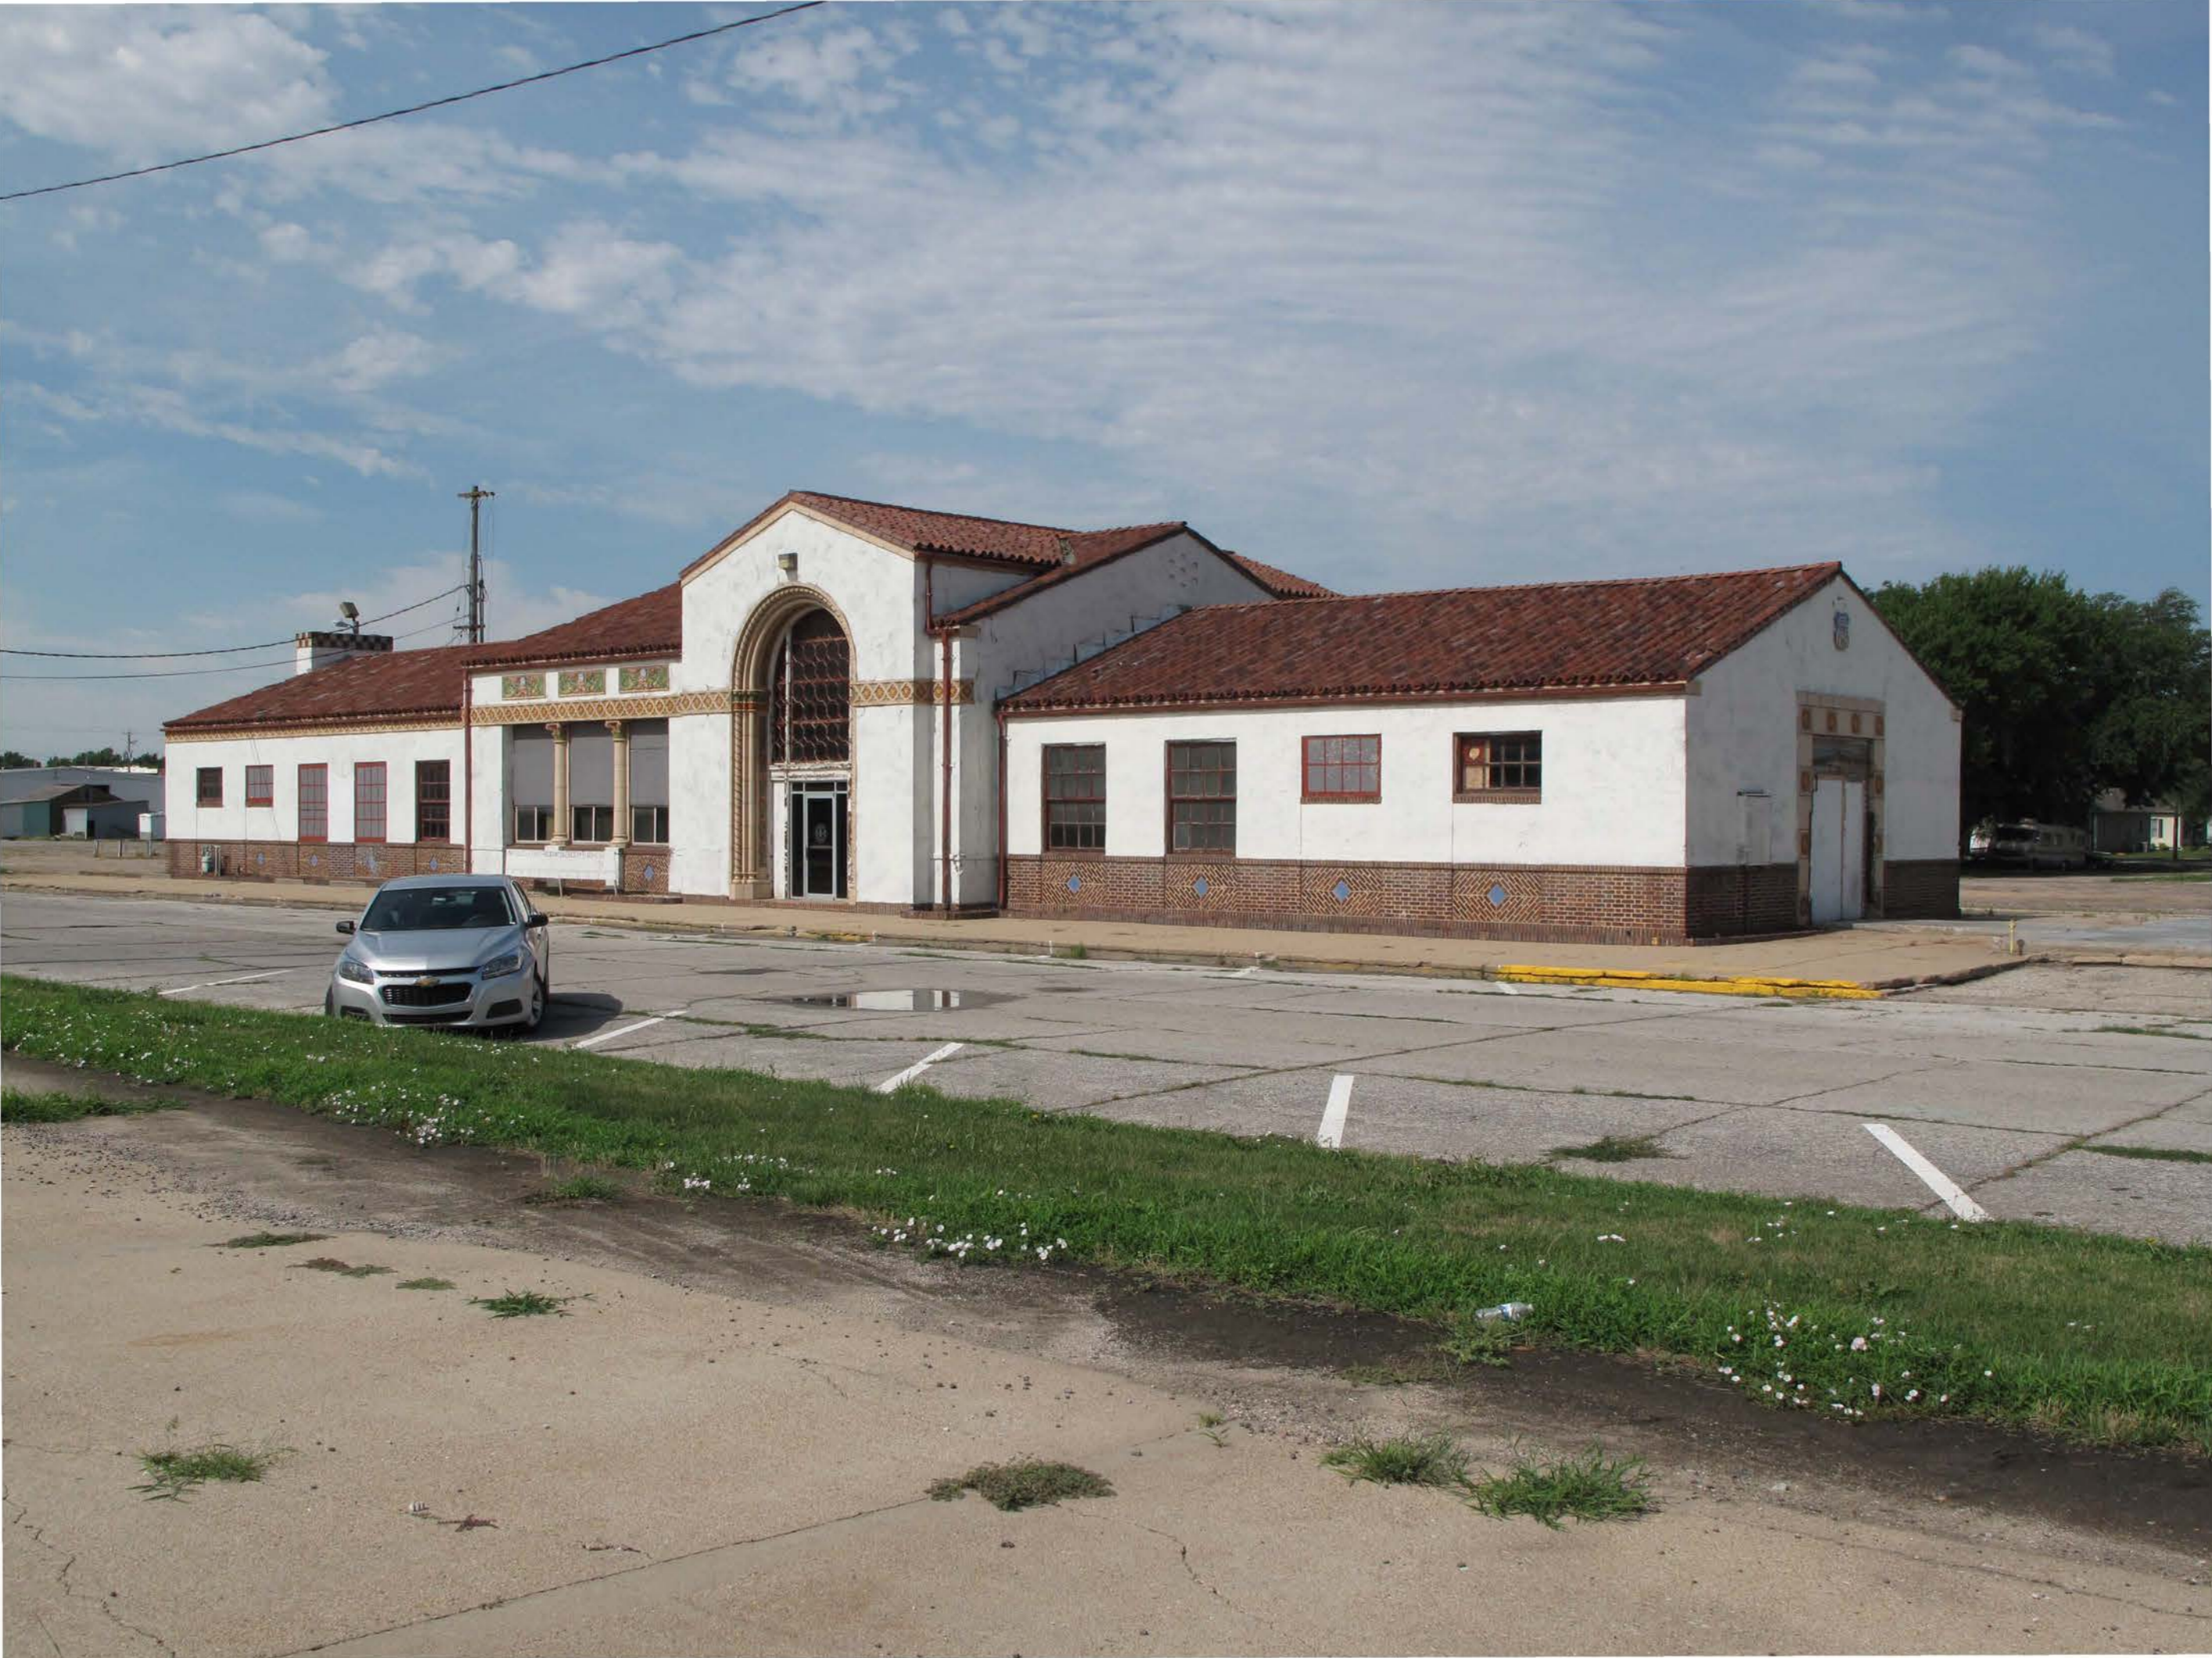
The building is a single-story structure with a white stucco finish and a red-tiled roof. It features a central arched entrance with a decorative brick surround and a small window above the arch. To the left of the arch, there are two columns supporting a small overhang. The building has several windows with red frames and decorative brickwork at the base. A large double door is visible on the right side of the building.

The east elevation faces Hedrix Avenue (*Photo 1*). The south wing is five bays wide. Each bay is slightly inset within the wall plane and features a window opening; four unevenly-spaced window wells are located in the south wing as well. From the south: Bay 1 is a fixed, historic eight-light window with brick rowlock sill; Bay 2 historically matched Bay 1, but the window opening is currently covered with plywood. Bays 3 through 5 were historically identical, but only Bay 5 features the historic 8-over-8 double-hung wood-sash units; Bay 3 and 4 are covered in plywood.³ A brick wainscot runs the entire length of this section. Between the bays, the brick is Flemish bond; within each window bay, the brick surrounds a centered blue diamond shape, parallel with each side of the diamond. Above the brick wainscot is stucco. Glazed terra cotta ornamentation highlights the upper perimeter of the building at the eave, setting off the stucco finish exterior. This terra cotta datum extends across the face of the center section and terminates at the north wing. The center section is four bays wide, with the fourth bay the main entry into the building. The south three bays are identical. Each bay is slightly inset from the wall plane and is divided from each other by a round terra cotta pilaster with decorative capital on a stucco plinth. Brick wainscoting is only found below each window opening and it contains the center blue diamond and diagonal brickwork seen in the south wing. The decorative terra cotta datum runs along the top of each bay. Centered above each window bay is a terra cotta panel featuring the Union Pacific Overland System logo centered within a floral background. A simple wood fascia board terminates the wall plane at the eave. The entry bay is a gable-front mass that protrudes from the wall plane. Its wall surface is stucco. Centered within this protrusion is a 20' terra cotta-framed arch with divided windows above the entry (*Photo 2*); a single aluminum framed door that replaced
