United States Department of the Interior
National Park Service
National Register of Historic Places
Registration Form

historic name Paonia First Christian Church

other names/site number Paonia Christian Fellowship, 5DT.1375

Section number 7 Page 1 Paonia Christian Fellowship, Delta County, Colorado

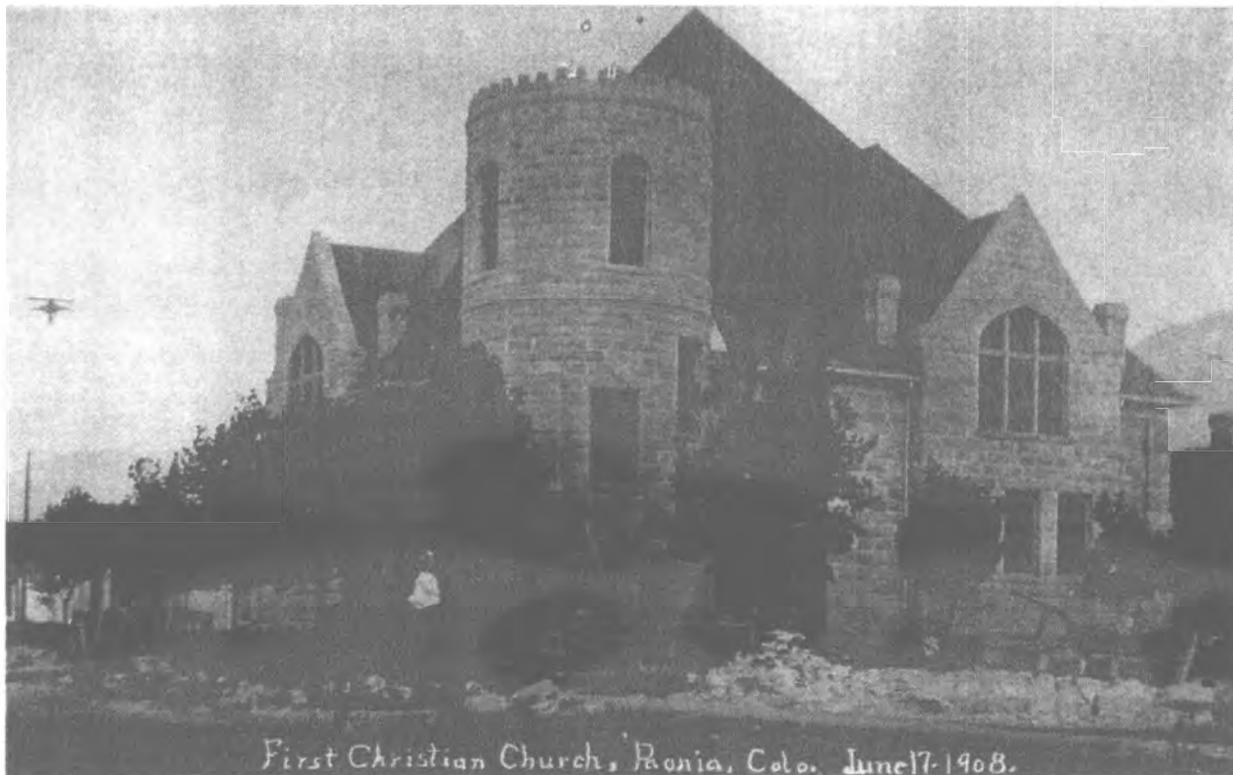
H004. June 17, 1908.

*First Christian Church, Paonia, Colo. June 17, 1908.*

H001	Stone cutter, Sege Stratton, working on tower
H002	Finished building, minus ornament on top and stained glass windows. June 17, 1908
H003	Building in progress, April 2, 1908
H004	June 17, 1908.
H005	Building in progress, early 1908
H006	Easter Sunday, March 31, 2002, photograph by Vic Ullrey
H007	Easter Sunday, April 22, 1962

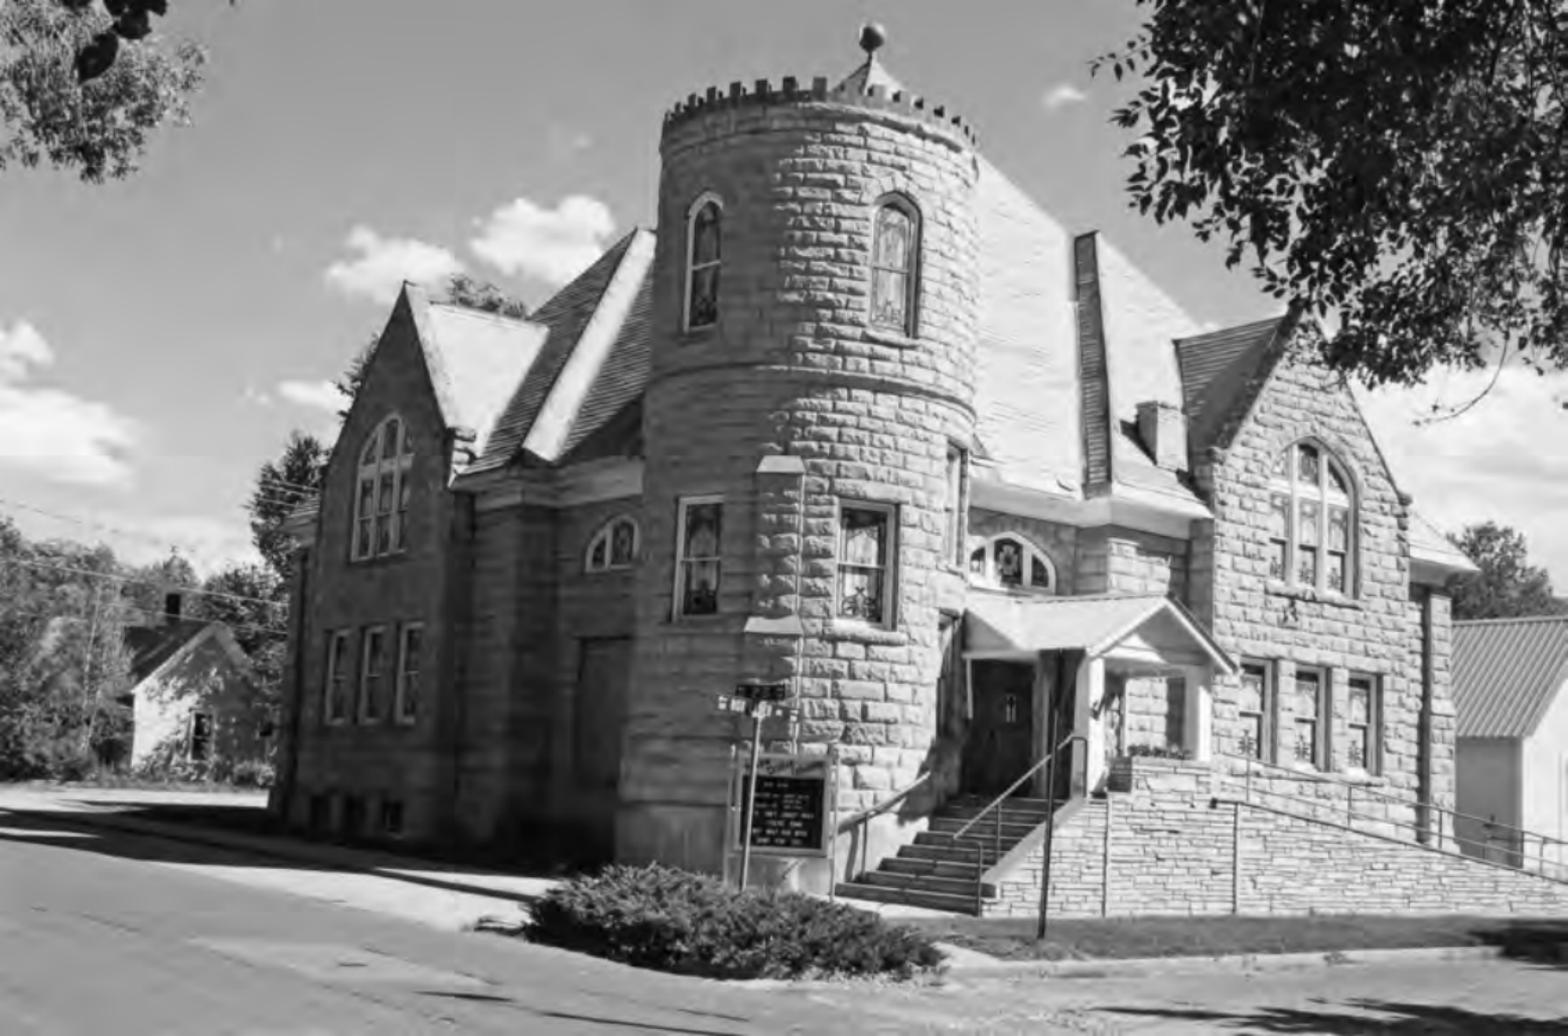
01

Photo No.	Photographic Information
0001	West facing side (front of church)
0002	South facing side
0003	North facing side
0004	East facing side (back of church)
0005	Foyer, entry doors
0006	Southwest corner of sanctuary/West balcony
0007	Stained glass windows/above west balcony
0008	West wall
0009	North balcony/north section main level
0010	South wall
0011	Southeast corner (taken from west balcony)
0012	Stained glass windows/above north balcony
0013	Main floor (taken from west balcony)
0014	Back of parsonage (north-east corner)
0015	South side of parsonage (south-east corner)
0016	Front of parsonage (west side)
0017	Garage (north-east corner)

The west façade (front) features the main entrance to the building with contemporary double doors covered by a porch, and steps leading down on the north and a contemporary accessibility ramp to the south. The entryway is surmounted by a three-light arched stained-glass transom. In the bay formed by the projecting gable to the south is flanked on either side with a wall, flanked on either end by graduated pilasters, that projects out from the entrance bay and the gable end projects further out from that wall. The roof is pierced by a brick chimney to the north of the gable. Within the gable end are a row of three windows at the base to provide light to the basement, three double-hung stained-glass windows on the main floor level, and a large stained-glass clerestory window above. The clerestory consists of a band of three double-hung stained-glass sashes surmounted by three fixed stained-glass windows, which replicate the arched transom over the entrance. All windows in the building are wood framed with stone sills and lintels for the square window openings and stone sills and segmented arches for the arched windows.
