# National Register of Historic Places Continuation Sheet

Property Name: Ellsworth Downtown Historic District

### National Register of Historic Places Registration Form

Historic name Ellsworth Downtown Historic District  
Other name/site number \_\_\_\_\_

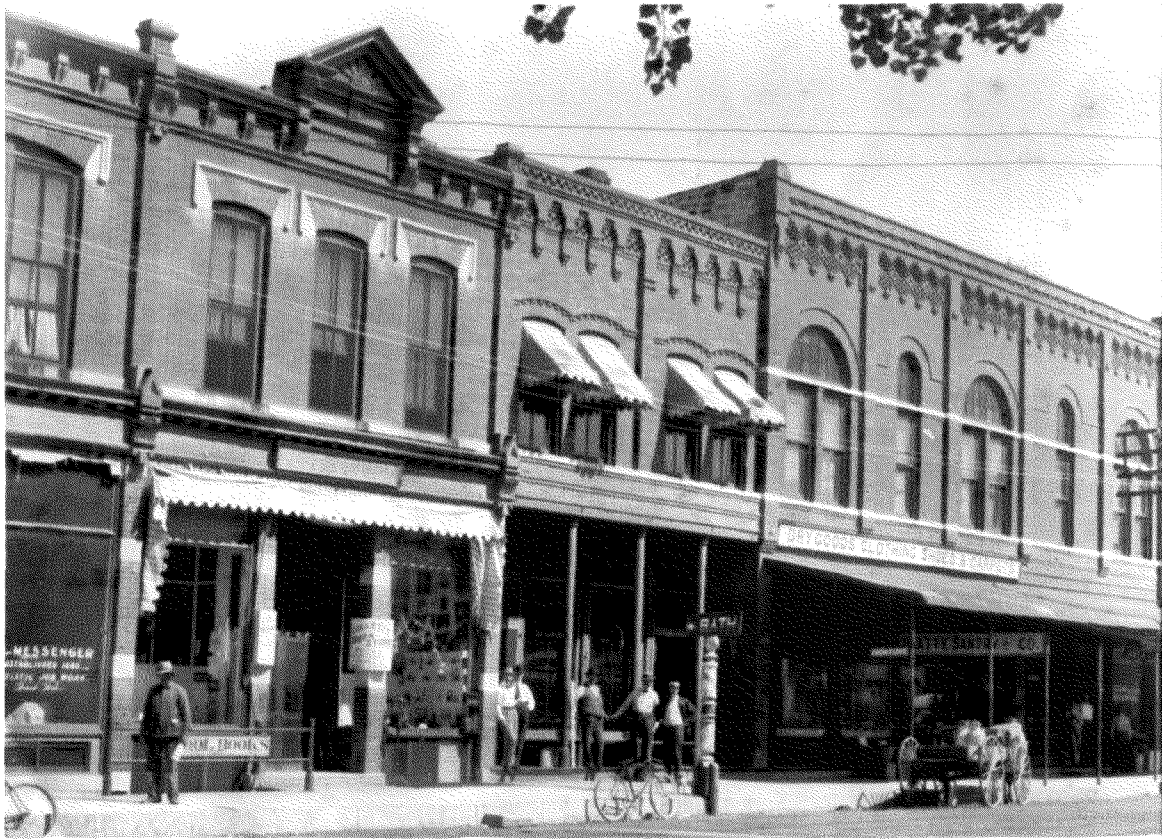
Figure 5 – The Wellington Block, west side of 200 block N. Douglas Avenue, c.1905

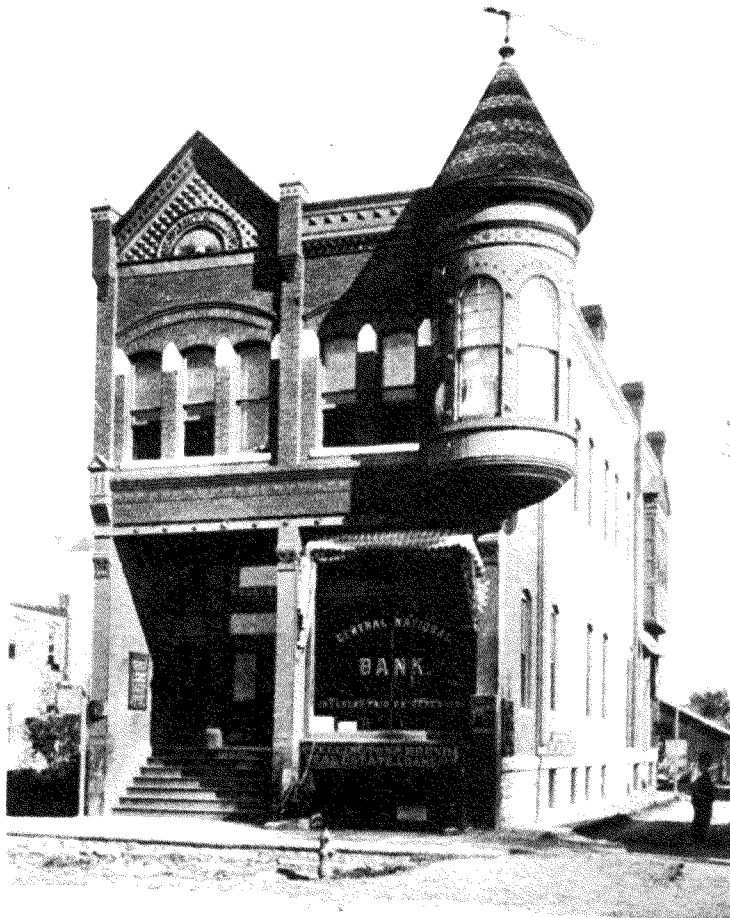
Figure 14 – Insurance Building constructed by E.W. Wellington 1887, occupied by Central National Bank 1905-1912

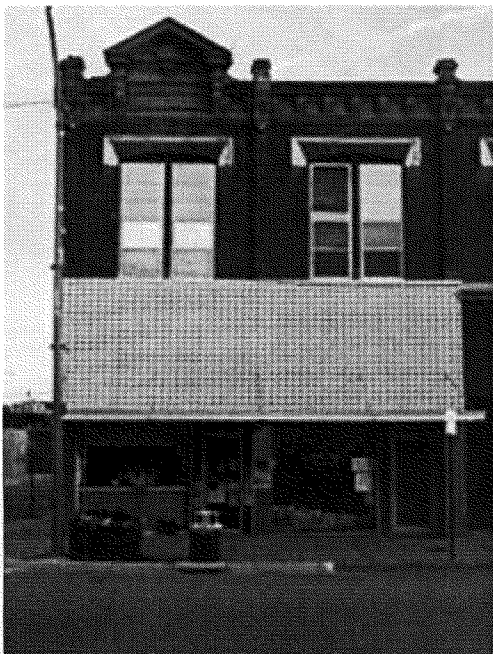
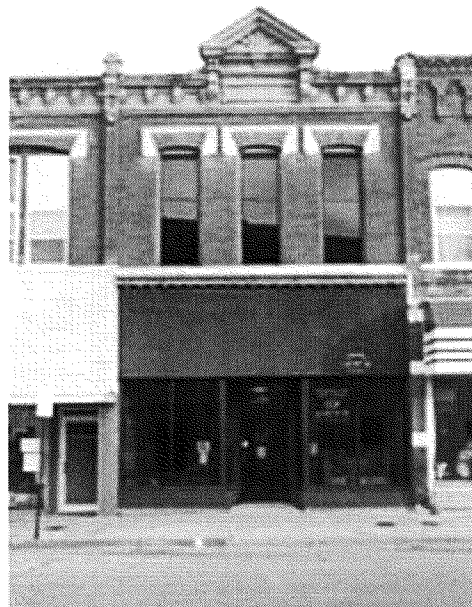
Pre-Rehabilitation (2006) 202 N Douglas (left); 204 N Douglas (right)

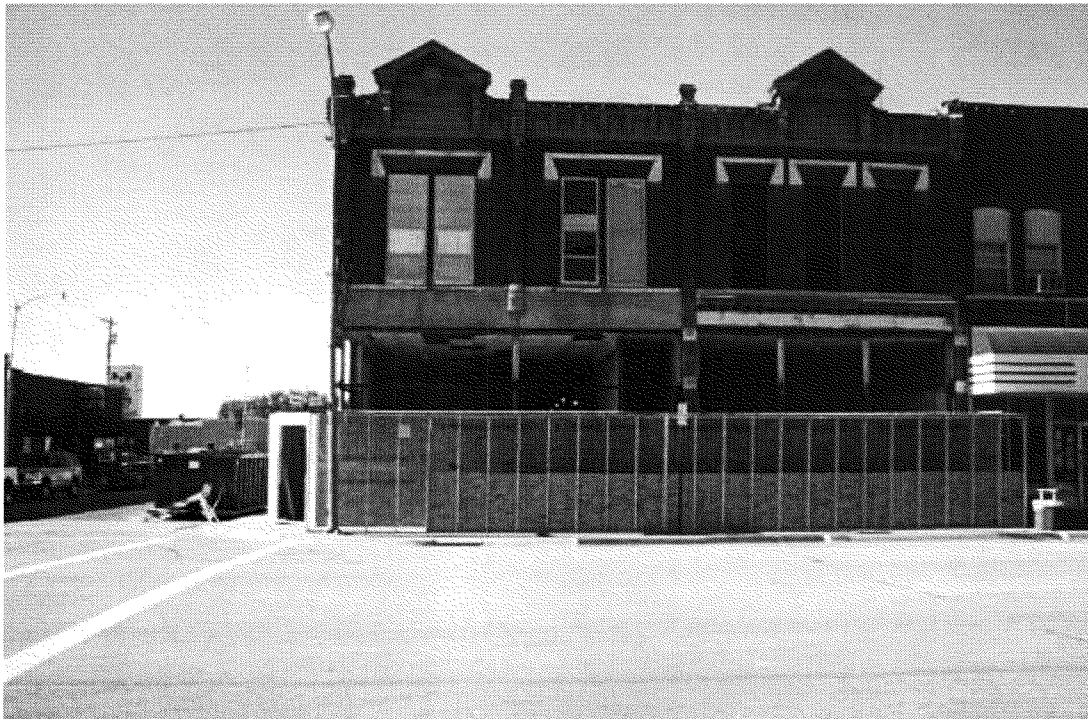
**During Rehabilitation (2007) – East-facing storefronts (below)**

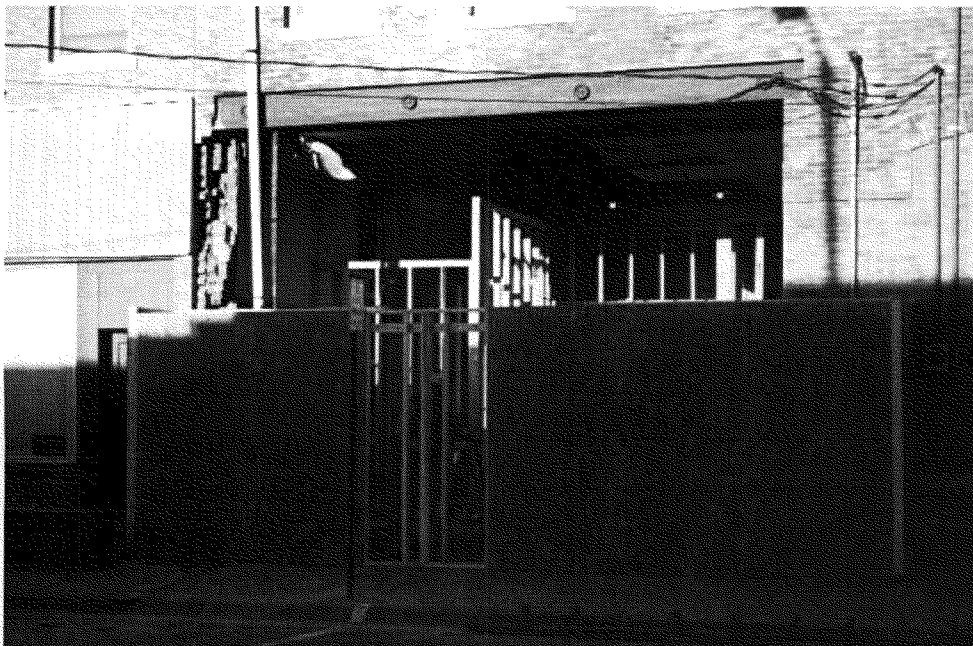
**During Rehabilitation (2007) – South-facing storefront (below)**

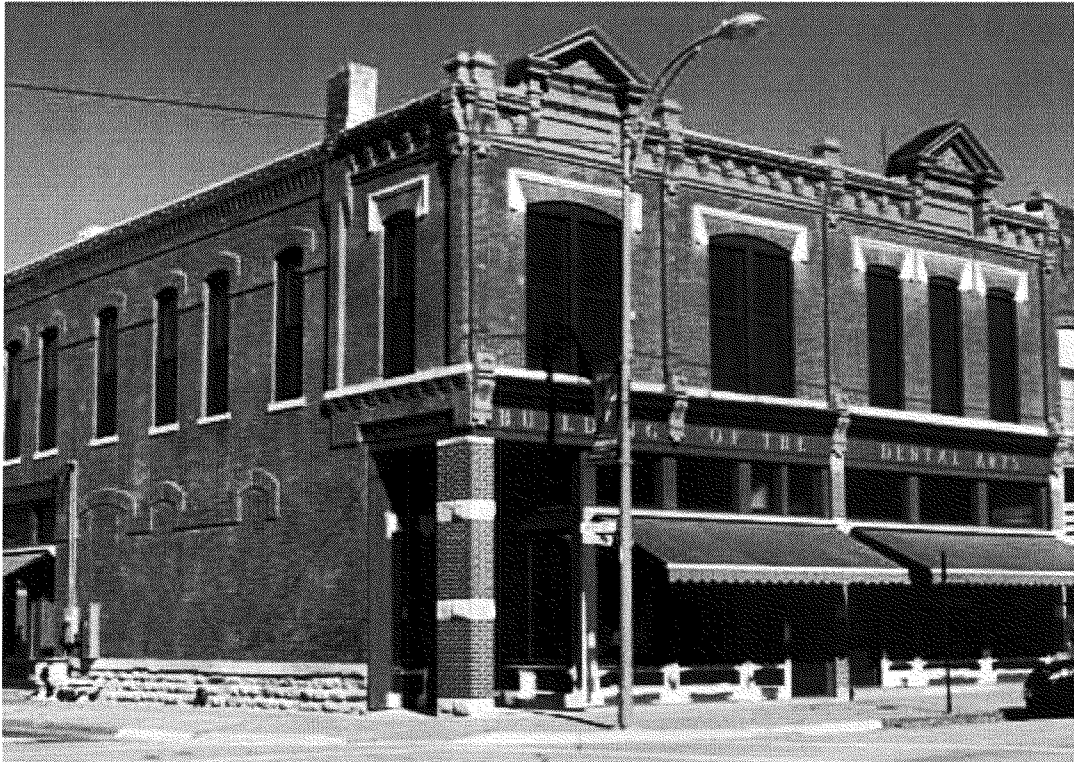
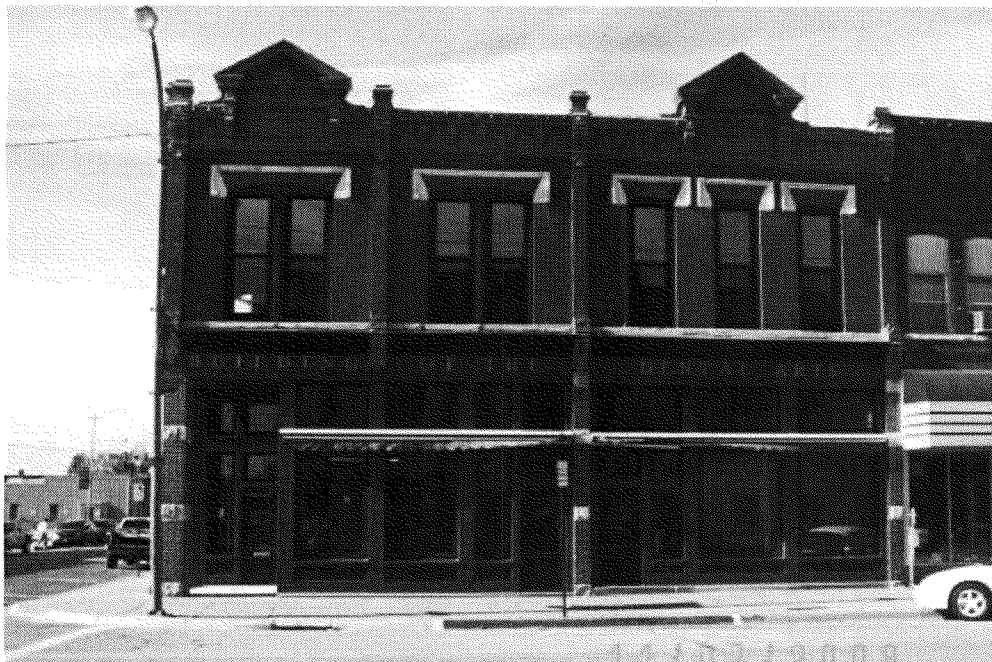
Post Rehabilitation (2008) - below

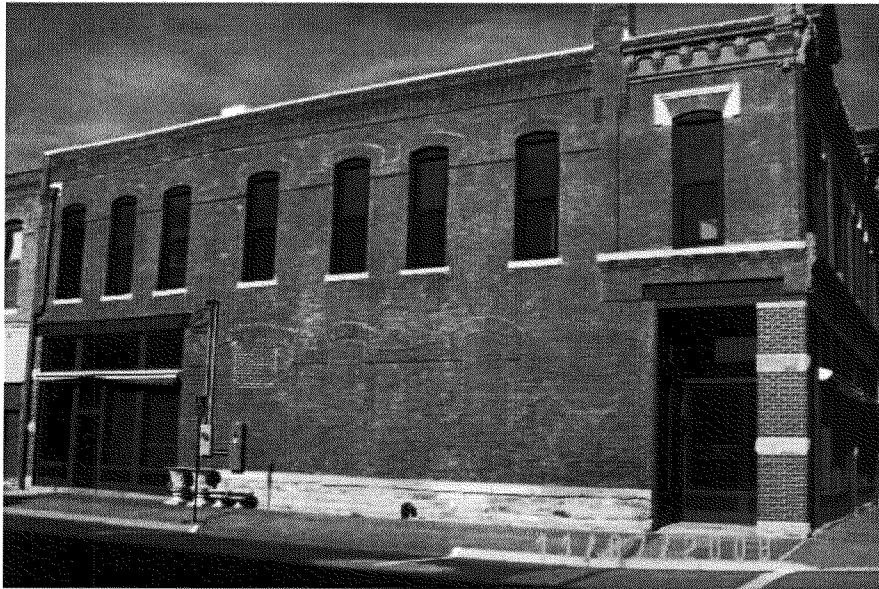
Post-Rehabilitation (2008) – south-facing elevation (below)

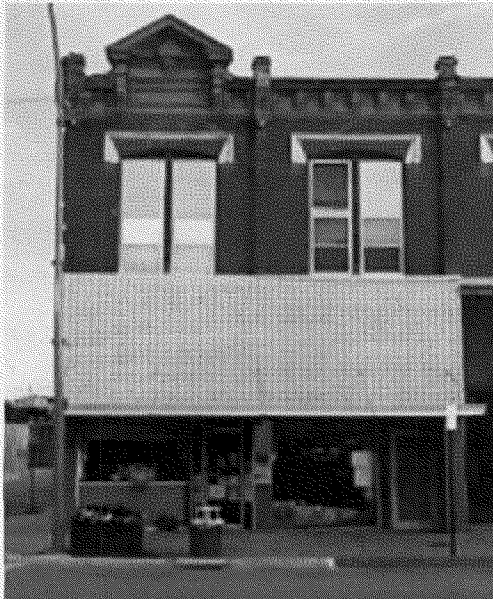
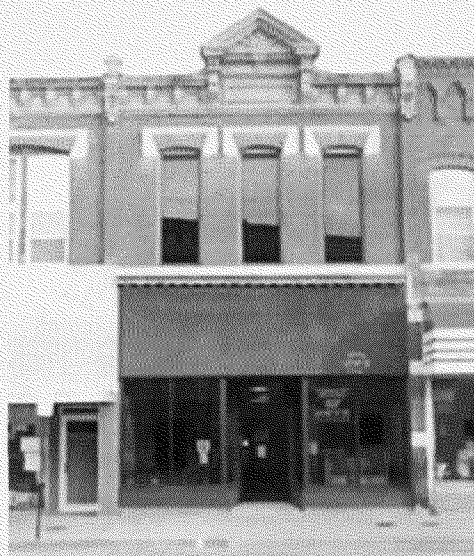
**Pre-Rehabilitation (2006) 202 N Douglas (left); 204 N Douglas (right)**

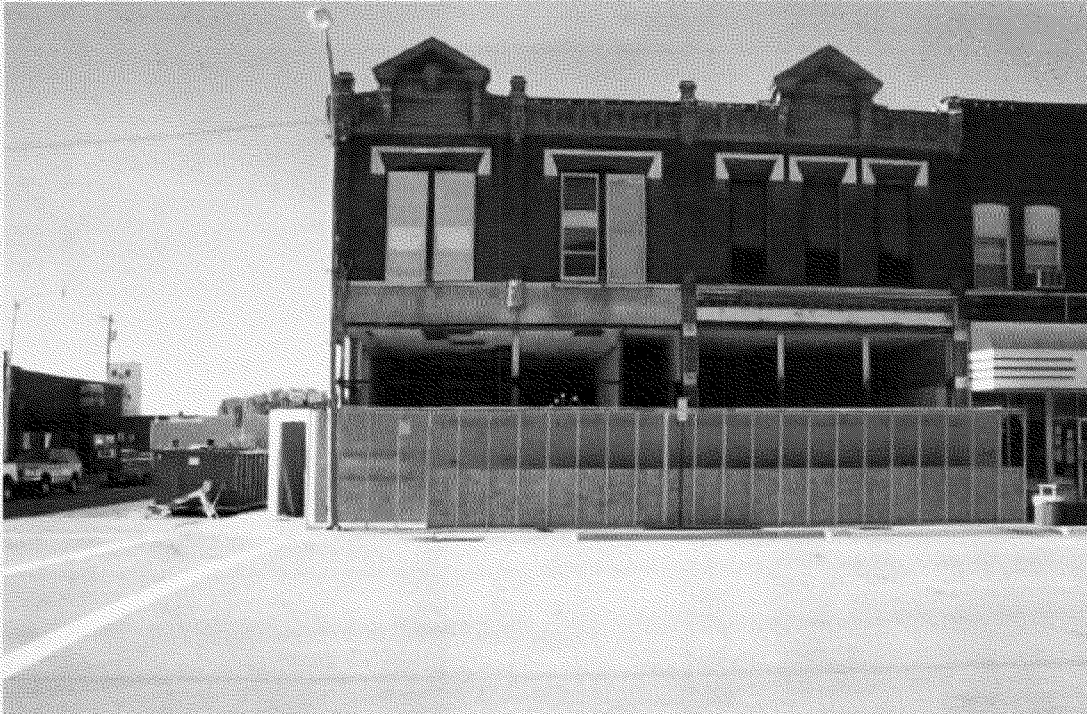
**During Rehabilitation (2007) – East-facing storefronts (below)**

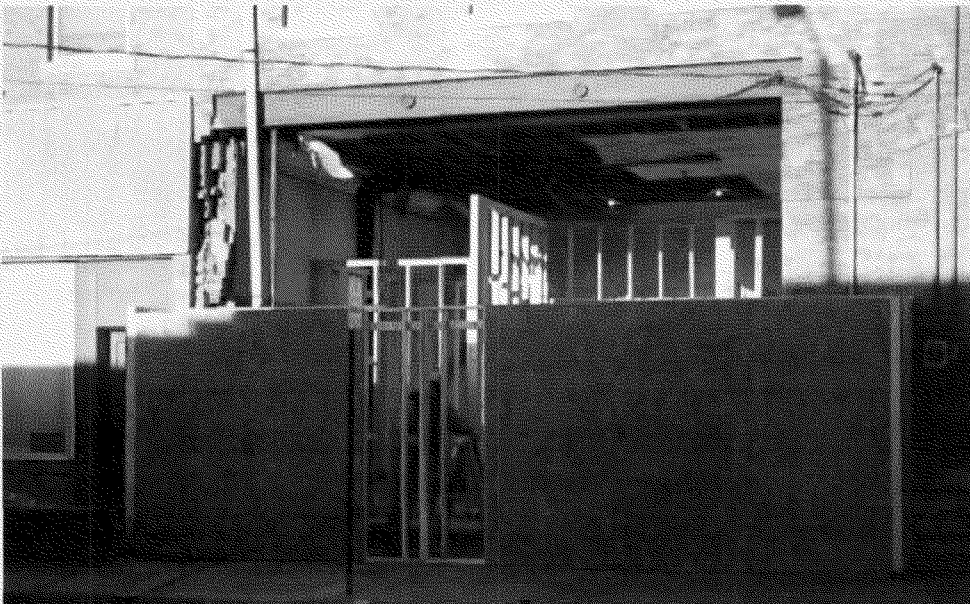
**During Rehabilitation (2007) – South-facing storefront (below)**

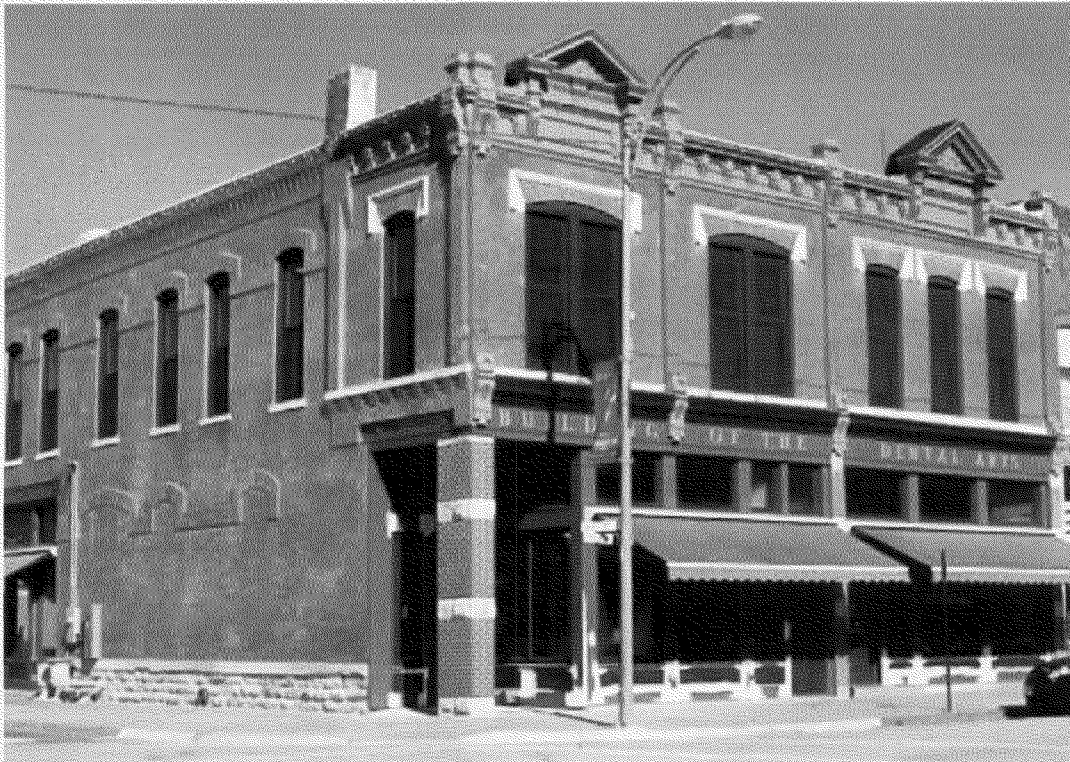
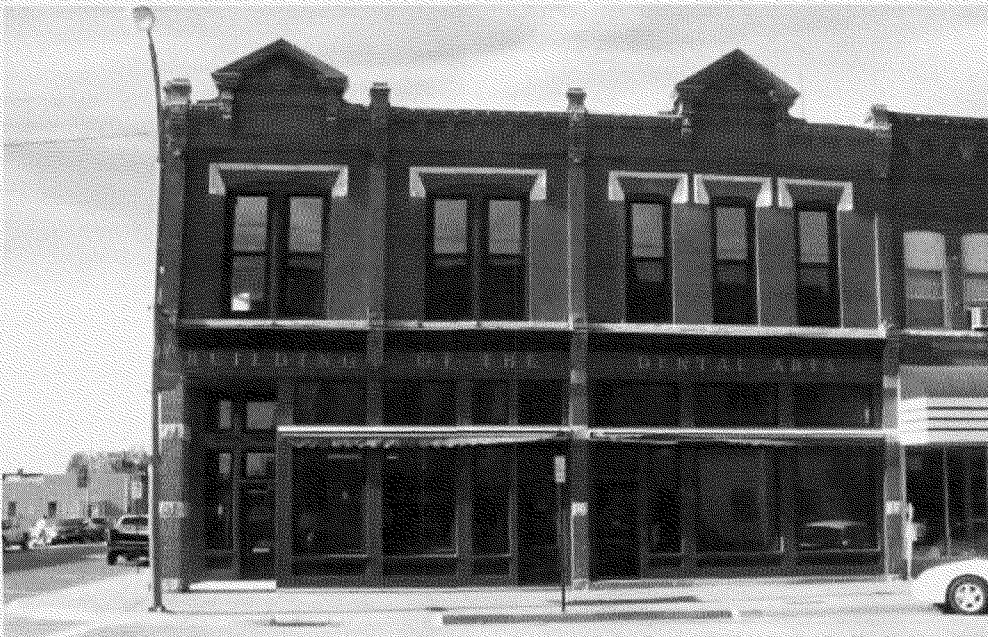
**Post Rehabilitation (2008) - below**

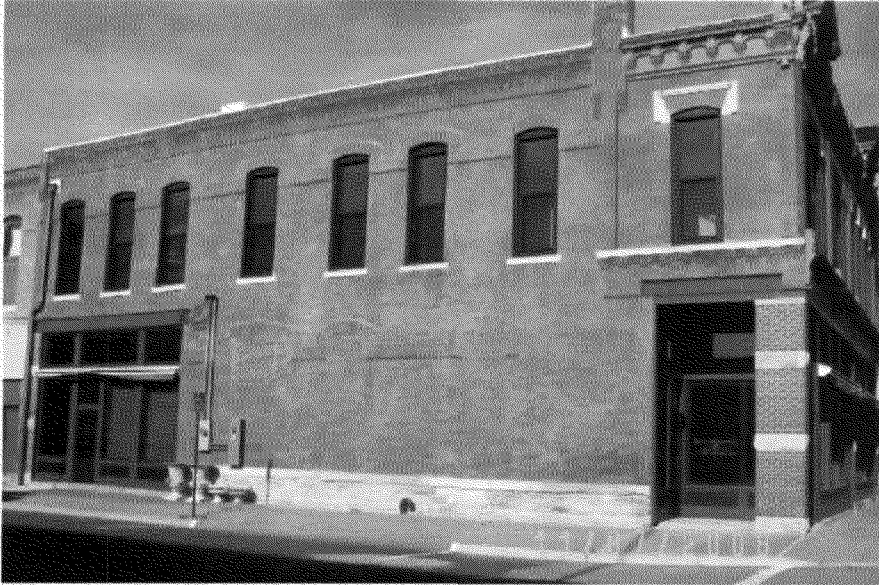
**Post-Rehabilitation (2008) – south-facing elevation (below)**
