National Register of Historic Places Registration Form

historic name Olallie Meadows Guard Station

other names/site number Olallie Meadows Cabin

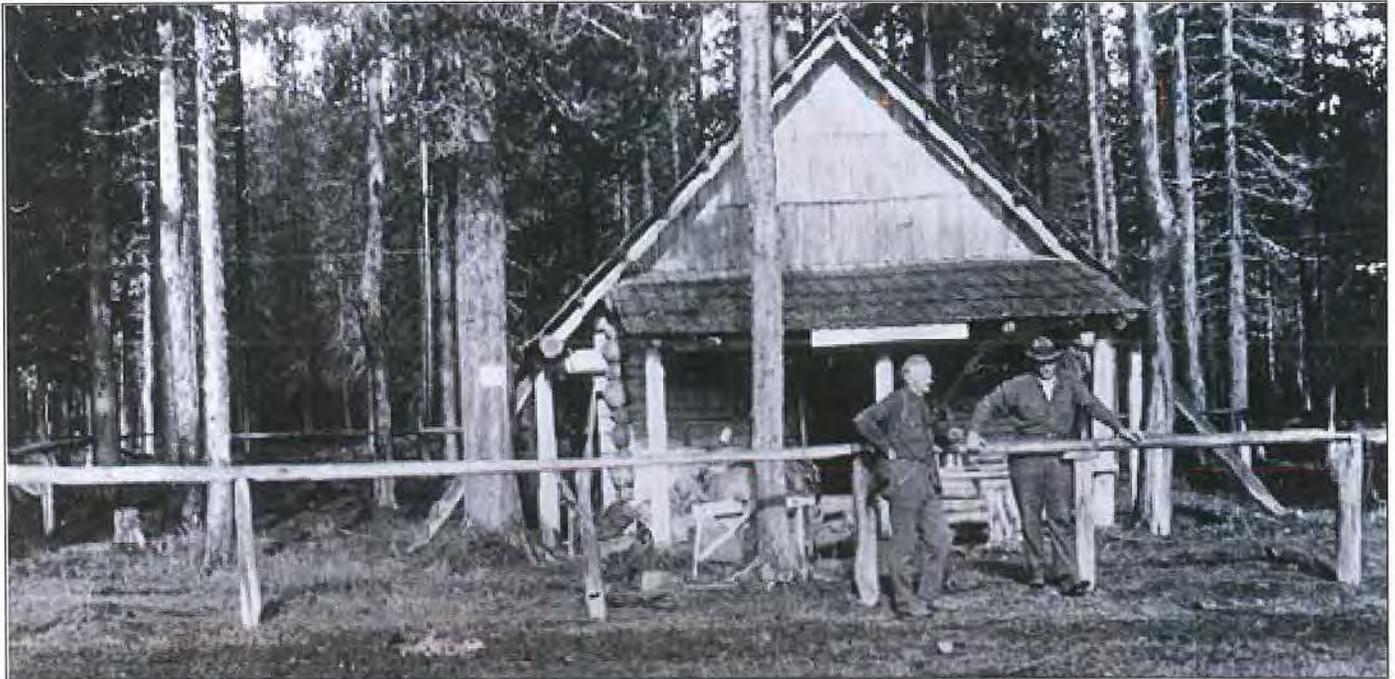
Figure 7: Photo of Olallie Meadows Guard Station, c.1919. From: Mt. Hood National Forest, Heritage Archives, 2014.

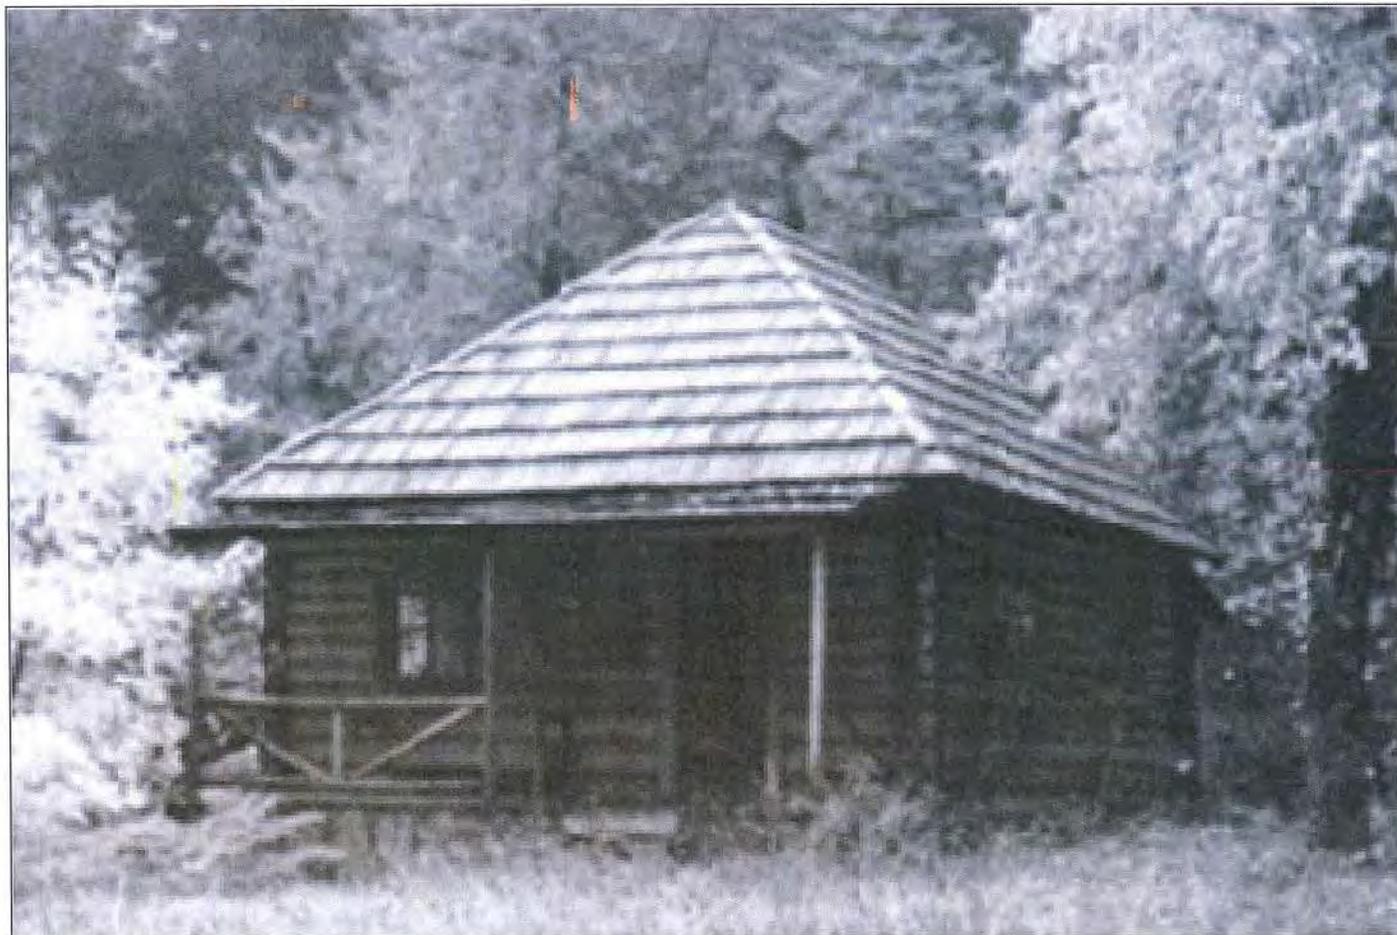
Figure 9: Photo of Interrorem Guard Station, Olympic National Forest. Photo From: Washington State Department of Archaeology and Historic Preservation

The Interrorem Guard Station was construction in 1907 and served as the first administrative site of the Olympic National Forest. The cabin was also used as a fire guard station. The log cabin has a hip roof with wood shingles, front porch with timber posts, and multi-light windows (See Figure 9).¹⁰

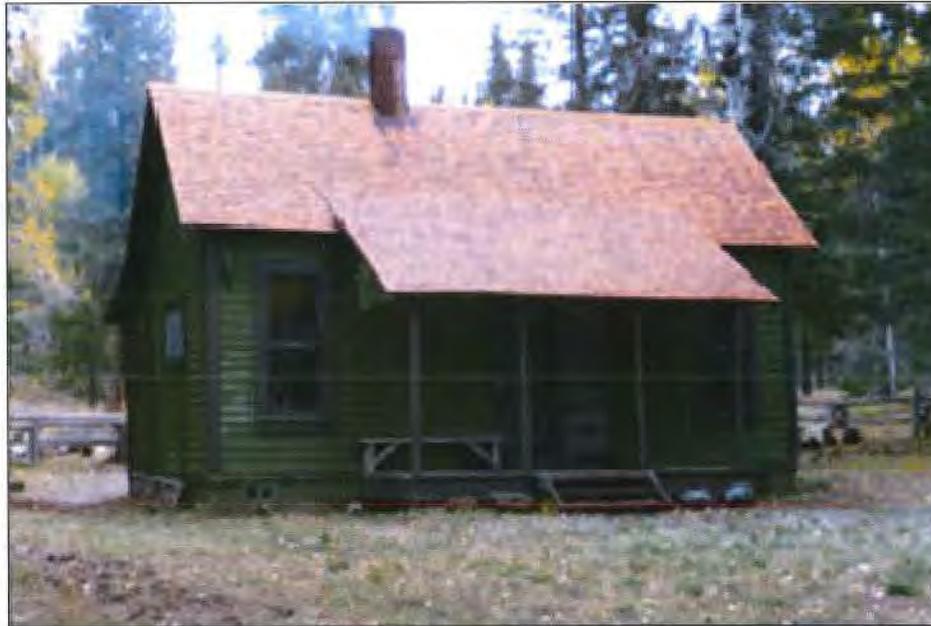
Figure 10: Photo of Gotchen Creek Guard Station, Gifford Pinchot National Forest.

Built in 1909, the station was used as the administrative headquarters for Mt. Adams District through 1916. The site was selected to administer grazing activities, which was a primary use of the national forest until the 1940s. The building is good example of vernacular-style ranger station remaining from the early period. The building has a side-facing gable roof, exposed rafter tails, wood-shingling roofing, interior ridge chimney, drop siding and four-over-four and one-over-one double-hung wood-sash windows, with a partial shed roof (See Figure 10).

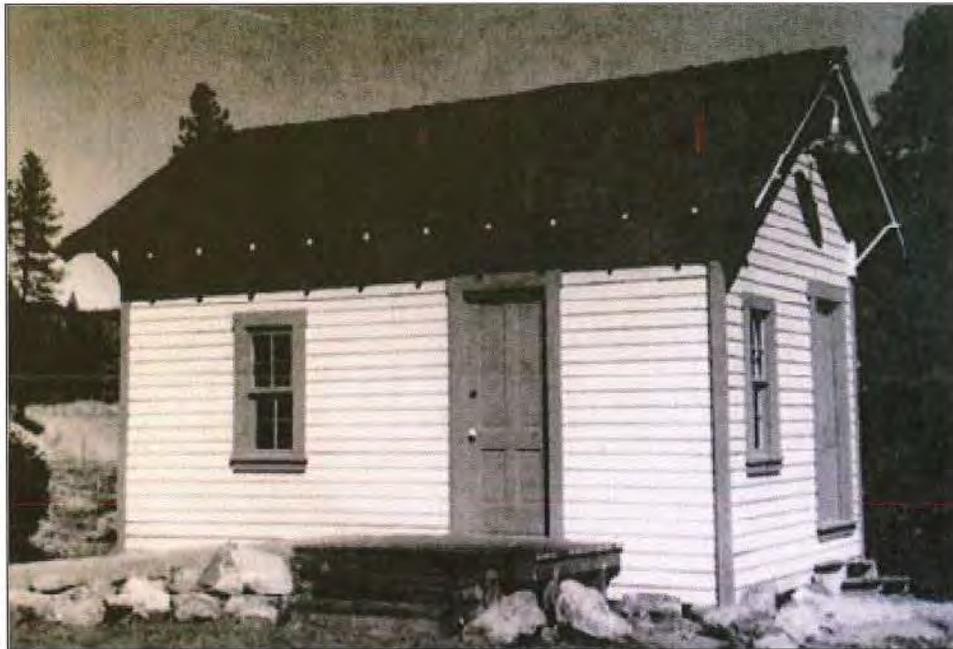
Figure 12: Star Ranger Station, Rogue River-Siskiyou National Forest. From: NR Nomination Form, 1999.

The Star Ranger Station Building, built in 1911 as the administrative headquarters on the Applegate Ranger District of the Rogue River National Forest, is significant for its association with the development of the Forest Service in southwest Oregon. The 1911 Ranger Station Building (or "Tack Room" as it is commonly known), is a simple vernacular wood-frame building measuring approximately 12'x20'. Resting on wooden piers and native boulders, the building has a gable roof with wood-shingle roofing and exterior walls clad with horizontal shiplap siding. Each wall contains a four-over-four, double-hung sash window with plain trim. The building has triangular knee braces at the gable peaks and eaves and exposed rafter ends. The two entrances contain four-panel doors with white ceramic knobs (See Figure 12).¹²

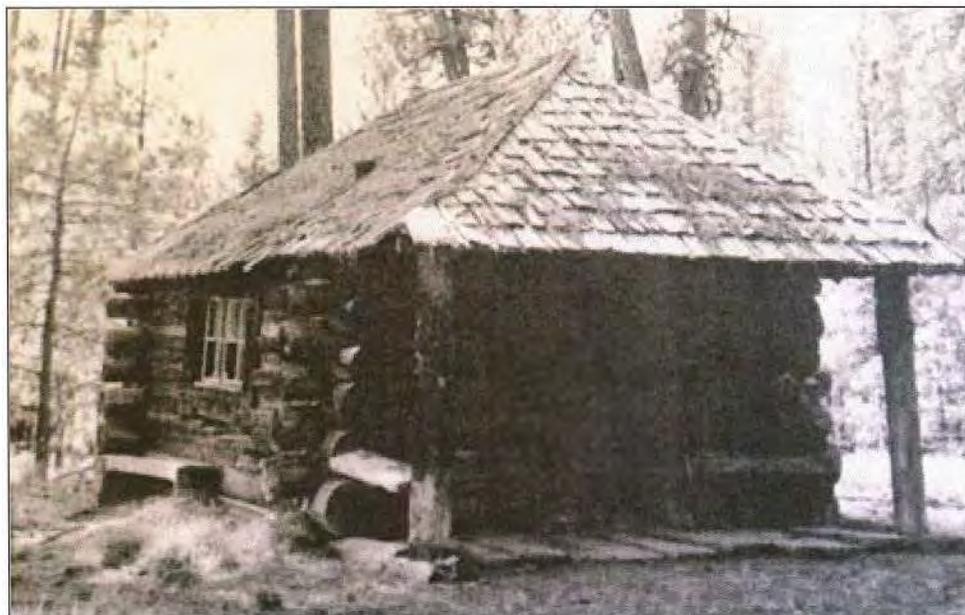
Figure 13: Photo of Allison Ranger Station, Malheur National Forest. From: NR Nomination Form, 1979.

The Allison Ranger Station, a log cabin, was built in 1911 by Ranger Ci Donnelly. It is located in the Snow Mountain Ranger District of the Ochoco National Forest in Oregon at an elevation of 5,500 feet. The Allison Ranger Station is historically significant in that it was among the earliest permanent structures built on the Ochoco National Forest for the purpose of administering the lands in that jurisdiction. As such, it was a focal point for the Forest Service's responsibilities of protecting and conserving those natural resources held in public trust. Because the timber and summer forage of the Ochoco National Forest were, and remain, important to the lumbering and stock raising industries that form the basis of the area economy. The cabin was used until 1935 when new facilities were built nearby. The cabin is chinked with rough-sawn boards and overlapping corner joints. The hand-split shingle roof extends out over the planked front porch, which is a 5' feet wide extension of the interior floor (See Figure 13).

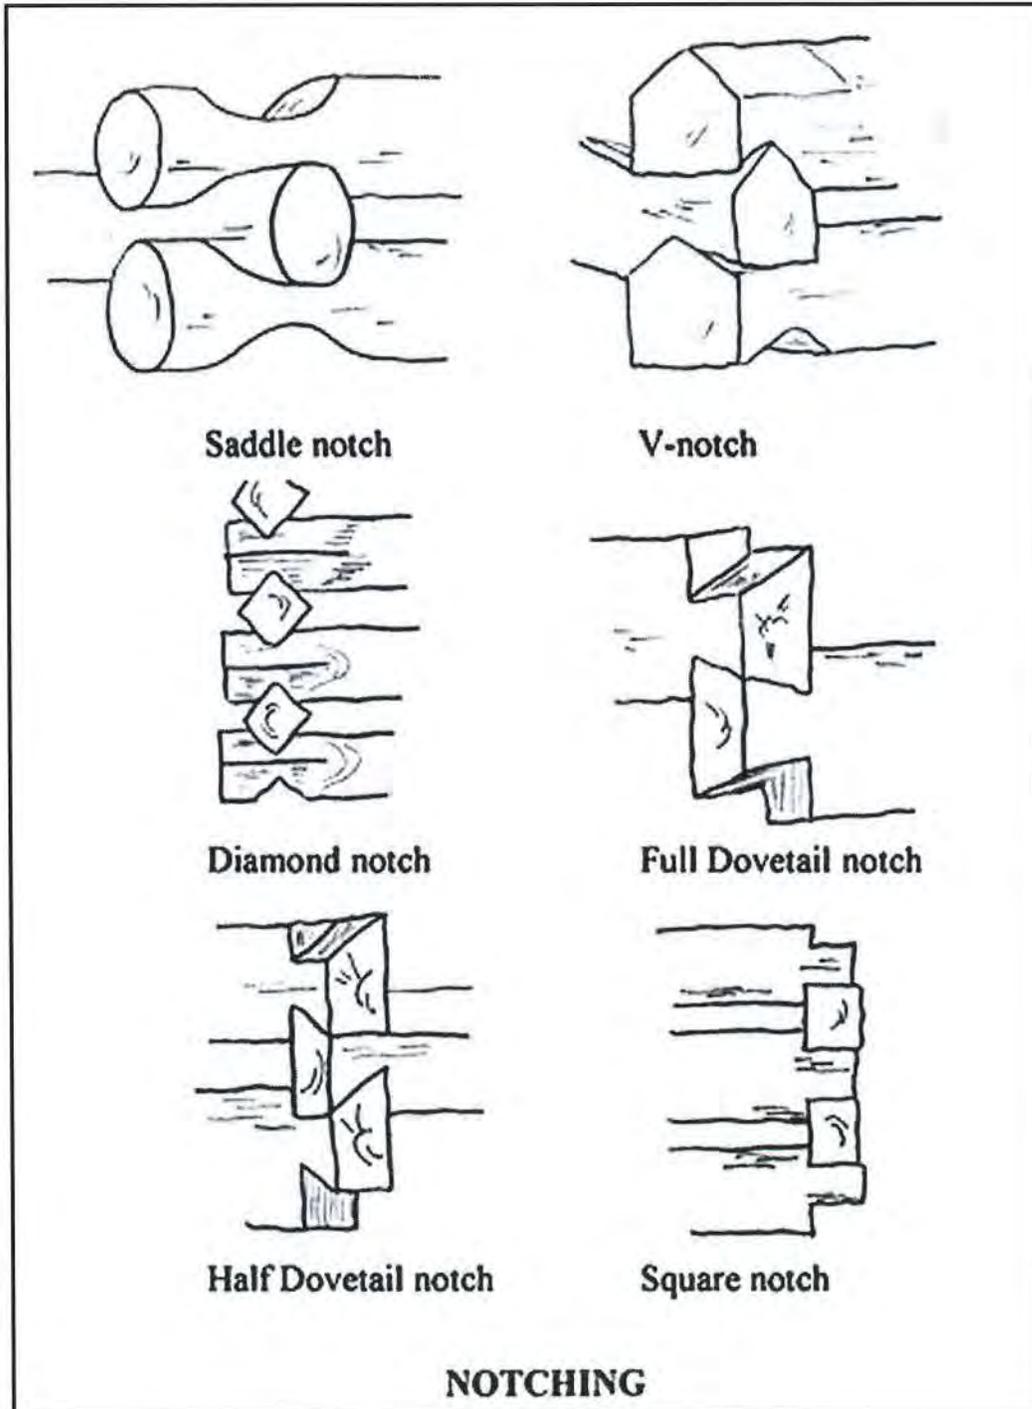
Figure 14: Diagram of different types of log notching techniques.

The walls of the guard station were constructed using peeled logs joined with a double-saddle notch with the corners vertically sawn and the joints being sealed with moss. The double-saddle notch is similar to the saddle notch, but instead of one-half round shaped notch on the top of the log, there is a notch on both the top and bottom sides on the log. In order for a double-saddle notch to work correctly, the butt ends of the logs need to protrude past the building corner.³ The saddle notch is one of the oldest and most common methods of corner notching. It is simple and easy to cut a half round notch in a log so that it can "cradle" the next log to fit on top. The space left between each log member is a chink, and traditionally chinking in the form of bark, stone, wood, or mortar was used to fill in this gap. The chinking used on the Olallie Meadows Guard Station are thin, horizontal strips of wood nailed to the logs.

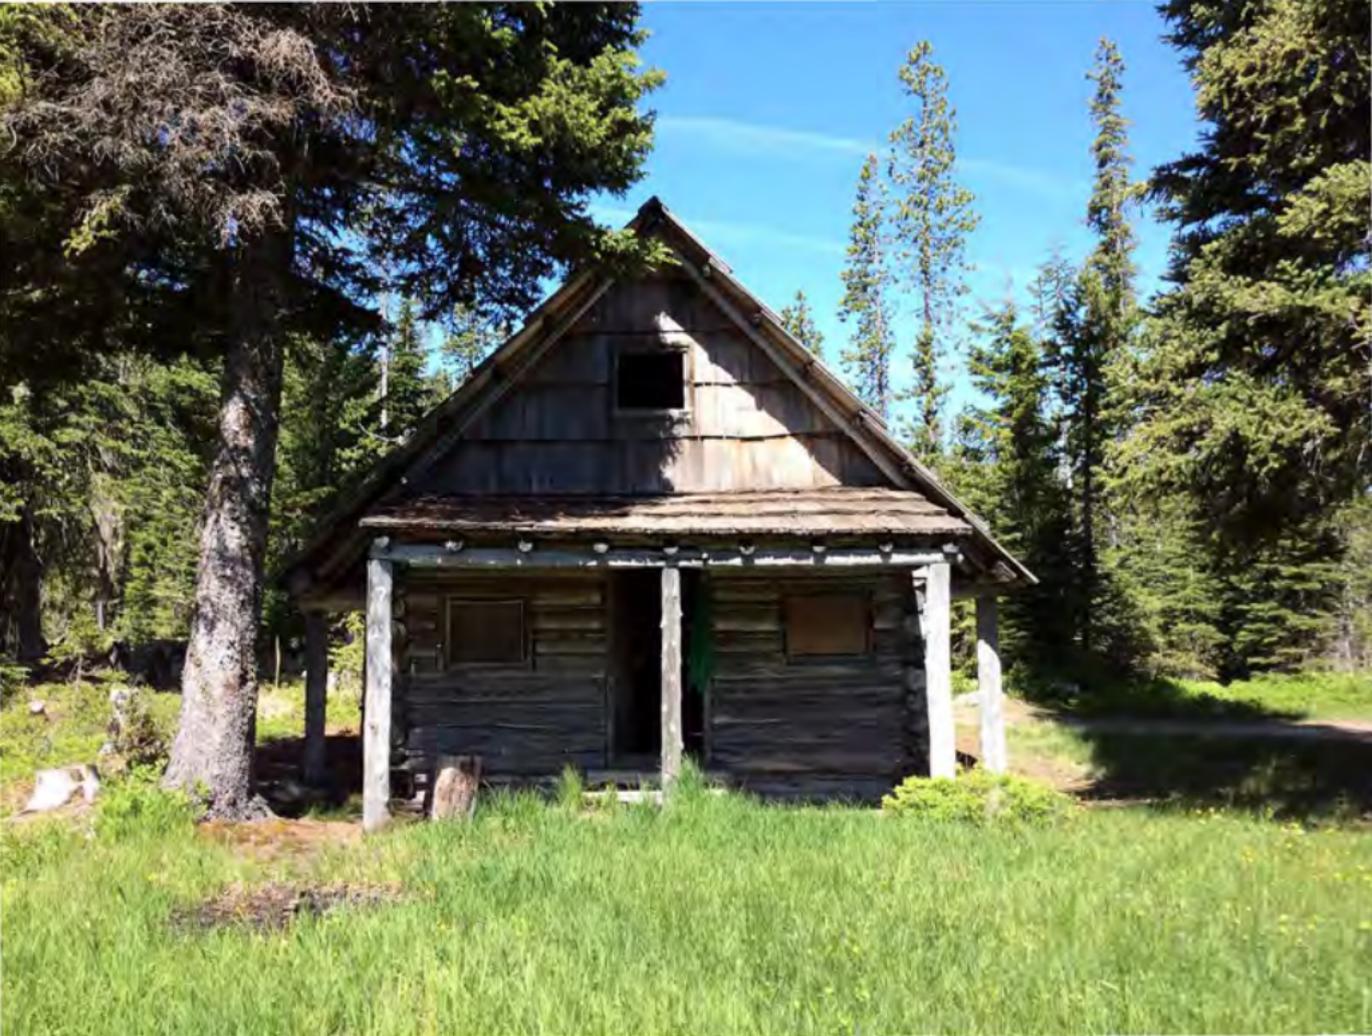
- Photo 1 of 8:** (OR_MarionCounty_OlallieMeadowsGuardStation_0001)
East Elevation, camera facing west.
- Photo 2 of 8:** (OR_MarionCounty_OlallieMeadowsGuardStation_0002)
North Elevation, camera facing south.

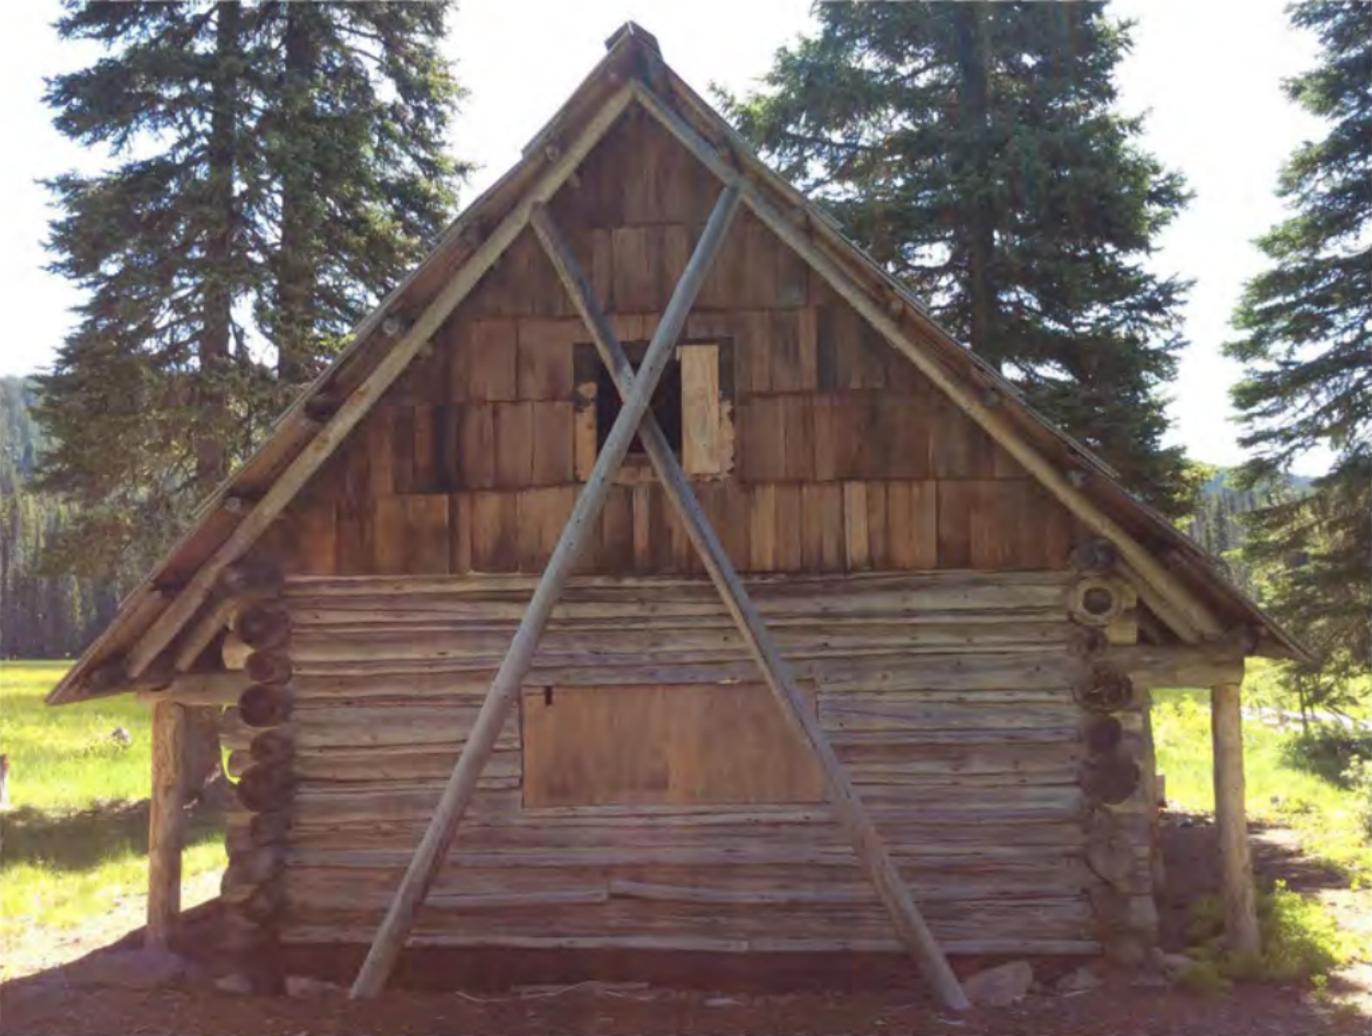
- Photo 3 of 8:** (OR_MarionCounty_OlallieMeadowsGuardStation_0003)
West Elevation, camera facing east.
- Photo 4 of 8:** (OR_MarionCounty_OlallieMeadowsGuardStation_0004)
South Elevation, camera facing north.

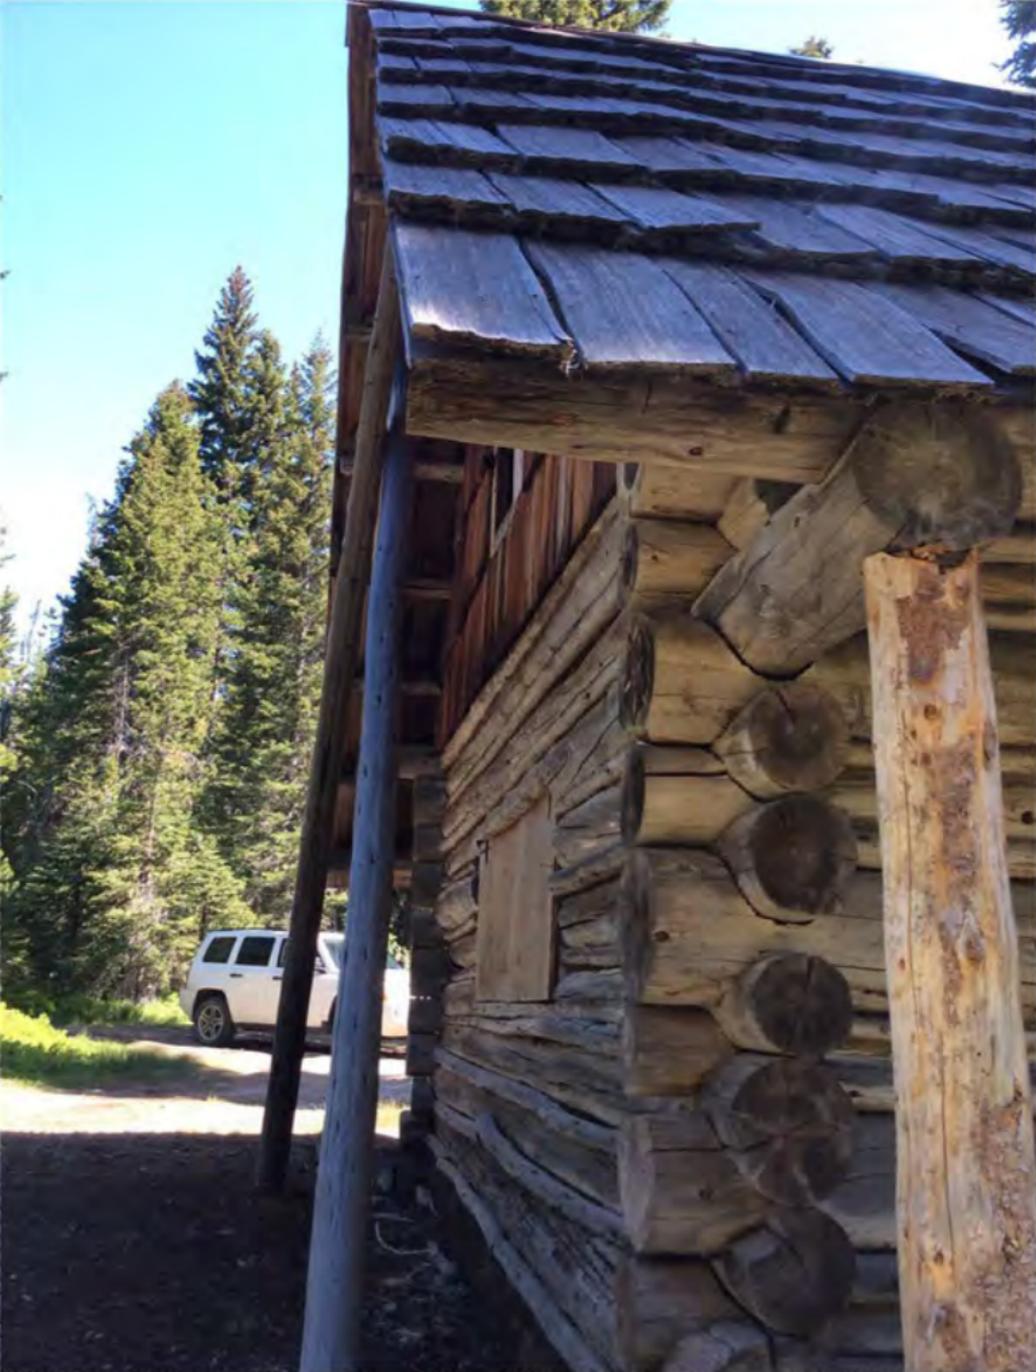
- Photo 5 of 8:** (OR_MarionCounty_OlallieMeadowsGuardStation_0005)
West Elevation, detail of log construction, camera facing east.
- Photo 6 of 8:** (OR_MarionCounty_OlallieMeadowsGuardStation_0006)
Interior photo of Olallie Meadows Cabin, facing east.
