KENTUCKY HISTORIC RESOURCES
Individual Inventory Form

Resource # 62
Shelby County

1. Name of Resource: John C. Brown House

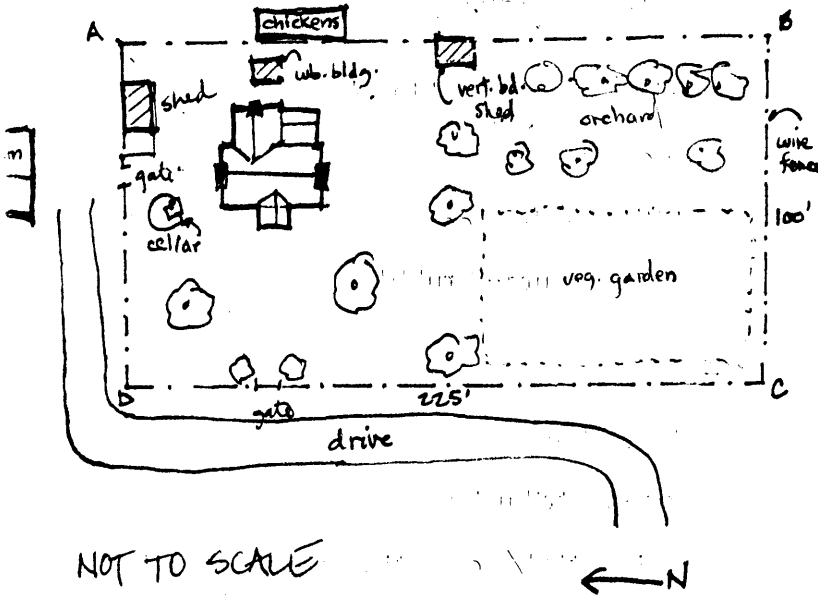
44. Site Plan (and boundary description and justification for N.R. sites):

Beginning at A, south 225' along a fence to B, thence west 100' along a fence to C, thence north 225' along a fence and tree line to D, thence east 100' along a fence and tree line to the point of origin. The boundaries were chosen to encompass the house and its domestic-related space which includes the remains of an orchard, a vegetable garden, and a cellar, as well as three non-contributing sheds. Although these sheds are of more recent construction than the house, they could not be eliminated from the nominated area without disrupting the relationship of the house and its setting.

Point A is at the intersection of two fences in the northeastern corner of the yard, and is 43 ft. northeast of the northeastern corner of the ell.

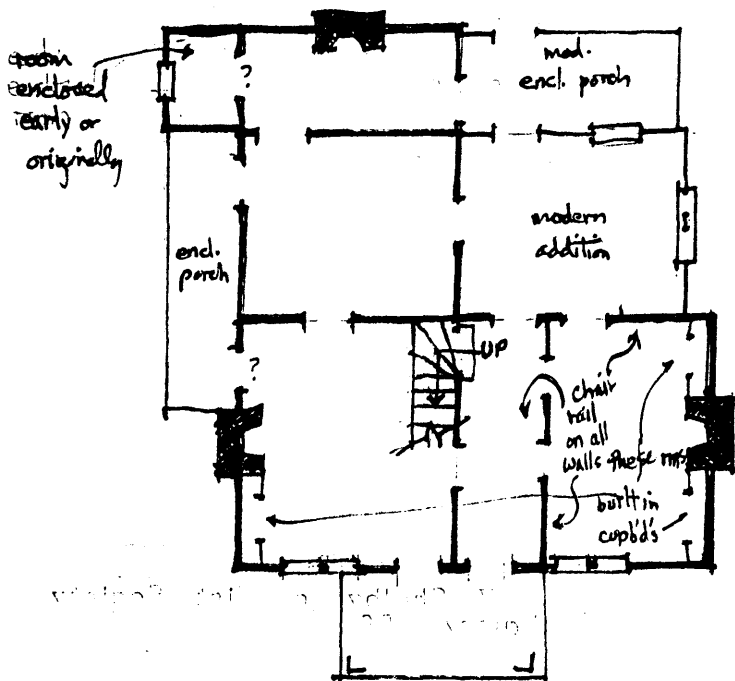
45. Description and House Plan:

1-story, 4-bay wood frame center-passage, single-pile plan, coursed rubble foundation, gabled roof, asymmetrical principal (west) facade, original windows in outer bays replaced with paired 1/1 sash, 3-pane transoms over the two central doors, doors are late 19th century replacements, exterior slope-shouldered coursed-rubble stone chimneys at east and west gable ends flanked by enlarged 2/2 sash garrett windows, house clad in asbestos siding, 1-story-gabled porch shelters entrance, original 1-story-ell with exterior stone chimney on east gable end, enclosed porch on north side of ell, 2 additions in south

angle of ell: a shed-roofed extension on the rear (east) of the house (brick foundation) with a later jalousie porch of concrete block appended to it.

South door opens into passage, north door opens into larger of the two rooms, this north room has simple federal woodwork, chairrail, low beaded baseboard, mantel with bull's eye corner blocks, cupboards flank fireplace, enclosed stairs in southeast corner of this room open into east end of passage; south room and passage have more elaborate woodwork: reeded door and window surrounds with corner blocks, high molded baseboards, chairrail, mantel in south room has central tablet

, bathroom added in northeast corner of south room; ell original but largely re-worked as modern kitchen.
