**NATIONAL REGISTER OF HISTORIC PLACES  
INVENTORY -- NOMINATION FORM**

Faneuil Hall

Dock Square (Faneuil Hall Square)

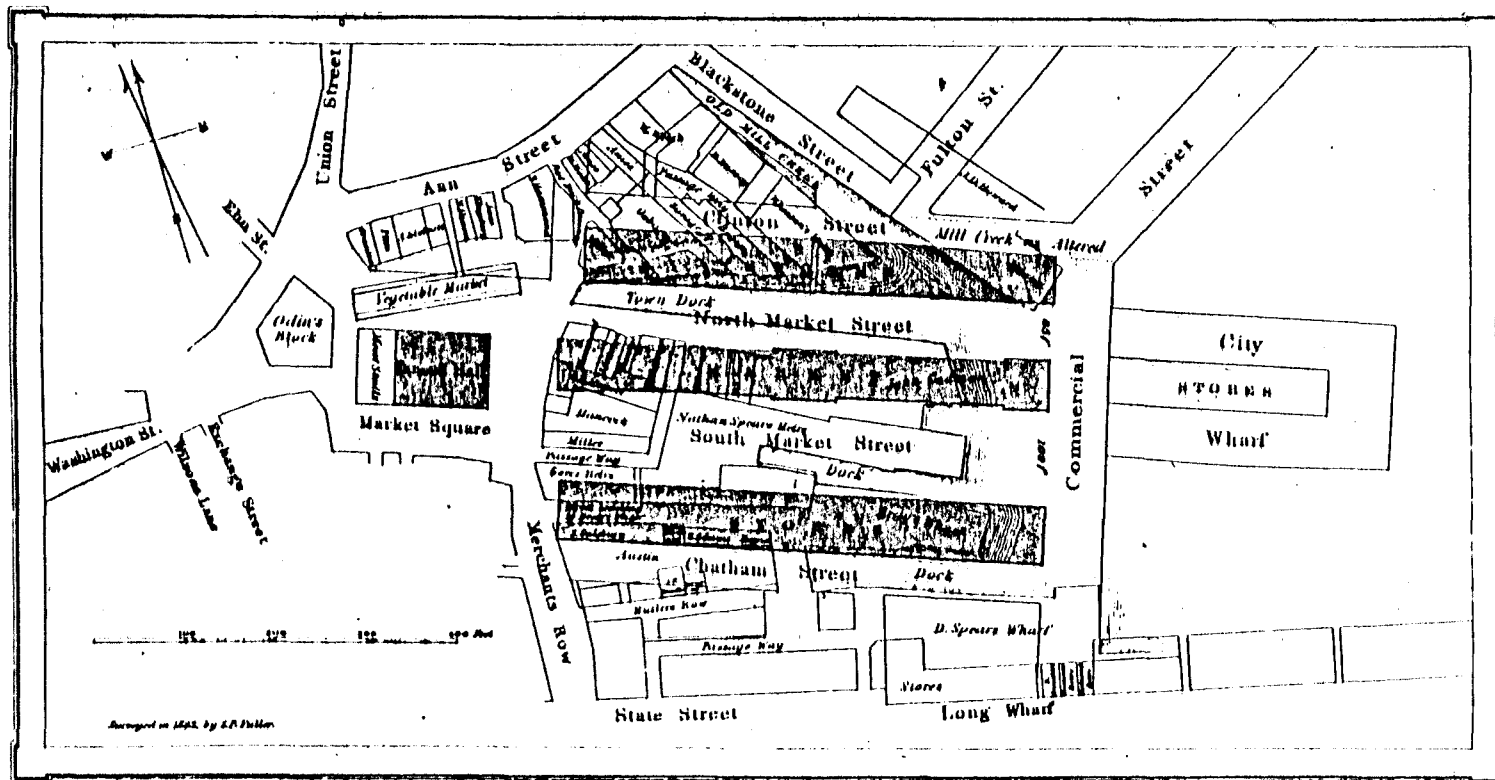
Illustration 25. Plan of Quincy Market and Faneuil Hall (1823).

GROUND PLAN OF THE MARKET HOUSE, ERECTED IN 1826, AND OF THE SPACE INCLUDED IN THE IMPROVEMENT.

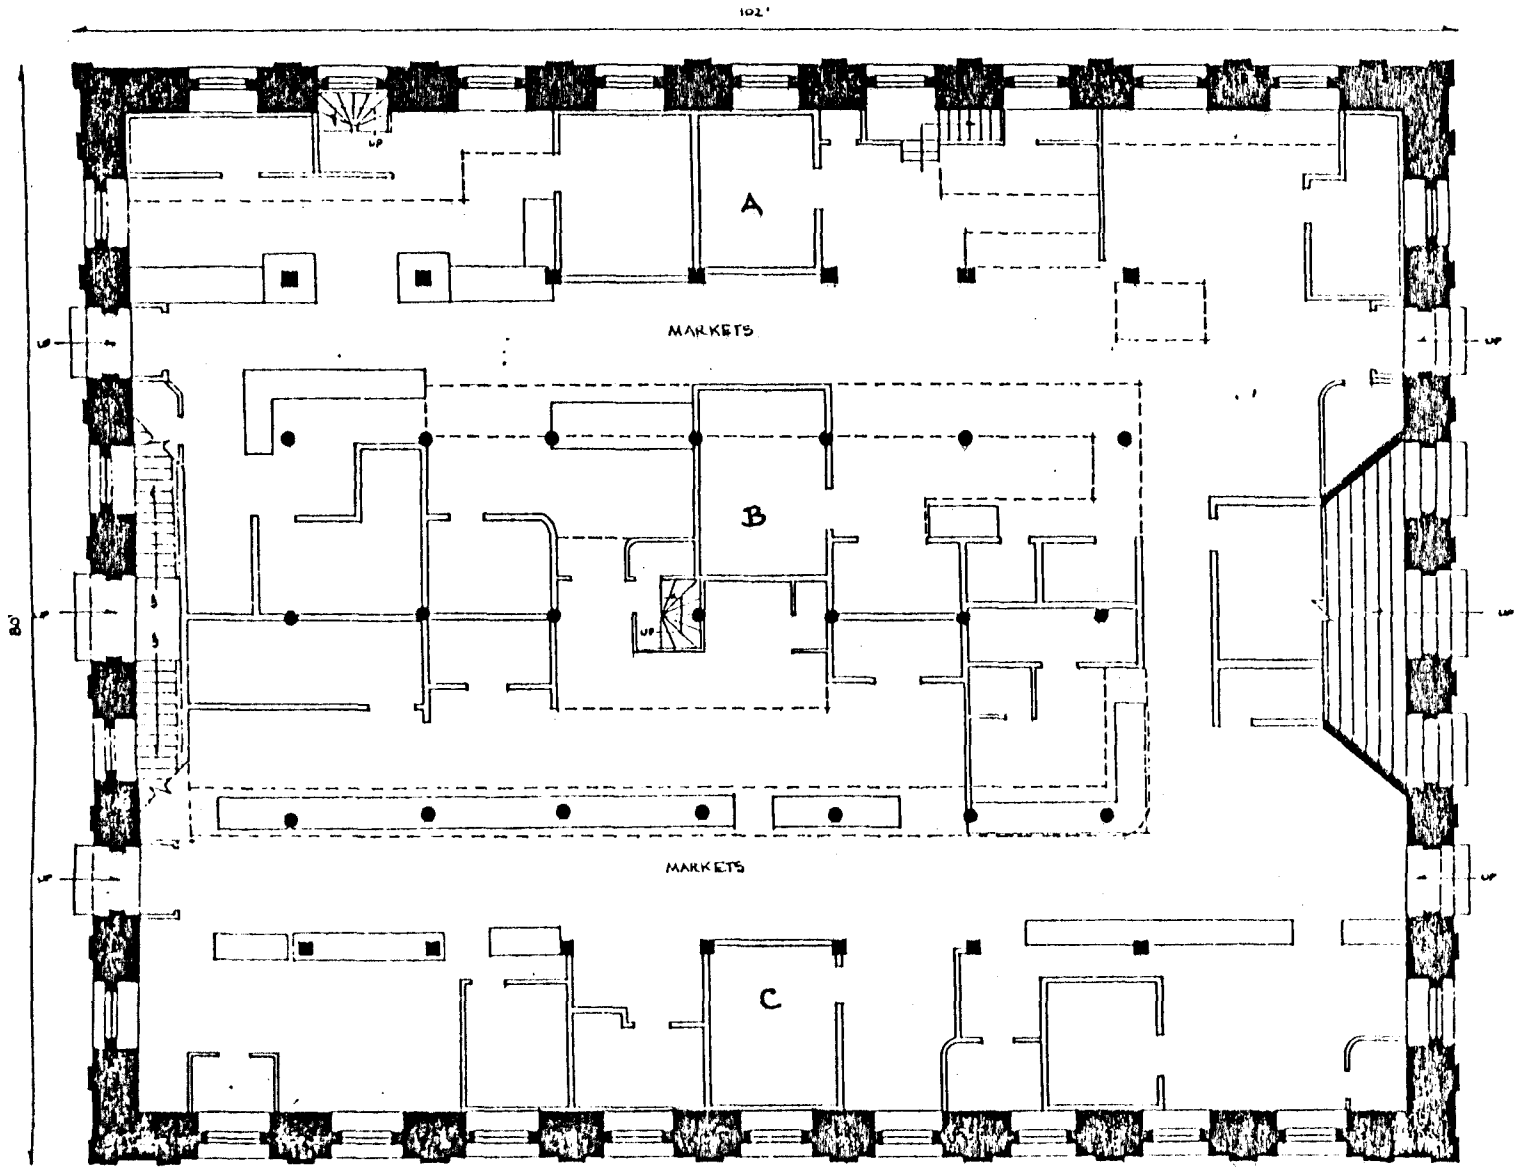
FANEUIL HALL  
FIRST FLOOR

DIAGRAM ONLY  
DIMENSIONS APPROXIMATE

Schematic plans (Ill. 78-82) made c. 1970 by Architectural Heritage, Inc., show the layout of the tenant areas on the ground floor and basement levels, as described above. However, the covered canopy, as well as half of the market stalls, would disappear during renovations made to the building in the 1970's. Waterfront Renewal proposals being made at that time included the restoration of Faneuil Hall Market ("Quincy Hall"), the North and South Market buildings, and Faneuil Hall (Ill. 83). Work on the latter was implemented in 1975-76. The project was funded partially by the City of Boston and partially by an historic preservation grant from the National Park Service through the Massachusetts Historical Commission. This work was carried out by Stahl/Bennett, Inc. It is described in their architectural drawings dated November 4, 1975, as well as in a "Completion Report" filed by them with the National Park Service shortly after the work was finished, under the firm's new title: Perry, Dean, Stahl, and Rogers. The work was performed under contract to the City of Boston's Public Facilities Department. It consisted primarily of an exterior renovation and an updating of interior fireproofing, with Cousins Company of Medford, Massachusetts, being the general contractor.(15)

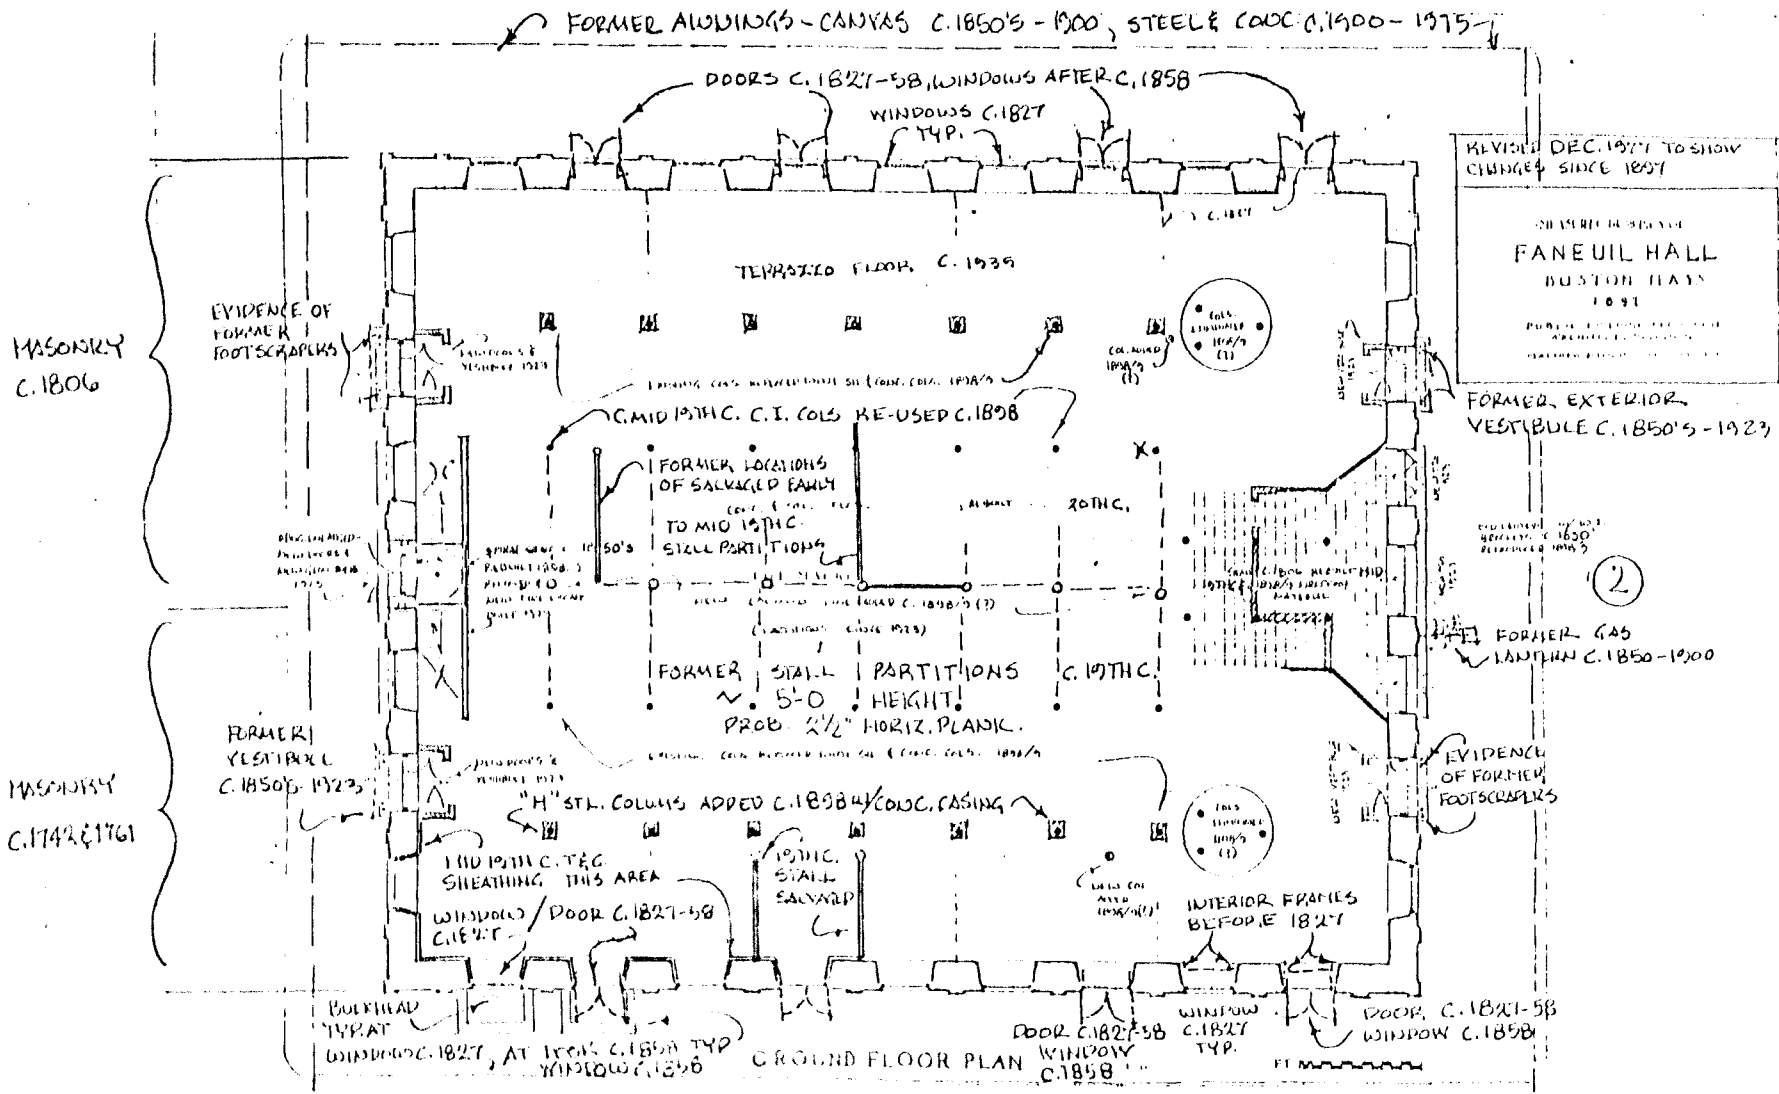
Illustration 98. Architectural Changes, Market Floor (1897/1977).

FANEUIL HALL - MARKET FLOOR, PLAN DATING MAJOR COMPONENTS
