United States Department of the Interior
National Park Service
National Register of Historic Places
Registration Form

historic name Montezuma Schoolhouse

Rural School Buildings in Colorado

Section number 7 Page 2
Rural School Buildings in Colorado MPS

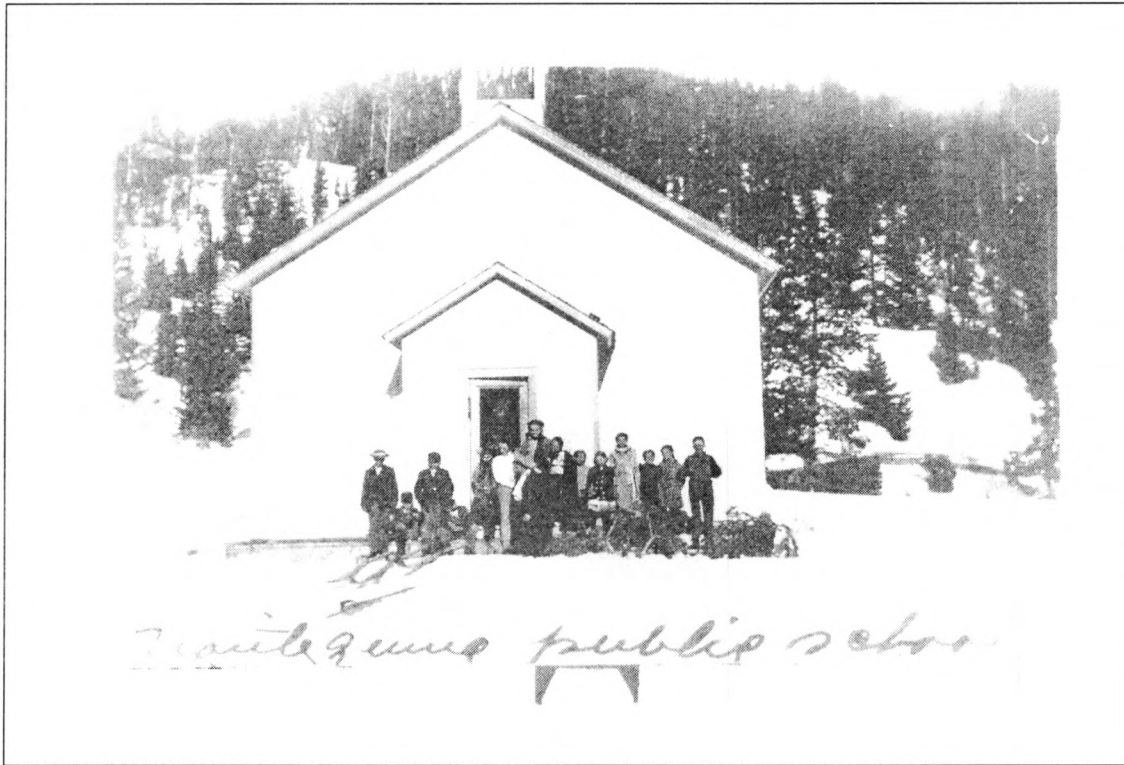
1910 Image

(Image courtesy of Summit Historical Society)

By 1910 a vestibule had been added to the west facade, horizontal wood clapboard siding covered the original board and battens, and the bell tower placed atop the roof. The bell was donated by the town of Montezuma and has a patent date of 1908. Electricity was brought in for lights by 1911. Also before 1910, a shed roof addition was put on the rear of the building. It included a coal room and storeroom. From an interview with Bob McCracken, a student in 1943, it was determined the building was still heated with a coal stove and the privies had been moved to the rear of the addition with direct access from the inside by then. Also, the swing, slide, and teeter-totter had been set up as a playground that is still used by the children of the community today. The wood shingle roof was replaced with galvanized metal and a propane tank by 1958 and a heater installed as well. No other changes have been made since 1958.
