KENTUCKY HISTORIC RESOURCES  
Individual Inventory Form

Resource # Be-119  
Boone County

1. Name of Resource: Hebron Deposit Bank

5. Location: 1871 Petersburg Rd. (Ky. 20)  
Hebron

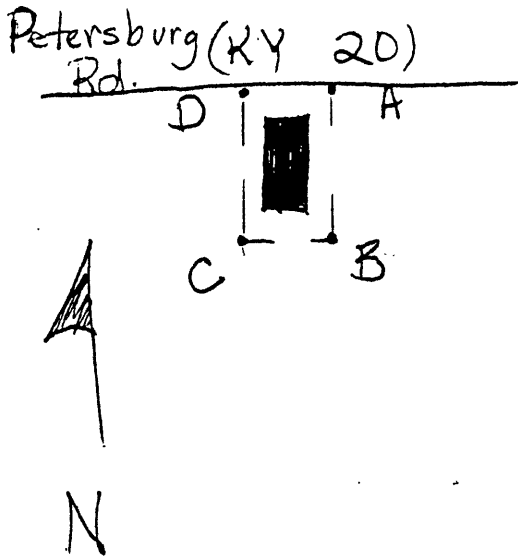
44. Site Plan (and boundary description and justification for N.R. sites):

The nominated property occupies the west 50' of city lot 31.

The boundary, a rectangle marked by points A, B, C, and D, includes the building and part of the city lot historically associated with the property. Boundary D-A is on the south side of KY 20.

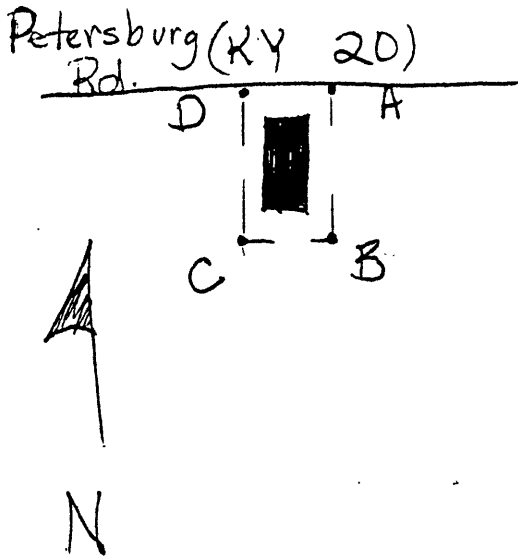
44. Site Plan (and boundary description and justification for N.R. sites):

The nominated property occupies the west 50' of city lot 31.

The boundary, a rectangle marked by points A, B, C, and D, includes the building and part of the city lot historically associated with the property. Boundary D-A is on the south side of KY 20.
