National Register of Historic Places Continuation Sheet

USDA Forest Service Administrative Buildings in OR and WA Built
by the CCC
Multiple Name

historic name NORTH BEND RANGER STATION

North Bend Ranger Station

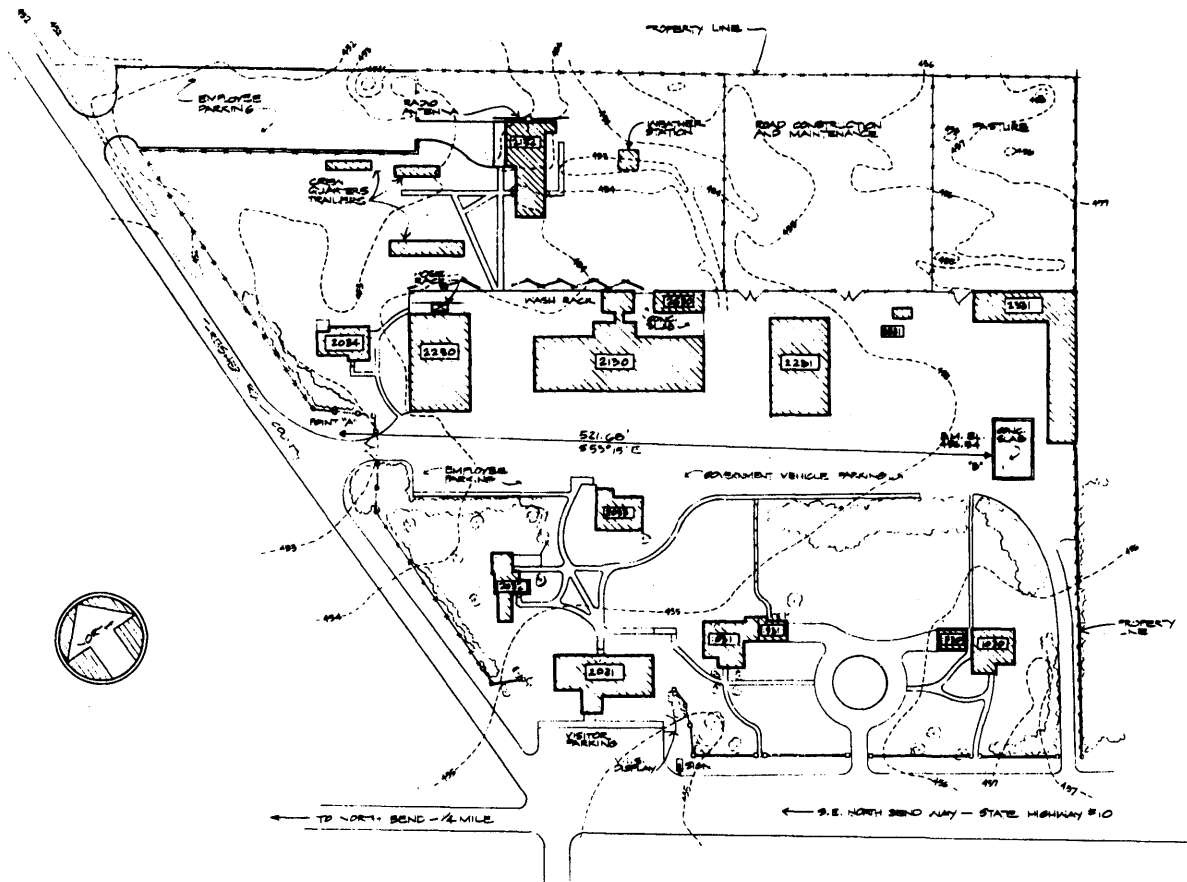
U.S. DEPARTMENT OF AGRICULTURE FOREST SERVICE		NORTH BEND RANGER STATION	
MT. BAKER-SNOQUALMIE NATIONAL FOREST			
THE PACIFIC NORTHWEST REGION			
DESIGNED	DATE	CHECKED	DATE
BY <i>J.B. Beck</i>	6/24/52	DATE	
TITLE <i>Beck</i>	DATE	DATE	
REVIEWED	DATE	DATE	
		S.T.B. SURVEY PLAT	
		SBC. 0 2.88, T. 23N, WM	
SHT	OF	SHT	OF
	3		3
