National Register of Historic Places
Registration Form

historic name Haven-Crandall House
other names/site number

street & number	220 South Janesville Street	N/A	not for publication
city or town	Milton	N/A	vicinity
state Wisconsin	code WI	county Rock	code 105
			zip code 53563

Haven-Crandall House
Milton, Rock County, Wisconsin

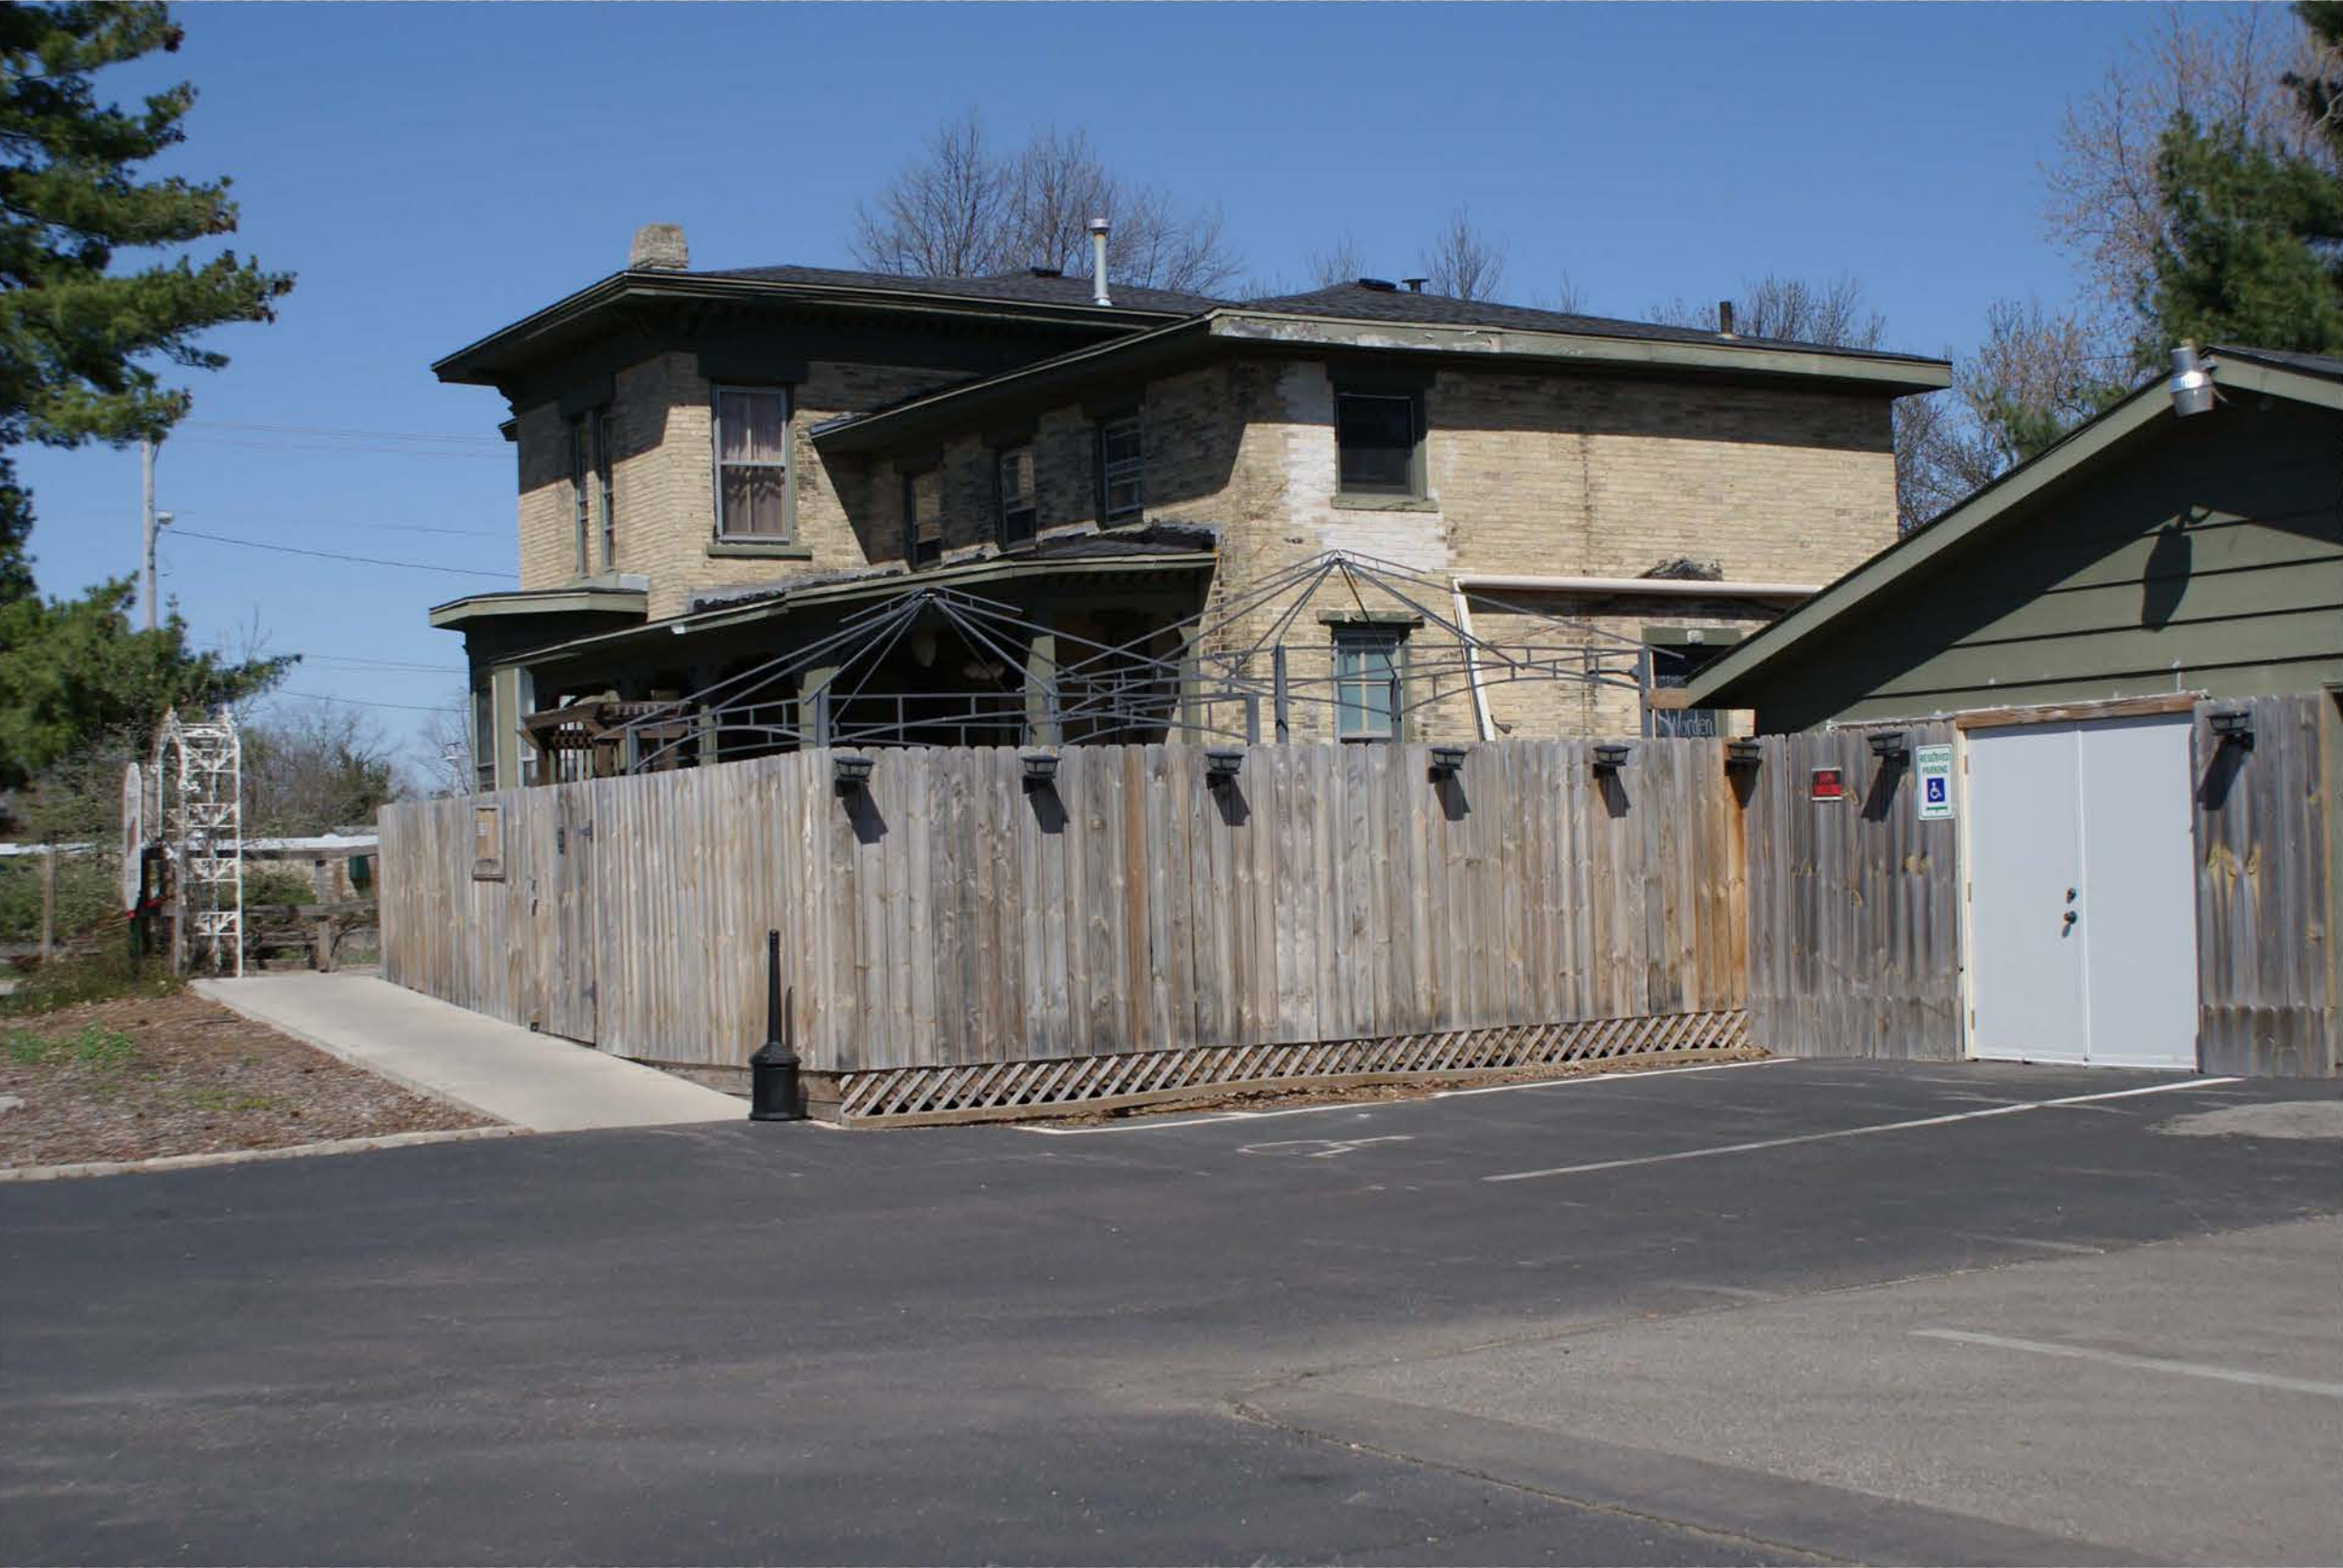
A two-story brick building with a dark roof and several windows. The building appears to be in a state of renovation or disrepair, with some missing siding and exposed structural elements. A metal framework is visible in front of the building, possibly for a porch or balcony.

A weathered wooden fence runs along the front of the property. The fence is made of vertical wooden planks and has a lattice base. A concrete sidewalk leads to a white metal structure on the left. A parking lot is visible in the foreground, and a smaller building with a white door is on the right.

A small sign with a blue and white accessibility symbol (wheelchair icon) is mounted on the fence. The sign is partially obscured by the fence's structure.

A white double door is set into a smaller building on the right side of the image. The door has a handle and a lock. The building has a dark green or grey roof and siding.

A paved parking lot with white lines marking the spaces. A black bollard is visible near the sidewalk. The lot is adjacent to the wooden fence and the brick building.
