Quarai before Excavation and Stabilization

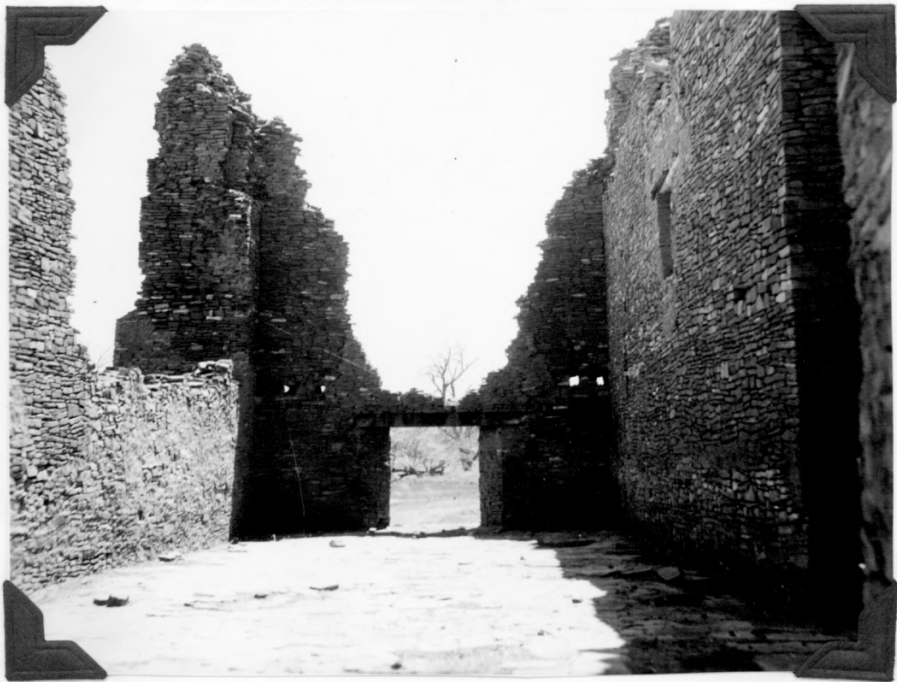
3. The front of the nave, Quarai (looking south through the main door). Note beam-holes; window at right.

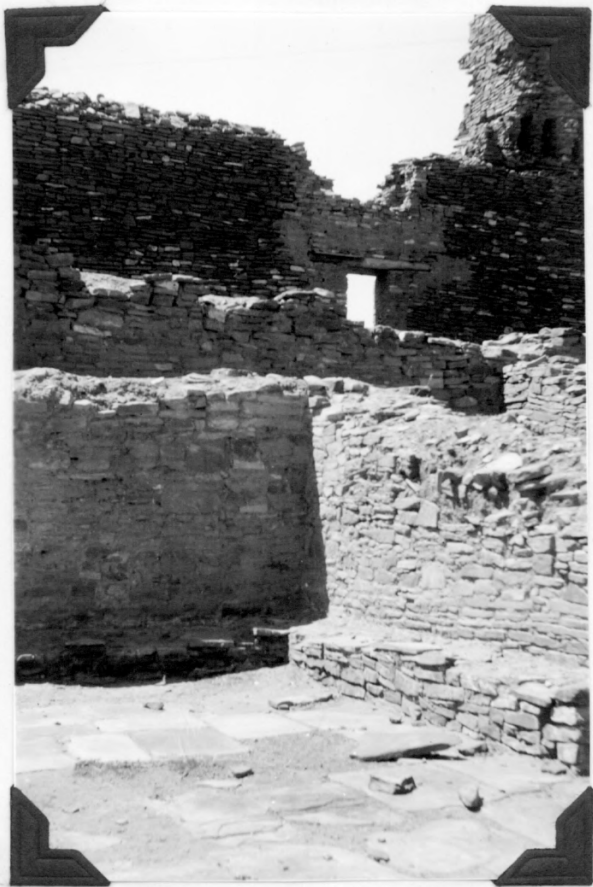
4. A portion of the monastery and of the east wall of the church, Quarai. Note flagstone floor in foreground; window.

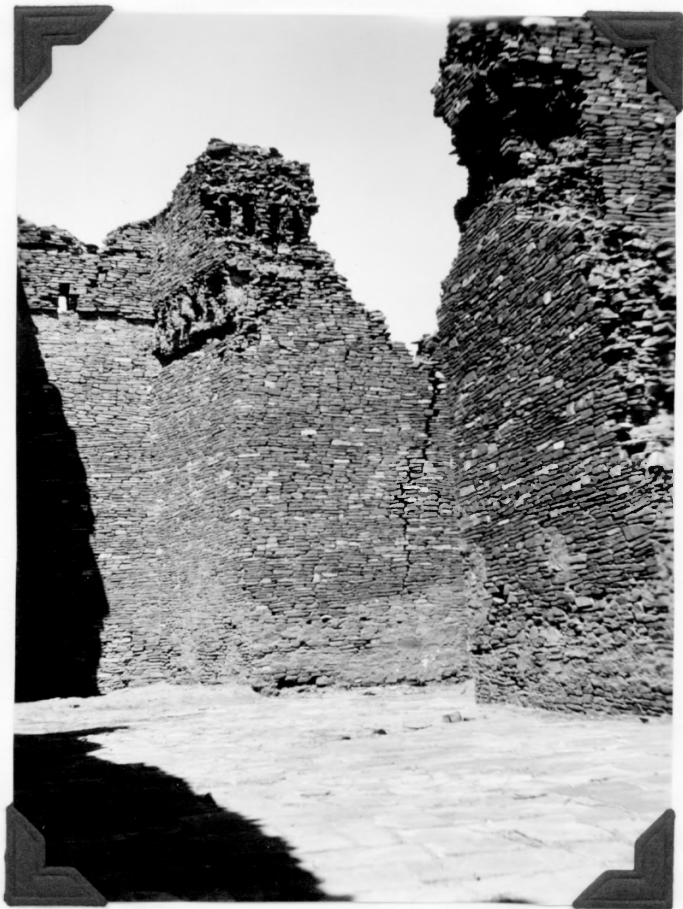
5. The northeast corner of the church, Quarai. Note rows of beam sockets, flagged floor, remnants of plaster, bad vertical crack.

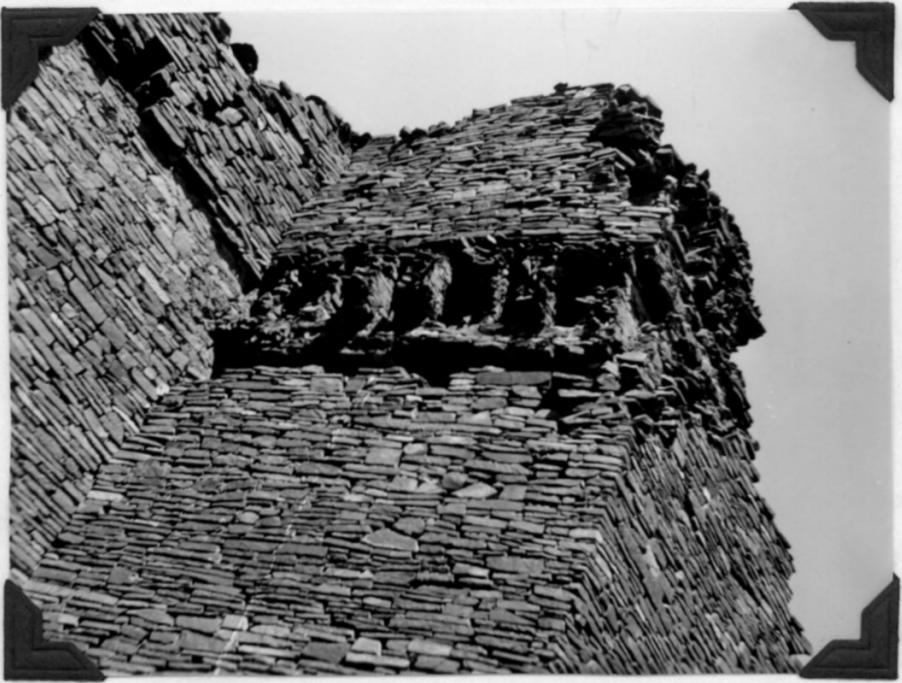
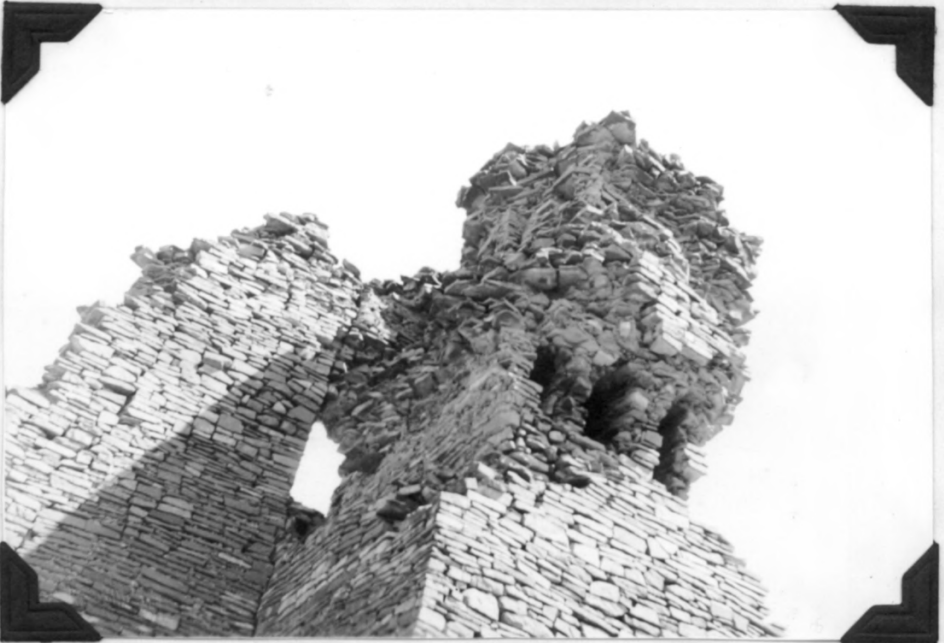
6a and b. Details from figure 5.

Note: the work done since these pictures were taken has not materially affected the appearance of the area; no work yet done on church.

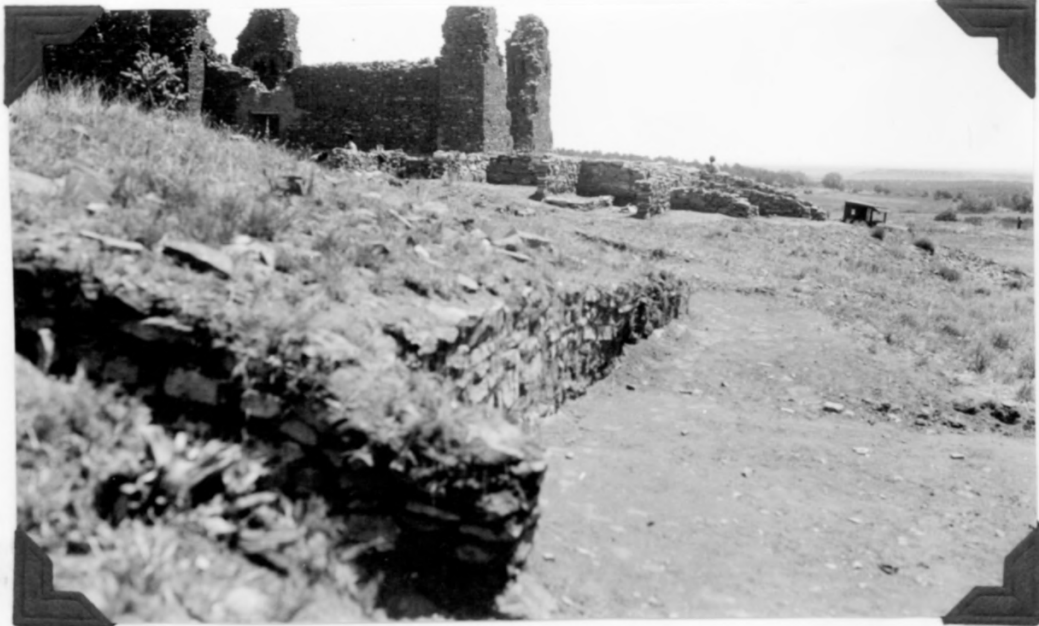
7. View showing, from front to back, recent outlining of a major portion of the pueblo ruin, excavated section of the pueblo, and west side of the church.

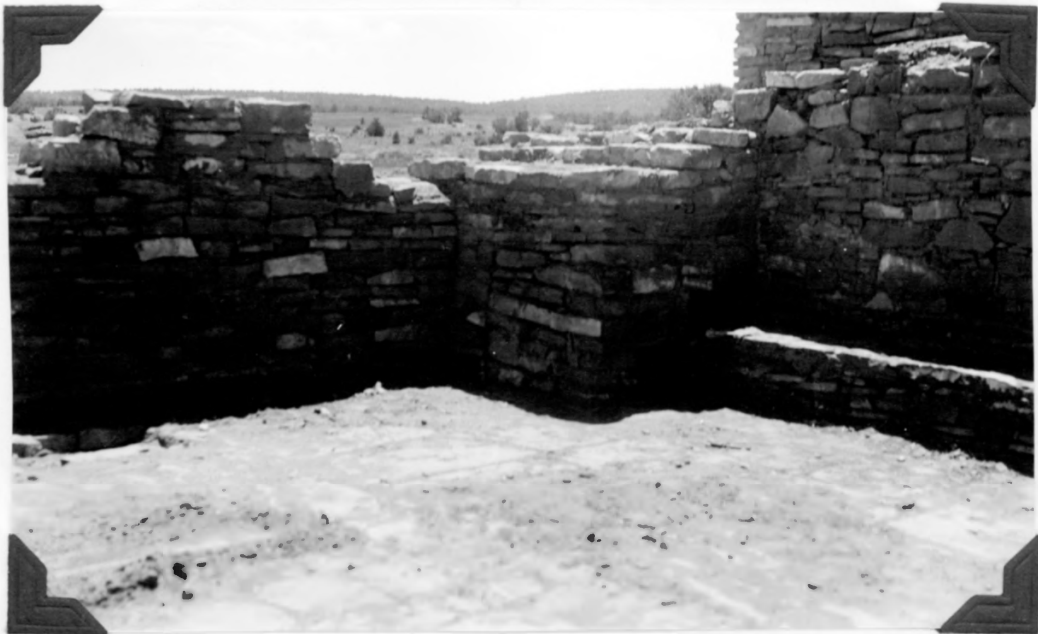
9. Room in southwest portion of the monastery. Note bench, believed to be for communicants waiting to see the priest, flagstone floor, peculiar structure in corner. Walls have been stabilized (top courses relaid in bitudobe, some minor rebuilding).

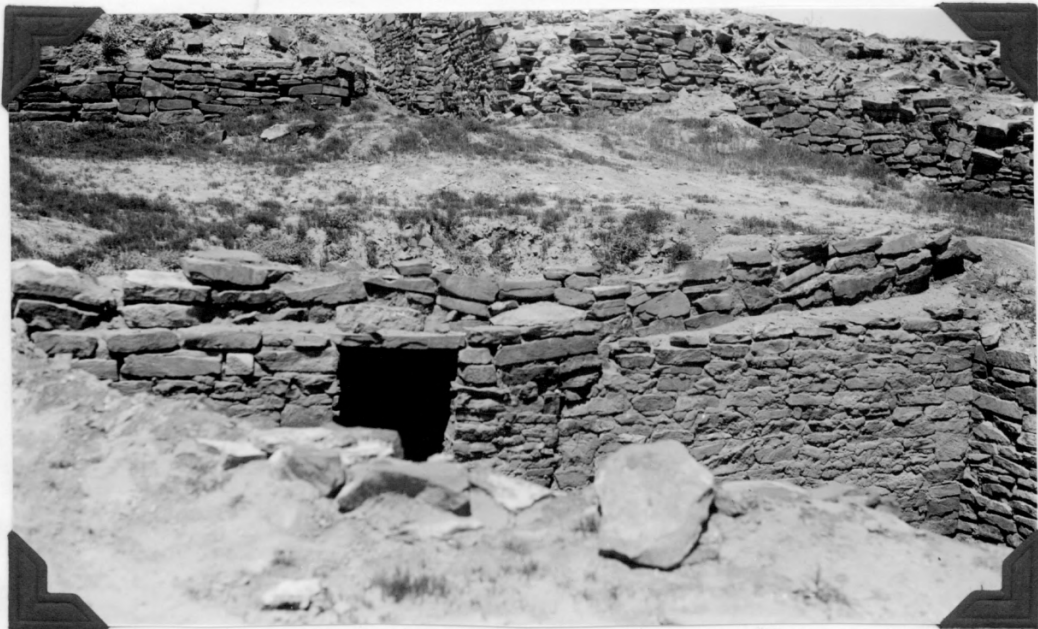
10. Round kiva in eastern portion of monastery area, with puzzling partition wall with a door partly filled, and with a terrace-enclosing monastery wall across the top of this partition wall.
