Charles A. Braun House, 790 Vale View Drive, Vista,
CA 92083

Photographer: Rick Alexander, August 15, 1984--
Negative property of San Diego Association of
Governments, 1200 Third Avenue, Suite 524, San
Diego, CA 92101

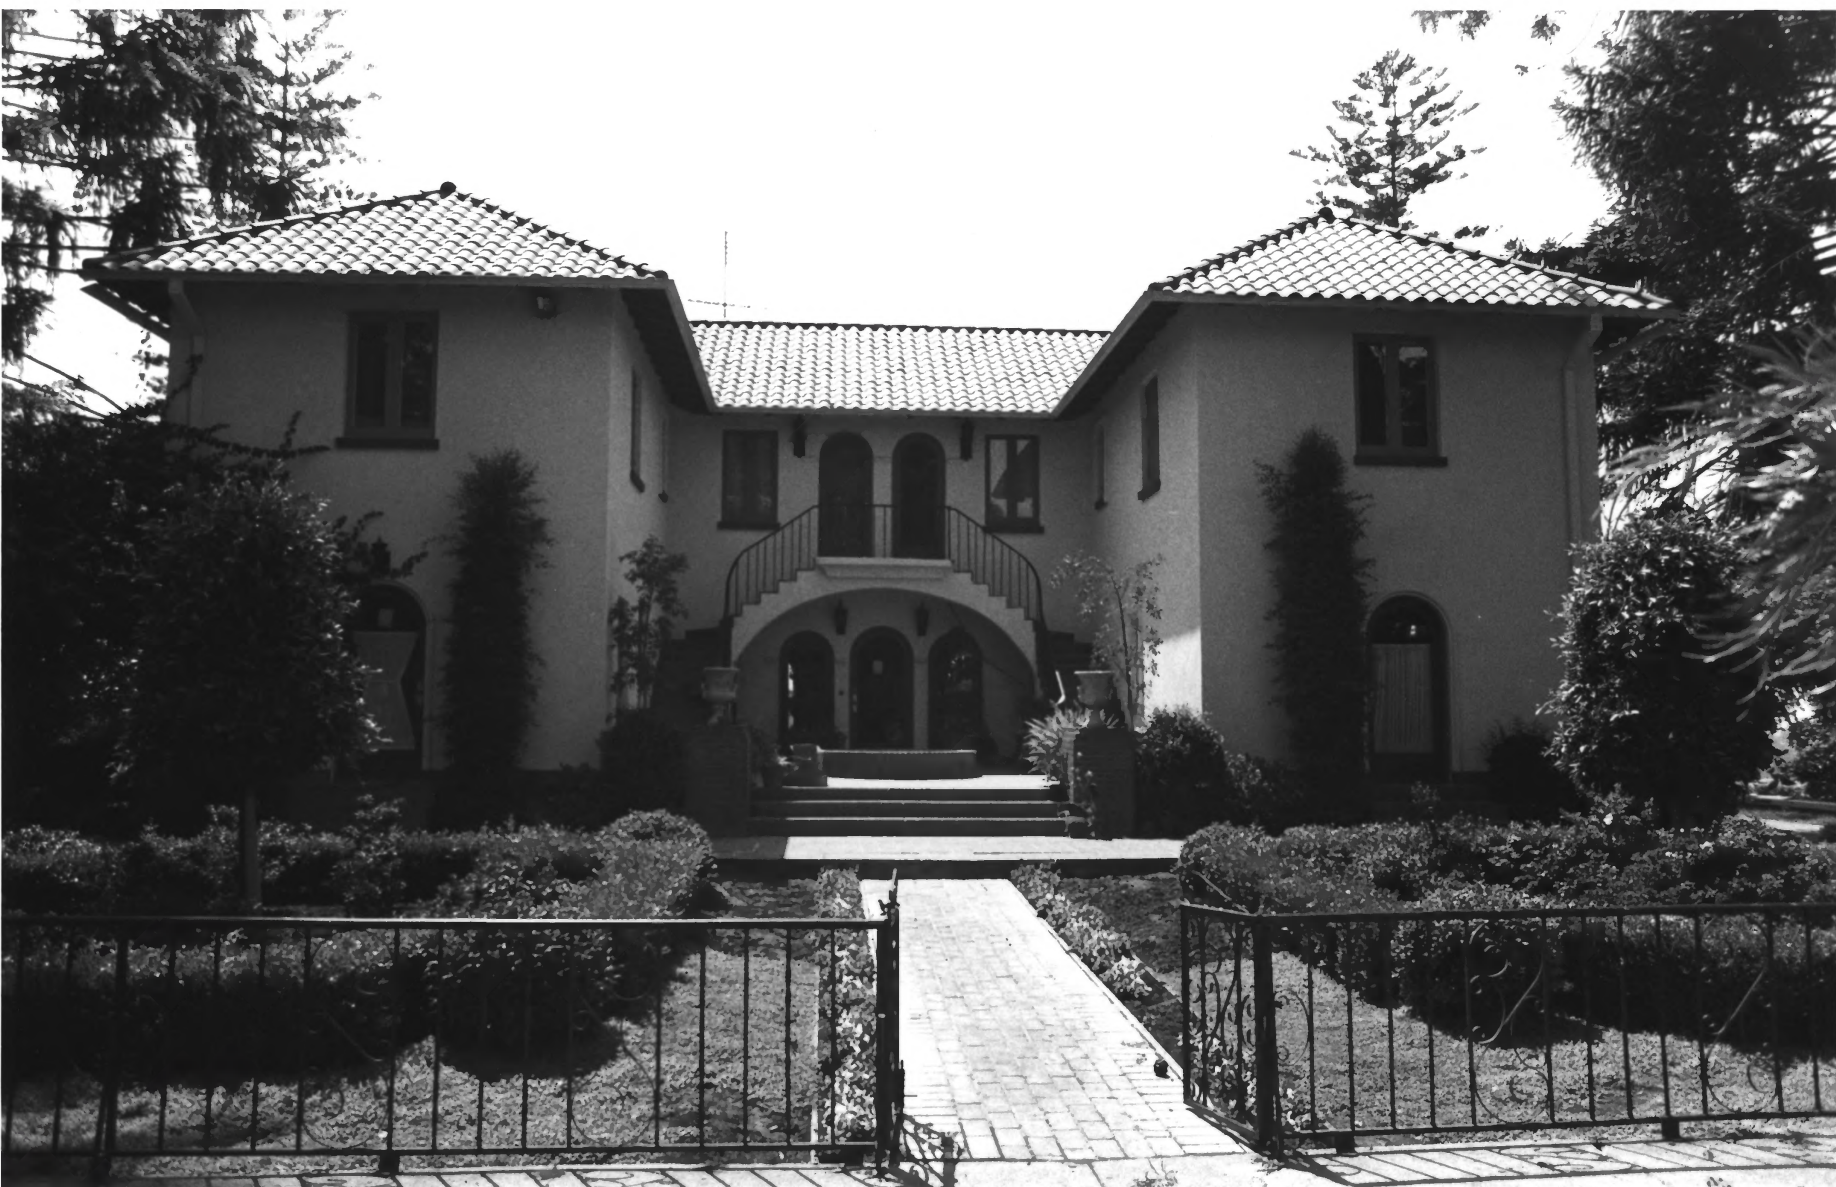
#1 of 1 photos.

View of structure from West showing front eleva-
tion, first and second floor entrance doors, and
brick porch and fishpond.

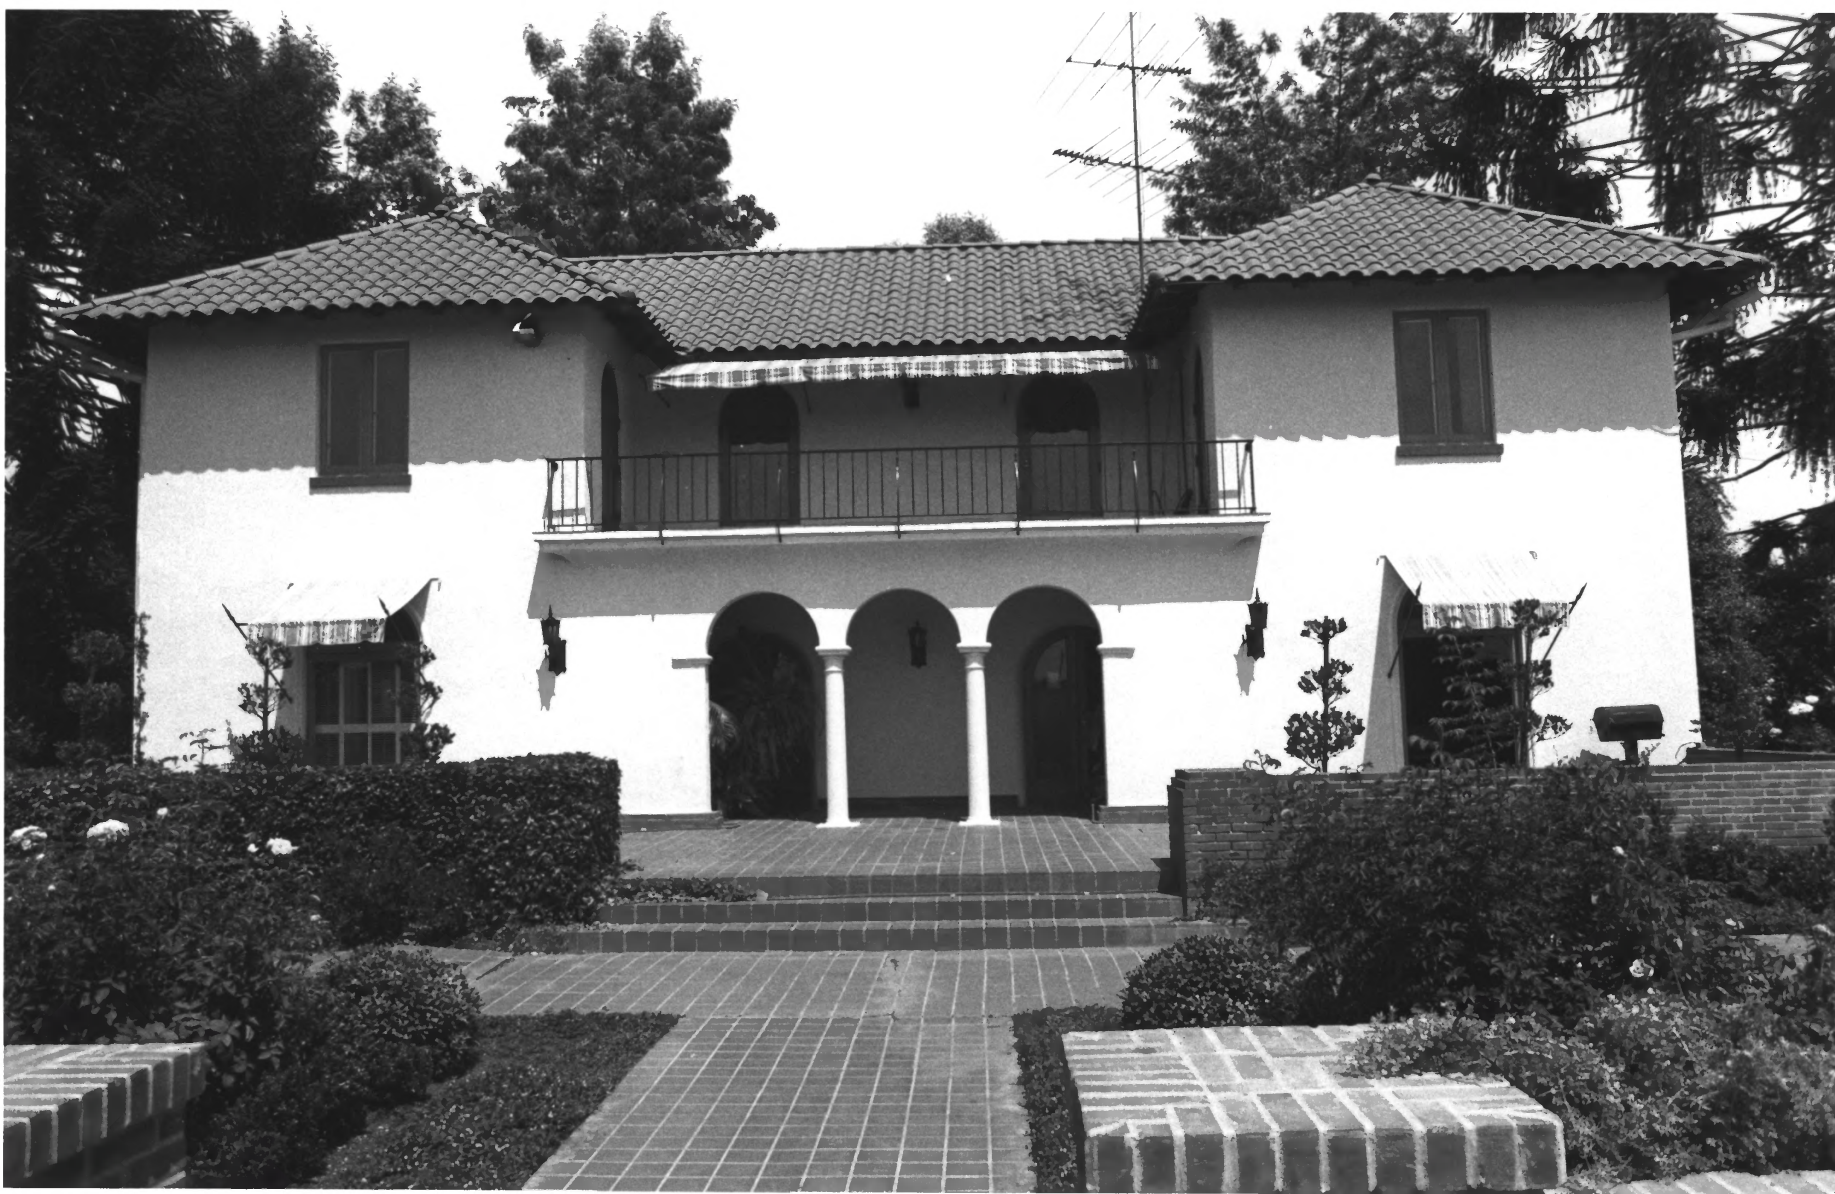
#2 of 1 photos.

View of structure from East showing rear eleva-
tion , rear entrance doors, upper gallery and brick
patio.

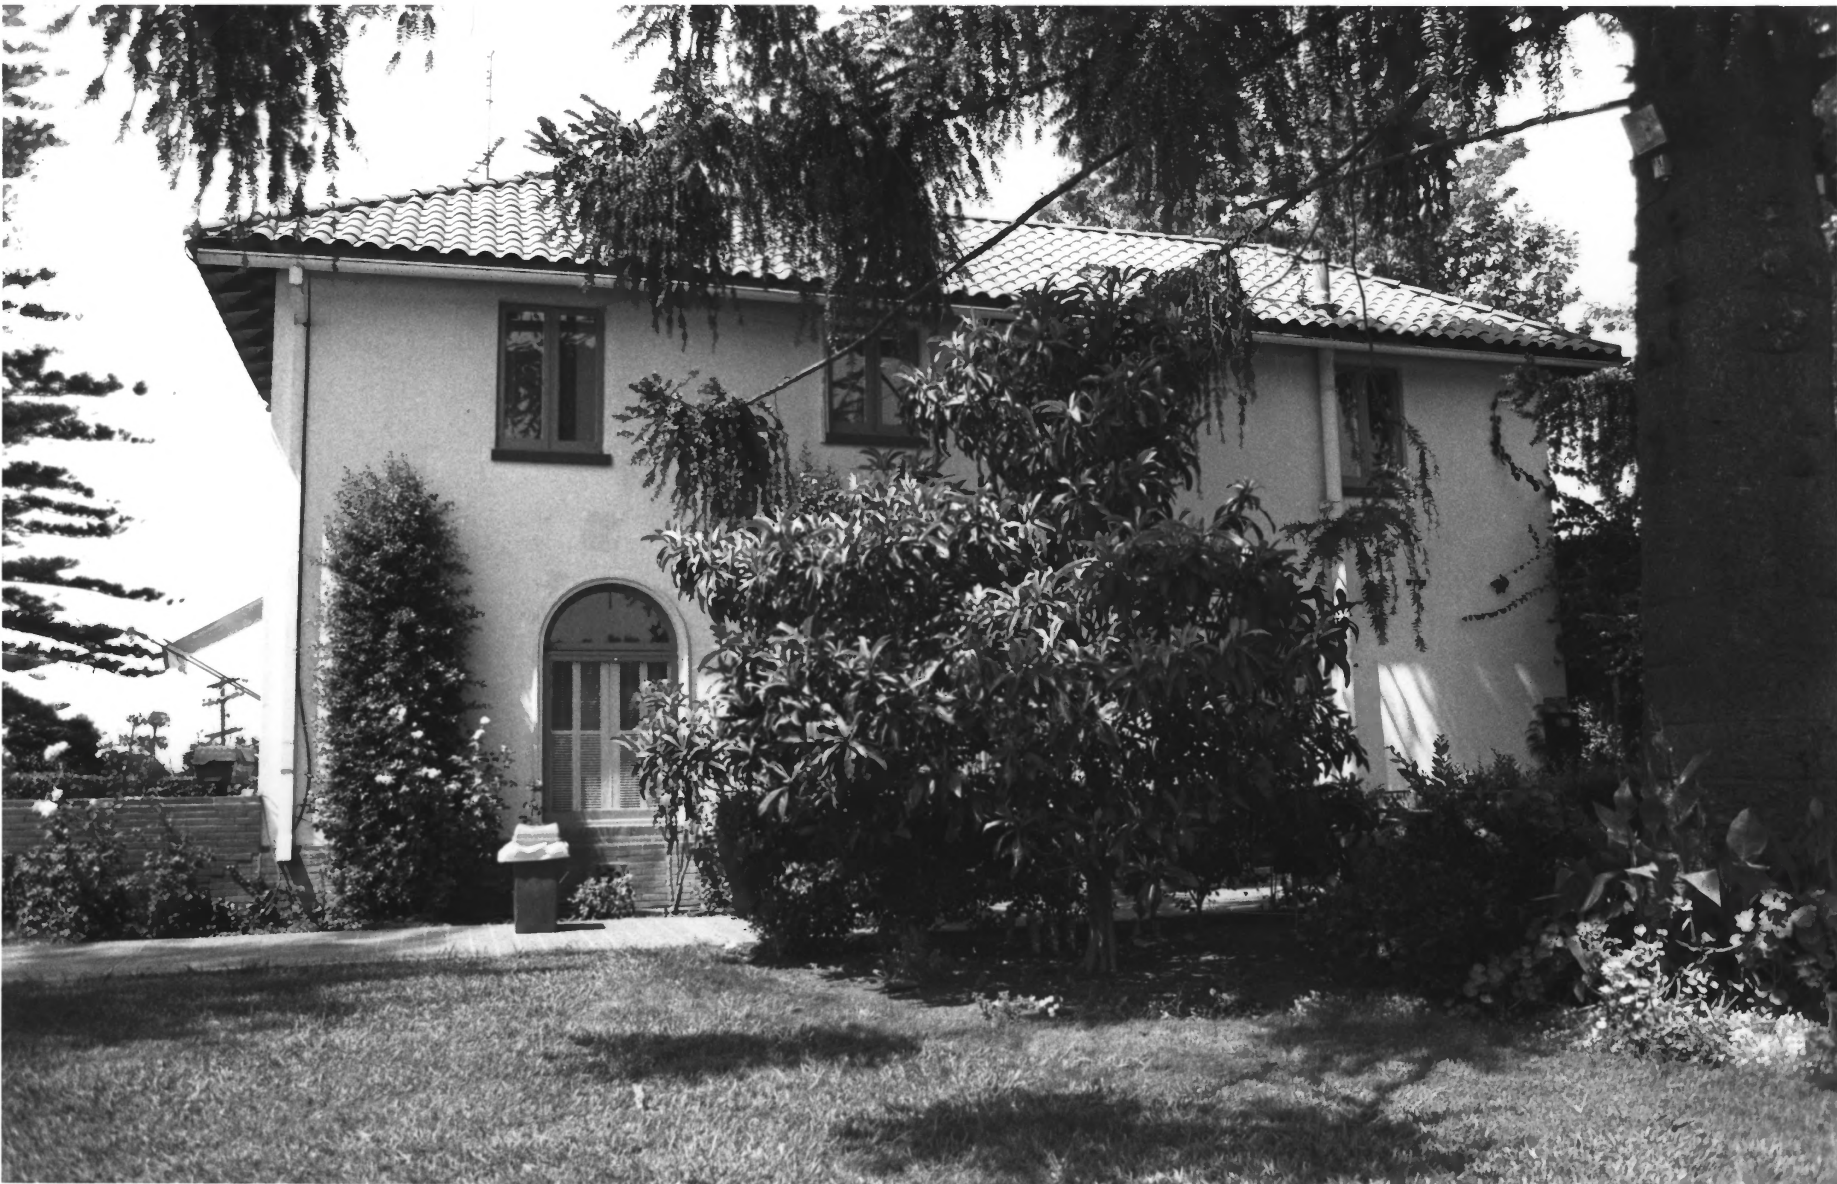
#3 of 1 photos.

View of structure from North showing upper floor
casement windows, tile roof and brick stemwall.

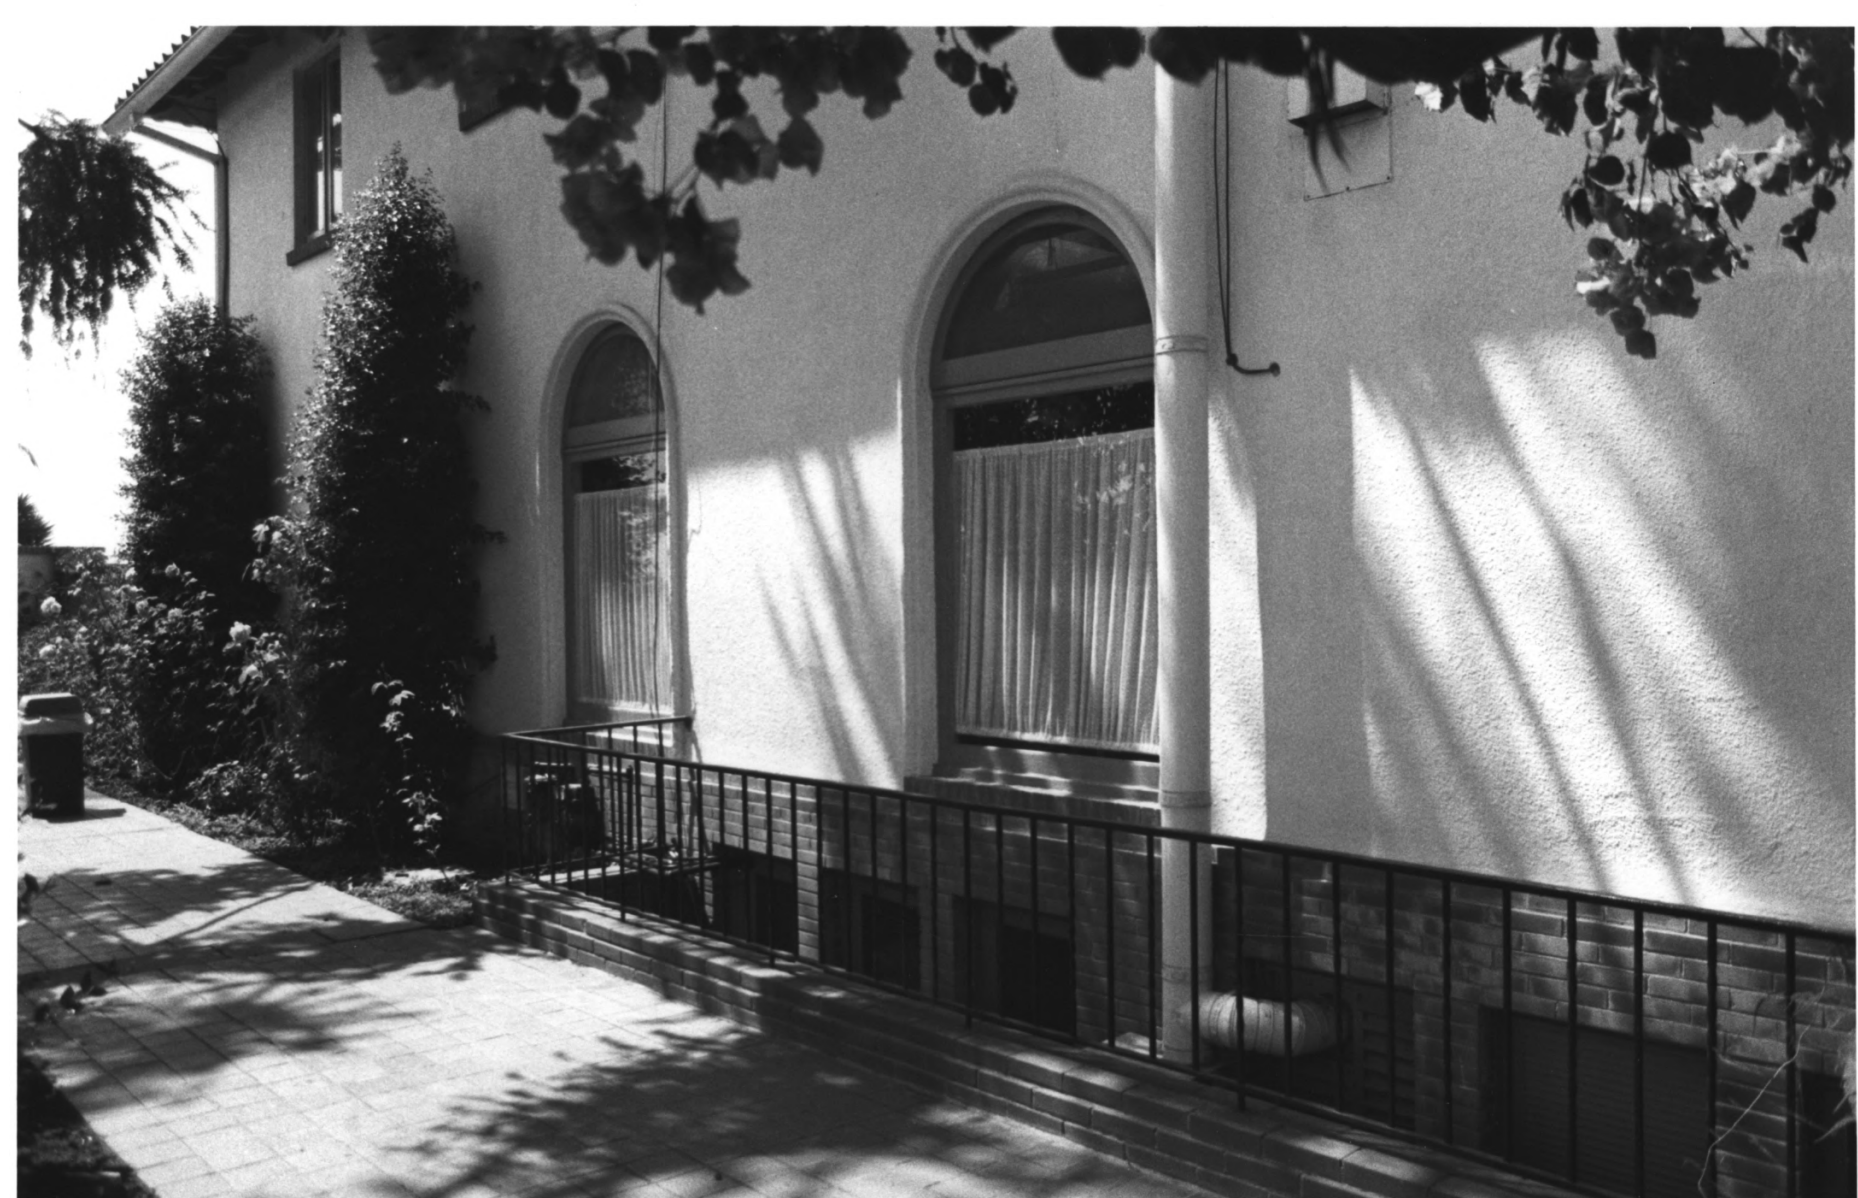
#4 of 1 photos.

Detail of South sidewall showing arched windows
with screened transoms, stucco exterior finish,
brick stemwall and outside basement access.

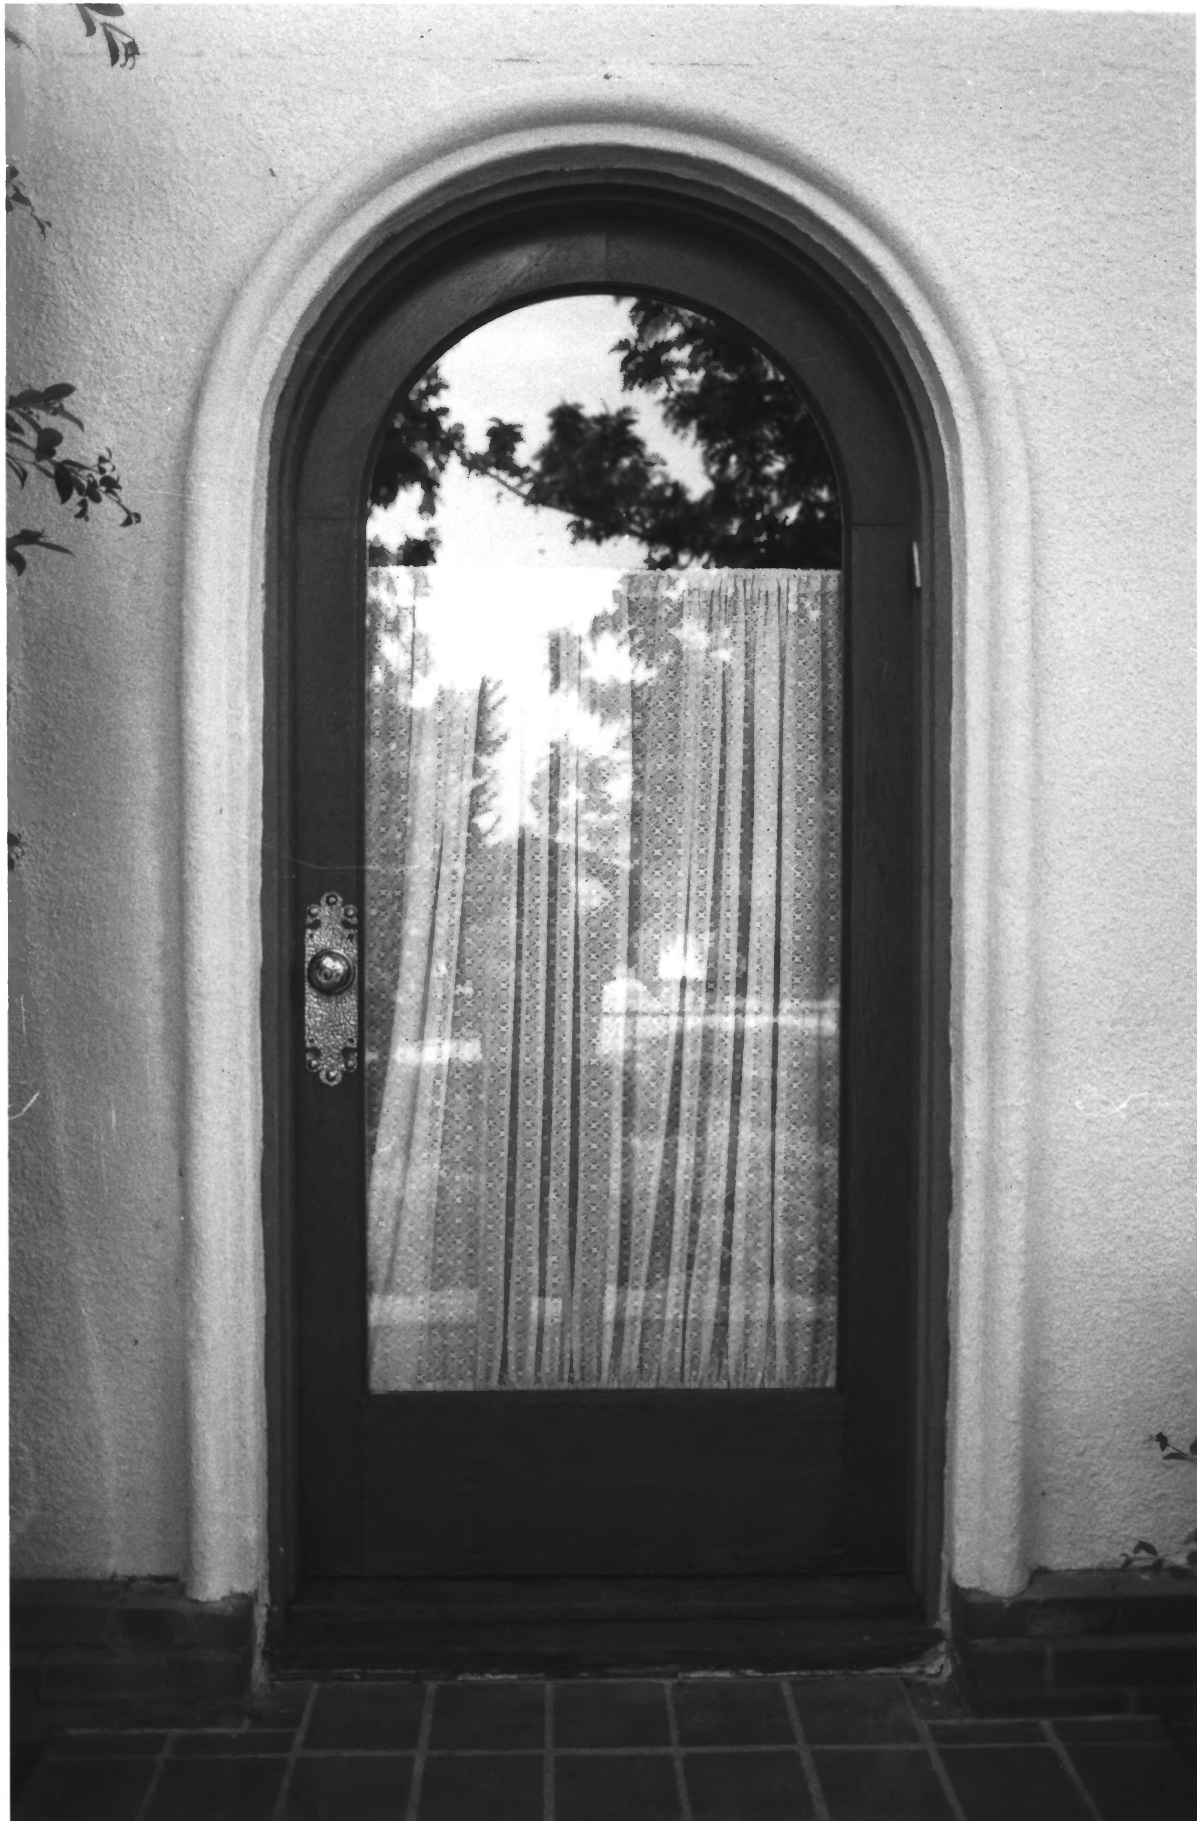
#5 of 12 photos.

Detail of typical arched exterior door; photo also
shows decorative concrete door frame with stucco
finish.

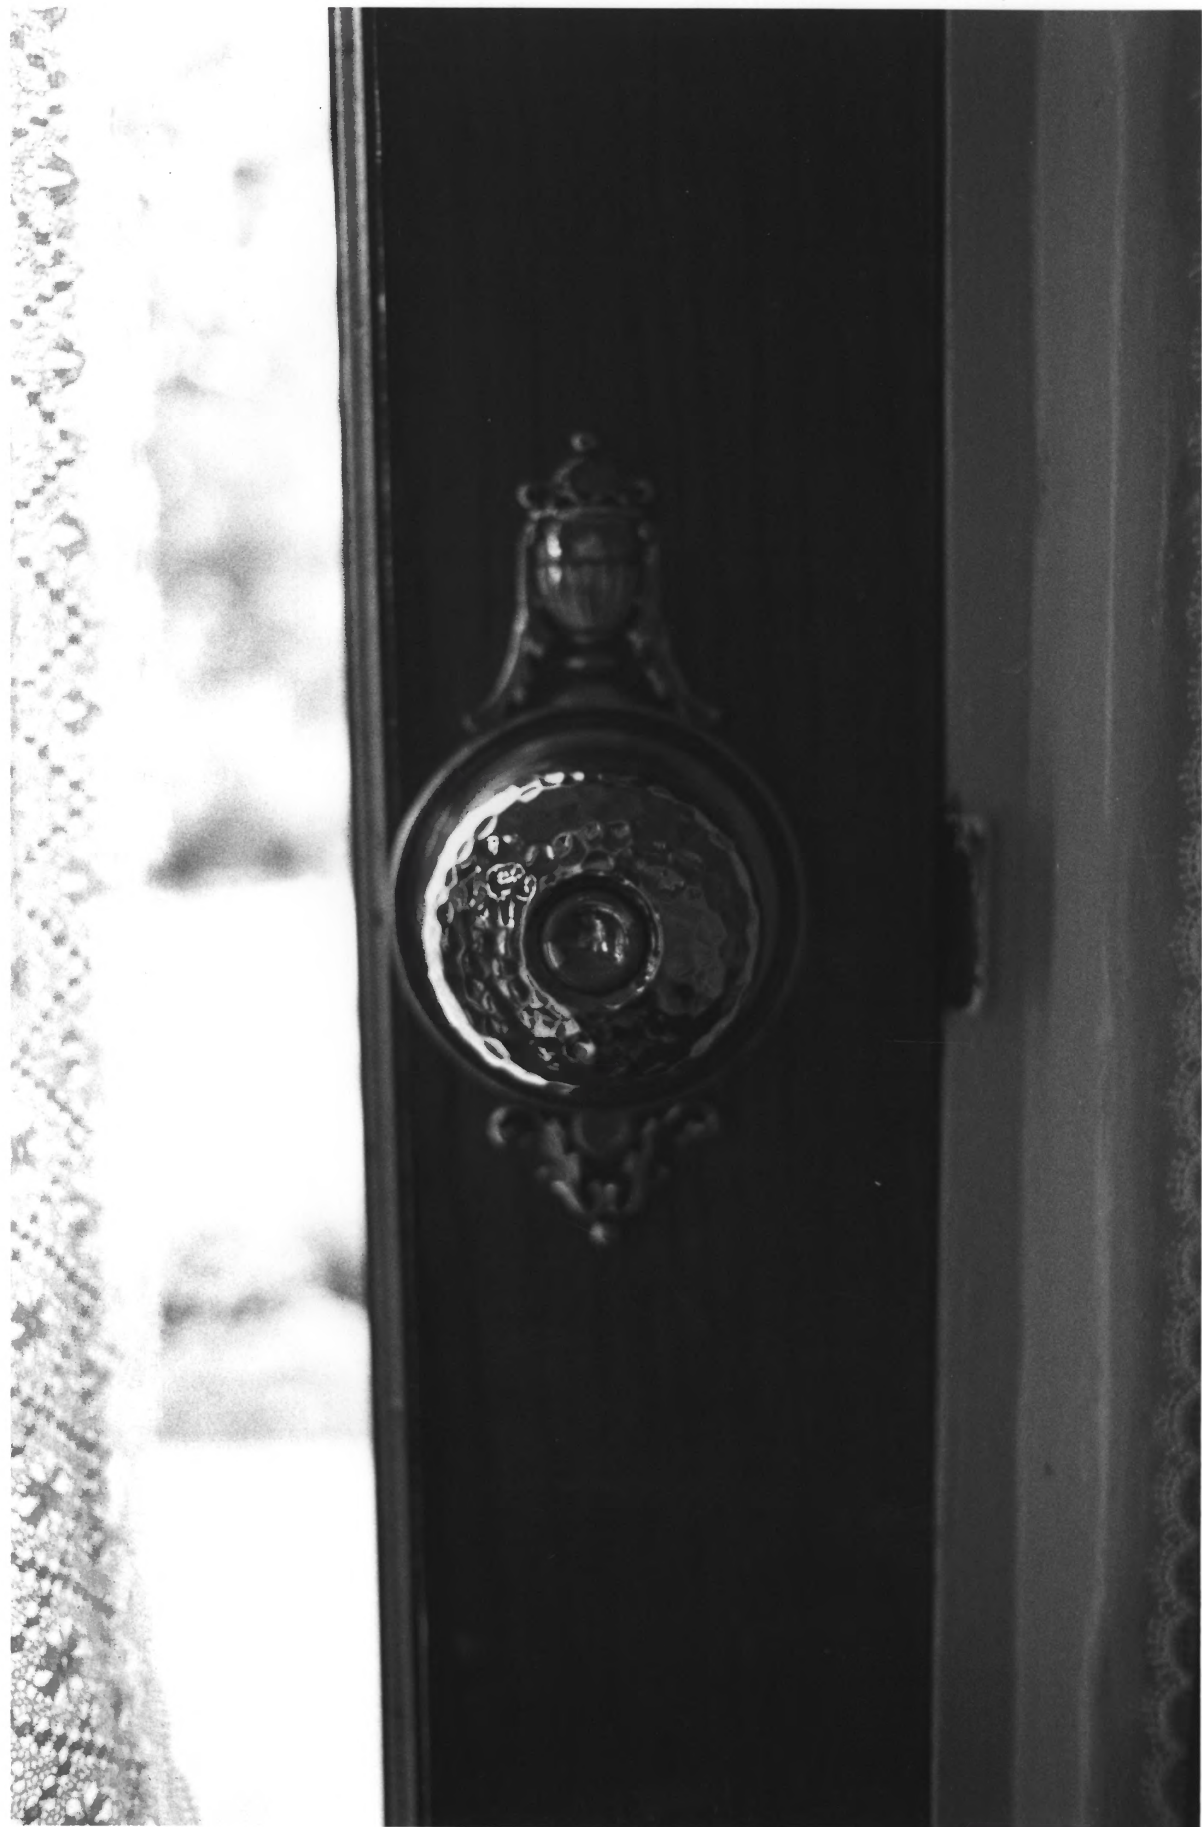
#6 of 1 photos.

Detail of custom brass interior door hardware.

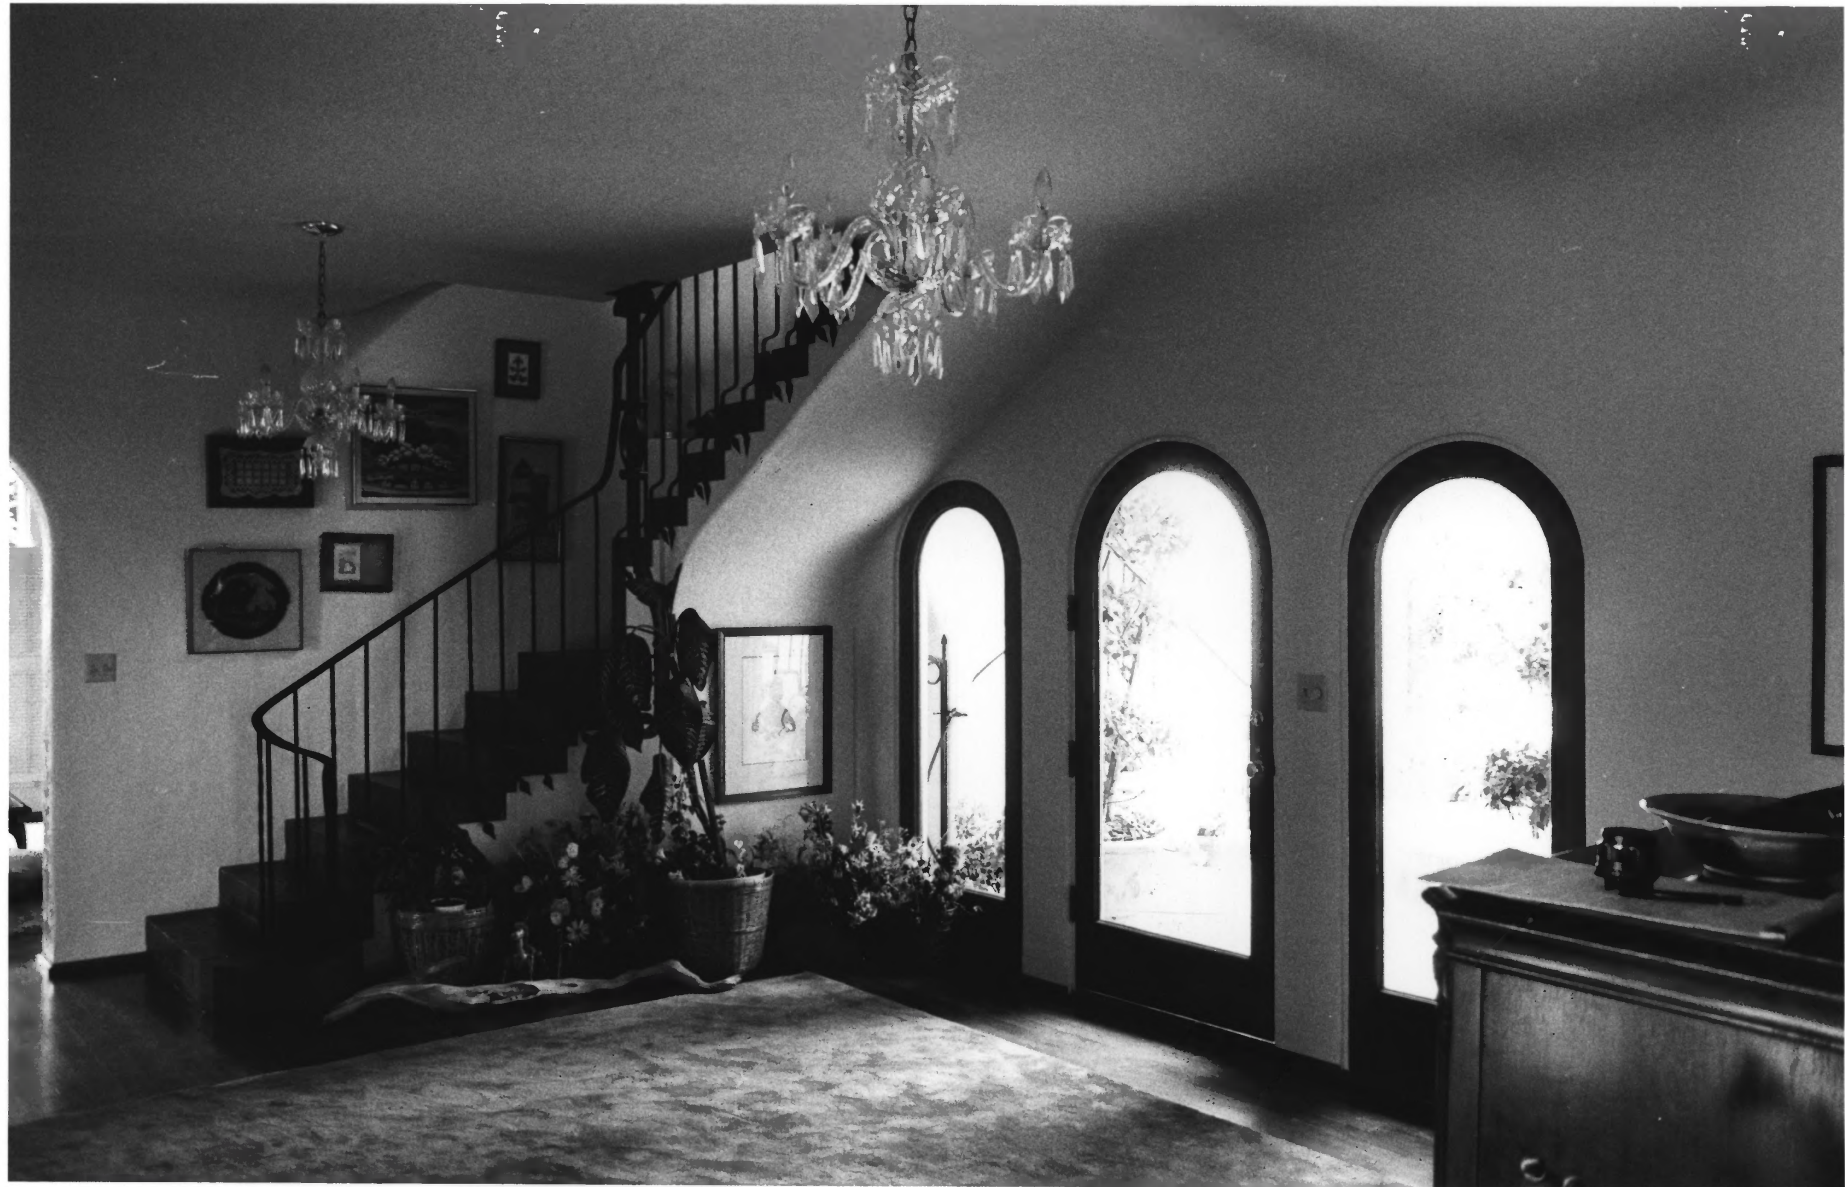
#7 of 9 photos.

First floor interior showing main entrance (to the
East) and stair access to second floor.

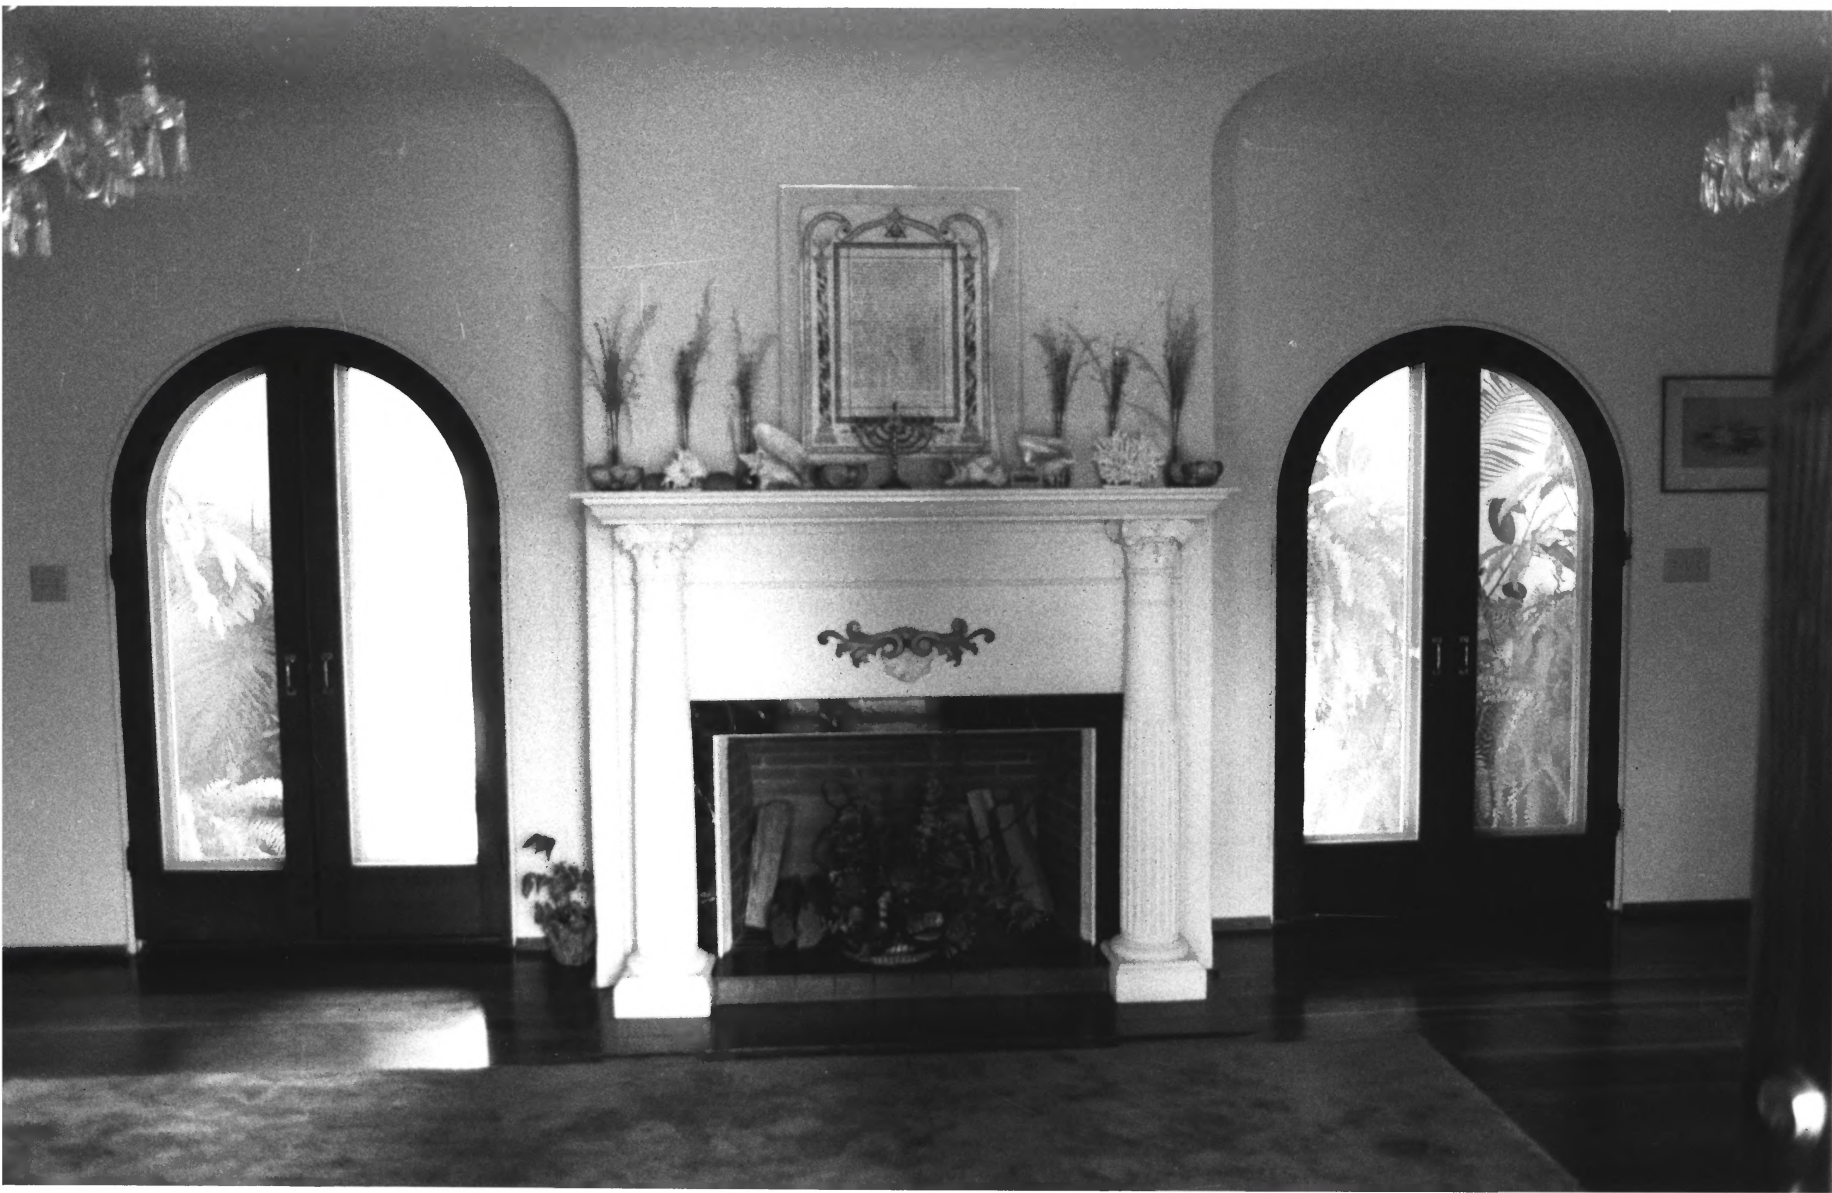
#8 of 1 photos.

First floor interior showing fireplace and paired,
arched doors leading to East patio. Ceiling coves
also shown.

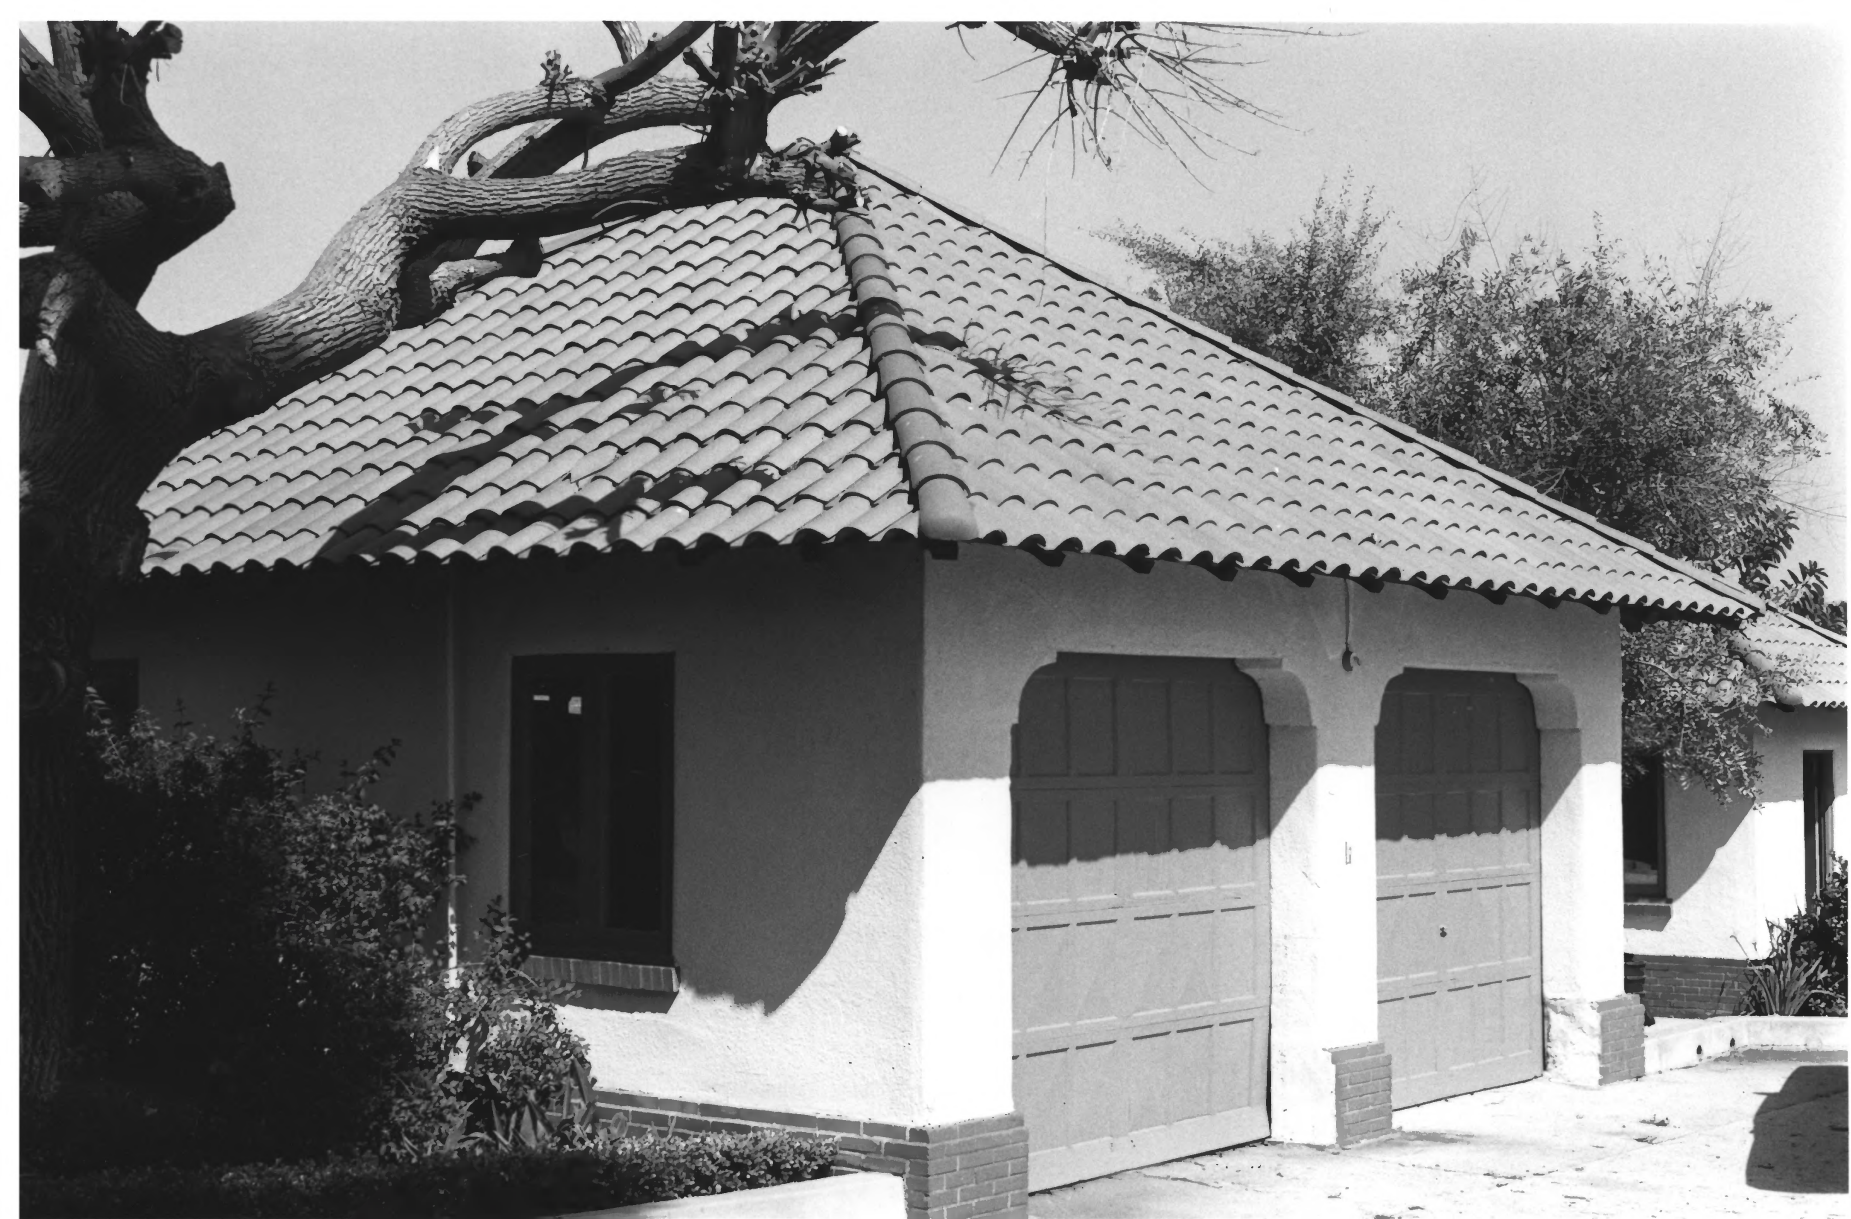
#10 of 12 photos.

Outbuilding #2 North garage showing details
which match main house, particularly tile roof,
brick stem wall and window treatment.
