National Register of Historic Places Registration Form

historic name Sandy Second Ward Chapel

Sandy Second Ward Chapel, Sandy, Salt Lake County, UT

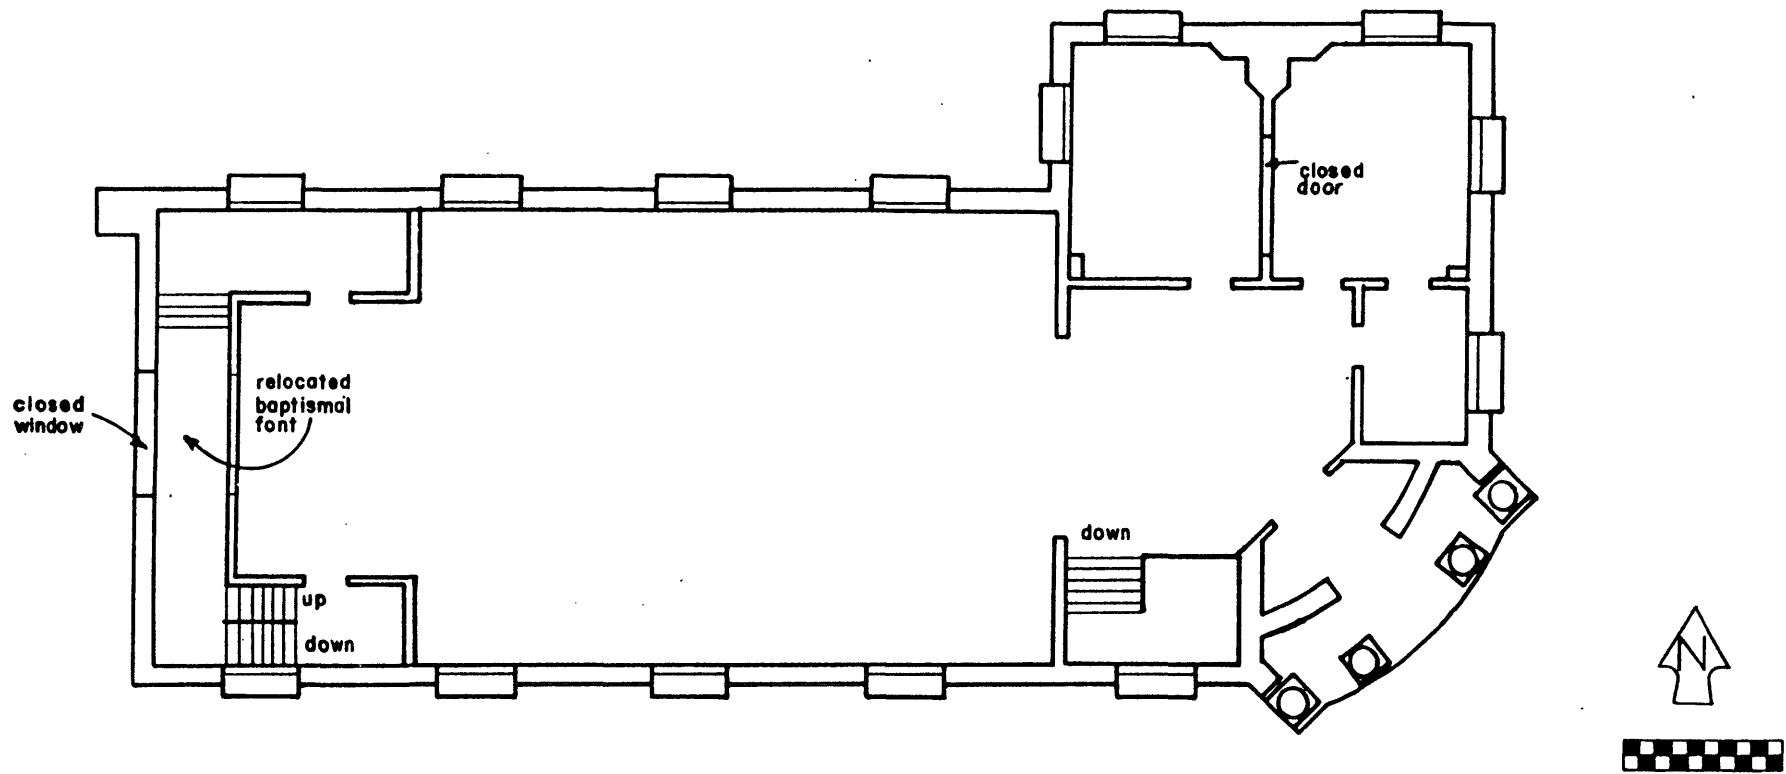
The Sandy 2nd Ward Chapel

1. Sandy Second Ward Chapel
2. Sandy City, Salt Lake County, Utah
3. Photographer: Korral Broschinsky
4. Date: July 1996
5. Negative on file at Utah SHPO.
6. North elevation of building. Camera facing south.
