**NATIONAL REGISTER OF HISTORIC PLACES**

**Section   9   Photograph   1**

**Charles M. Pratt House**

**Ventura County, California**

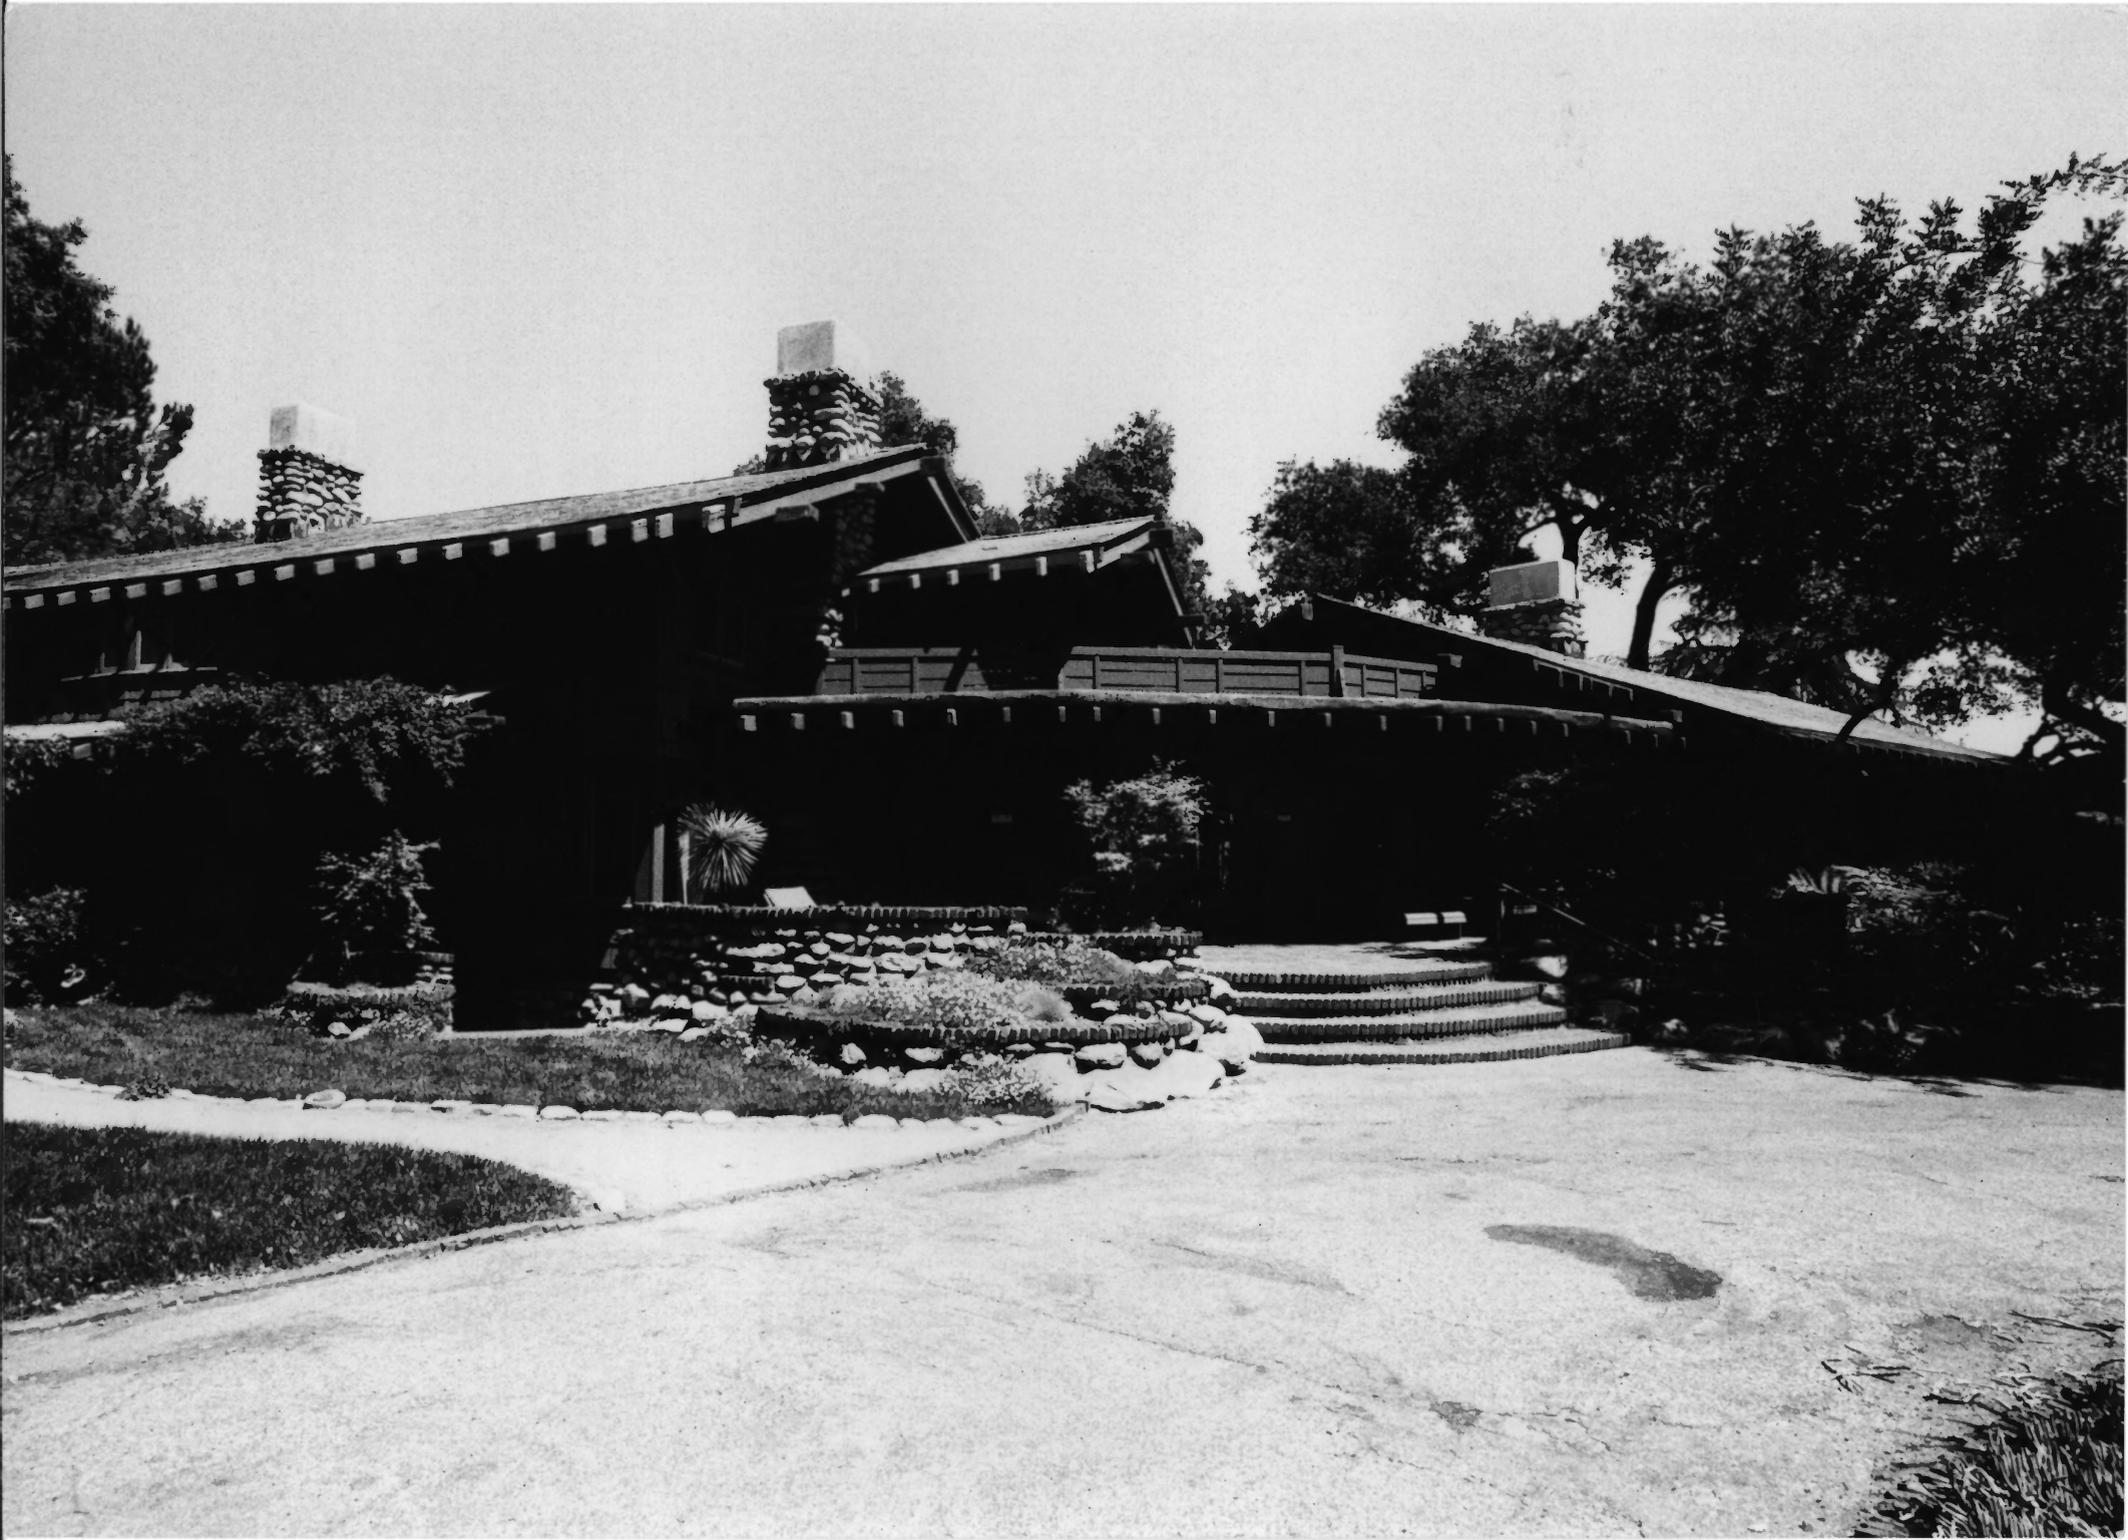
**View from driveway looking north east. Front entrance has typical Greene and Greene elements: river rock and clinker brick masonry and deep overhanging eaves. Unique to the Pratt house is: the modified U-shaped floor plan, the degree to which the house is integrated into the landscape and the asymmetrical composition of the second story which makes a transition from the two story bedroom wing to the one and one half story dining room on the right.**

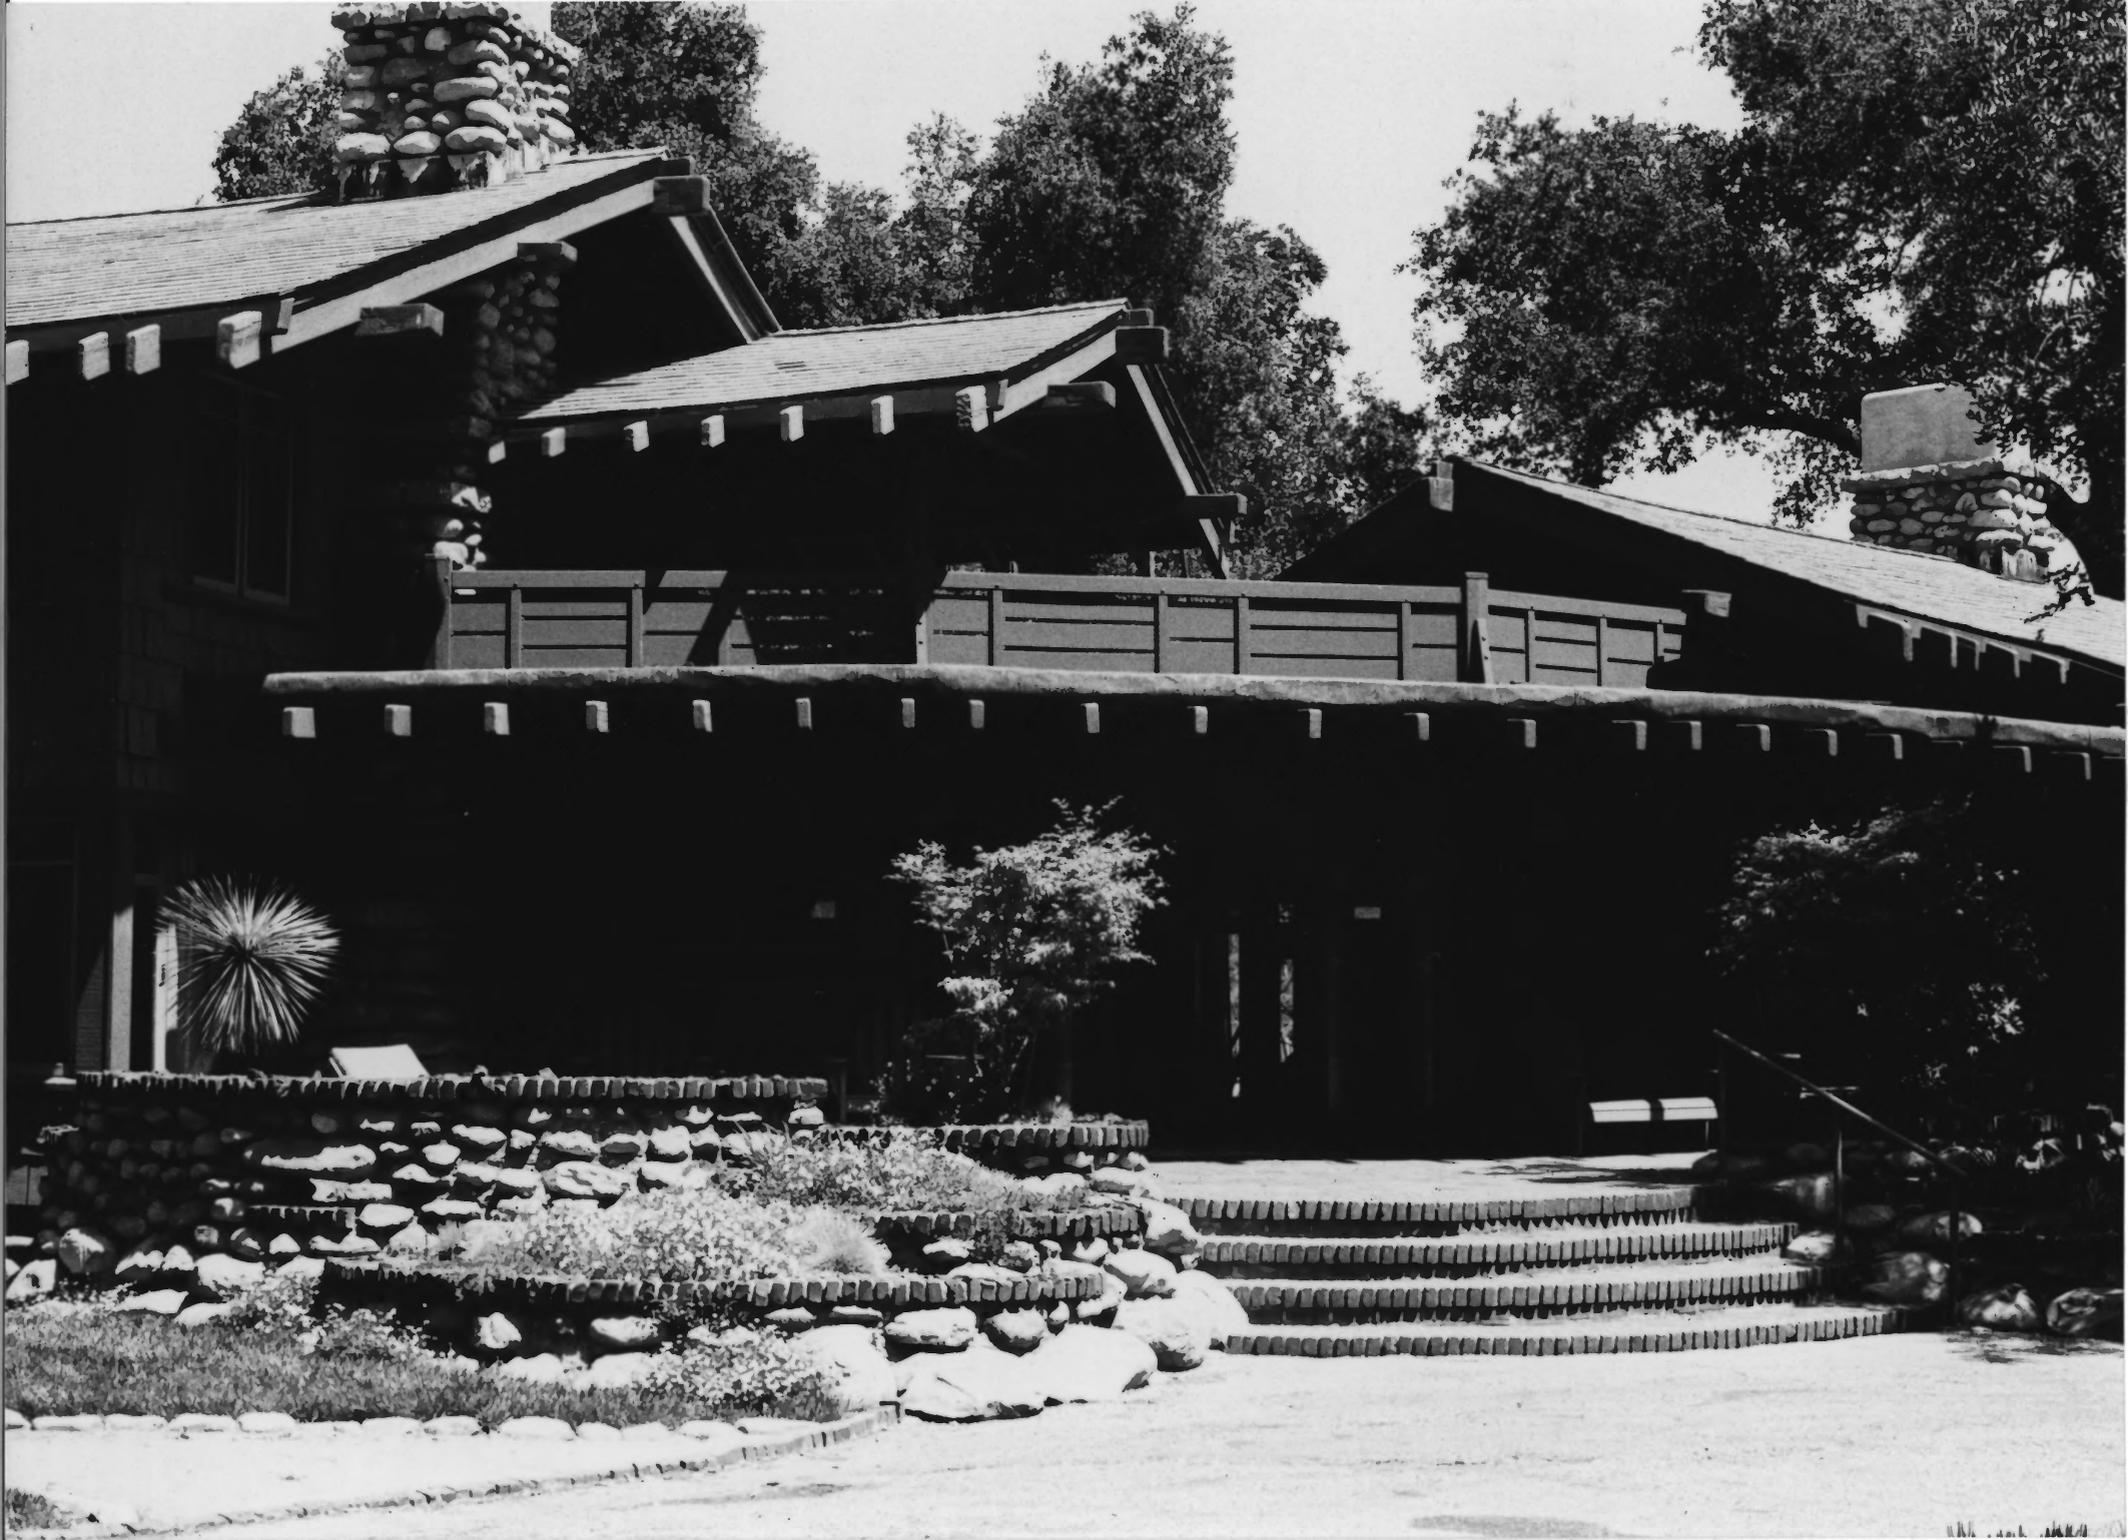
Section 9 Photograph 2

View from driveway looking north east. Front entrance has typical Greene and Greene elements: river rock and clinker brick masonry and deep overhanging eaves. Unique to the Pratt house is: the modified U-shaped floor plan, the degree to which the house is integrated into the landscape and the asymmetrical composition of the second story which makes a transition from the two story bedroom wing to the one and one half story dining room on the right.

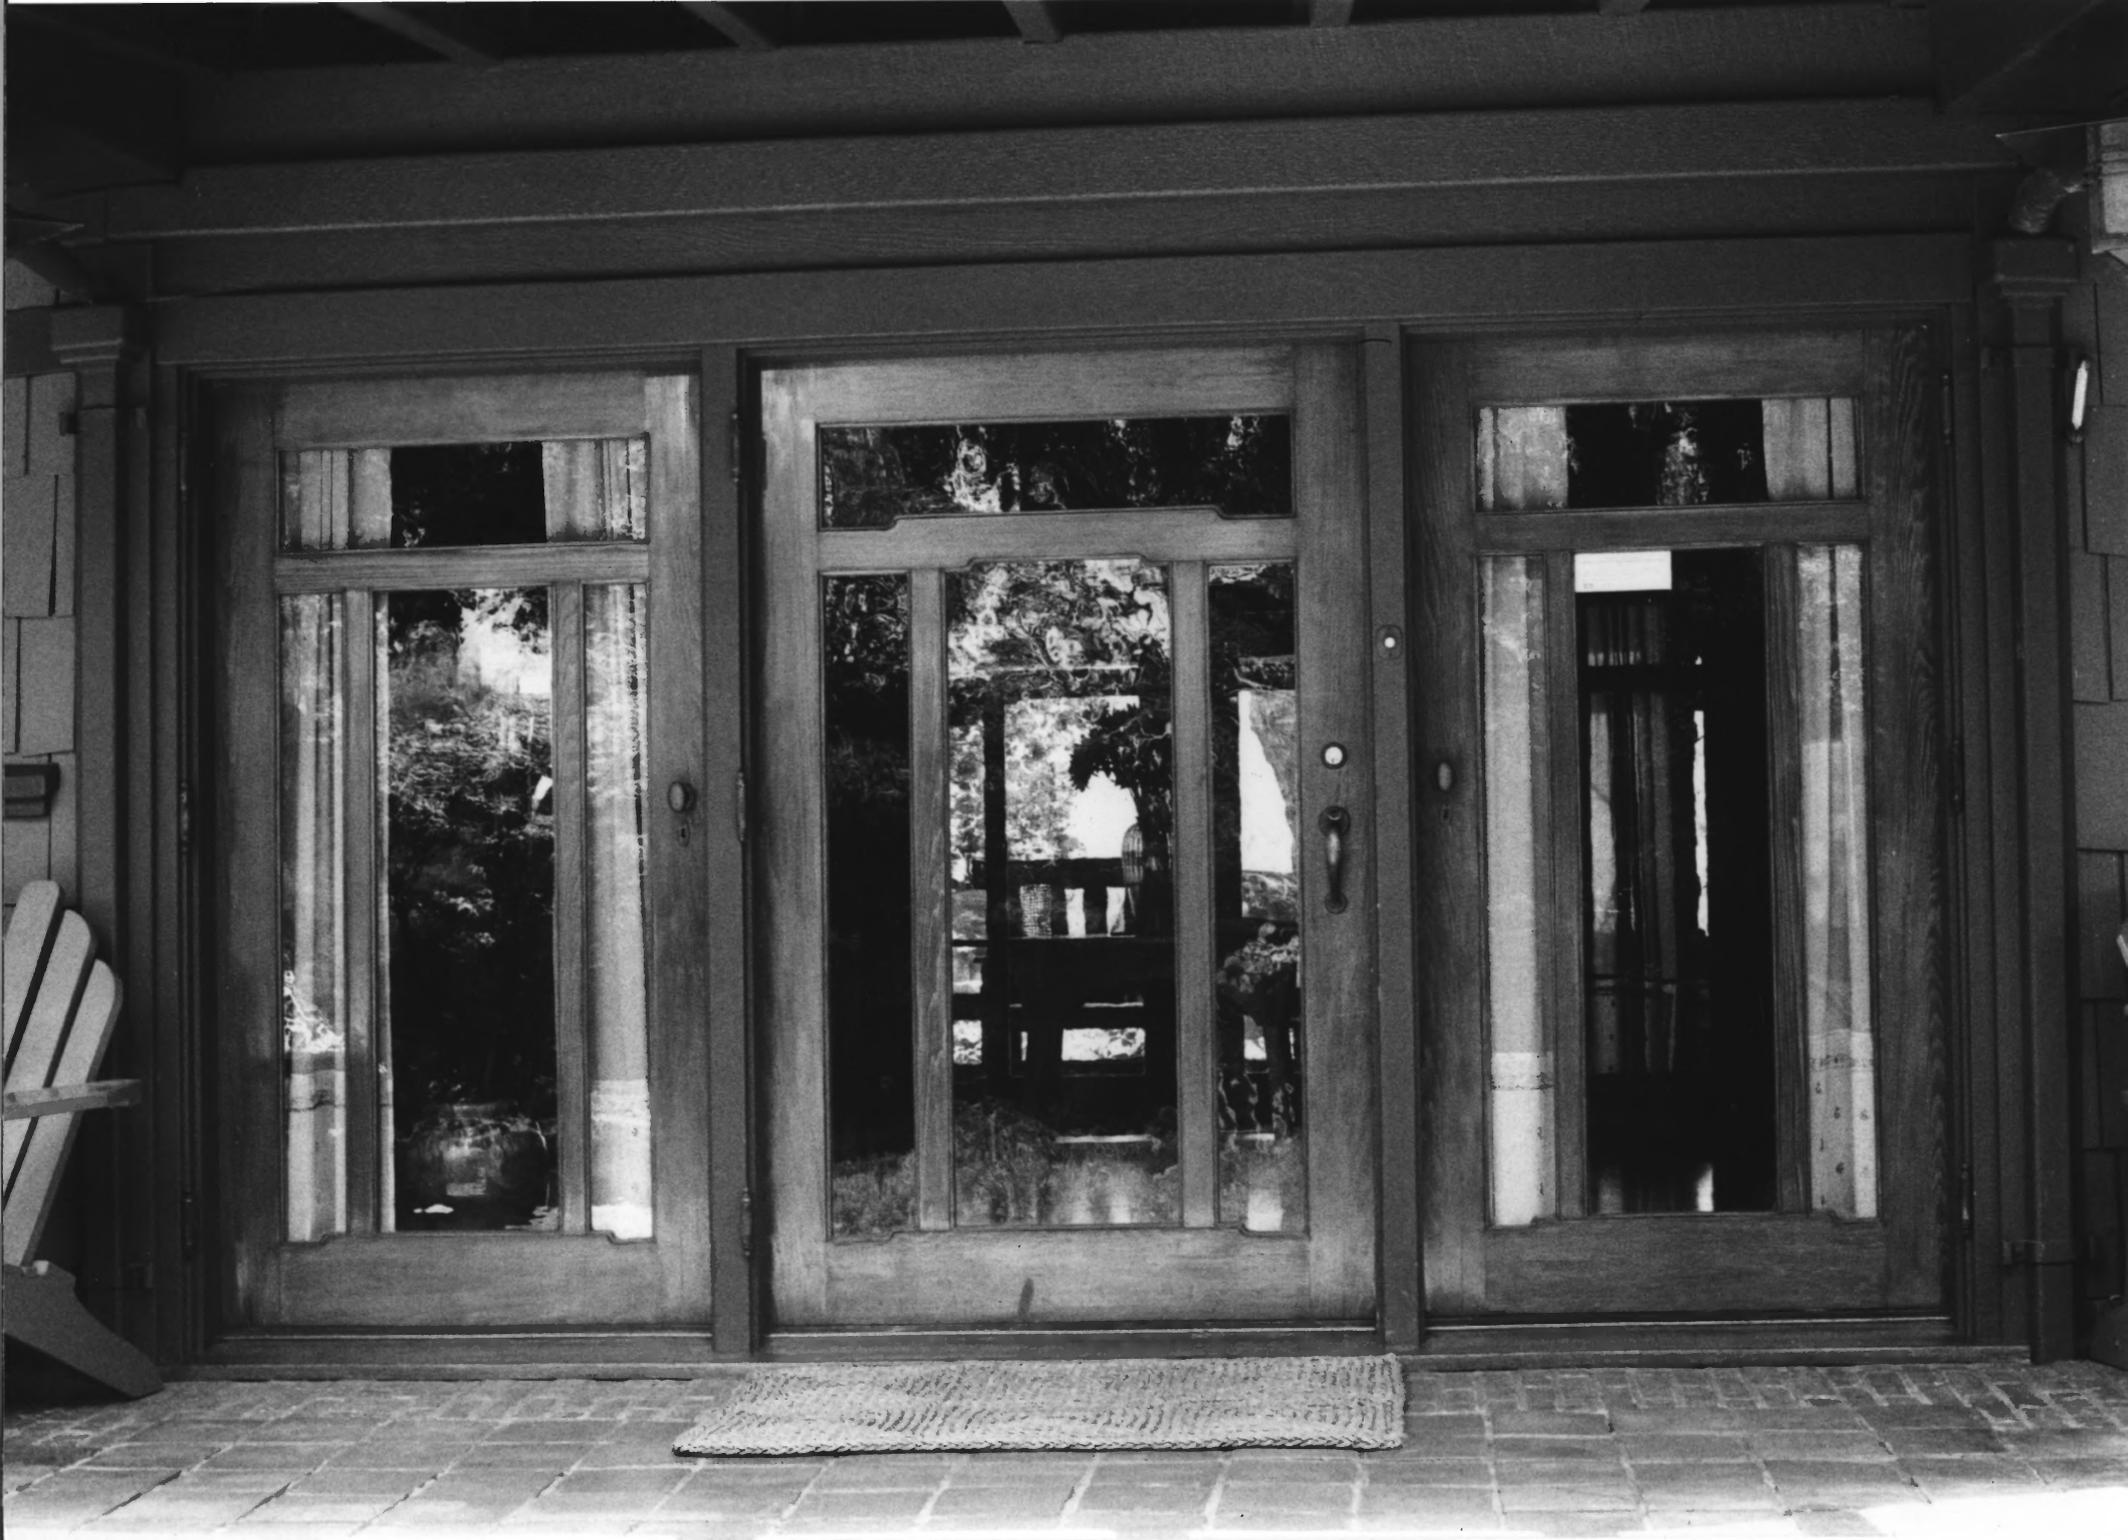
Section 9 Photograph 3

View from front porch looking into living room. Wide front door has signature cloud lift rails. Photo shows light coming from patio on the opposite side of the living room.

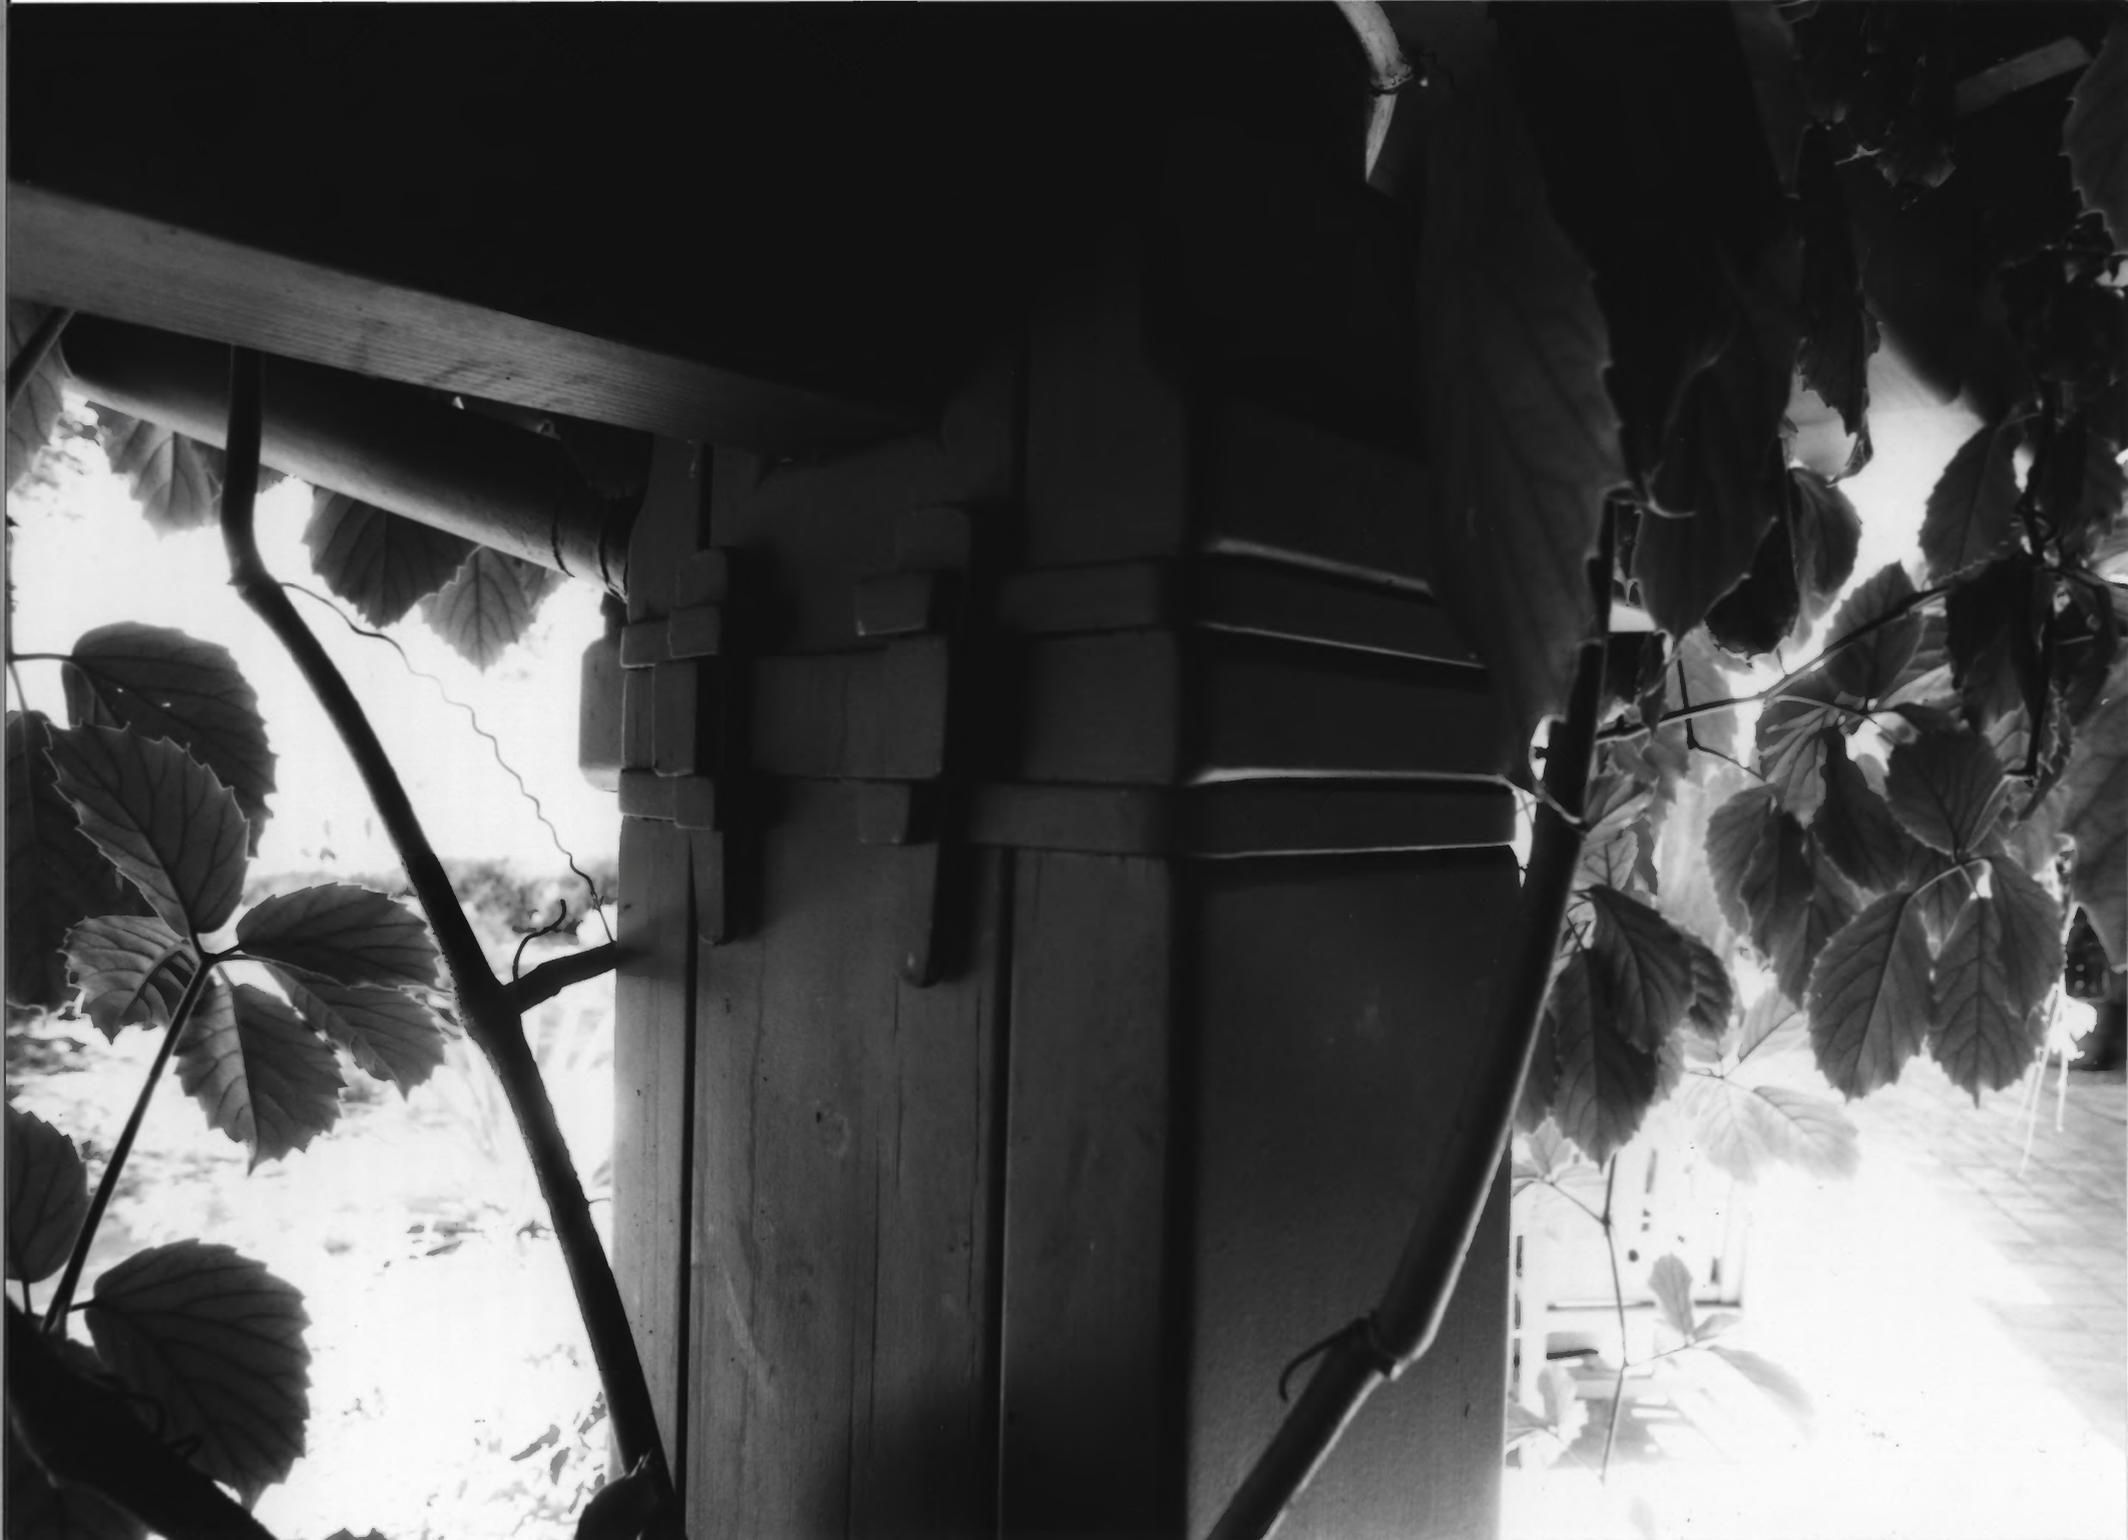
Section 9 Photograph 5

Detail of patio post showing composite construction and complex strapping.

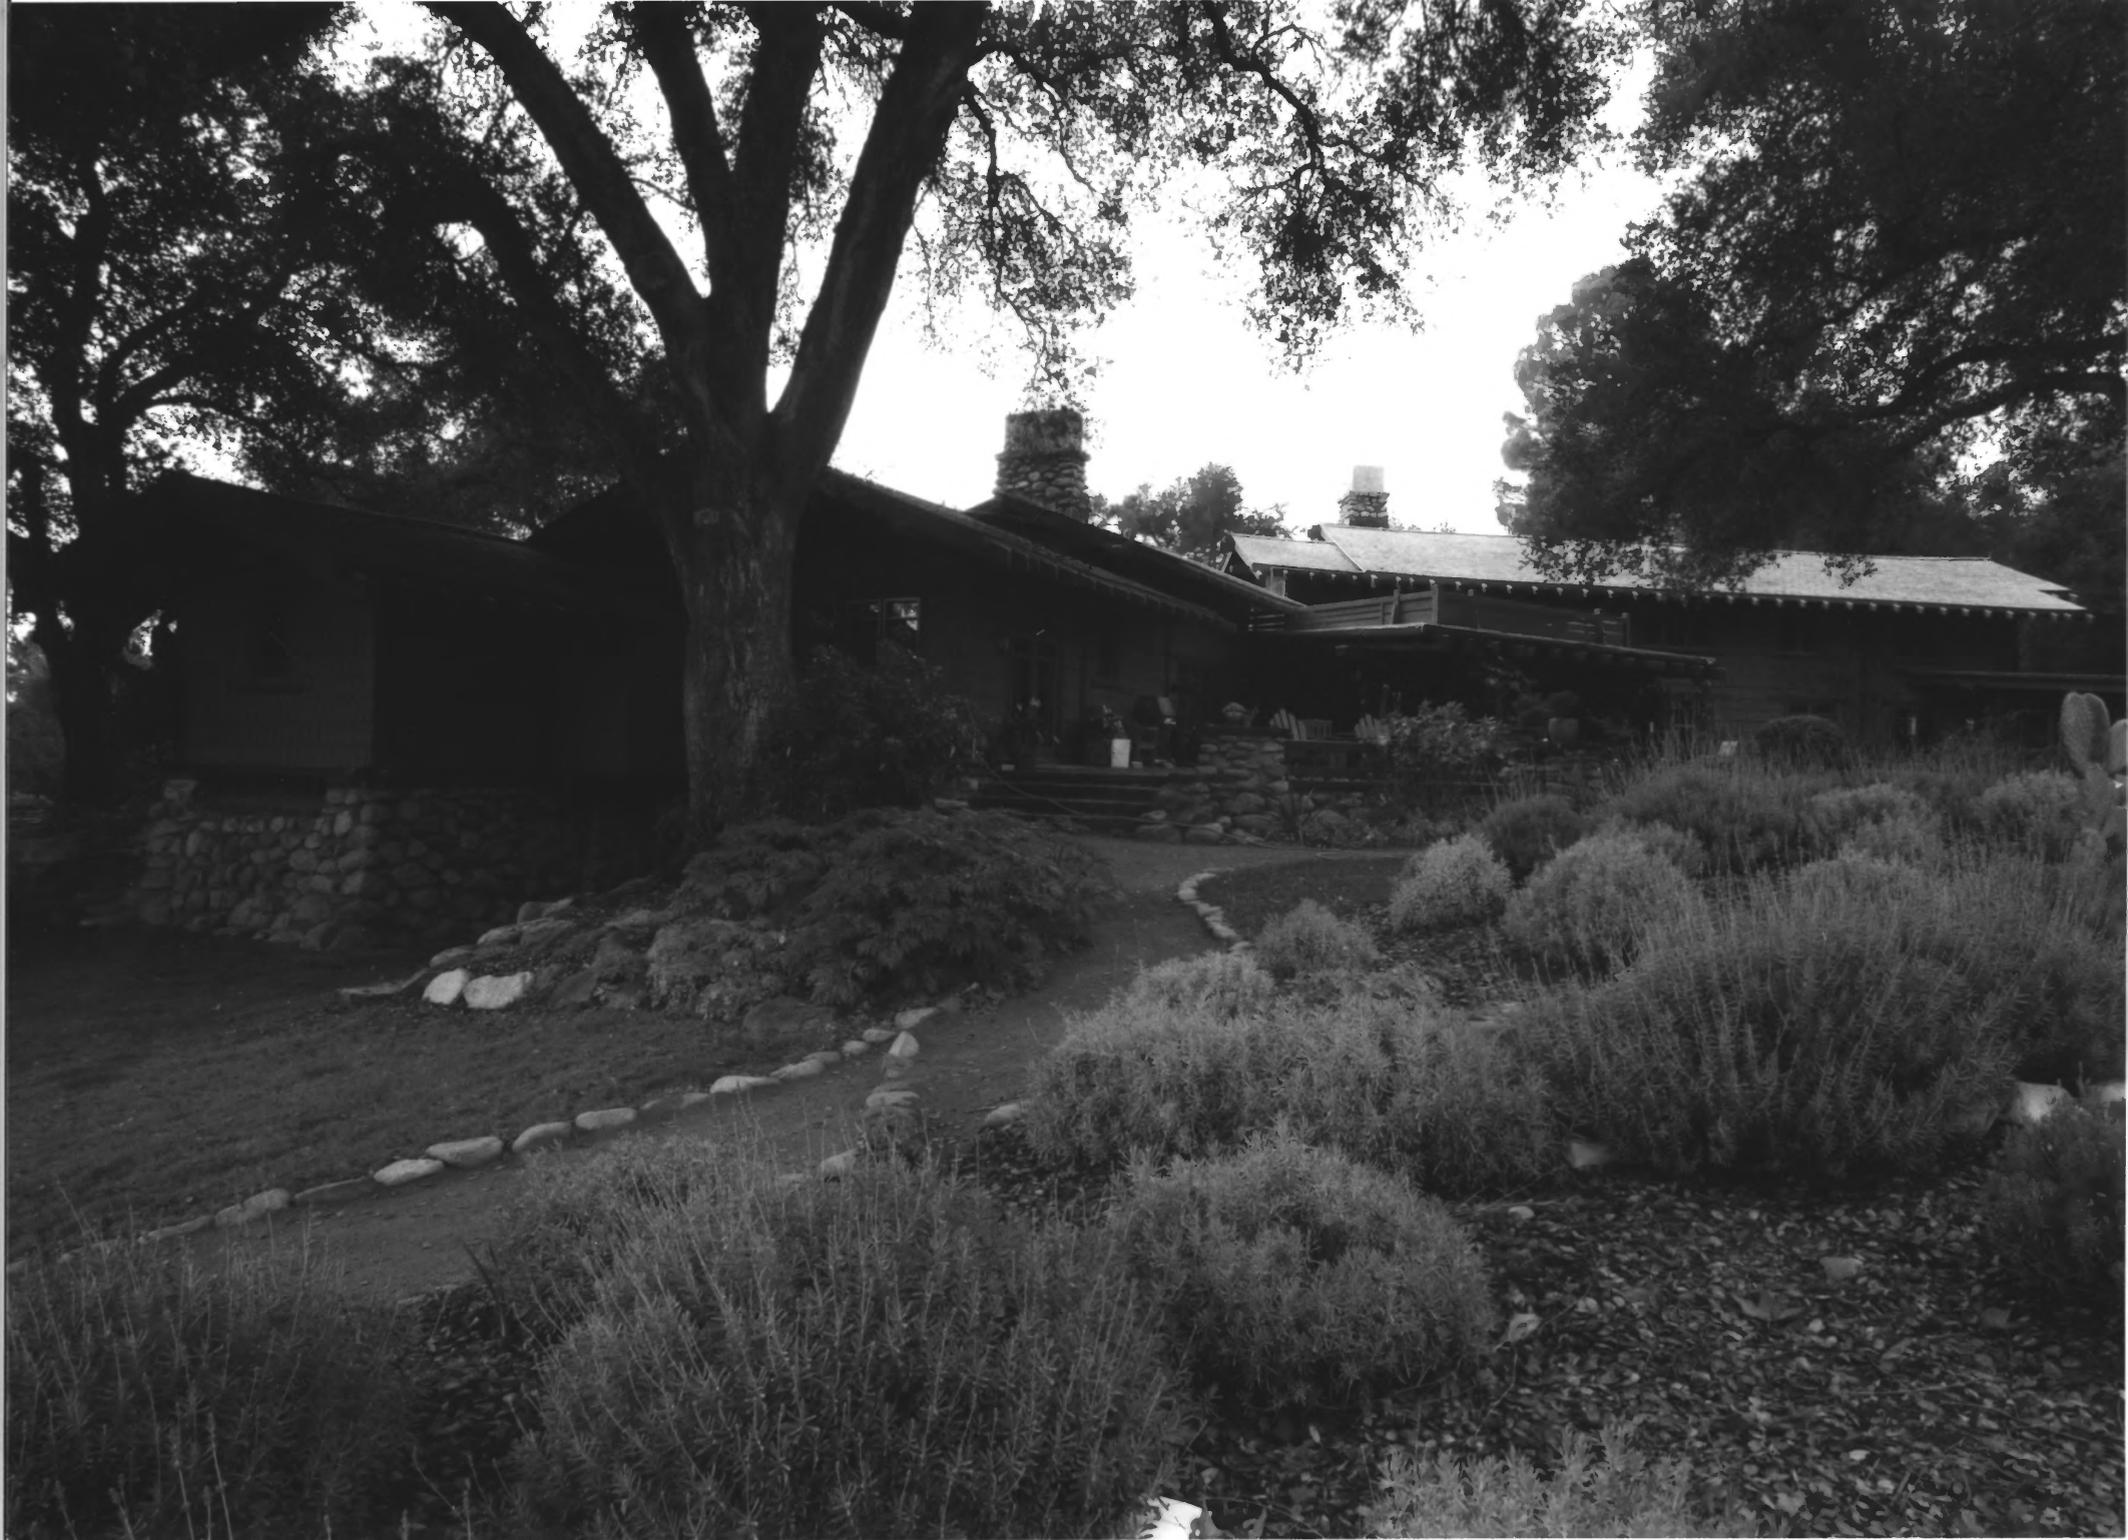
Section   9   Photograph   6

View from edge of barranca looking south west. Photo shows (left to right) maids room, kitchen, dining room, patio and bedroom wing.

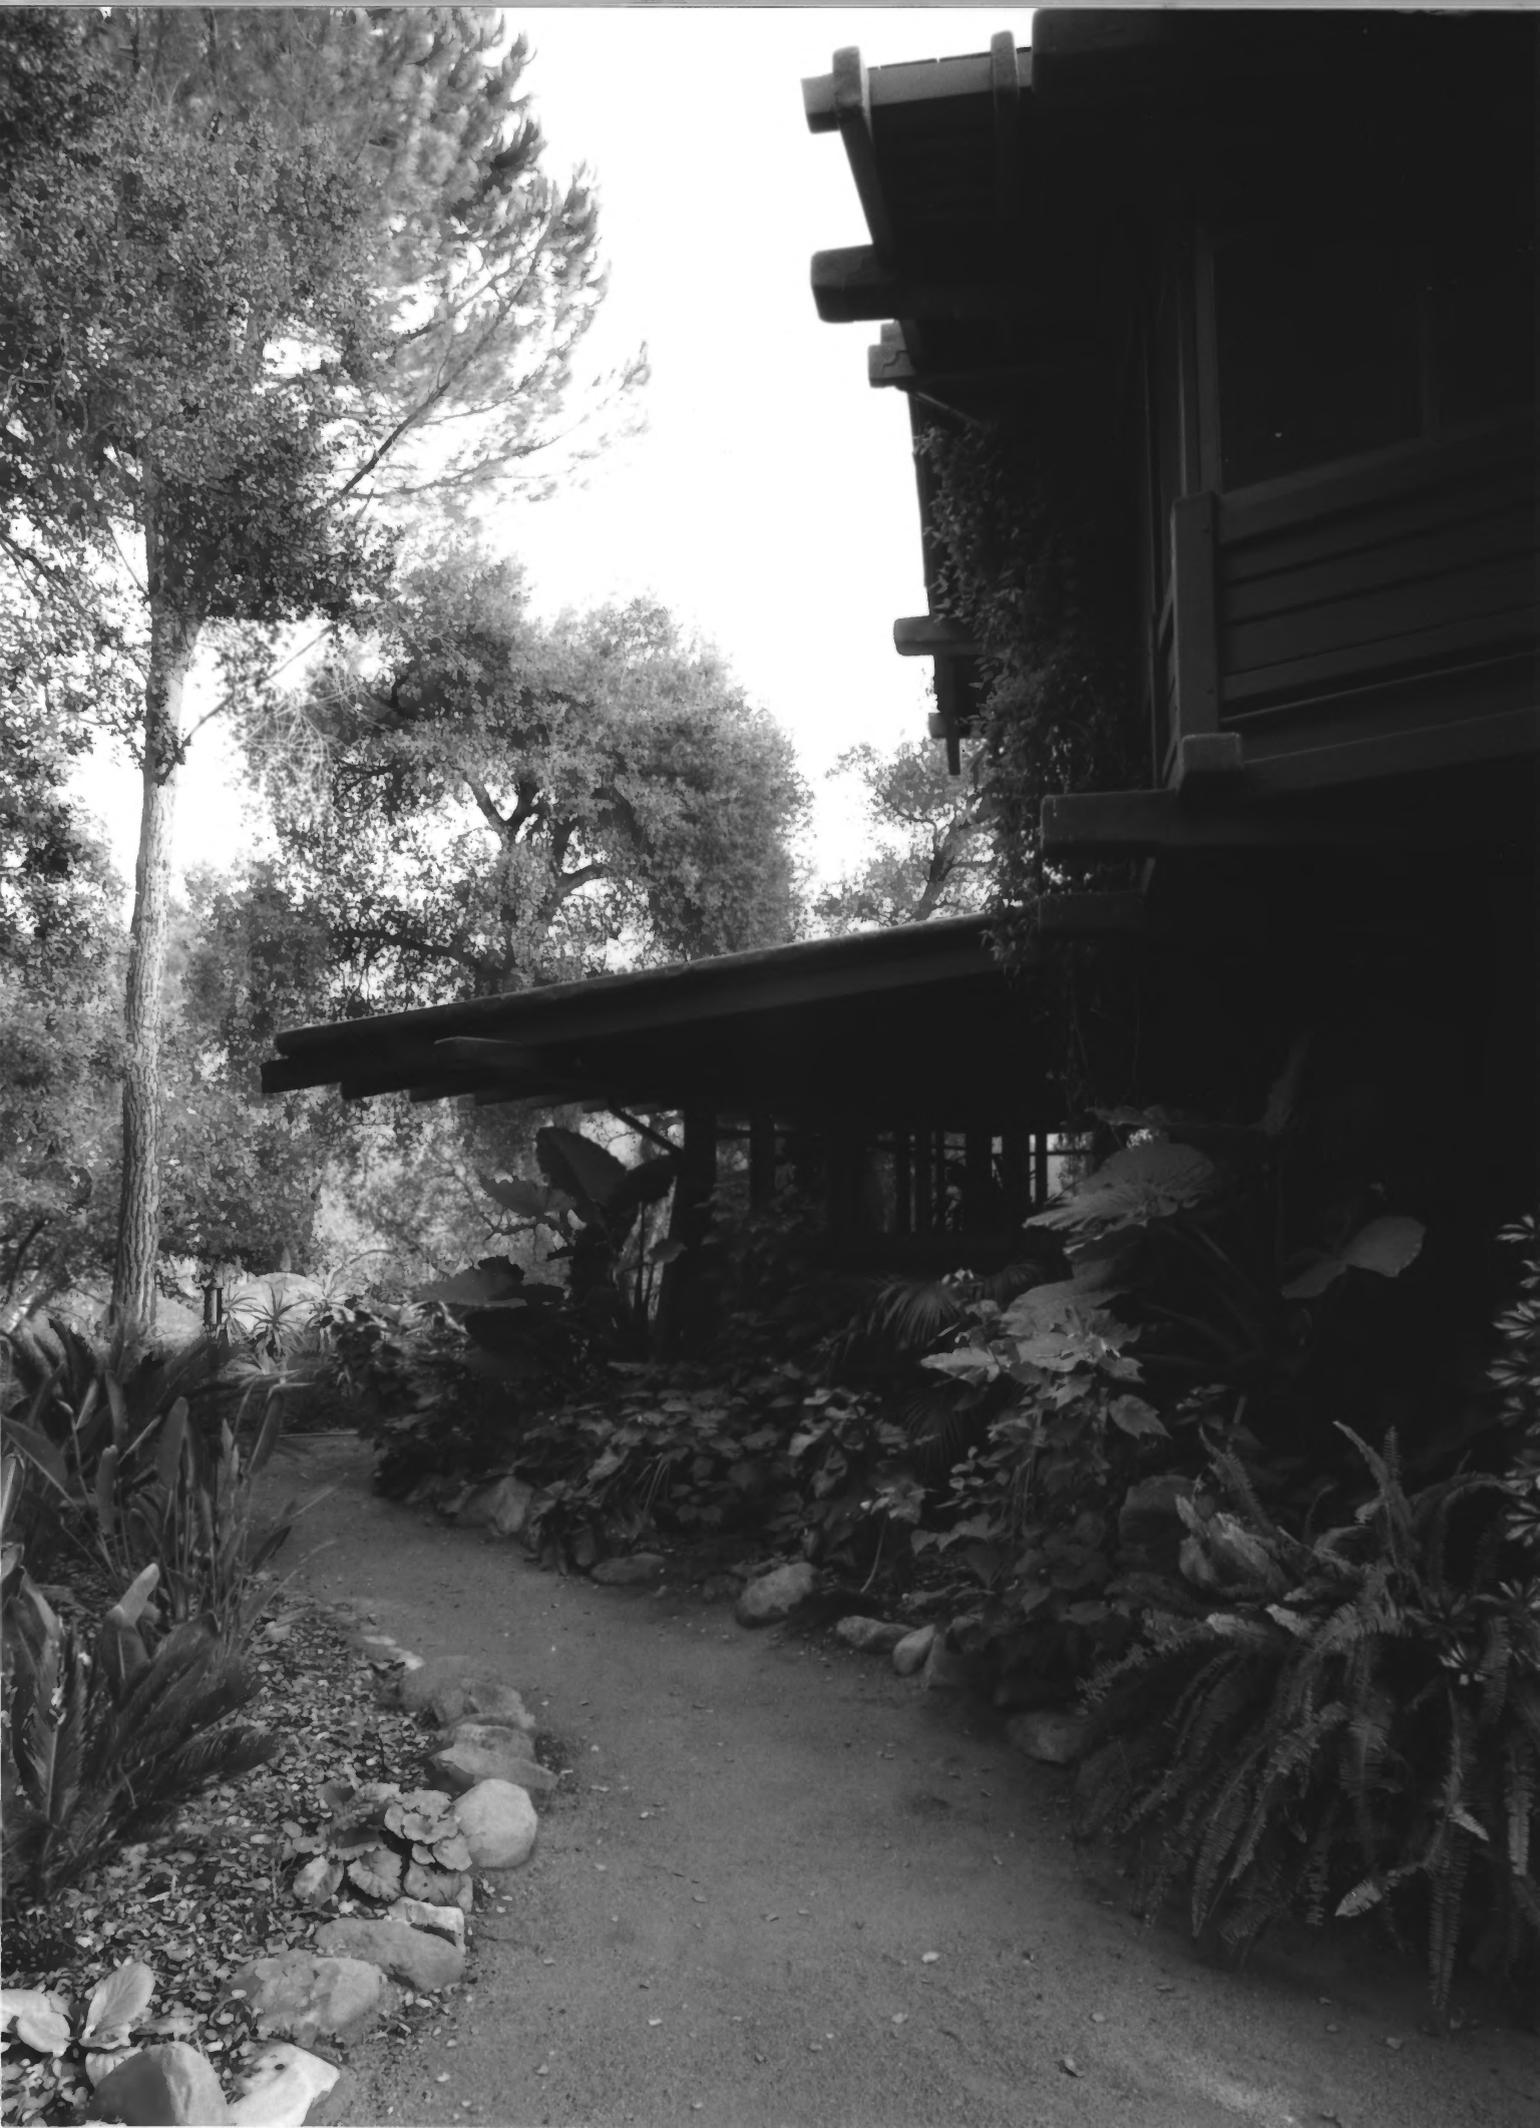
Section 9 Photograph 7

View of sleeping porches on the north end of the bedroom wing. Photo shows angled sleeping porch of downstairs bedroom and trapezoidal sleeping porch of the upstairs bedroom. Note the tapered beams and jointery.
