**NATIONAL REGISTER OF HISTORIC PLACES**

**Section   9   Photograph   1**

**Charles M. Pratt House**

**Ventura County, California**

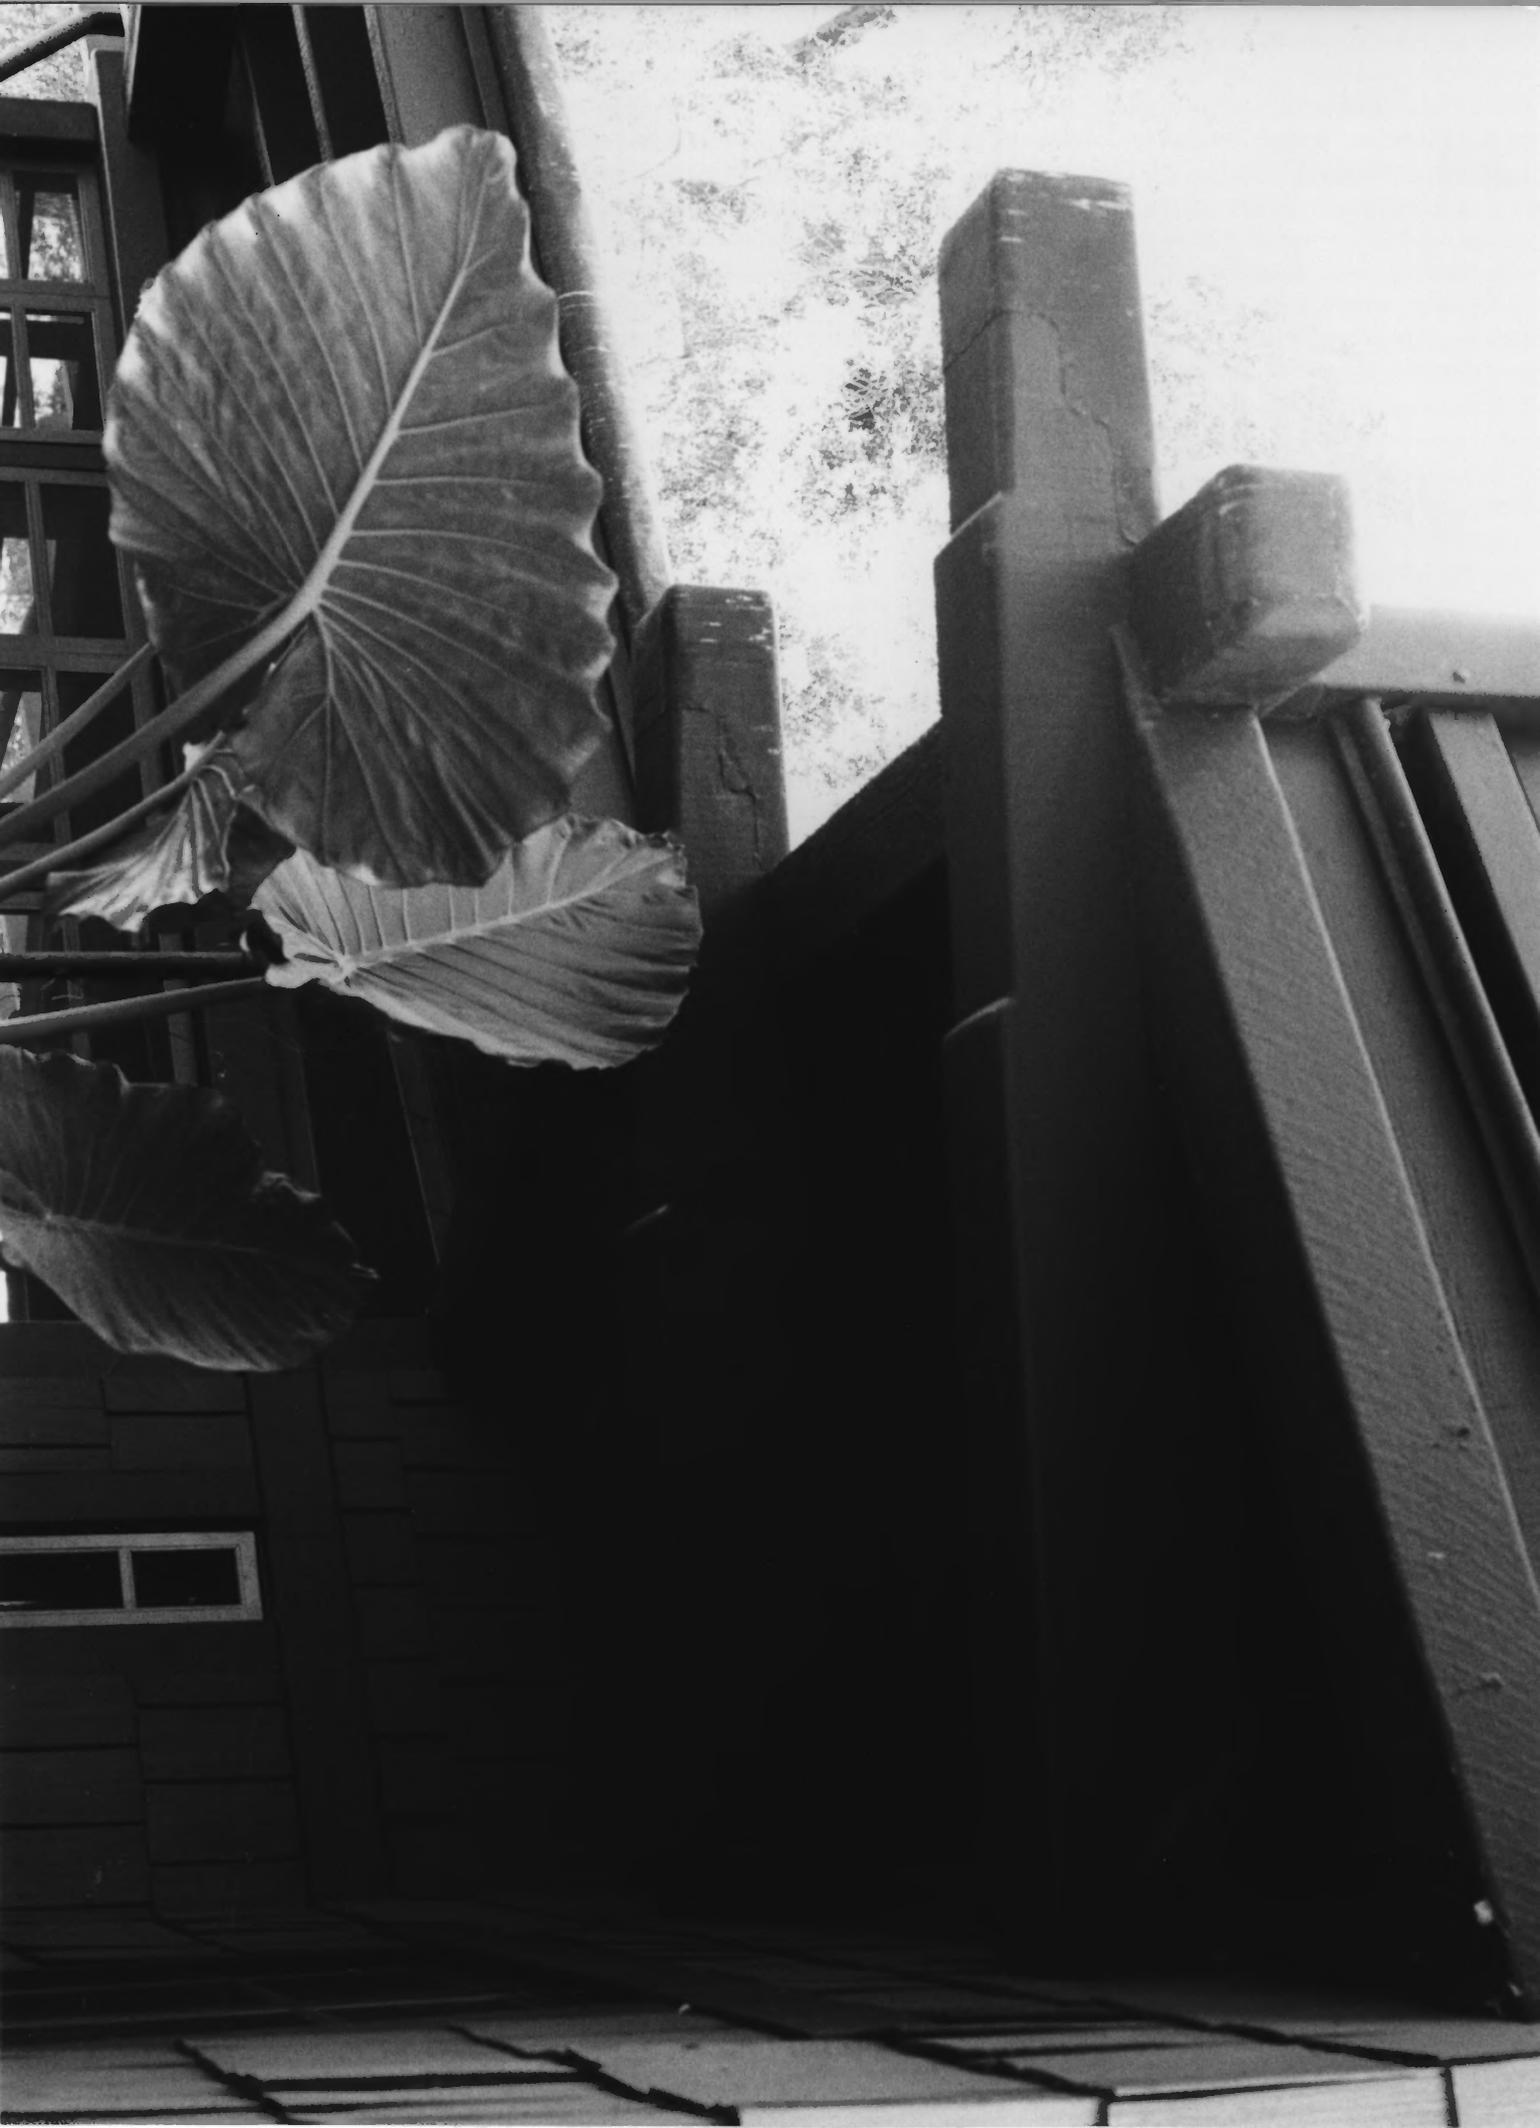
Section 9 Photograph 8

Detail of the tapered beam and jointery of the upstairs sleeping porch. Note the copper end caps.

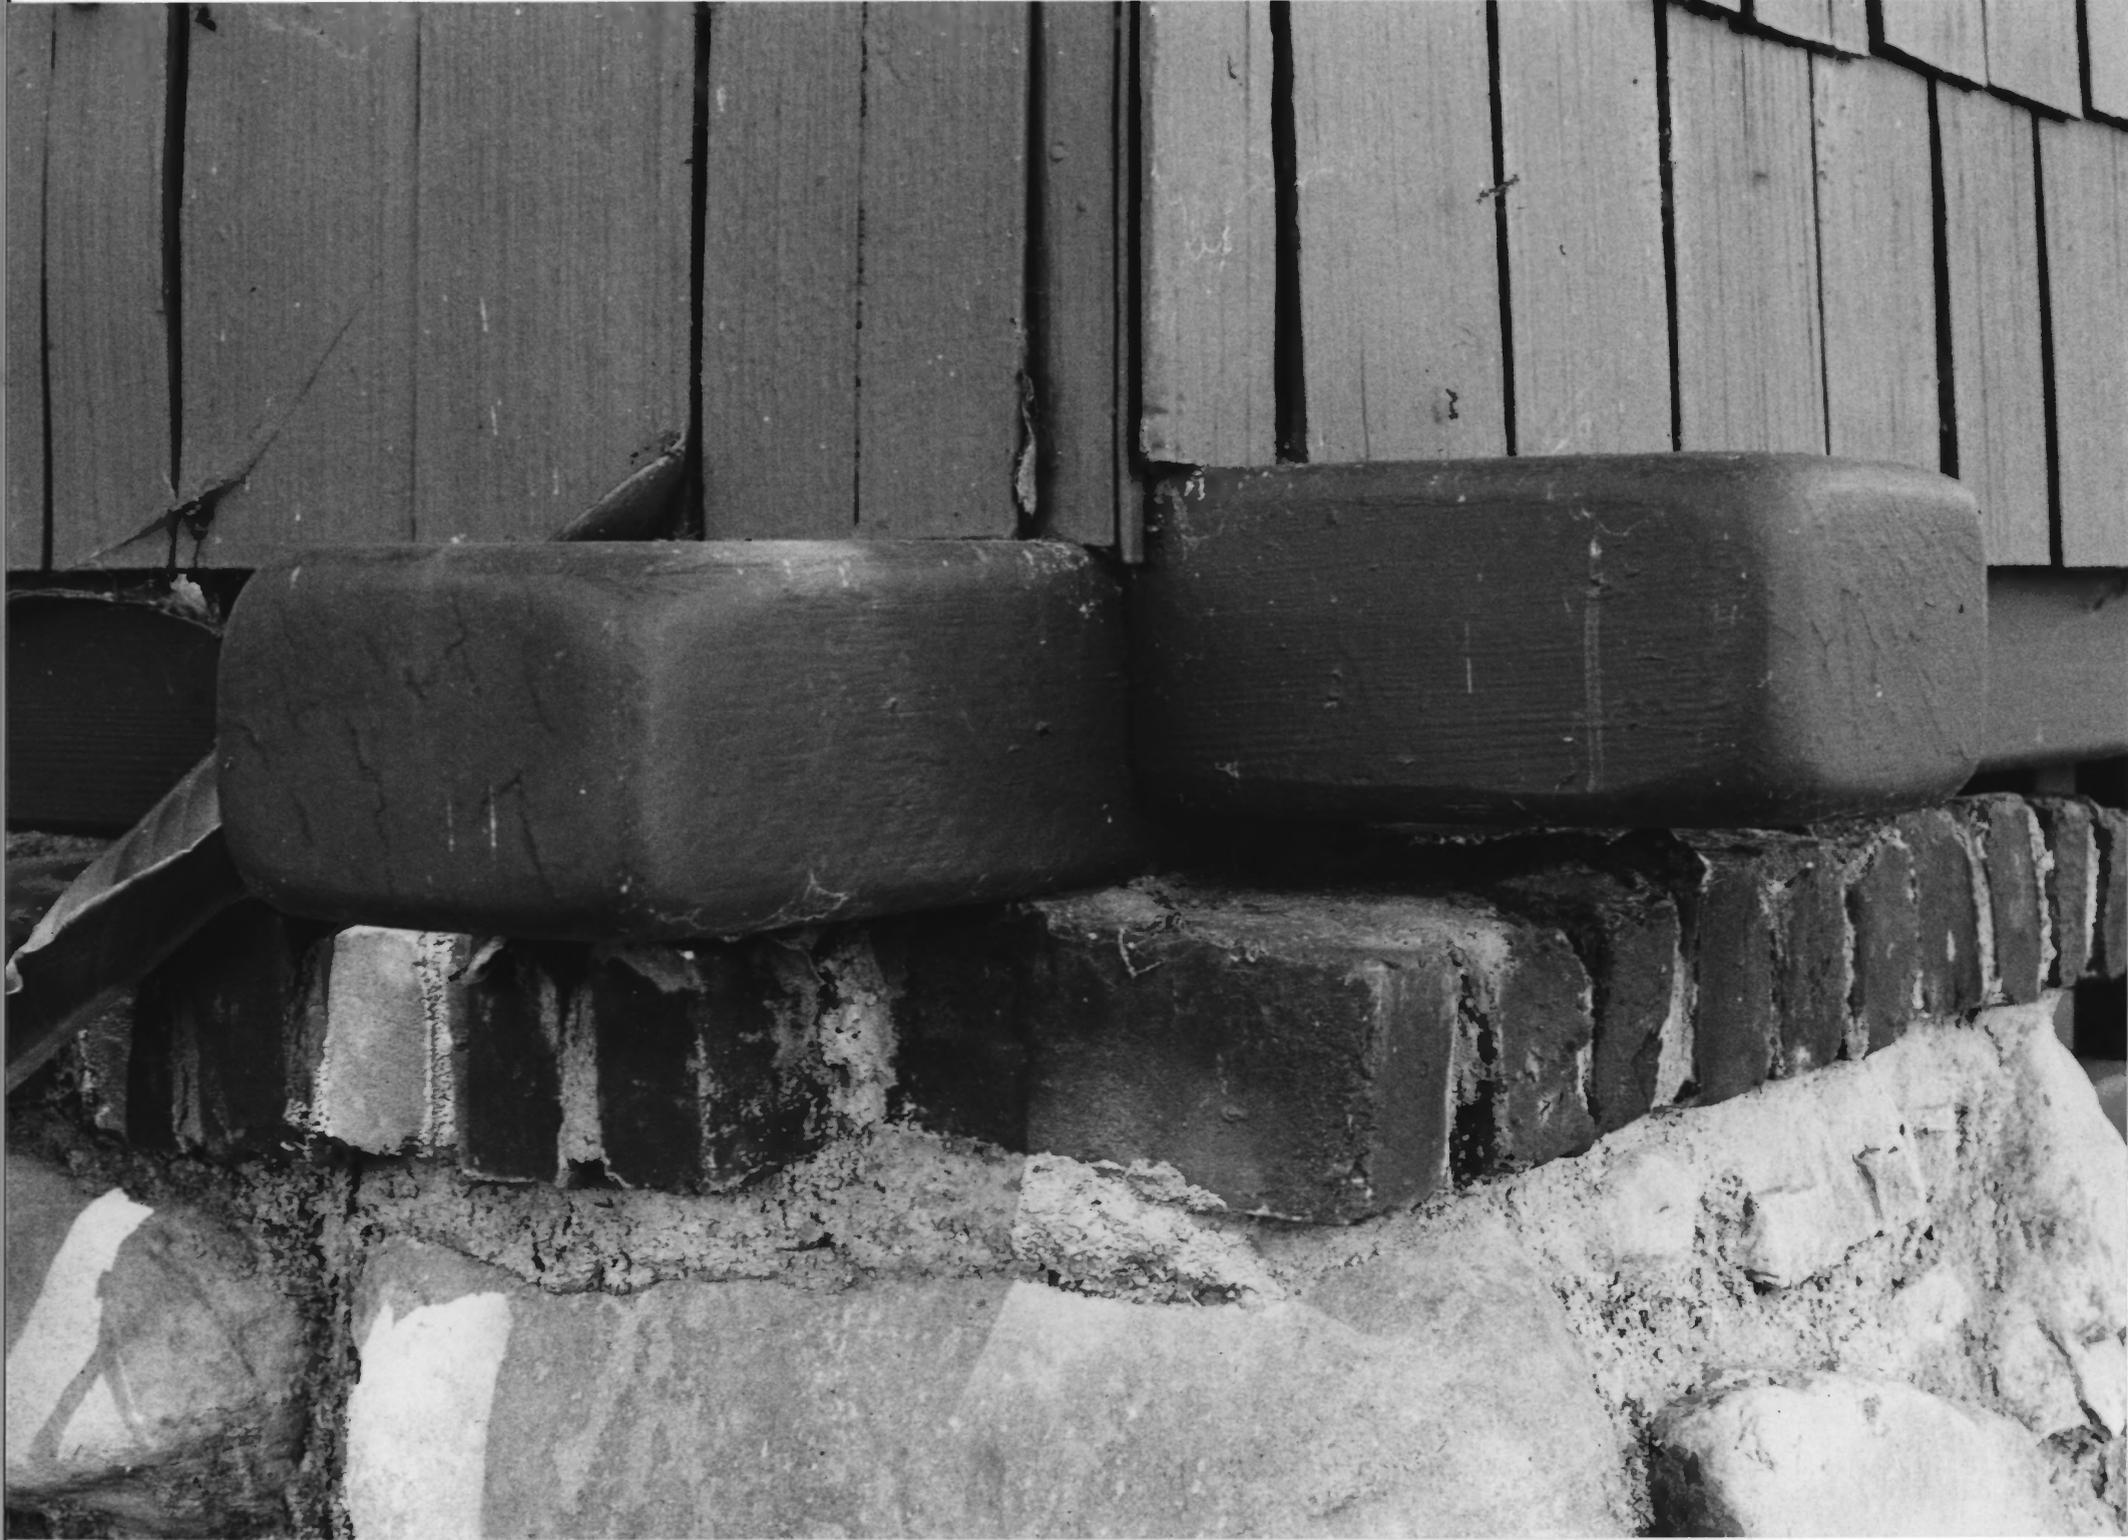
Section 9 Photograph 10

Detail of corner sill plate showing lap joint and brick to over river rock pillar.

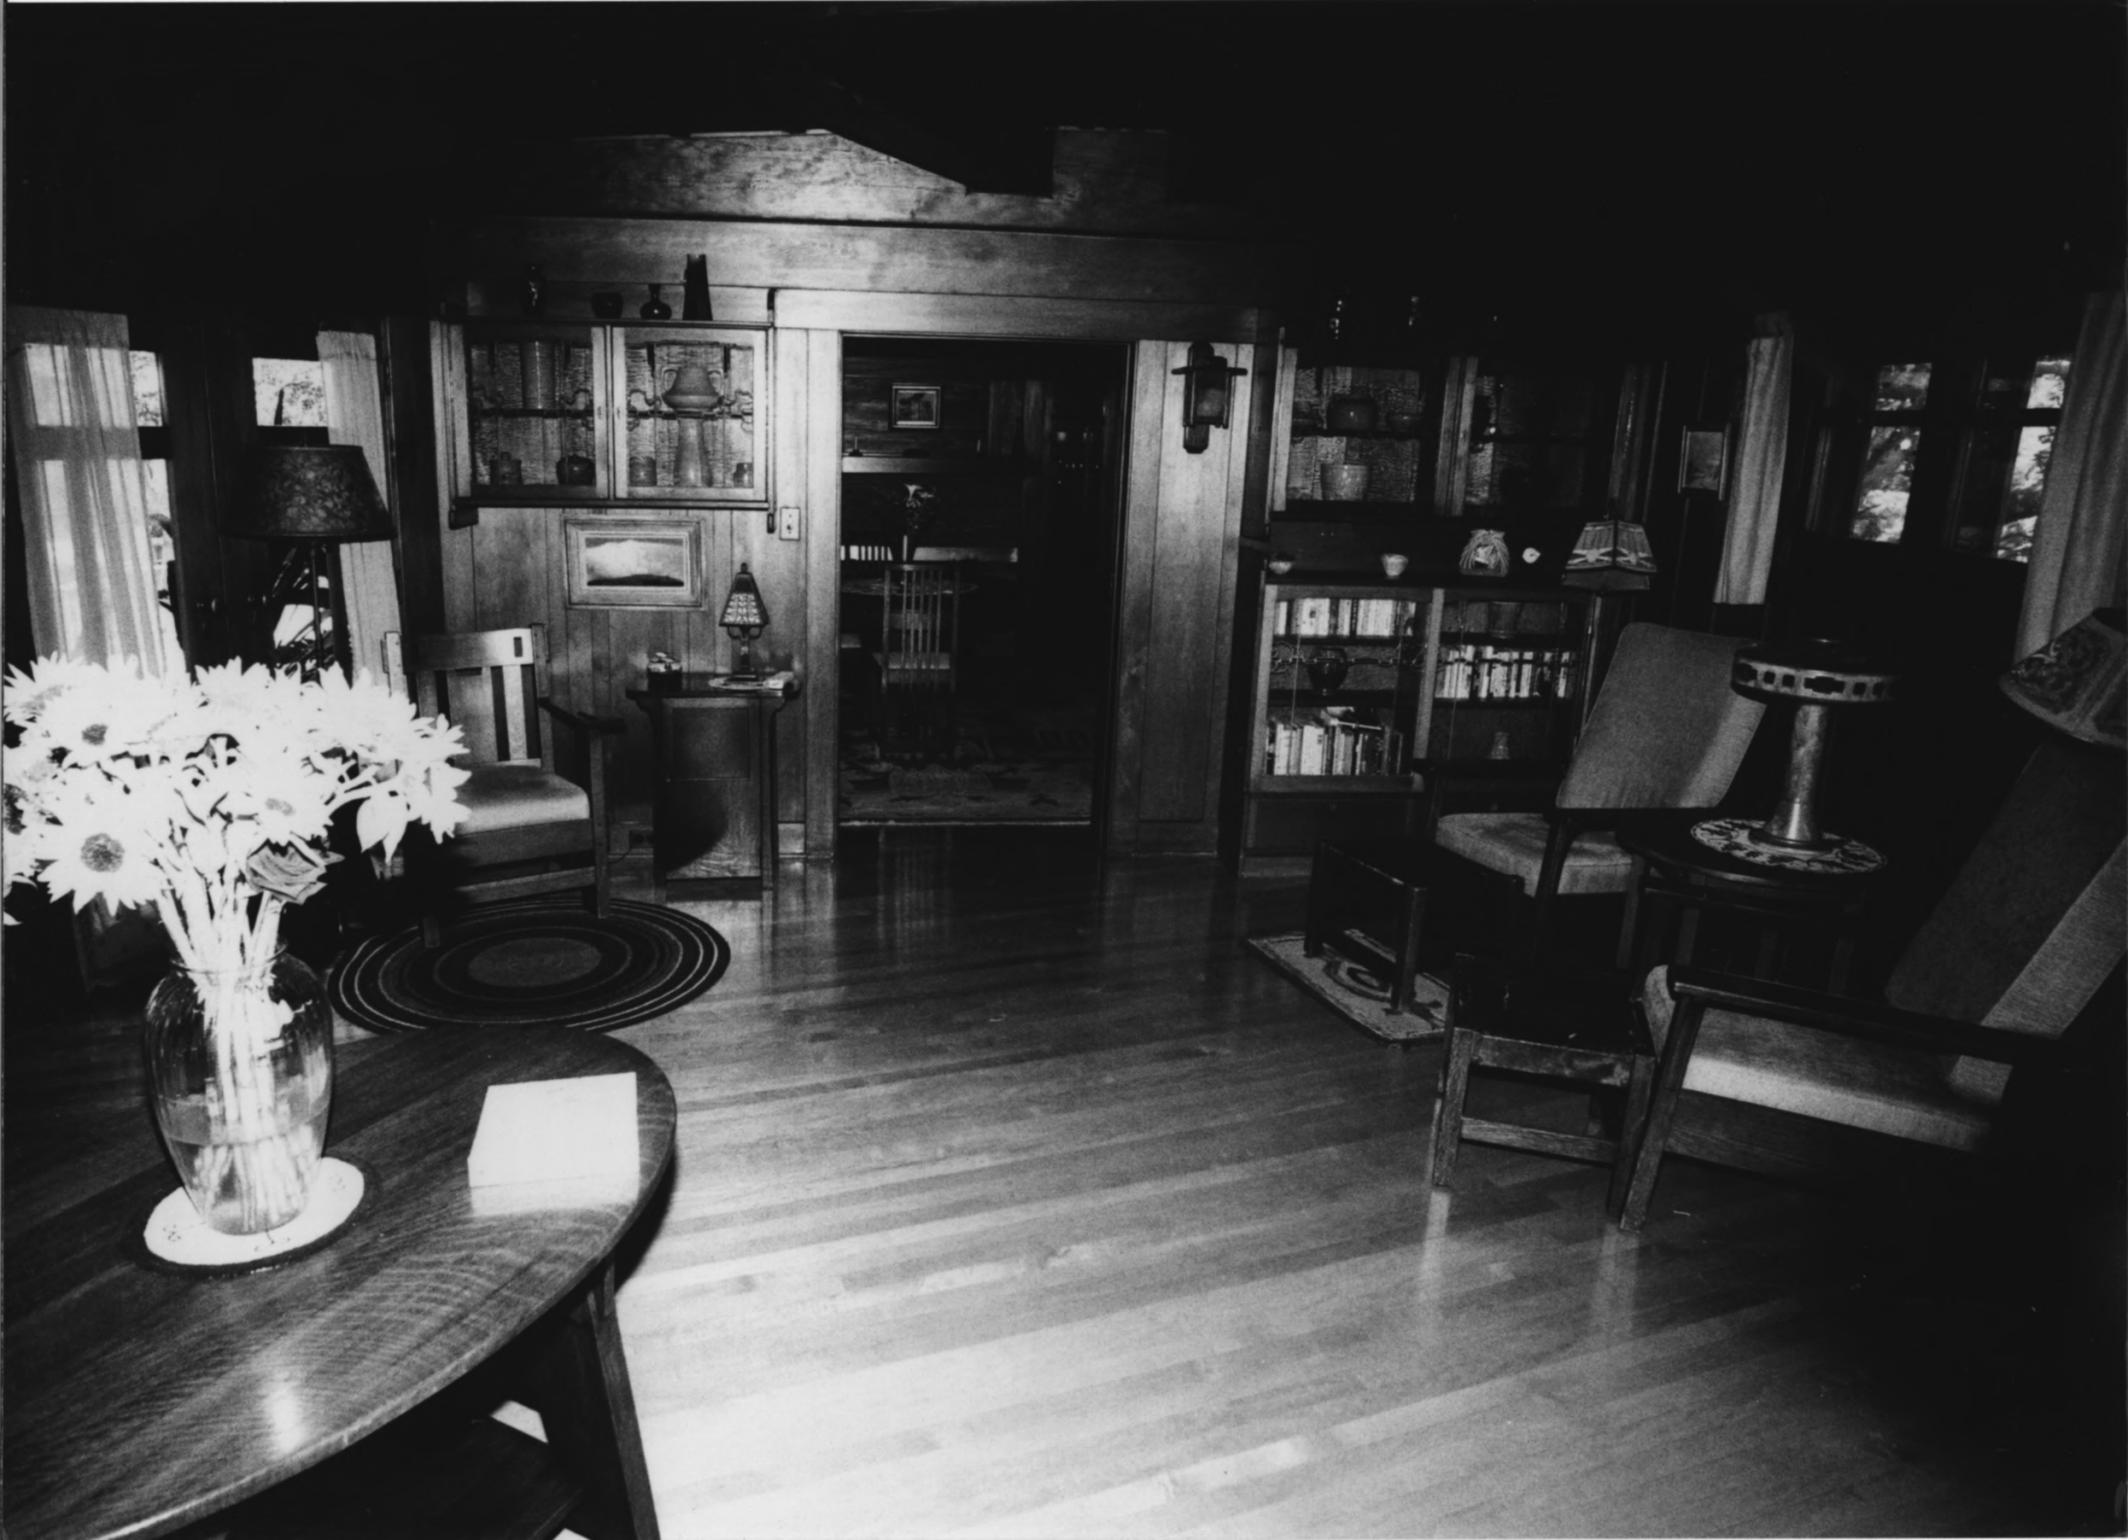
Section 9 Photograph 11

View of living room looking through door into dining room. Notice rectangular sconce and built in bookcases with leaded glass doors.

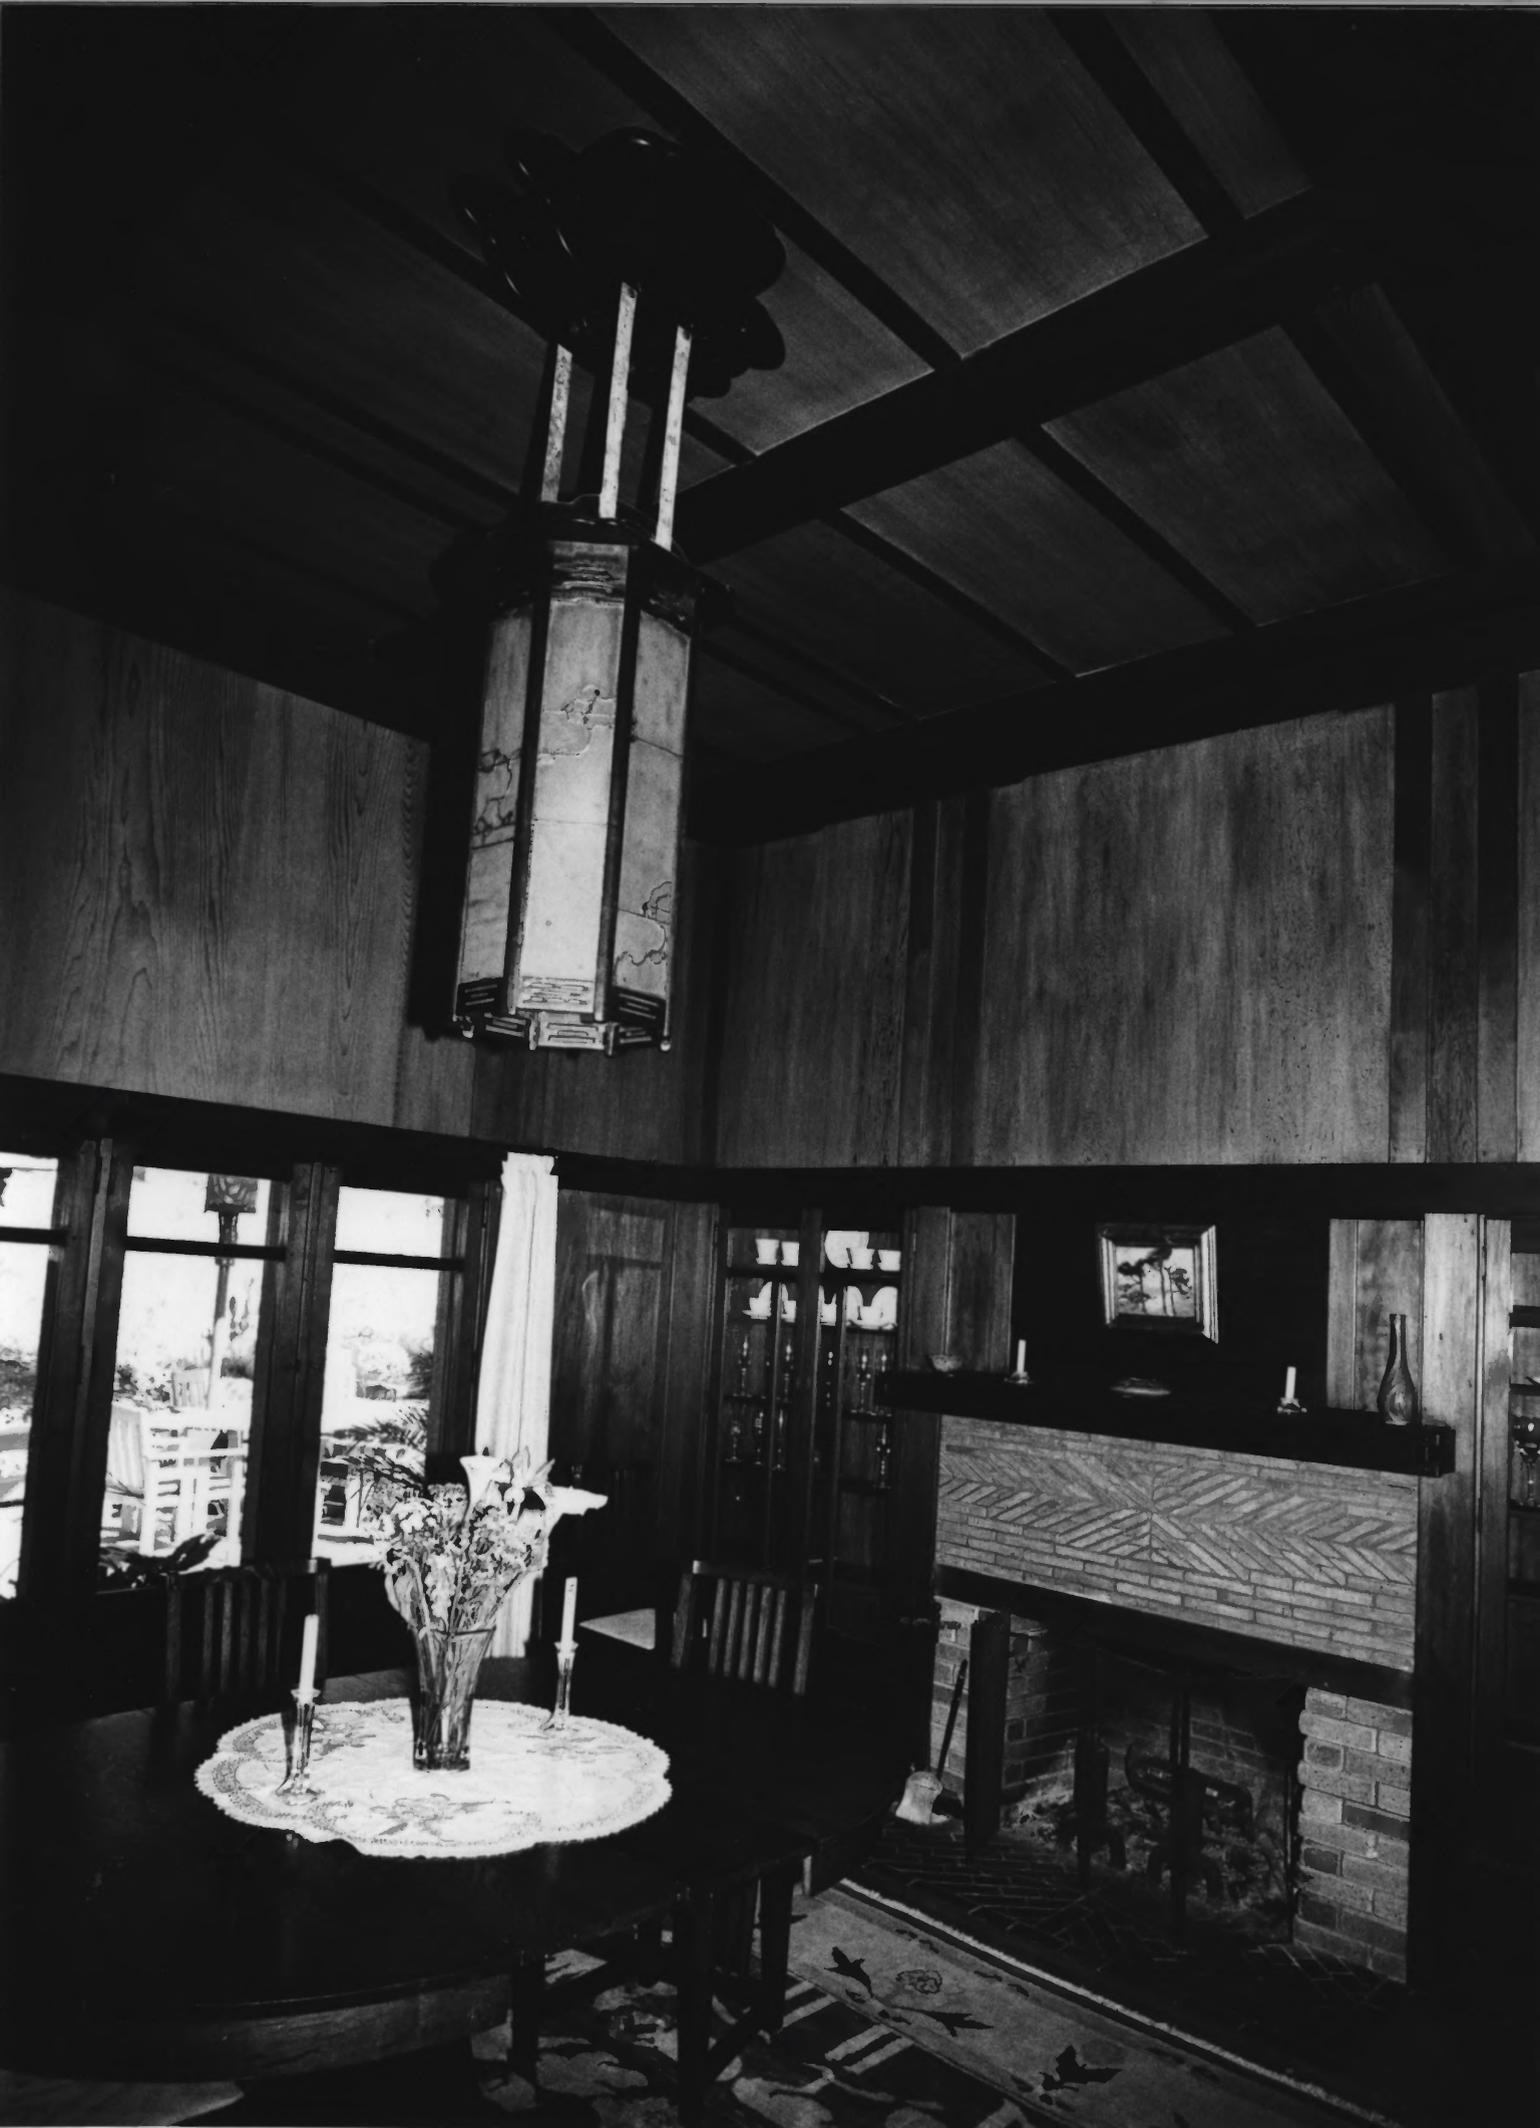
Section 9 Photograph 12

View of dining room looking from left door to butler's pantry. Notice the octagonal chandelier, wide redwood paneling on the upper walls and "native American textile" brickwork of fireplace..

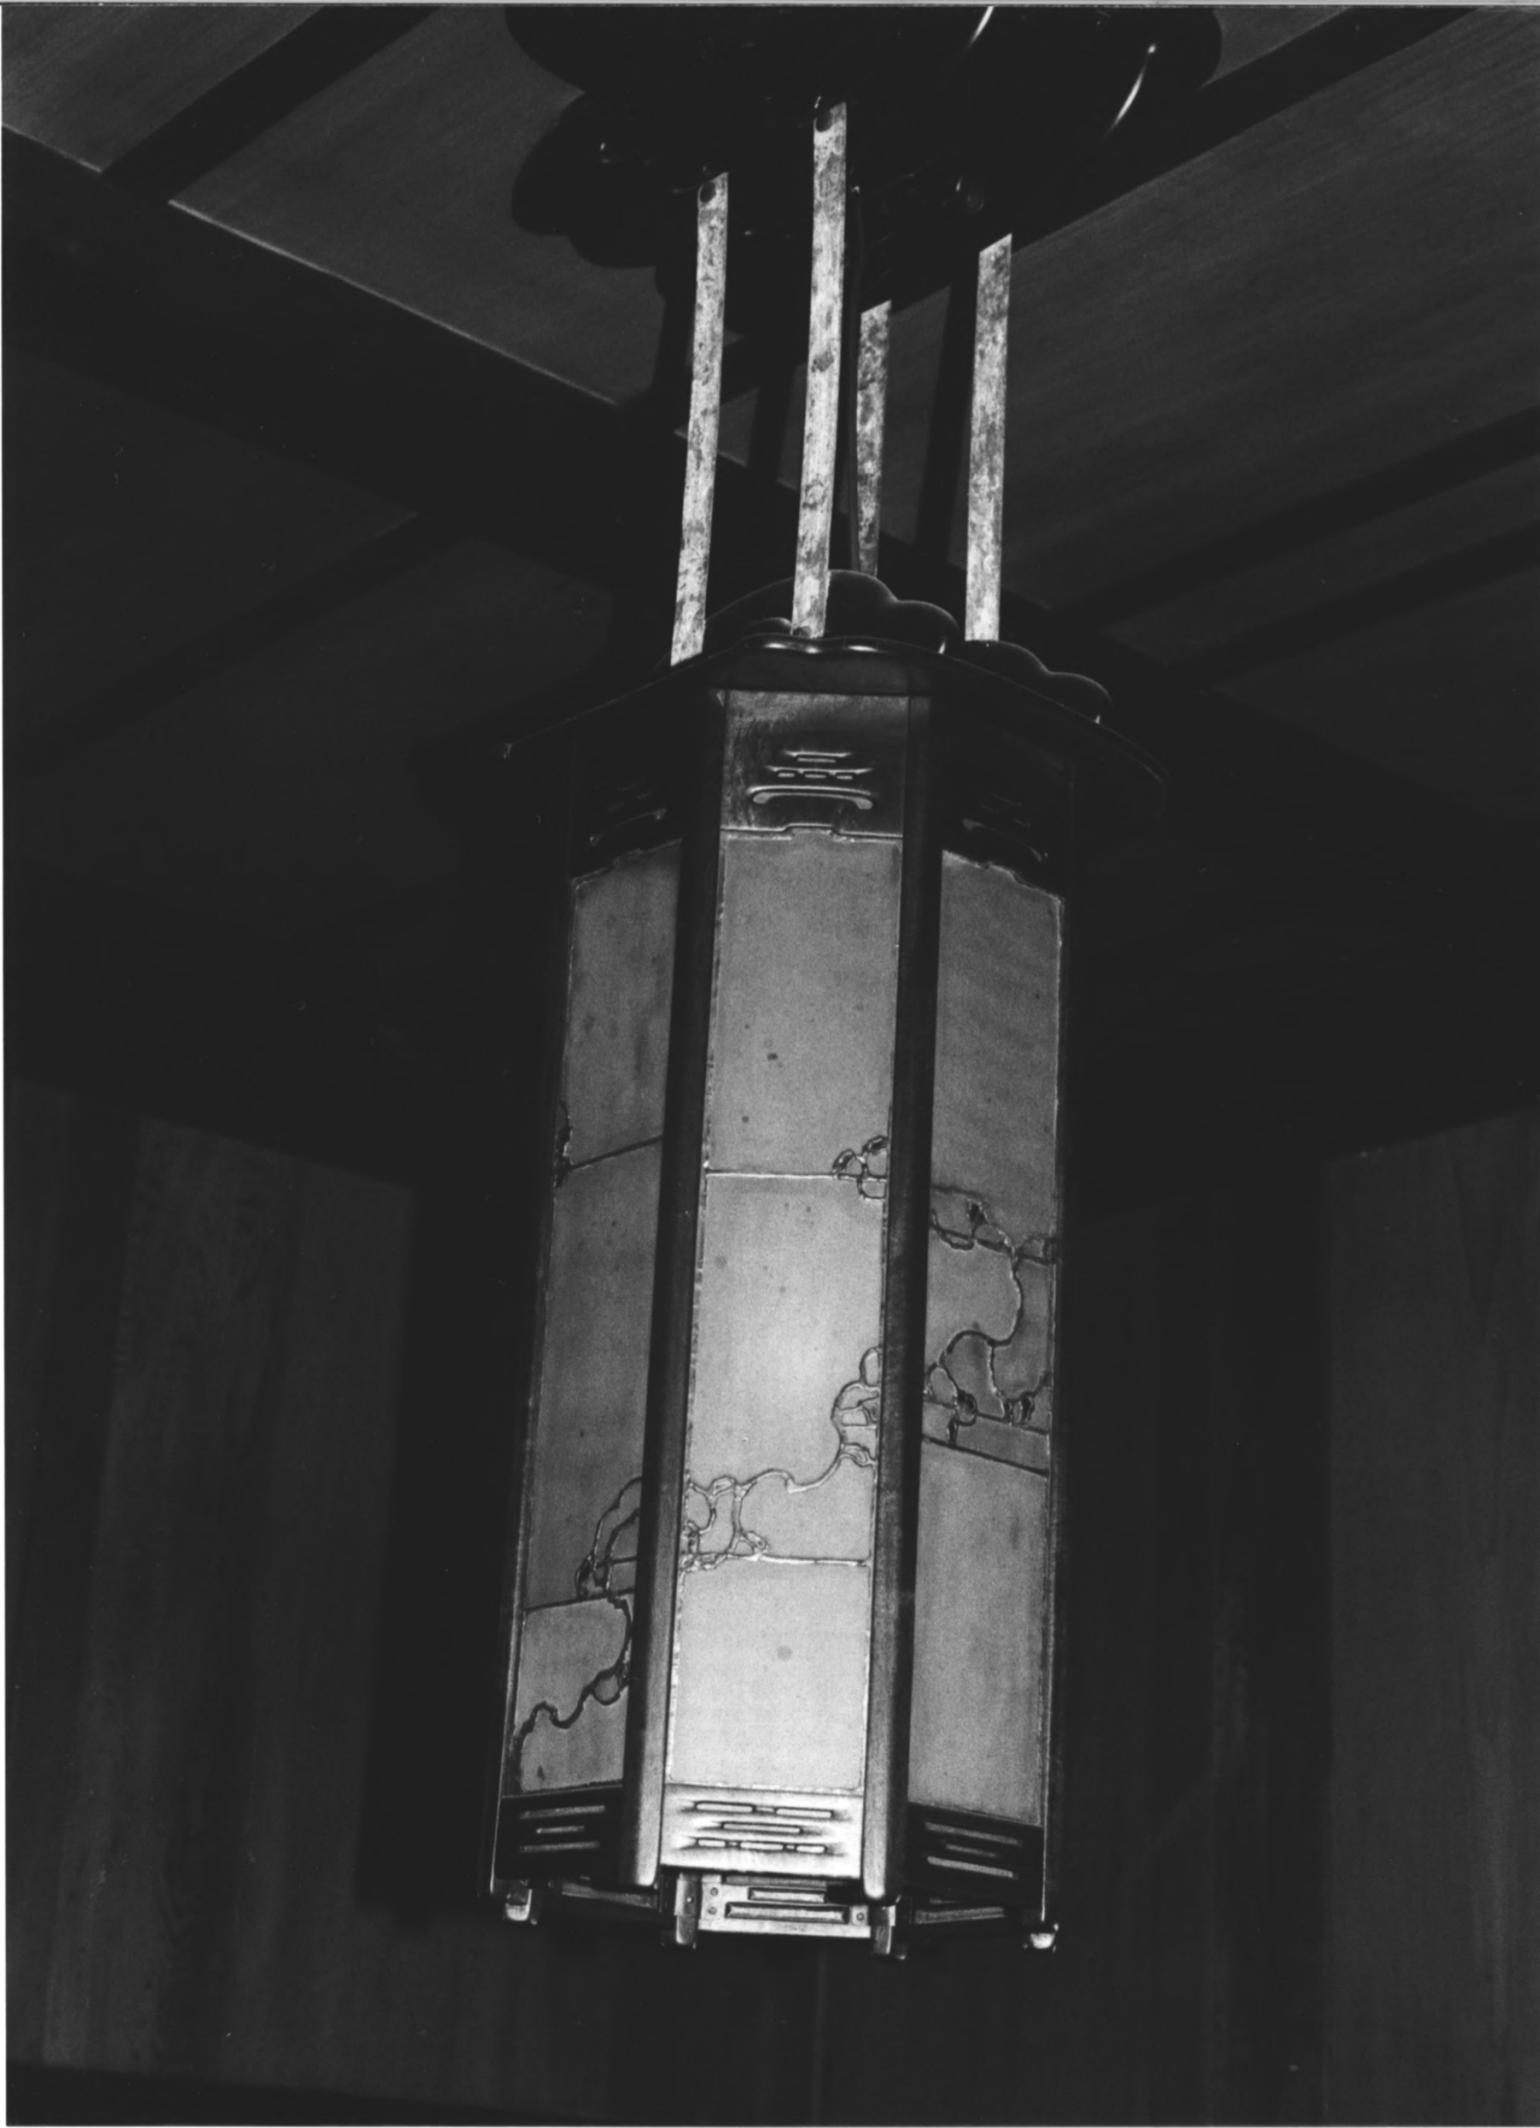
Section 9 Photograph 12A

Detail of the dining room chandelier with glasswork by Emile Lange from the Tiffany Studios in New York.

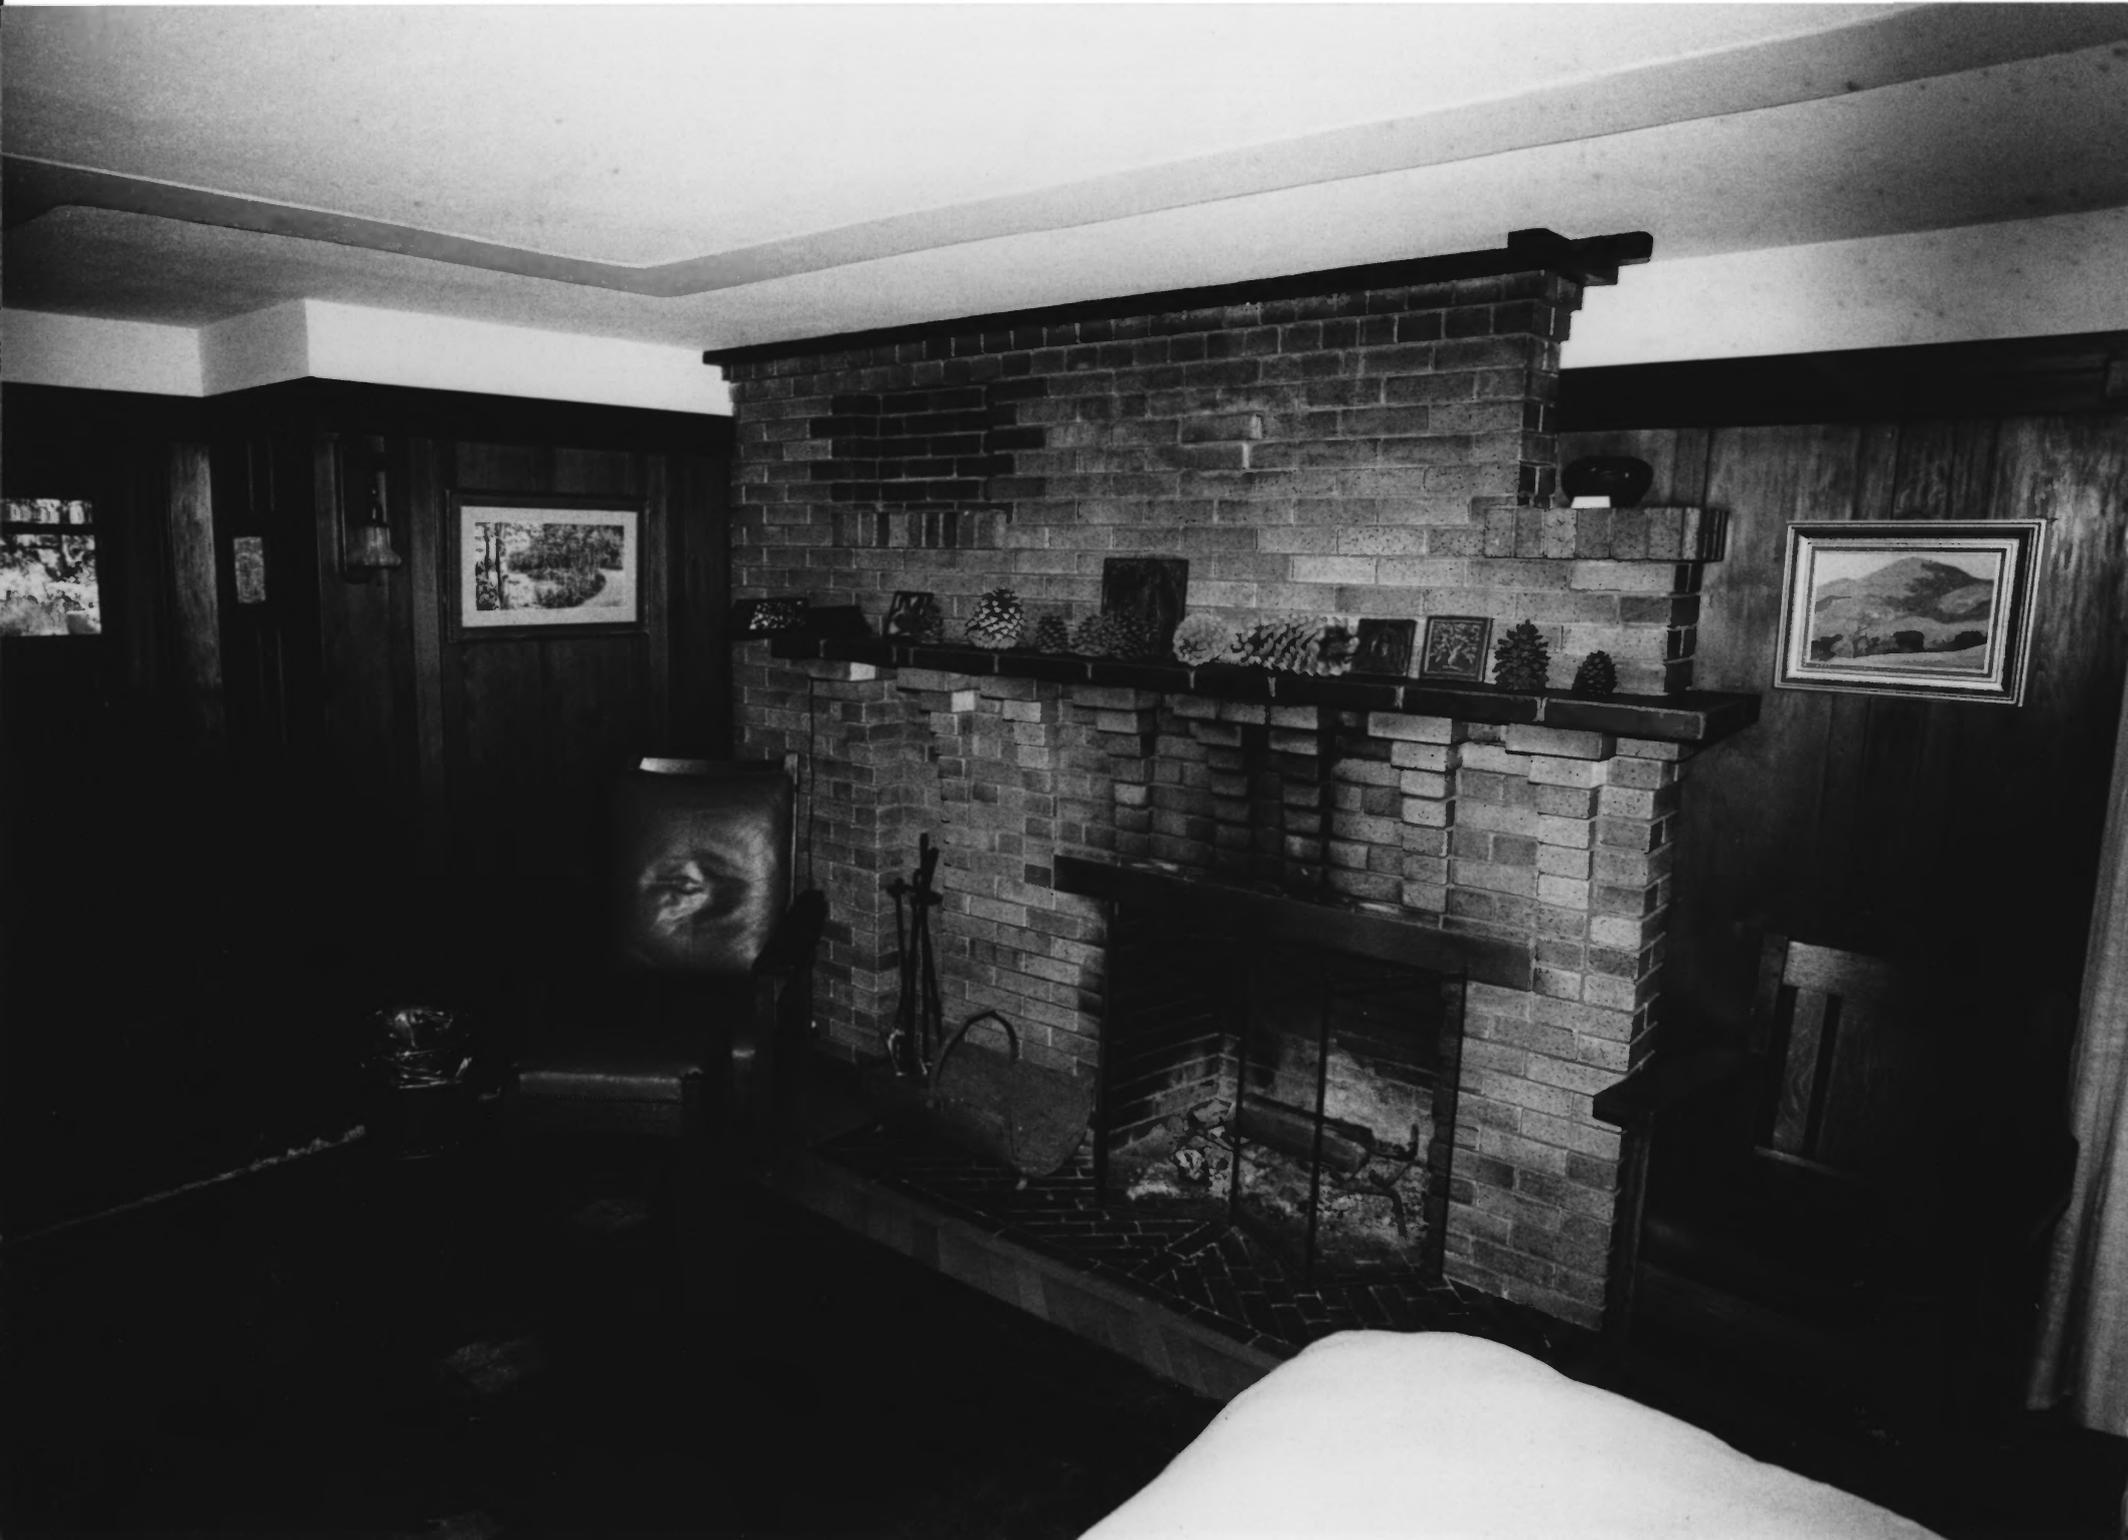
Section   9   Photograph   13

View of the number one bedroom or study. Note the cloud relief on the ceiling.

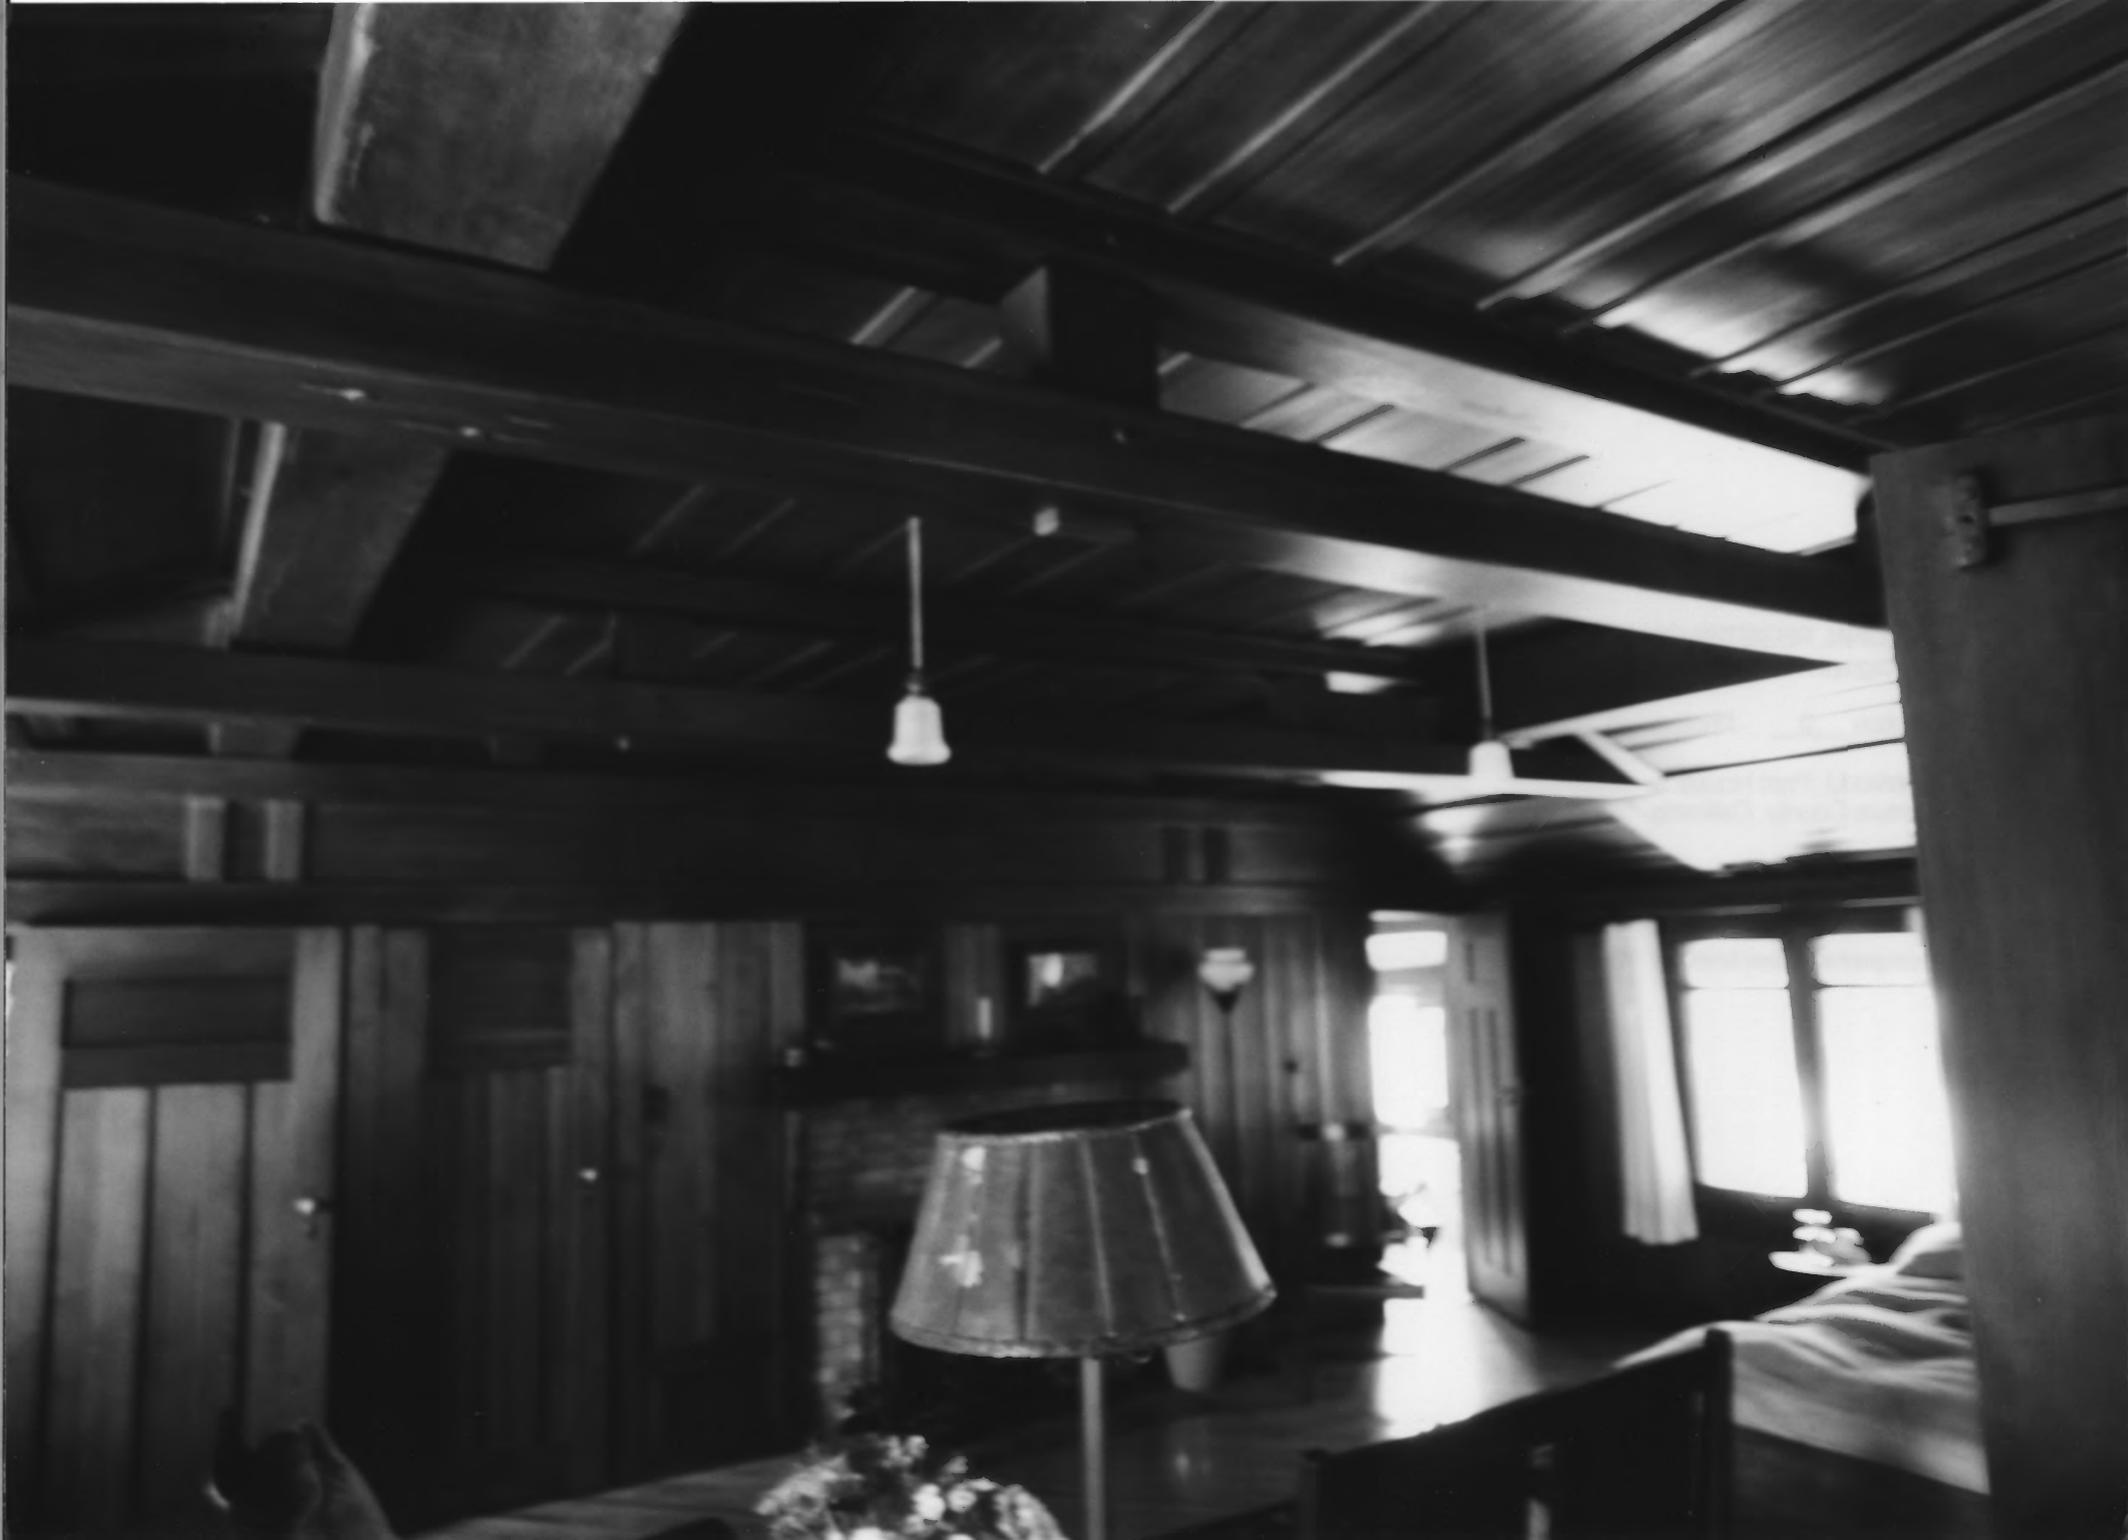
Section 9 Photograph 14

Detail of the Downstairs north bedroom timbered ceiling.
