KENTUCKY HISTORIC RESOURCES INVENTORY

Site No. B0 194

1. Historic Name(s) <u>Caldwell house</u>		22. ADD/County <u>Bluegrass, Boyle</u>	
Original Owner <u>Phillips Caldwell?</u>		23. U.S.G.S. Quadrant (15'/75') <u>Danville vic.</u> G.I.S. Mod. <input type="checkbox"/>

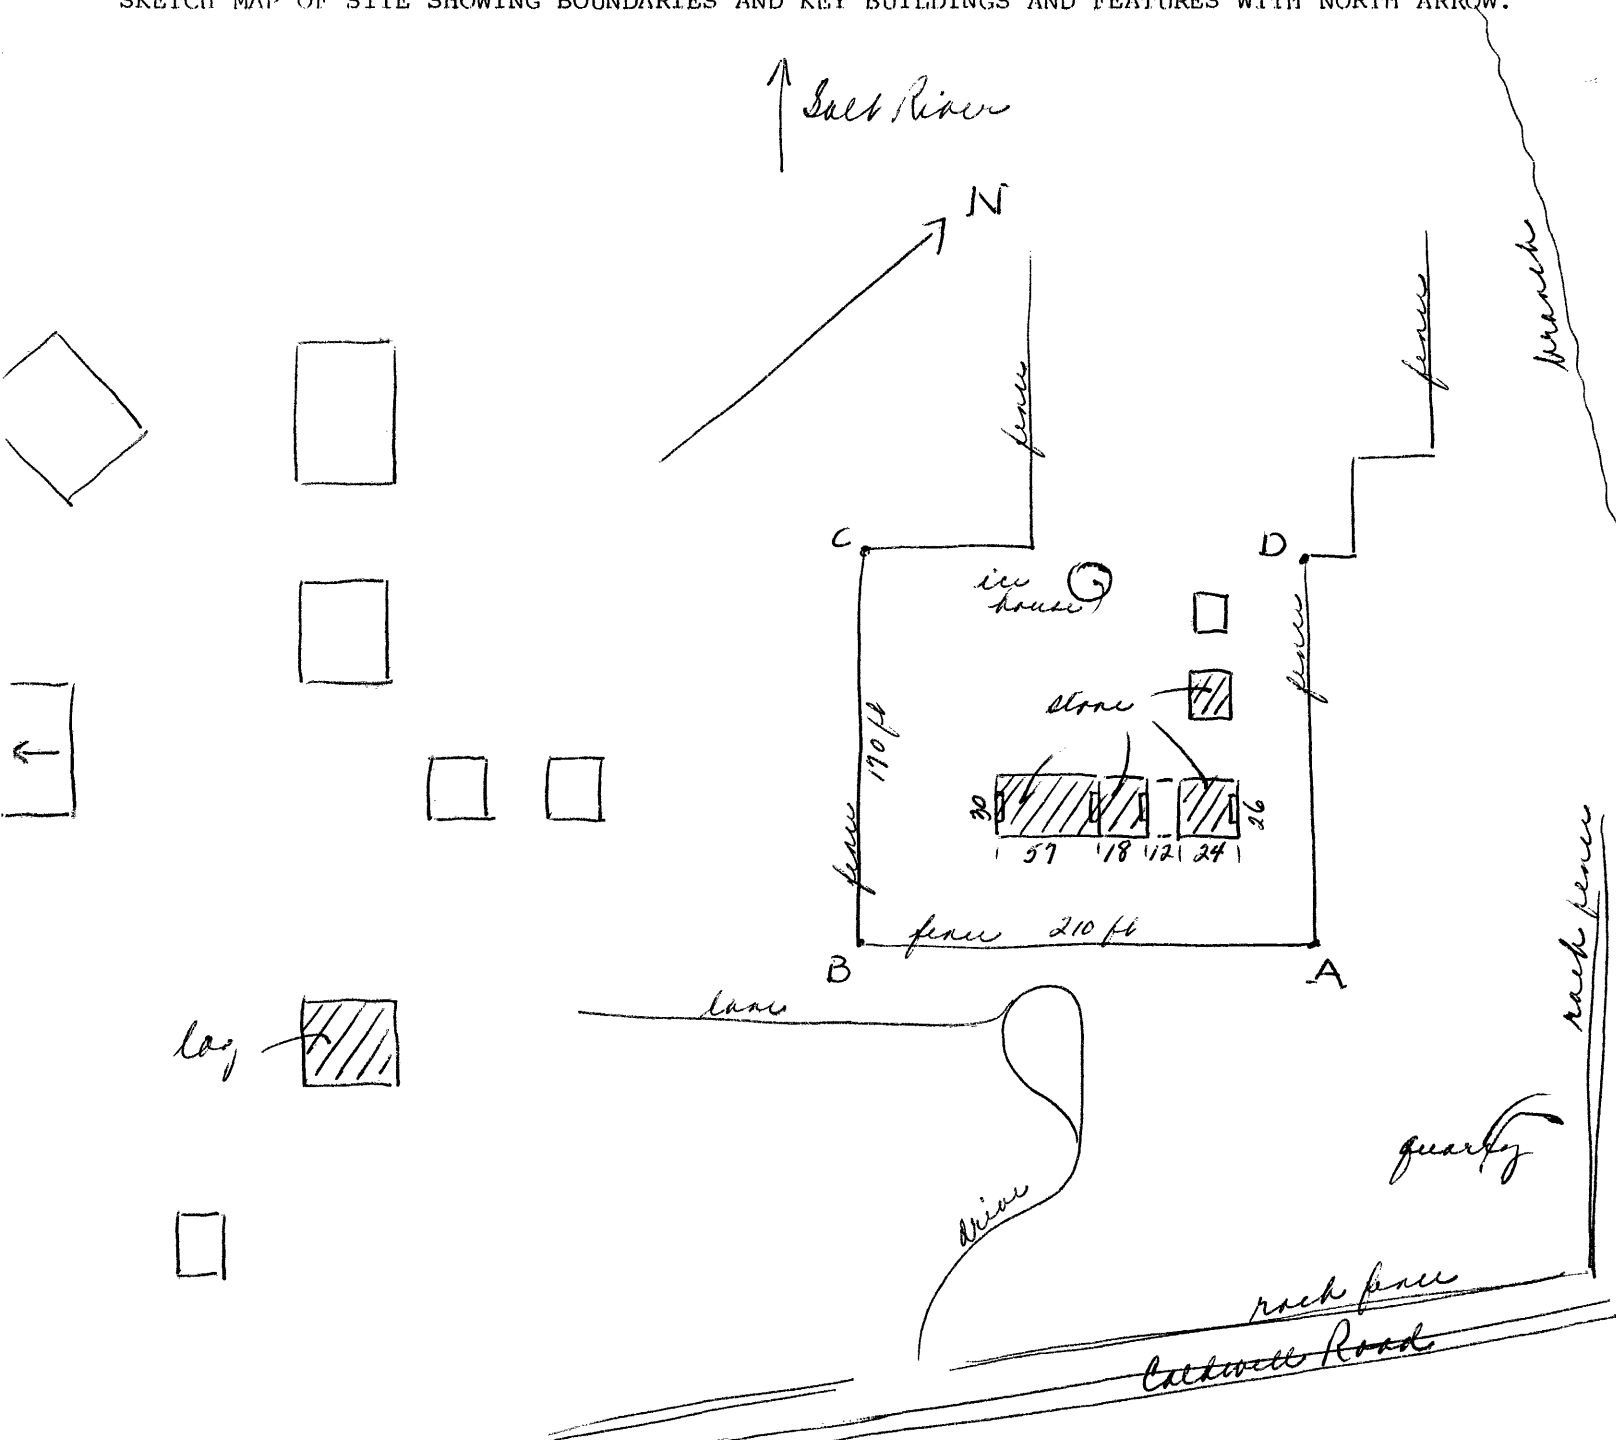
SKETCH MAP OF SITE SHOWING BOUNDARIES AND KEY BUILDINGS AND FEATURES WITH NORTH ARROW.

Beginning at A at the E corner of the yard, thence SW 210 ft to B, NW 170 ft to C, NE 210 ft to D, and SE 170 ft to the beginning, containing the stone house, stone kitchen, stone grain house, stone ice house foundation, about 8/10 acre.

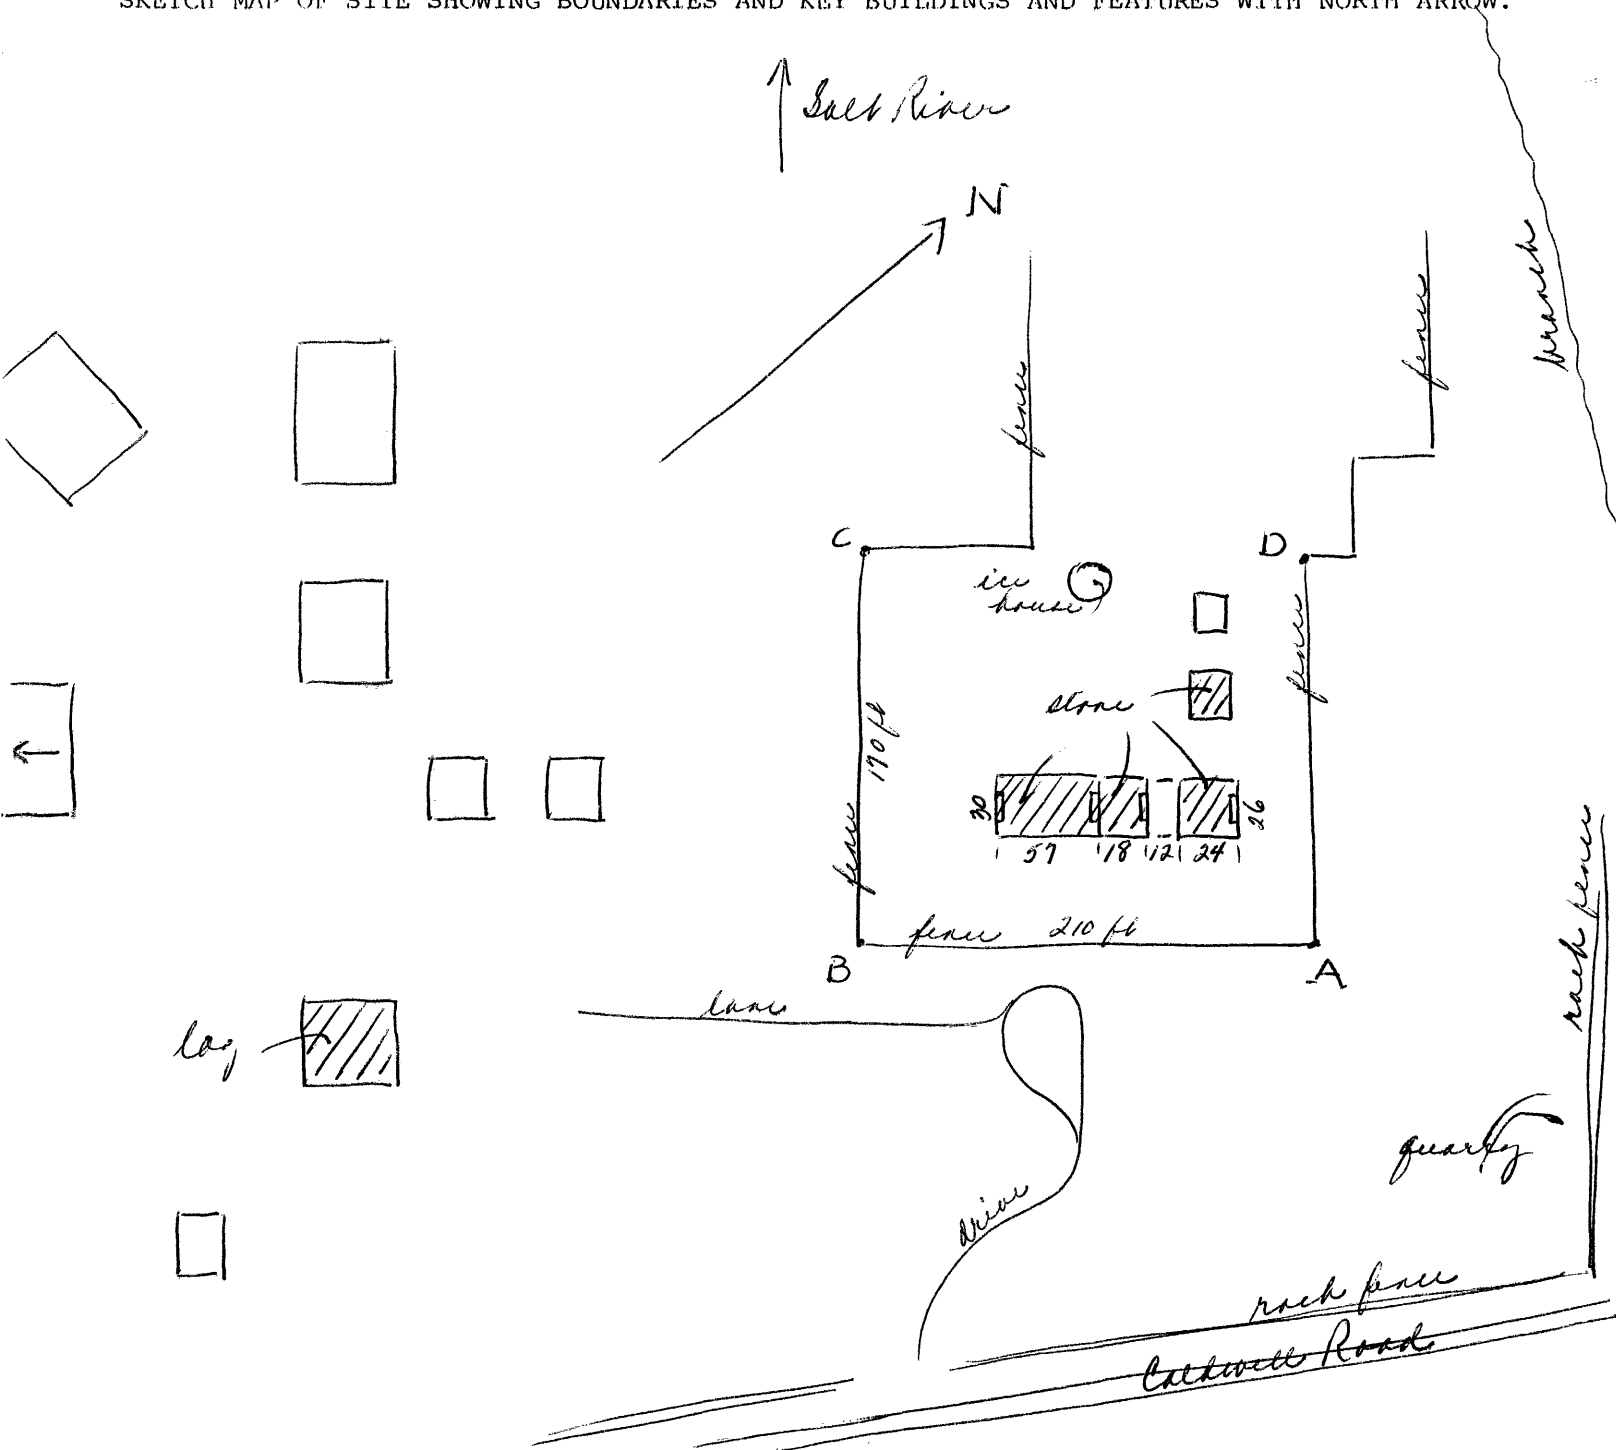
SKETCH MAP OF SITE SHOWING BOUNDARIES AND KEY BUILDINGS AND FEATURES WITH NORTH ARROW.

Beginning at A at the E corner of the yard, thence SW 210 ft to B, NW 170 ft to C, NE 210 ft to D, and SE 170 ft to the beginning, containing the stone house, stone kitchen, stone grain house, stone ice house foundation, about 8/10 acre.
