**United States Department of the Interior
National Park Service
National Register of Historic Places
Inventory—Nomination Form**

1. Hendrick and Waldur Hendrickson (Henry Lehtola) Farm
Henry Lehtola Farm
2. 2 miles west of Lake Norden, Hwy. 28
Lake Norden Vicinity
South Dakota 046 Hamlin 057
3. buildings; privately owned; NA acquisition; unoccupied;
agriculture
4. Hilda Lehtola
Nursing Home
Lake Norden, South Dakota 57248
5. Register of Deeds
Hamlin County Courthouse
Hayti, South Dakota 57241
7. good; unaltered; original site

HENDRICKSON
(LEHTOLA) SAUNA
Hamlin Co, SD
pre 1910

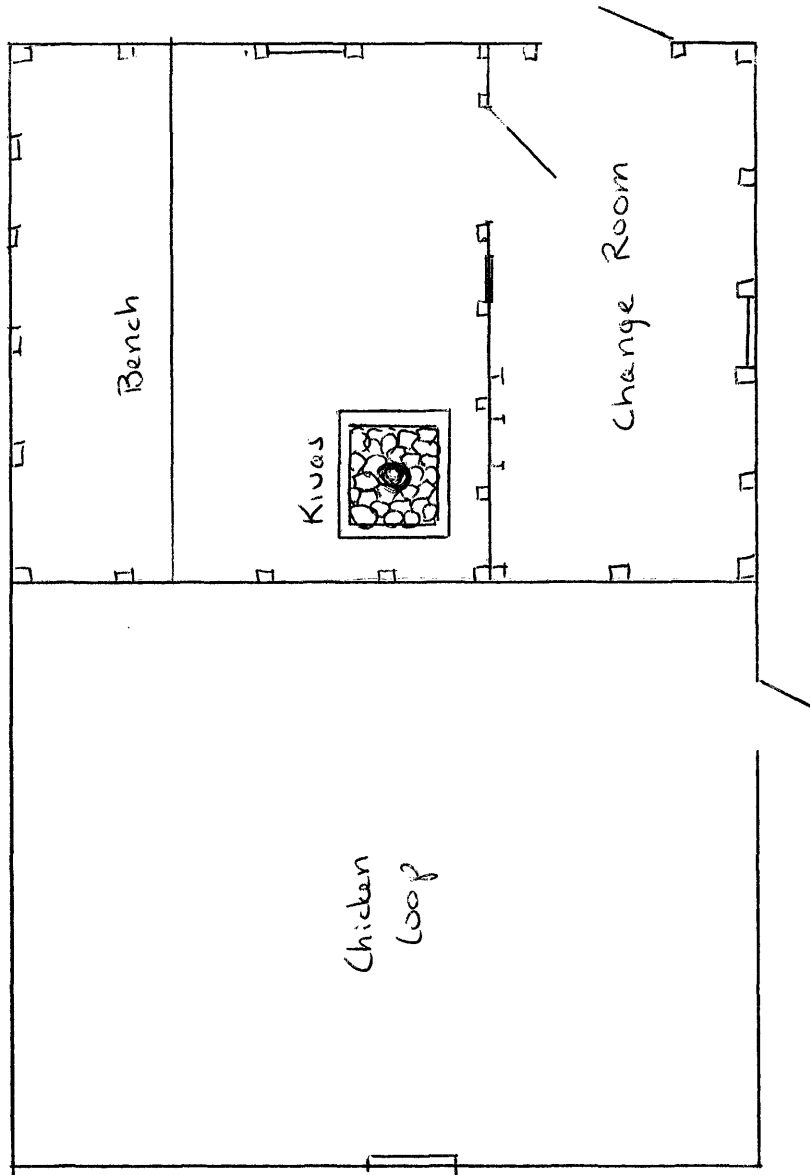
The sauna (contributing), located between the barn and the summer kitchen, is the most interesting building on the site. Constructed of frame, the building has an attached chicken-coop, shed addition (probably original) on the rear, axial facade. The building is covered in wood shingle and rests on an unmortared stone foundation. Measuring 14' 5 1/4" in length, the sauna is 10' 3 1/2" in width with the coop addition adding another 12' 3".

On the interior the sauna is divided into two rooms which have been blackened with smoke from the stove. This is a sayusauna and has a rare, surviving conical stone kiuas. Hilda Lehtola remembers the sauna

being built when she was a child which dates it prior to 1910. In recent years the sauna has been used for storage and several of the benches on the rear, west wall have been removed. A small smoke flue is controlled from the inside with a latch.

Although three smoke saunas survive intact in South Dakota, this sauna has, in addition, an extremely rare conical, stone kiuas. While later, non-smoke kiuas are self-contained metal furnaces, the very early kiuas in America was a primitive stone furnace. A hearth of flat stone was laid on which the fire was built. Over the fire pit was built a vaulted, stone casing made of unmortared stone which allowed the stone to expand and contract. Often metal was used to help support the arch or "roof" of the fire pit. The wood fire was kept burning for half a day and allowed to die out before the bath was taken. Over this time the rocks had

heated and the bather simply splashed dippers of cold water onto the rocks to create steam. Of course some of the smoke of the unvented fire remained in the room and was allowed to escape through a roofed vent in the ceiling.
