| | 4 |
|--|---|
| NATIONAL REGISTER OF HISTORIC PLACES REGISTRATION FORM | INTERAGENCY RESOURCES DIVISION NATIONAL PARK SERVICE |
| HISTORIC NAME: Floor of the Valley Road | |

Washington County, UT Zion National Park MRA

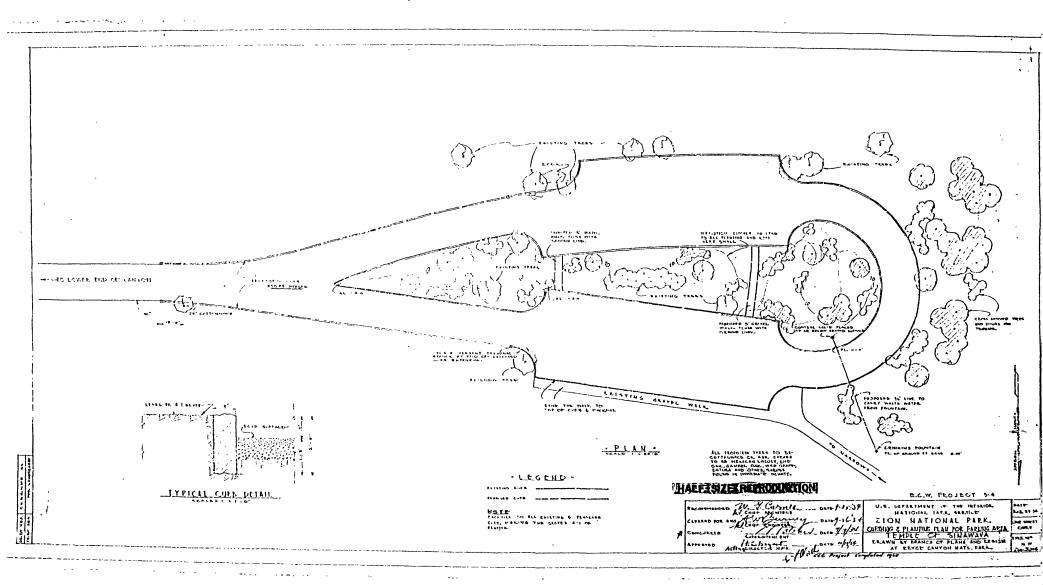
Temple of Sinawava Parking Area, original design

The Temple of Sinawava Parking Area is located at the terminus of the Floor of the Valley Road. It is a one-way parking loop, approximately 420 feet long and 200 feet wide at its widest point, with parking spaces located on either side of the road. The entire parking area has red ashlar sandstone curbing along its inner and outer perimeter. The curbing was built to specifications that required 6" to 1' lengths of dressed stone to be approximately 9" high (above parking area grade) and 8" wide. Surrounding the outside perimeter, are 5-foot wide gravel walkways which lead to the Gateway to the Narrows Trail which was listed on the National Register as part of the 1987 multiple property submission. The east end of the parking area was expanded in the 1960s, when some of the original curbs were relocated to accommodate the construction of additional parking spaces. As the original curbing was reused and the expansion did not significantly alter the design of the parking area, it still retains sufficient integrity to be a contributing feature to the Floor of the Valley Road.

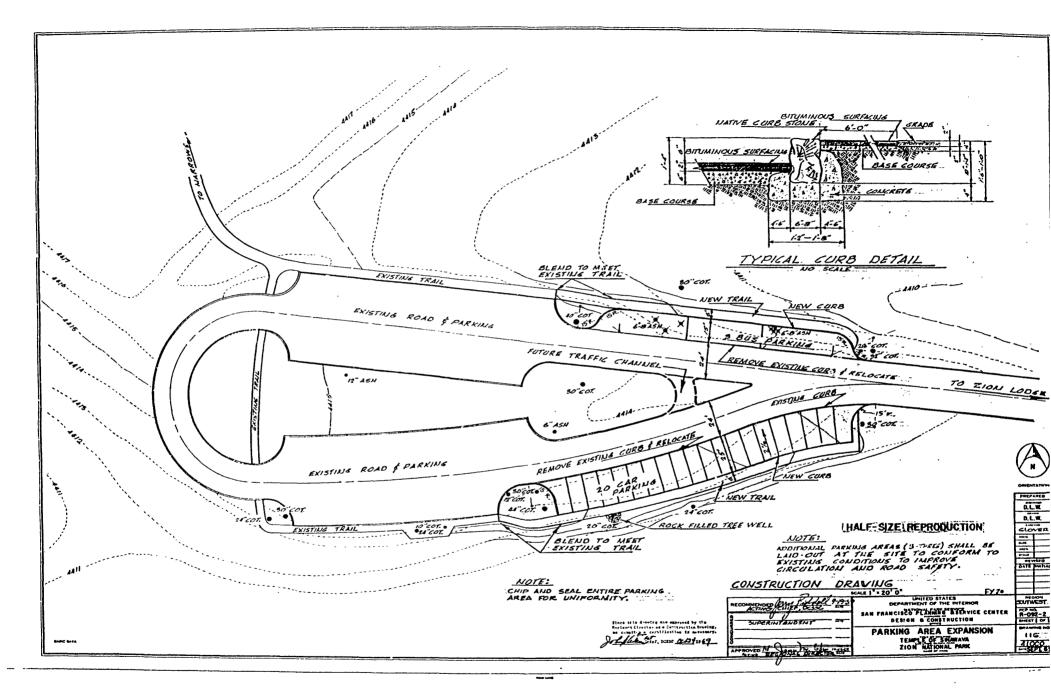
Temple of Sinawava Parking Area, 1969 modifications

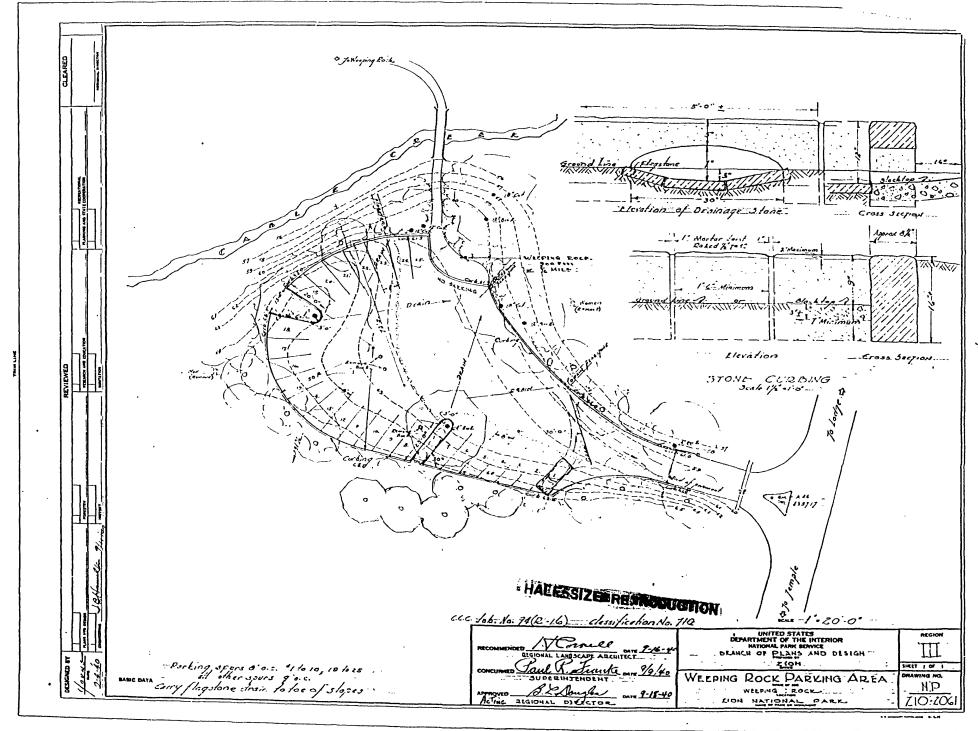
(6)

| Page No. | Title/Drawing No. | Date |
|---|---|---|
| 6 | Weeping Rock Parking Area, #2061 | 9/40 |

This 230-foot long and 150-foot wide (at its widest point) teardrop shaped parking area is connected to the road by a single, two-lane driveway approximately 50 feet long. The parking area has red ashlar sandstone curbing (which follows the same design specifications as the Temple of Sinawava Parking Area) and is surrounded with 5-foot wide walkways (surfacing varies - gravel, asphalt, concrete). Two small islands jut into the parking area from the northeast and southeast. Two stone stairways lead from the parking area down to Cable Creek. Built in the 1970s, these are nonhistoric. Also located between the parking area and Cable Creek (but not visible from the parking lot) are several retaining walls. Additions were made to the original walls in the 1970s, approximately doubling their

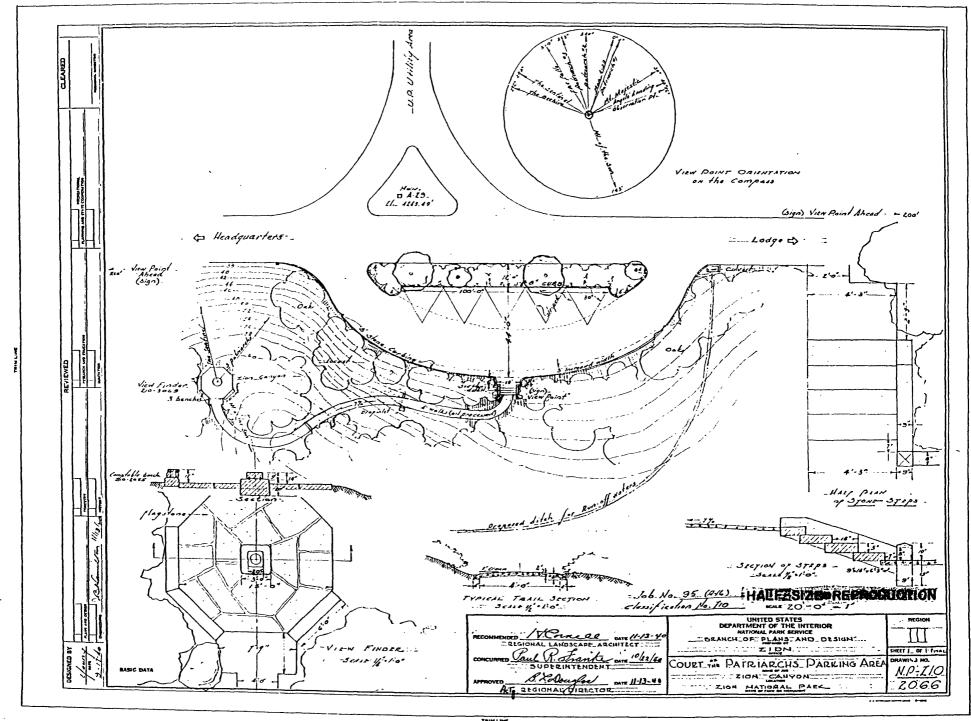
(7['])

| Page No. | Title/Drawing No. | Date |
|---|---|---|
| 7 | Court of the Patriarchs Parking Area, #2066 | 11/40 |

This 220-foot long and 44-foot wide semicircular parking area is separated from the road by a 12-foot wide baguette shaped island. The entire parking area (including the island) has red ashlar sandstone curbing which follows the same design specifications as the Temple of Sinawava Parking Area. There are no sidewalks around the parking area, only an approximately 150' long, 6' wide trail to the viewing area. (An original stone stairway that once led to the trail was removed in the 1960s.) The asphalt surfaced trail (once gravel surfaced) has sandstone curbing. The trail terminates at a circular viewing area, about 15' in diameter, and interpretive display. The parking area, and associated trail and viewing area are all part of the original design and are considered contributing resources.

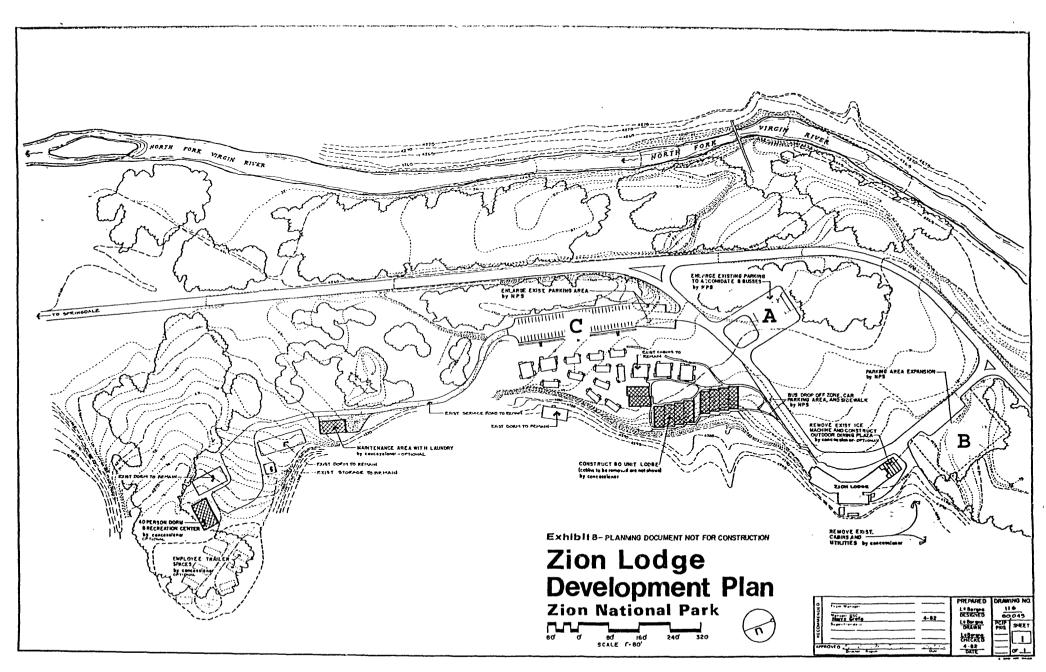
(12) Zion Lodge Entry and Parking Areas (existing and proposed, 1982)

A 1947 map indicates plans to construct a parking area immediately south of the swimming pool. This parking area was soon constructed, as it appears on a 1954 site map of the area. After the main lodge was destroyed by fire in 1968, the lodge was rebuilt. The swimming pool and bathhouse (and presumably the walkway) were removed in 1974. In the mid-1980s, the portion of the loop that was in front of the lodge was closed to vehicular traffic and replaced with concrete patio and pedestrian walkways. A new, larger parking area was built in the vicinity of the pool site (see "A" on 1982 site map) and a much larger, teardrop-shaped lot was superimposed over the parking area north of the lodge (see "B" on 1982 site map). In addition, the parking area at the quest cabins was lengthened on the north end (see "C" on 1982 site map). Of all the features in the entry area, only this last parking lot retains any degree of integrity. Because of its historical association with the lodge guest cabins, it is considered a contributing landscape feature to the Zion Lodge Historic District rather than the Floor of the Valley Road (an amendment to the district nomination should be prepared at a later date). The Zion Lodge Entry Area does not meet National Register criteria as a designed landscape, nor is it a contributing feature to the Floor of the Valley Road due to loss of integrity.
