National Register of Historic Places Registration Form

Historic name: Park Vista and Pine Manor Apartments

Other names/site number: Concord Apartments

Street & number: 5807-5825 14th Street, N.W.

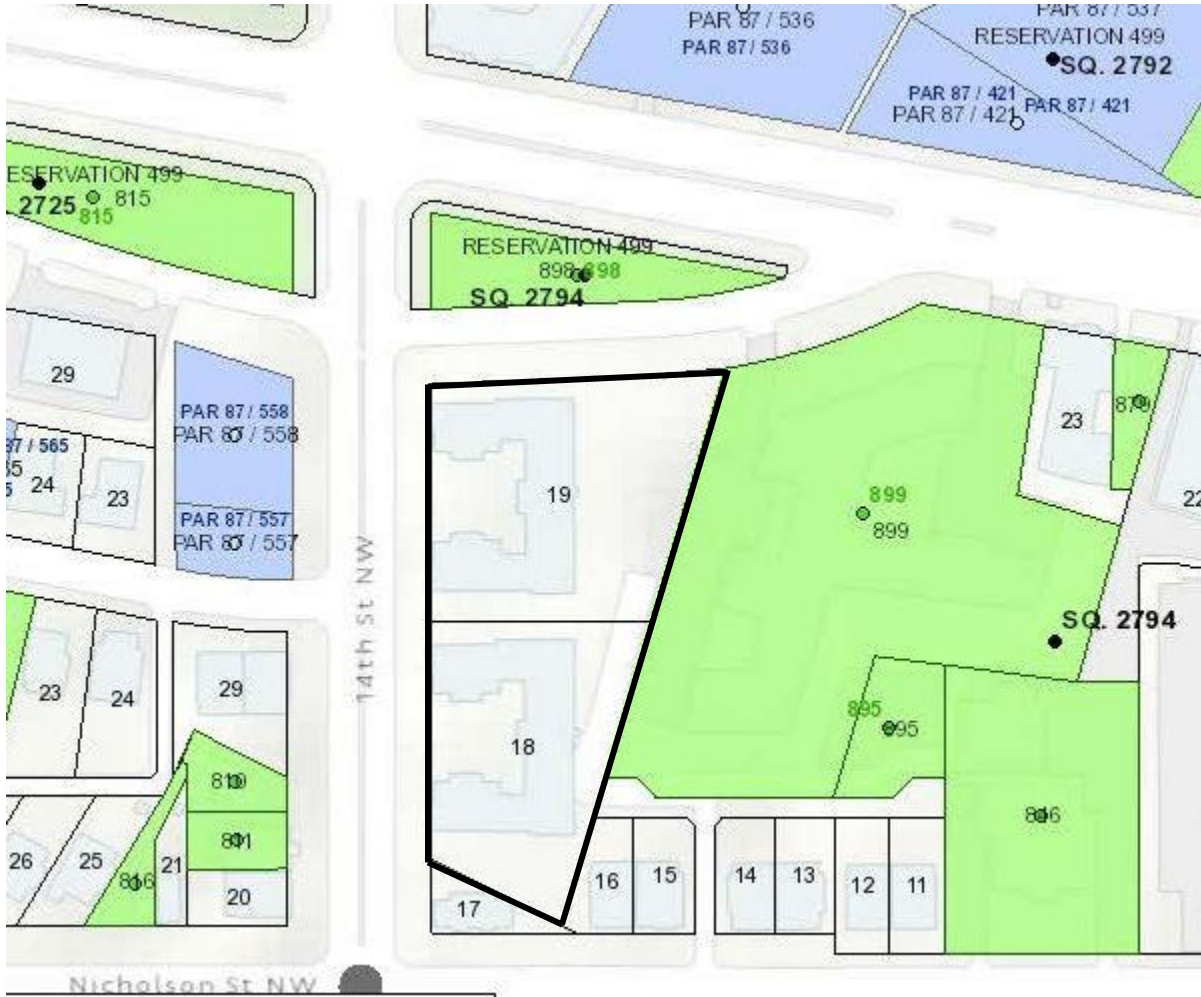
Site Map showing National Register Boundary (Square 2794, Lots 18 and 19)

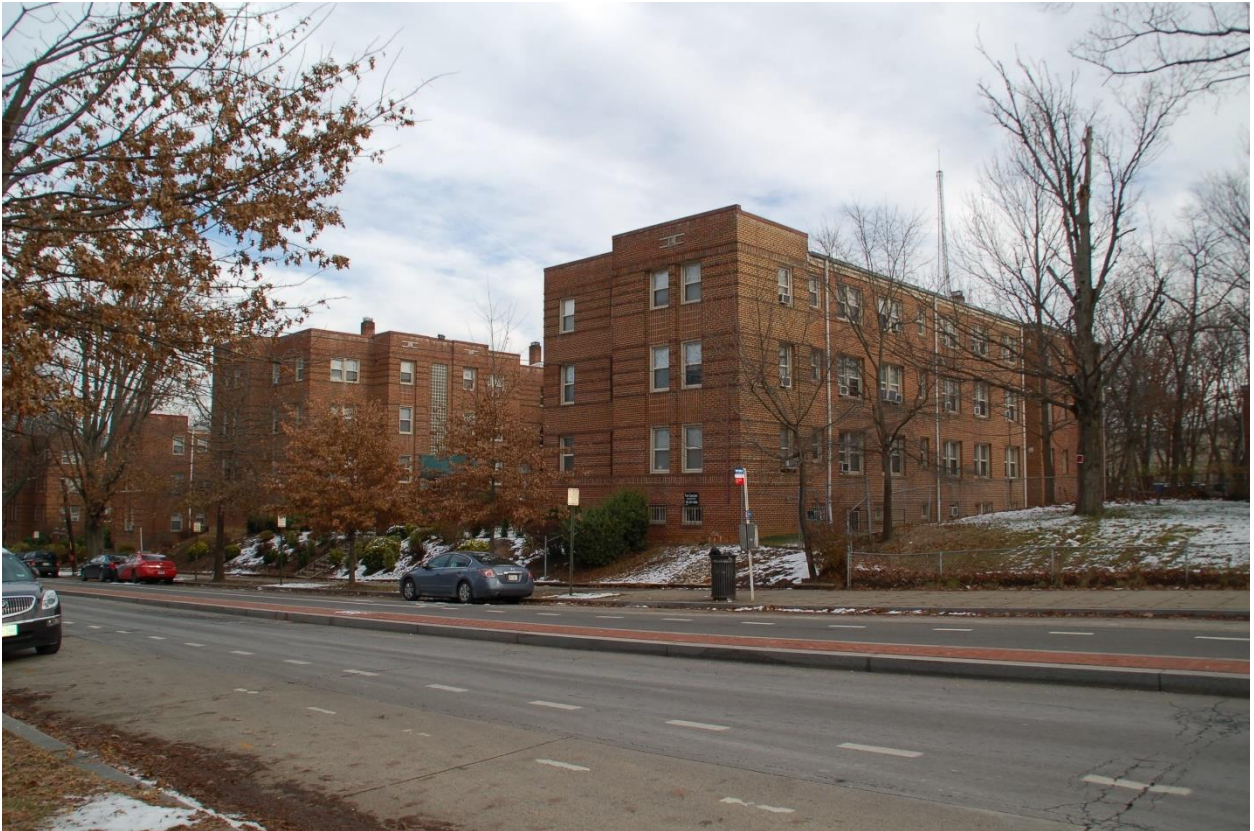
Façade and south elevation of south building, view northeast from west side of 14th Street.
1 of 17.

The center section of each of the two brick-faced buildings is nine bays wide on the 14th Street elevation with a three bay wide and one bay deep center projection demarcating the main

entrance. The flanking wings have five bays each. The main entrances are projected out three bays across and one bay deep, marked by curved canopies situated over several concrete steps with a curved metal handrail. The wings are further set back two bays wide and two bays deep from the center projection. The 14th Street elevation of each wing has a projection two bays wide and two bays deep. The exterior walls are constructed of brick laid in six-course common bond with five rows of brick string courses running horizontally between the windows on the 14th Street (west) elevation. Each building has an EPDM roof behind a shallow parapet.

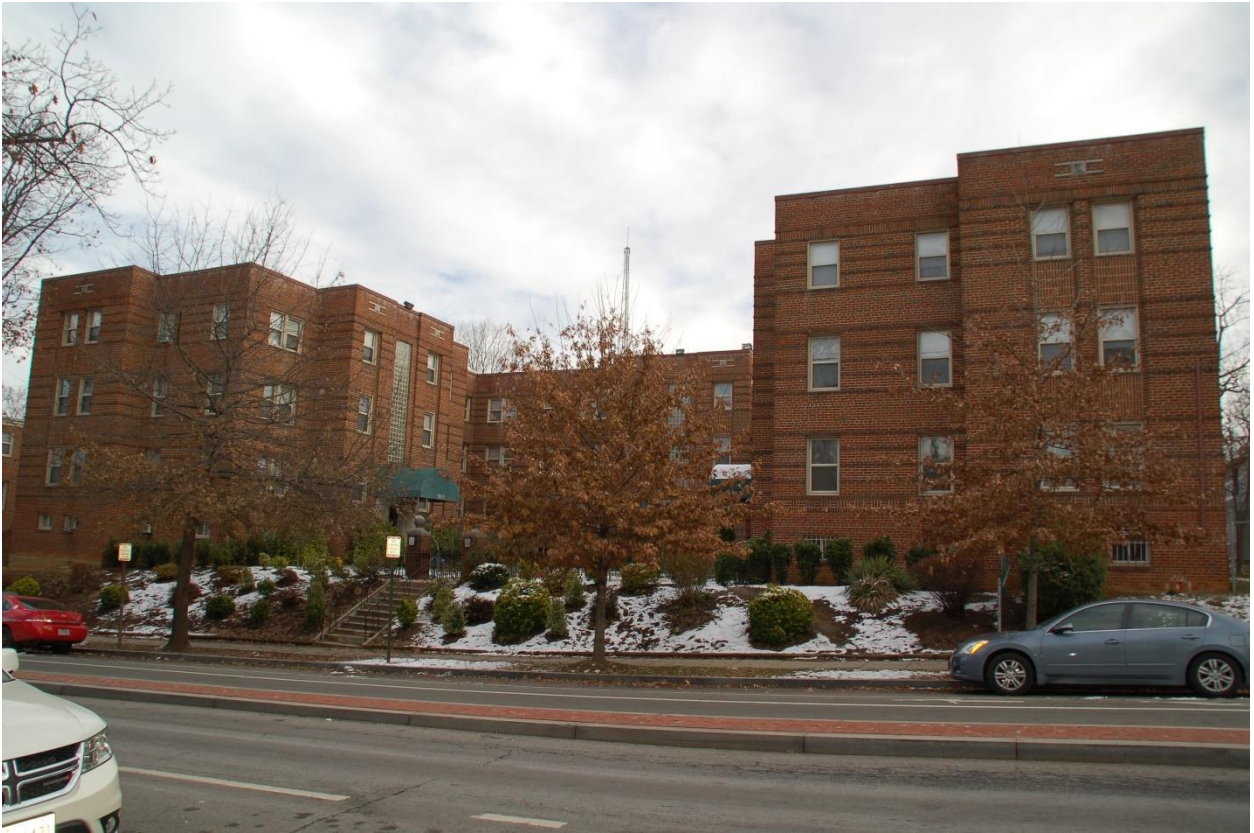
2 of 17.

Façade of south building, view northeast from west side of 14th Street.

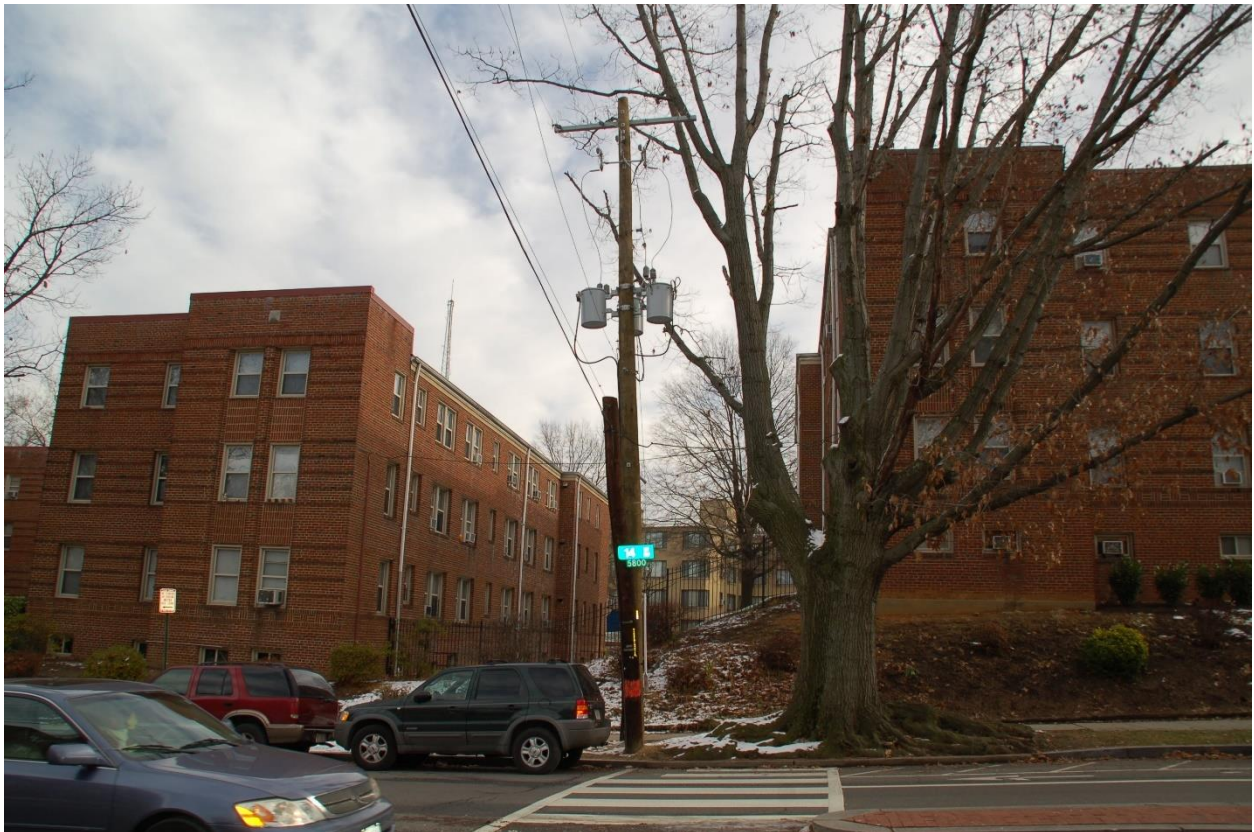
From left to right: façade and south elevation of north building; embankment between the two buildings; north end of façade of north building; view east from west side of 14th Street.
3 of 17.

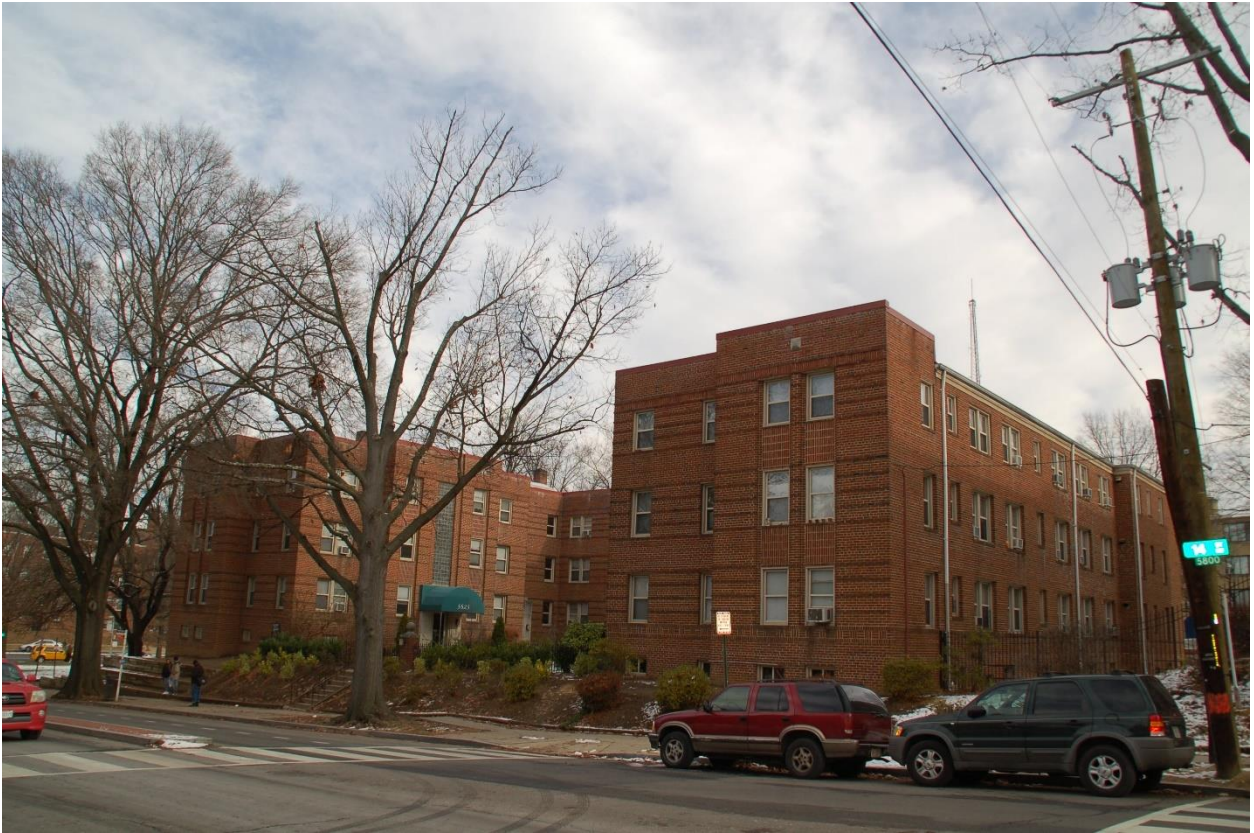
Façade and south elevation of north building; view northeast from west side of 14th Street.
4 of 17.

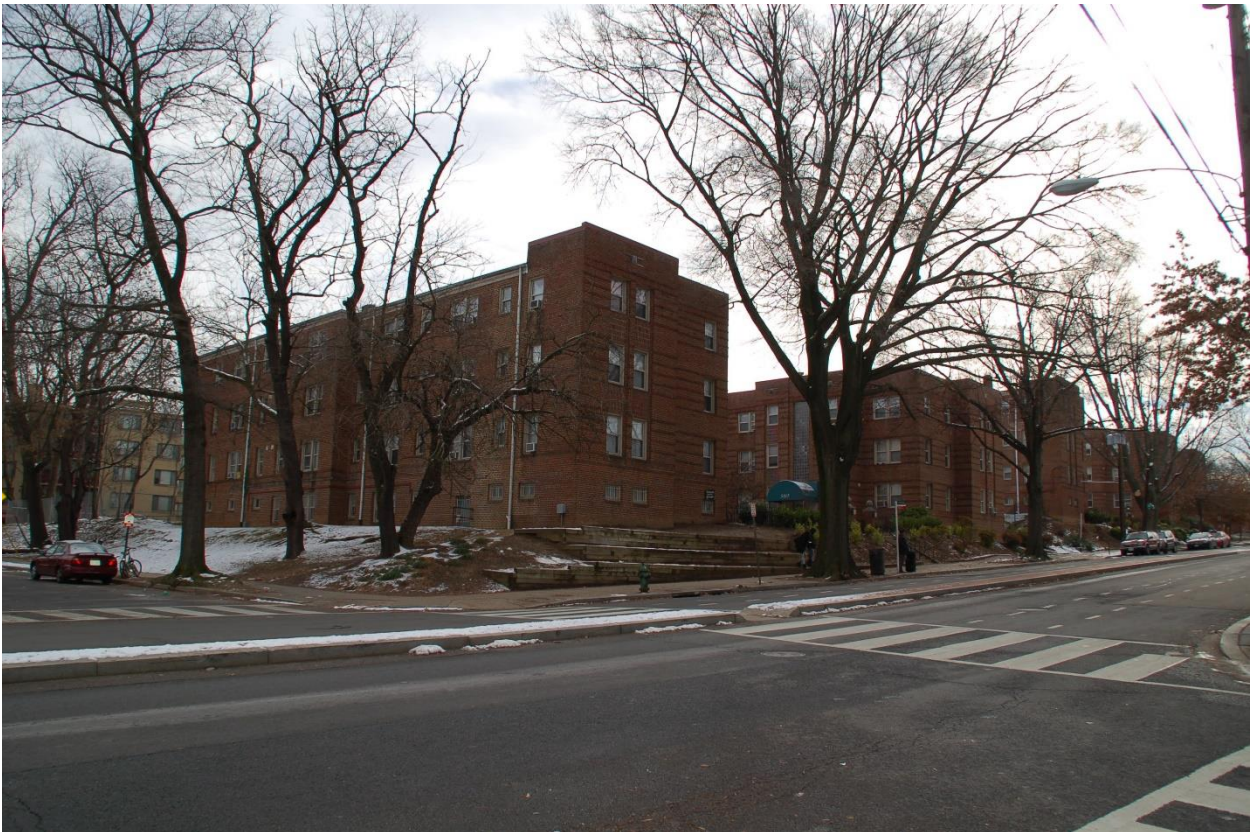
5 of 17.

North elevation and façade of north building; façade of south building at far right; view southeast from corner of Missouri Avenue and 14th Street.

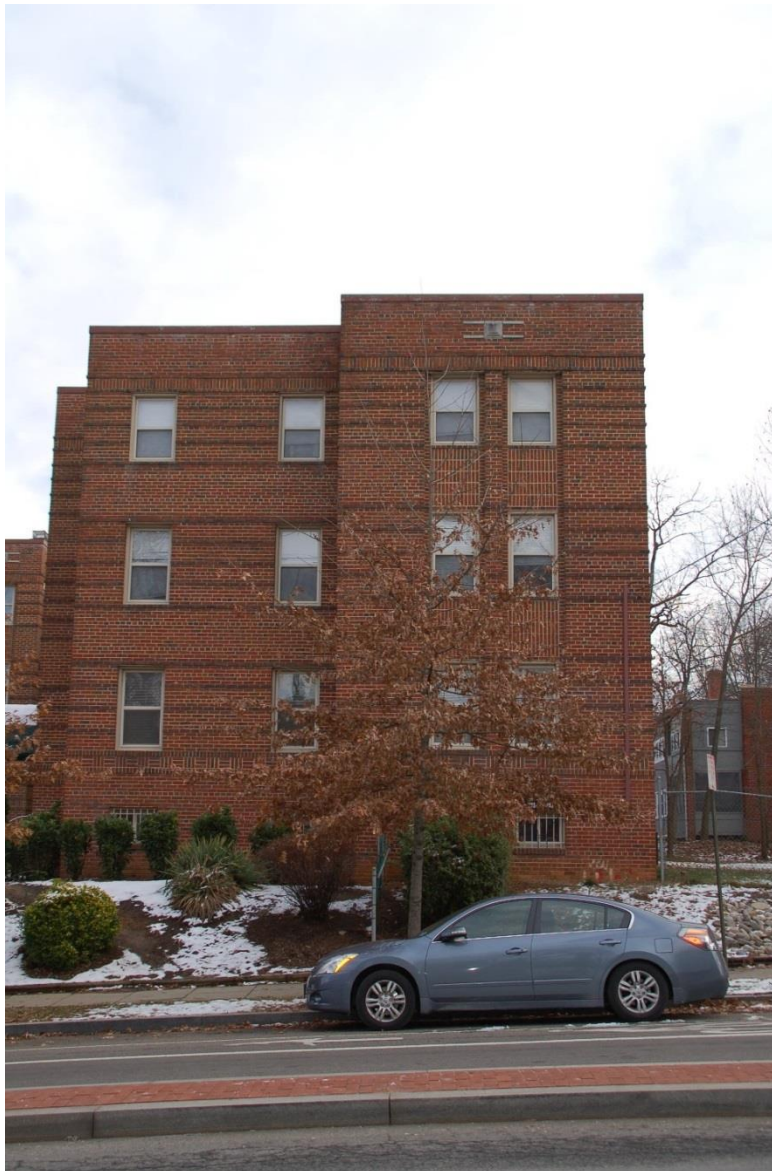
6 of 17.

South building, detail of façade wings, showing brick ornamentation (typical of both buildings).

Each projecting entrance bay features a relatively simple, one-story concrete surround and a single-leaf metal and glass door. Centrally above each entrance is an architrave with Art Deco geometric patterns; non-historic green canopies obscure this detail at each of the buildings' main entrances, but the detail is exposed on the two secondary entrances. Directly above the one story surround is an inset section of glass blocks, extending vertically to the third story. The glass blocks measure six across at the main entrances and four across at the secondary. Each projection is capped with a simple stone square ornamentation contained by two, vertical stone bands. The stone ornamentation is repeated on the 14th Street elevation of the north and south wings' projections. The streamlined form and glass and metal materials used on the entrance bays reflect Santmyers's transition to a more Moderne architectural vocabulary. The three primary entrances are also flanked by a bay of inset windows. A row of weave bond, three bricks by three bricks of contrasting colors, runs below the first floor windows and is sandwiched between two rowlock brick string courses. This pattern repeats on the elevations facing the courtyard on the buildings' 14th Street elevations, and wraps around the corner to the rear elevations, extending to the first bay of single windows. The verticality of the central projections contrasts with the horizontal brick courses running between each floor of windows, a common theme in many of Santmyers's apartment buildings built after 1930, illustrating his evolving use of modern forms. A frame of five rows of soldier-course bricks vertically flanks the second and third story inset windows, capped by a sixth brick belt course row, separating the third floor from a short brick parapet. The fenestration pattern features a more classical composition by alternating two bays of single and one bay of paired one-over-one double-hung windows on the rear (north) elevations, and single one-over-one double-hung windows at the projections on the 14th Street elevations. All windows are non-historic replacements. The 14th Street and interior courtyard elevations feature brick header sills and brick stretcher lintels. The rear elevations feature brick header sills, but overall far less ornamentation than the 14th Street elevation. The rear elevations of the wings have eleven bays roughly divided in half by a shallow one bay by six bays setback, marked by a projecting chimney stack.

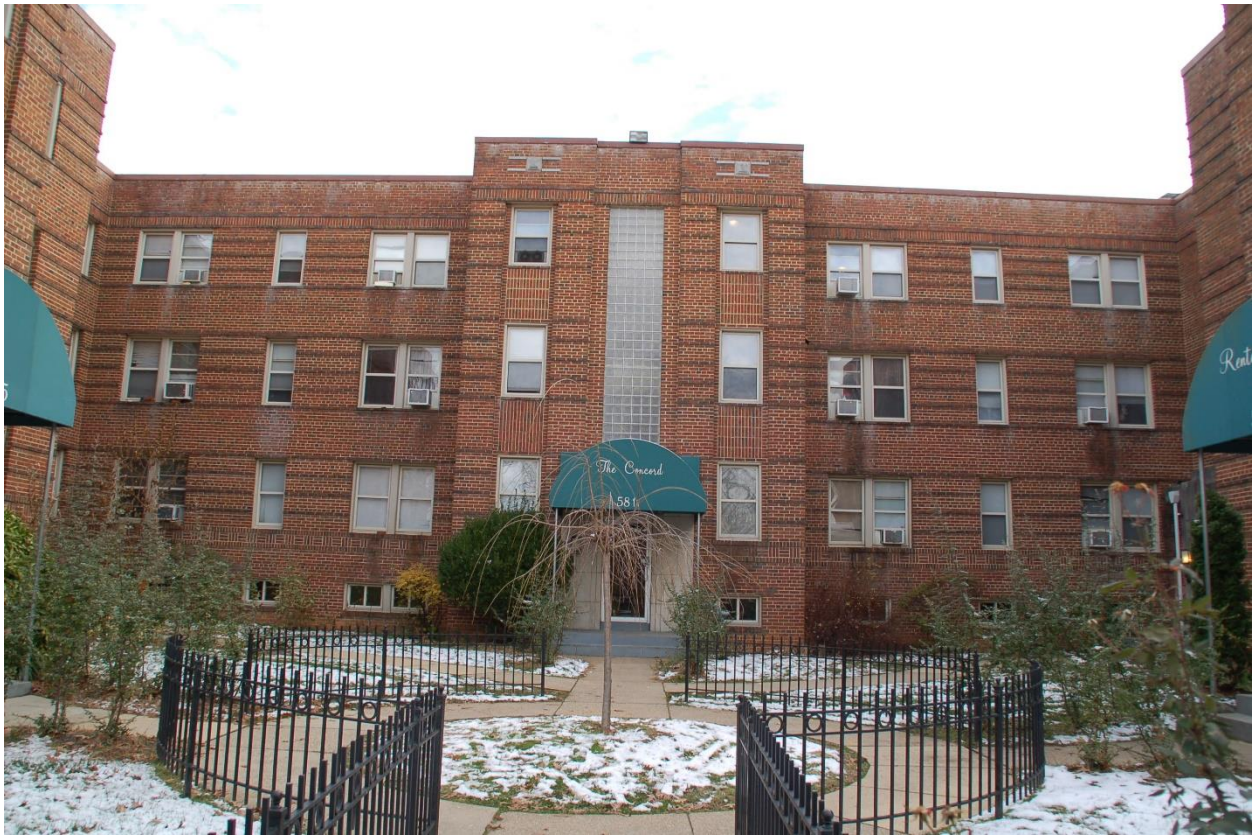
7 of 17.

South building façade, view east from within courtyard (typical of both buildings).

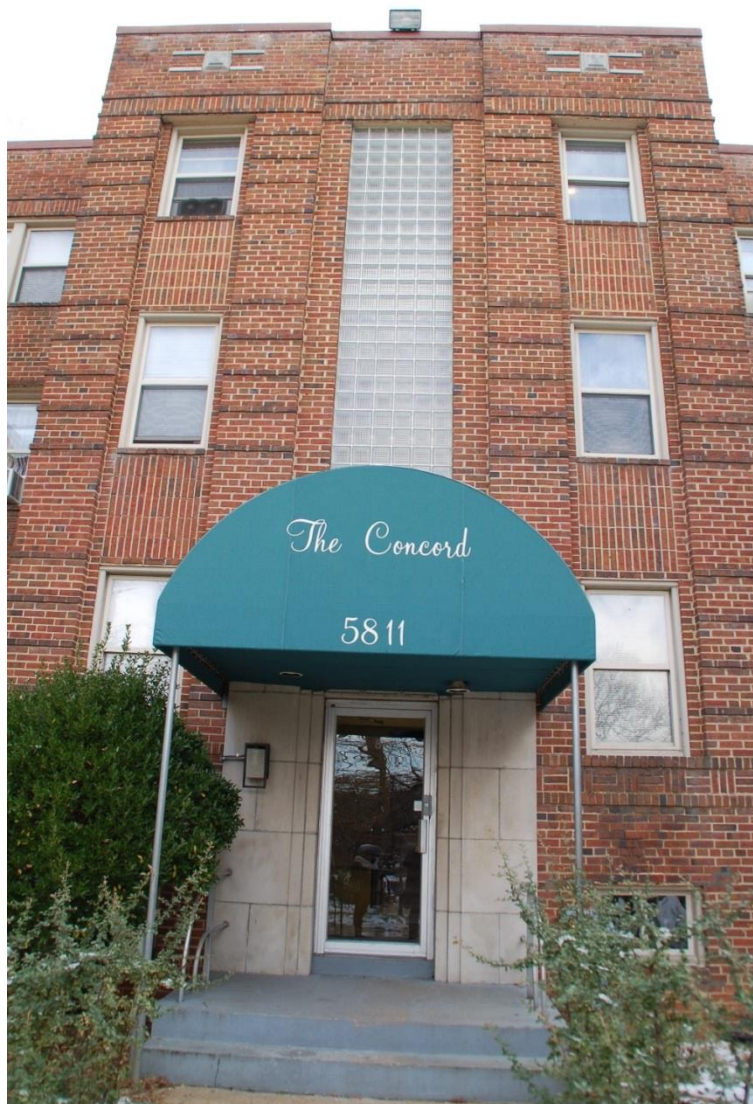
8 of 17.

South building façade, view east to west elevation from within courtyard, detail of a primary entrance (typical primary entrance of both buildings).

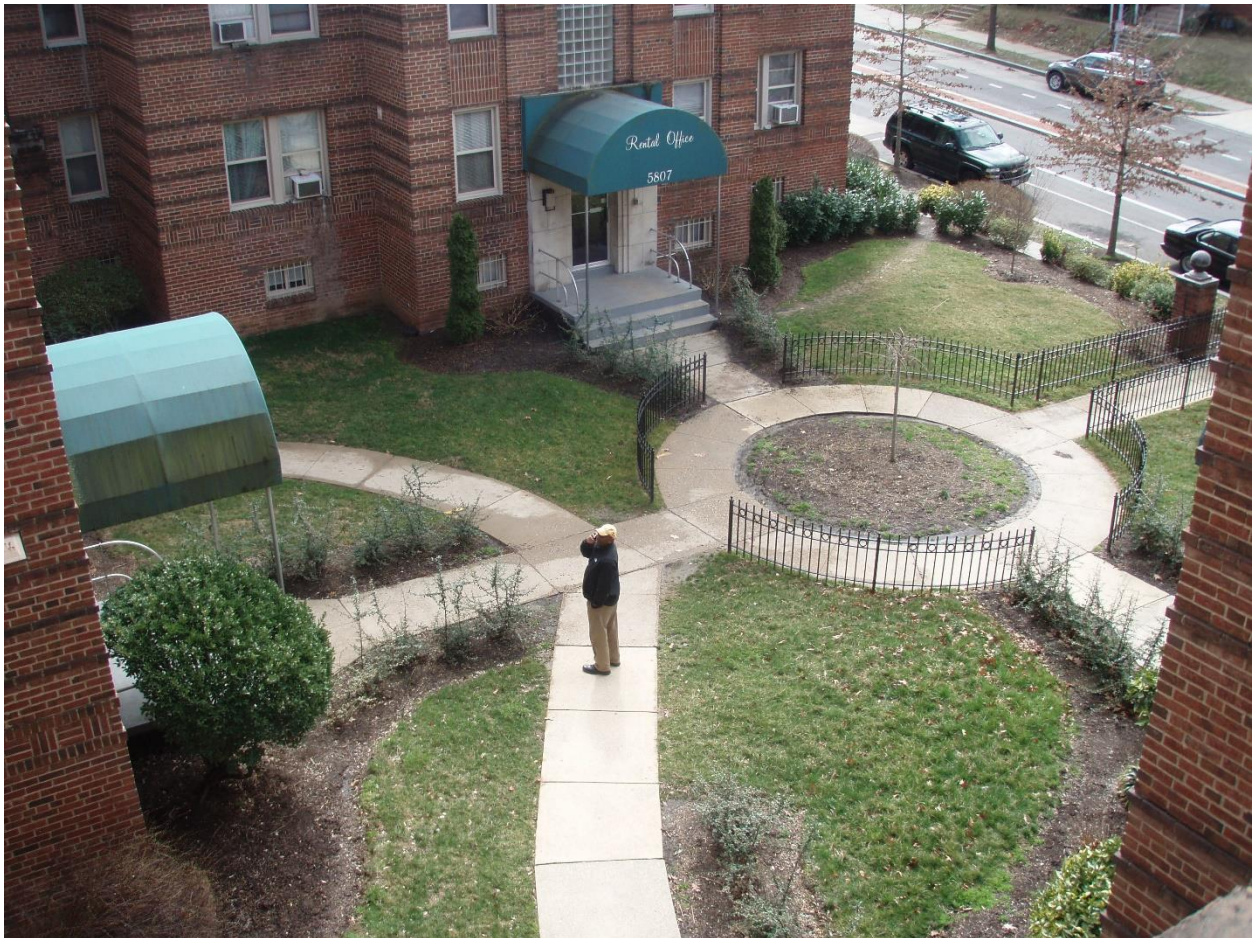
10 of 17.

South building, view of circulation courtyard, looking southwest from roof (typical of both buildings).

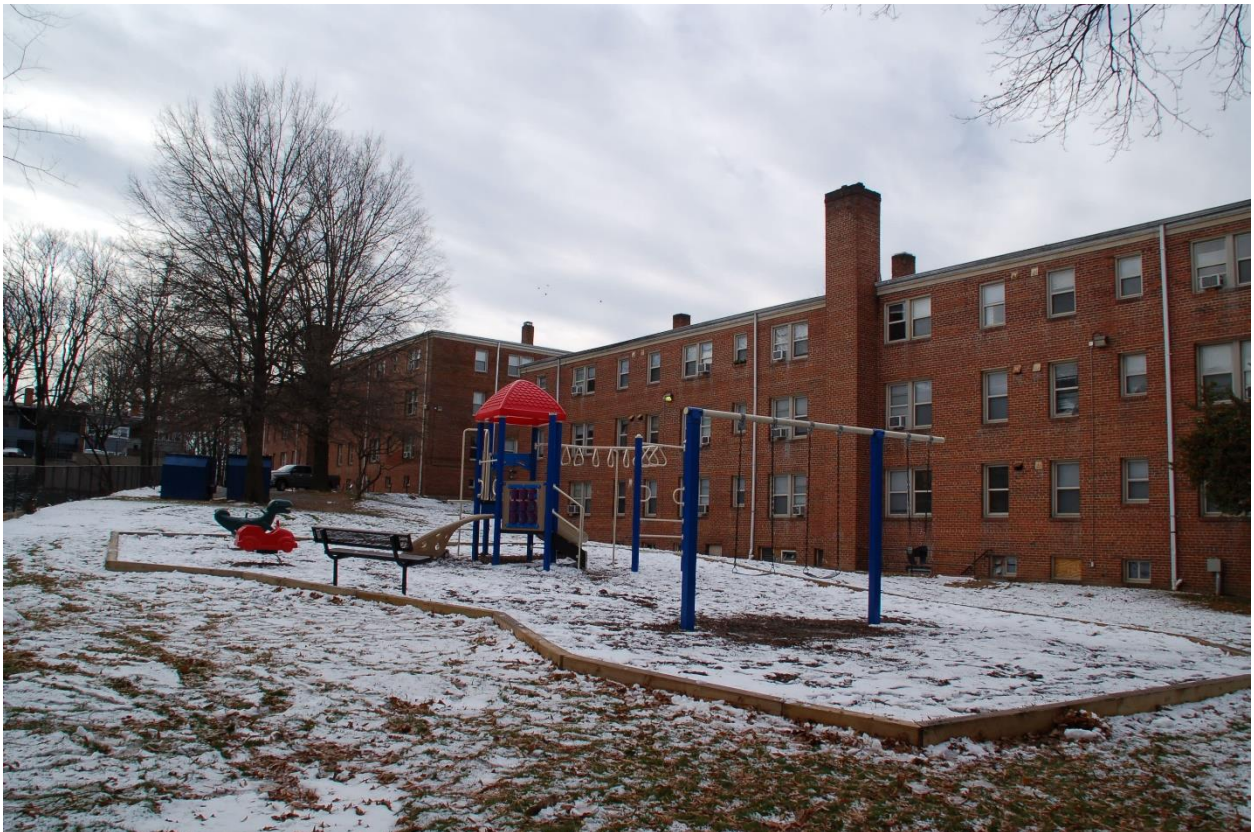
11 of 17.

West (rear) elevations of buildings (south building at far left; north building at right), view southwest from rear yard and tot lot.

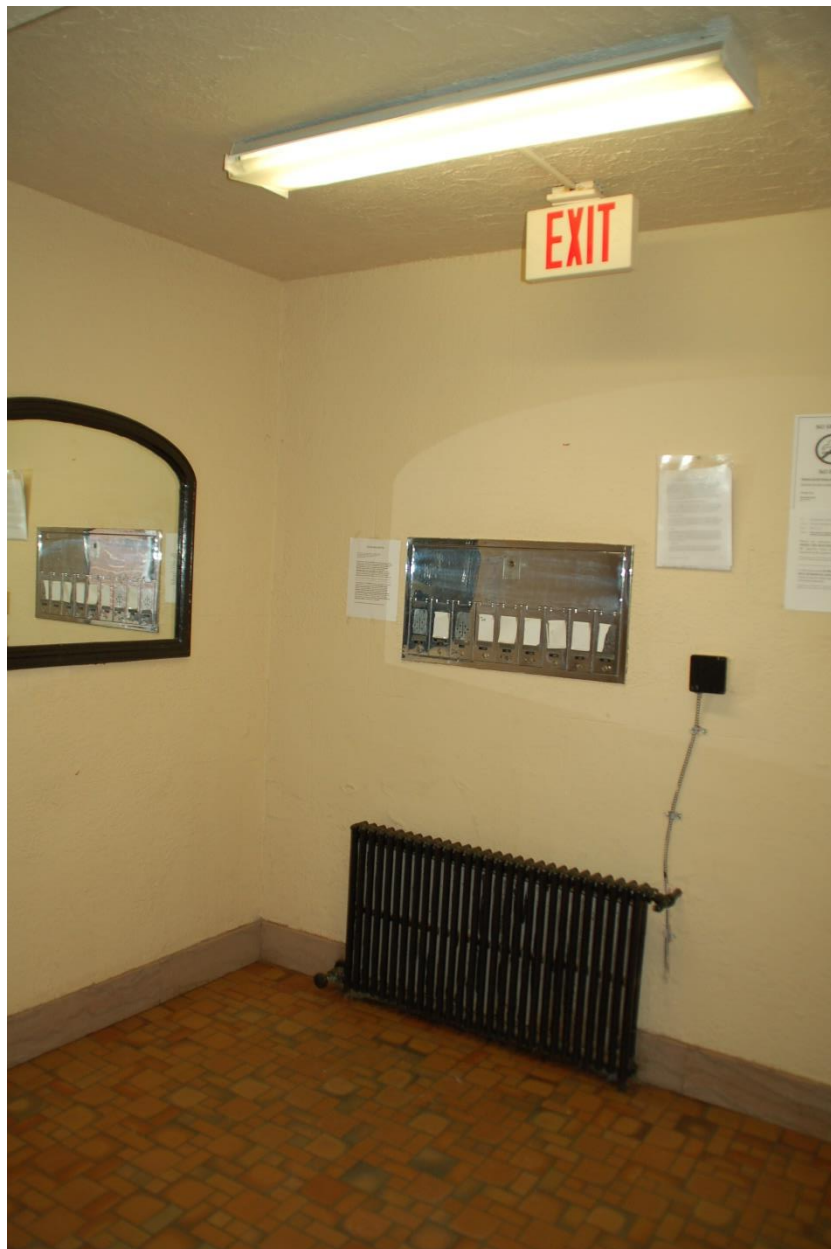
Entry foyer with mailboxes; painted walls and ceiling with stucco-like application is evident. This particular foyer retains original tile flooring and marble base (typical of some foyers).
12 of 17.

Interior alterations are largely at the cosmetic level. Entry vestibules have received, in most cases, modern tile flooring; the stair treads have also been replaced in many instances. Most units have received updated kitchens, likely in the 1990s, including new flooring finishes and cabinetry; bathroom vanities, toilets and some bathroom flooring and shower tiling has also been replaced.

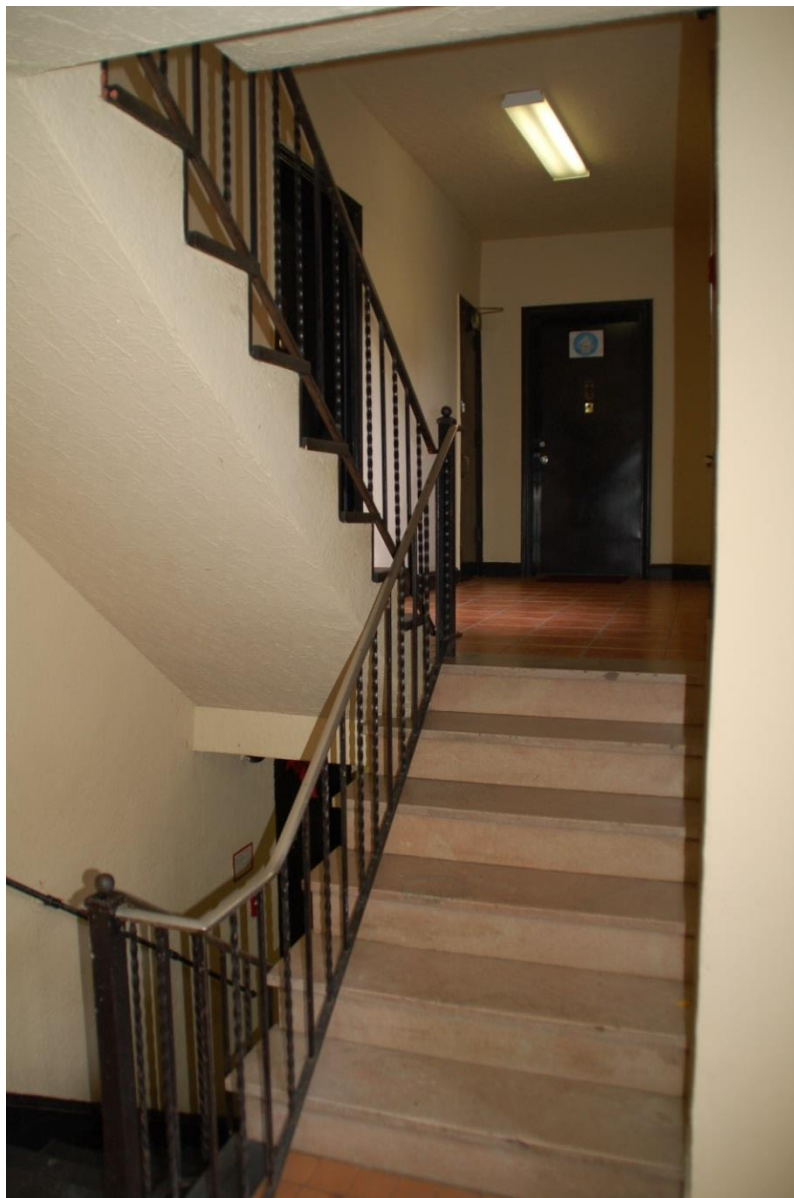
13 of 17.

View of stairs and upper floor landing. This stair, unlike most, retains original marble treads.
Upper floor landing has received replacement tile (typical).

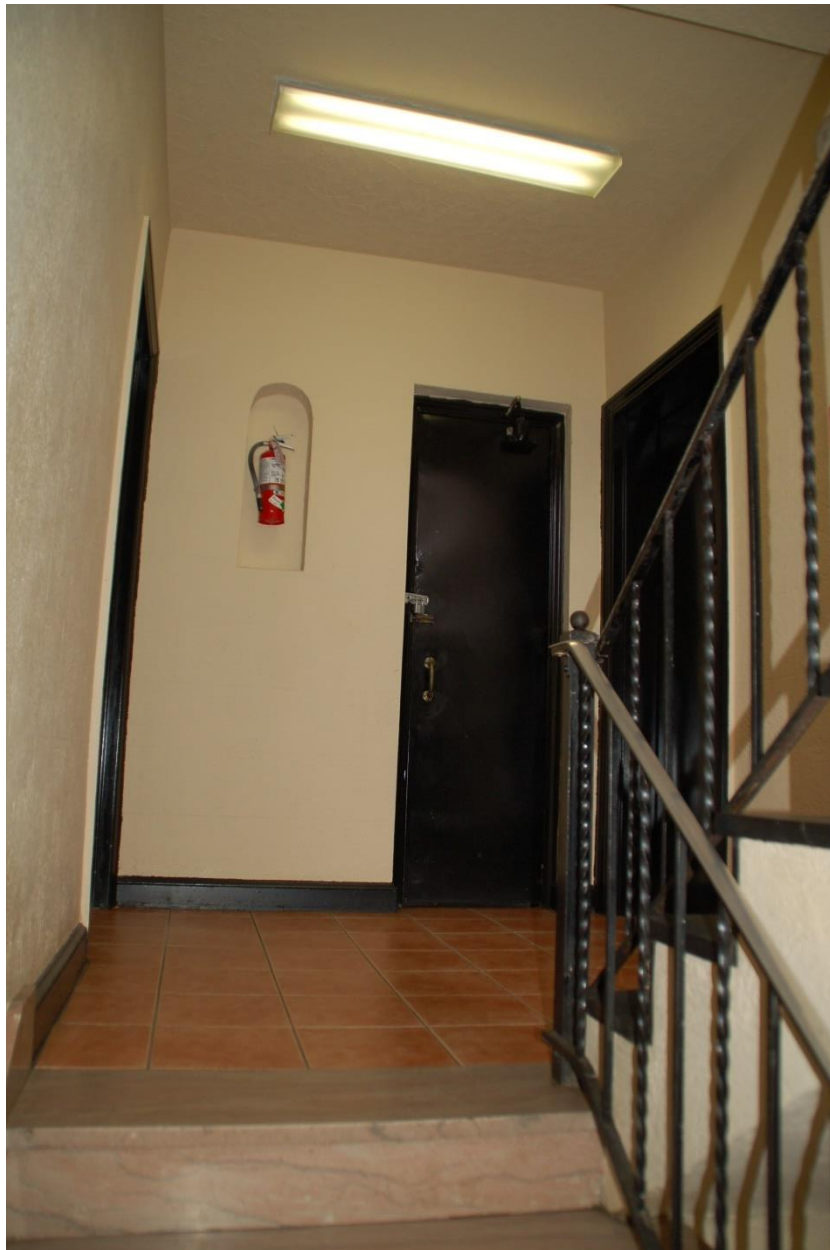
Upper floor landing with round-arched niche for fire-extinguisher (typical of most landings).
14 of 17.

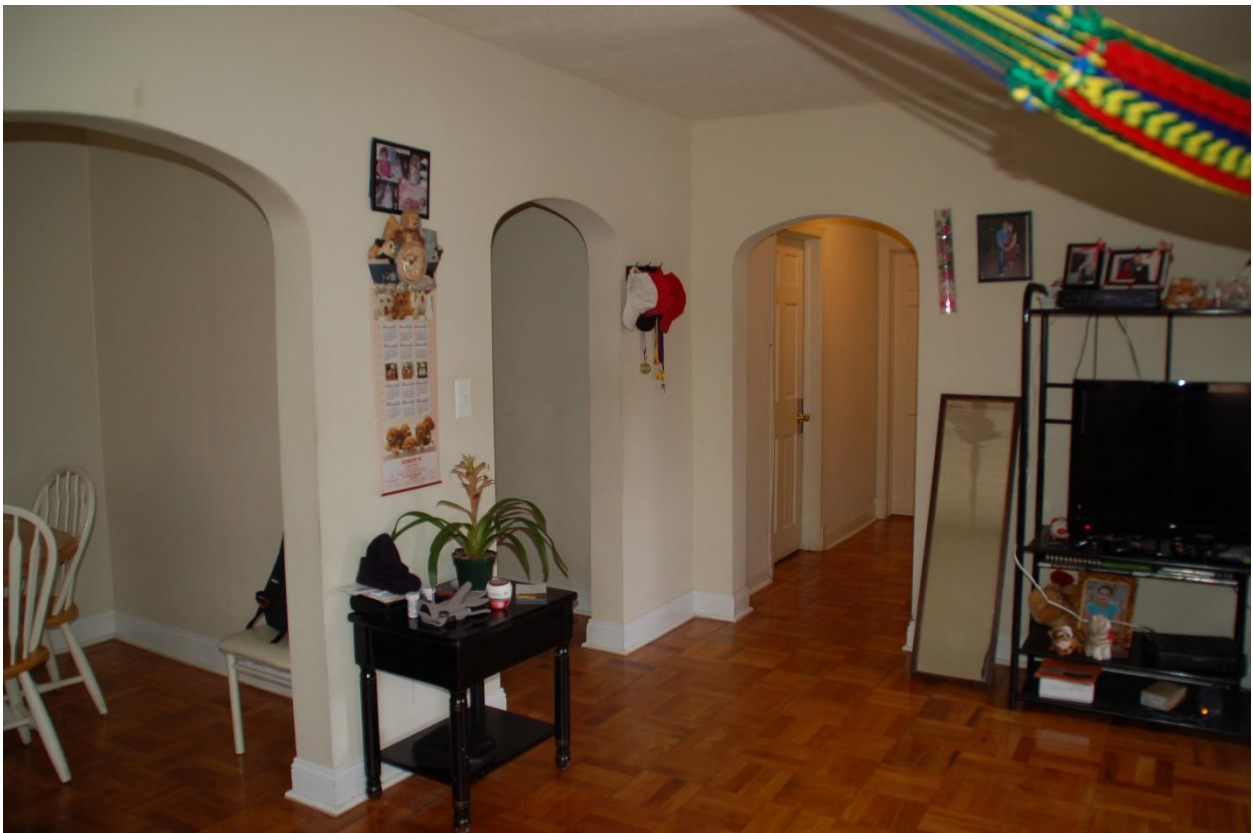
Living area within unit. Round arches delineating the spaces and parquet flooring (typical).
15 of 17.

The interior layout appears to remain essentially original to the building, with the unit count changing only from 80 to 81 units. Additionally, the interior continues to reflect accents of Spanish Colonial Revival-influence, popular through the 1930s. The common areas of entry vestibules and landings have painted finished walls and ceilings featuring a stucco-like application; the stairwells' thin, wrought-iron railings remain, although handrails appear to have been replaced. Round-arched niches at landings hold the fire-extinguishers. Within units, the architectural features of round arches delineate openings between living spaces and hallways, for instance; alcoves are extant in some bedrooms, and recessed hexagonal arches that frame bathtubs remain.

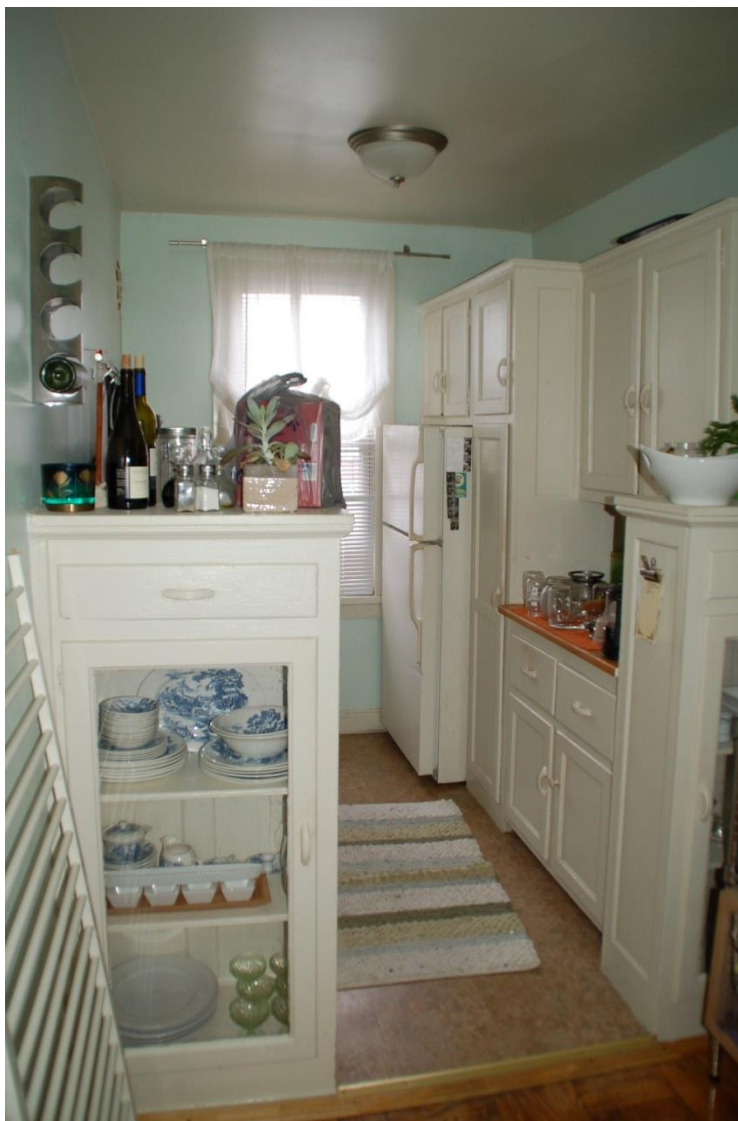
16 of 17.

Unit kitchen with historic cabinetry.

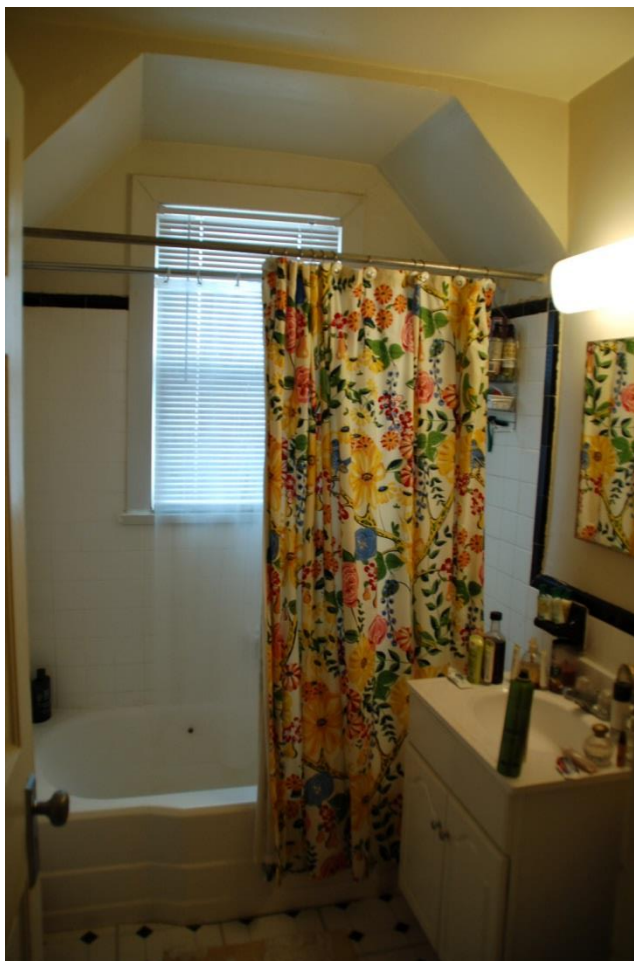
17 of 17.

Unit bath showing the hexagonal arch framing the bathtub (typical).
