# National Register of Historic Places Inventory—Nomination Form

Type all entries—complete ap	plicable sections		
1. Name			hadro Janii ani
nistoric First Missionar	y Baptist Church		15- 1 10 1 2 5 6 I
and/or common N/A

2. Location			
street & number 7th at Ga	ines (701 S. Gaines)	N,	/A not for publication
city, town Little Rock	N/A vicinity of	atte do recivil p	E 78-7 61.21)
state Arkansas	code 05 county	Pulaski	code 119

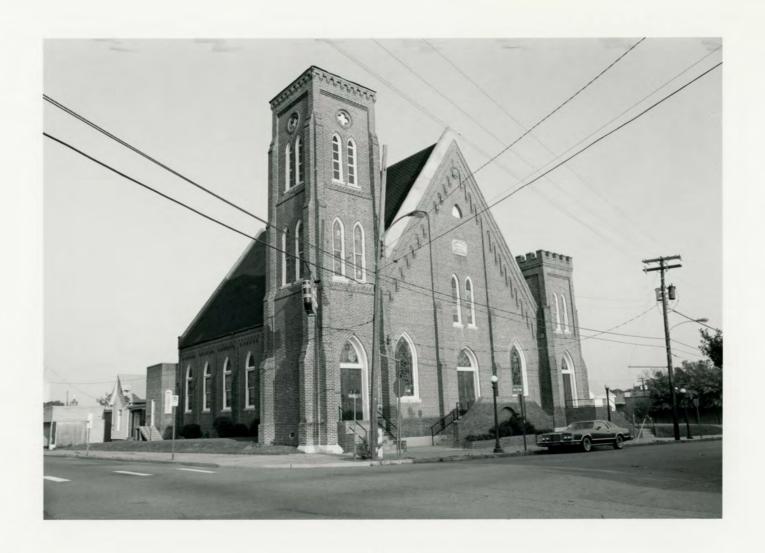
First Missionary Baptist Church Little Rock, Pulaski County Alice Jones, photographer May, 1983 Negatives filed at AHPP View from the Northwest

The First Missionary Baptist Church is an outstanding 1882 example of the application of the Gothic Revival to ecclesiastical architecture. Traditional in plan, the church features rectangular sanctuary with square towers at each corner of the front facade. Beautifully detailed throughout, the brick structure is highlighted by decorative corbeling on three of its four elevations.

Located at the southeast corner of Seventh and Gaines Streets in downtown Little Rock, the 101 year old First Missionary Baptist Church is a Gothic Revival structure of red brick with wood and stone trim. The church has a rectangular plan, with a square buttressed tower at each corner of the front facade. A steeply pitched gable roof, originally covered with slate, was covered with asbestos shingles in the early 1960's. A stone parapet embellishes each gable end. The most distinctive exterior detail is the corbeled brickwork along the cornice line of each of the four principal elevations. The sanctuary is seven bays deep, with six pointed arch stained glass one-over-ond double-hung windows with transoms and brick surrounds, alternating with buttresses on each side elevation (north and south). All windows, with the exception of those on the rear elevation, are of stained glass and have, through the years, been donated by members and organizations of the church. While some of the windows have been relettered, repainted or repaired following tornado damage, none has been replaced. The front elevation (west), which is a gable wall, consists of a center entrance, with an entrance in each projecting corner tower. All three entrances have double doors with stained glass transoms. Buttresses extending the full height of the elevation flank the center entrance. Large fixed stained glass windows, positioned between the center entrance and two corner towers were installed and dedicated in 1919. A pair of lancet windows are located above the center entrance. A stone plague commemorating the building's date is positioned above the two windows. Railed steps lead to each tower entrance, while reconstructed double stairs, original in placement and configuration, are located in front of the principal center entrance. The three-story belfry tower, positioned at the southeast corner of the front facade, originally had a pyramidal spire. Pairs of lancet windows pierce the north, south and east sides of the belfry. Those on the second floor are double-hung. The third story windows are fixed with five lights each. A quatrefoil fenestration with round brick surround is positioned in the wall above the windows. The west side of the belfry has a single round third floor window. The twostory flatroofed tower at the north corner has identical fenestrations and a crenellated parapet. Located at the rear of the church is a one-story projection that consists of a center gable roof, with a flat-roofed section with parapet on either side. Side entrances are located at the

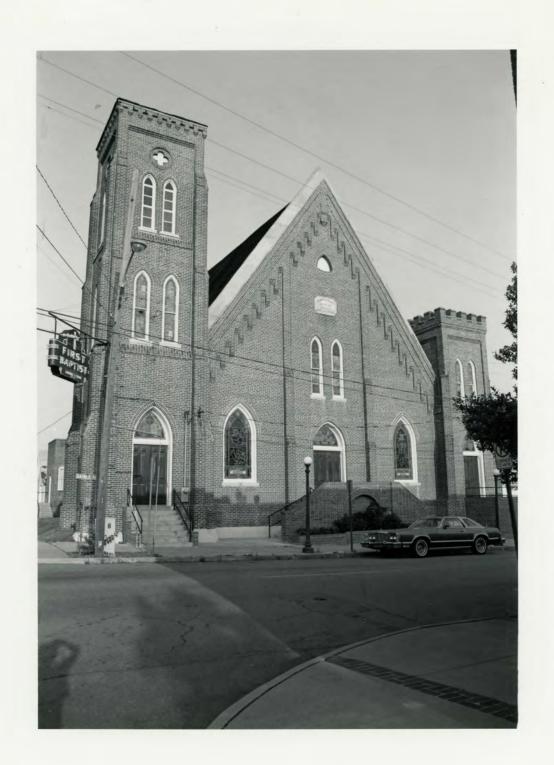
First Missionary Baptist Church Little Rock, Pulaski County Alice Jones, photographer May, 1983 Negative filed at AHPP View from the West

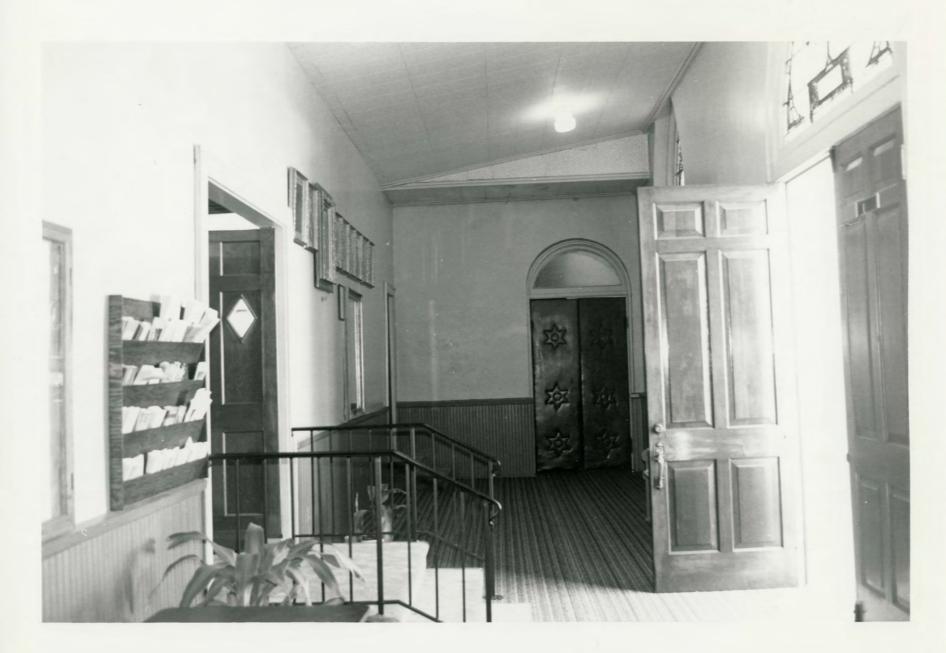
First Missionary Baptist Church Little Rock, Pulaski County Alice Jones, photographer May, 1983 Negative filed at AHPP Interior

The vestibule was created by sectioning off a portion of the original sanctuary. Stairs in each corner tower lead to the balcony which is supported by paneled square wood columns and exaggerated scroll brackets. Three doors lead from the vestibule to the sanctuary. Because of poor acoustics and heating problems, the floor of the sanctuary has been raised and the ceiling lowered. The pulpit, which faces west, is positioned at the edge of the elevated choir stand, which at some point was added. Located in the center of the choir stand is a pipe organ installed in 1915. The original rectangular bapistery is directly behind the alter and beneath the choir stand. The original pews of the church have been replaced by two sections of new pews. Those removed are used in the Sunday School building and as supplemental seating throughout the church. To the rear of the sanctuary, on either side of the choir stand, are doors leading to the rear of the building. The door to the right leads to the Pastor's study, while the choir room and a restroom are reached through the left door. When built, the church possessed the modern conveniences of fans and steam heat.

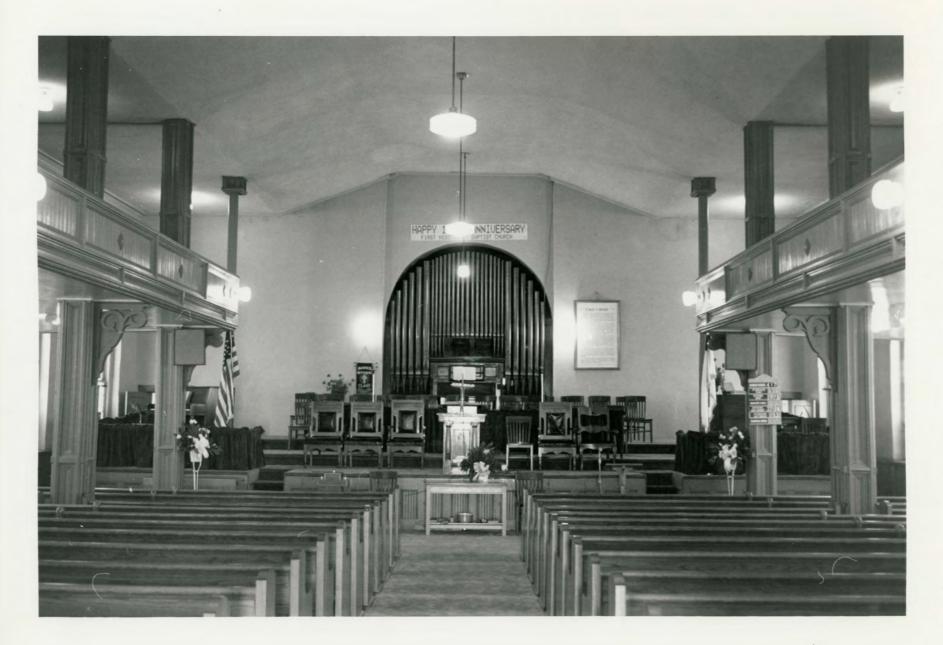
First Missionary Baptist Church Little Rock, Pulaski County Alice Jones, photographer May, 1983 Negative filed at AHPP Interior

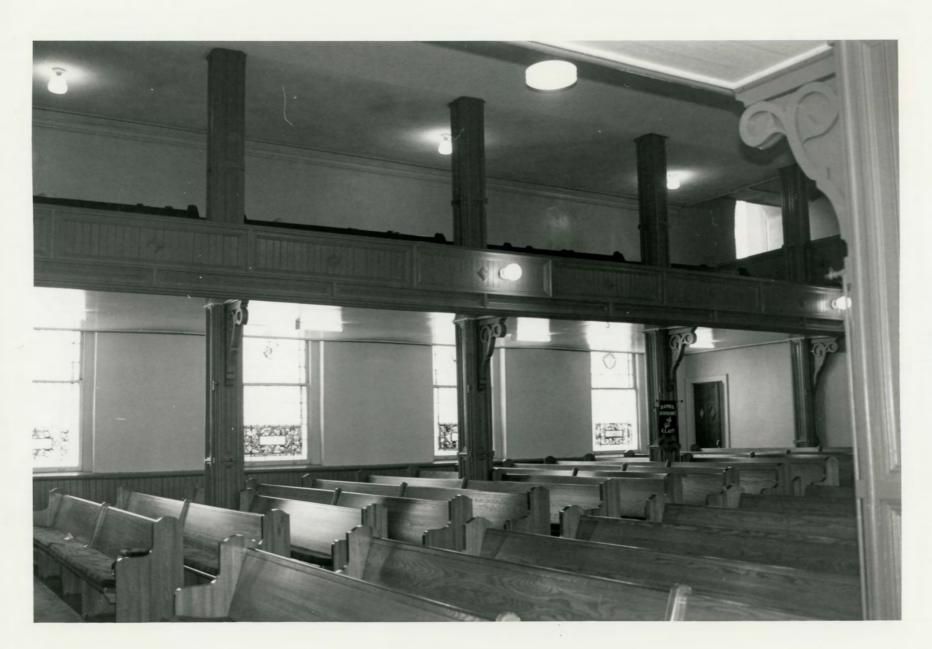
First Missionary Baptist Church Little Rock, Pulaski County Alice Jones, photographer May, 1983 Negative filed at AHPP Interior
