18. cont. :

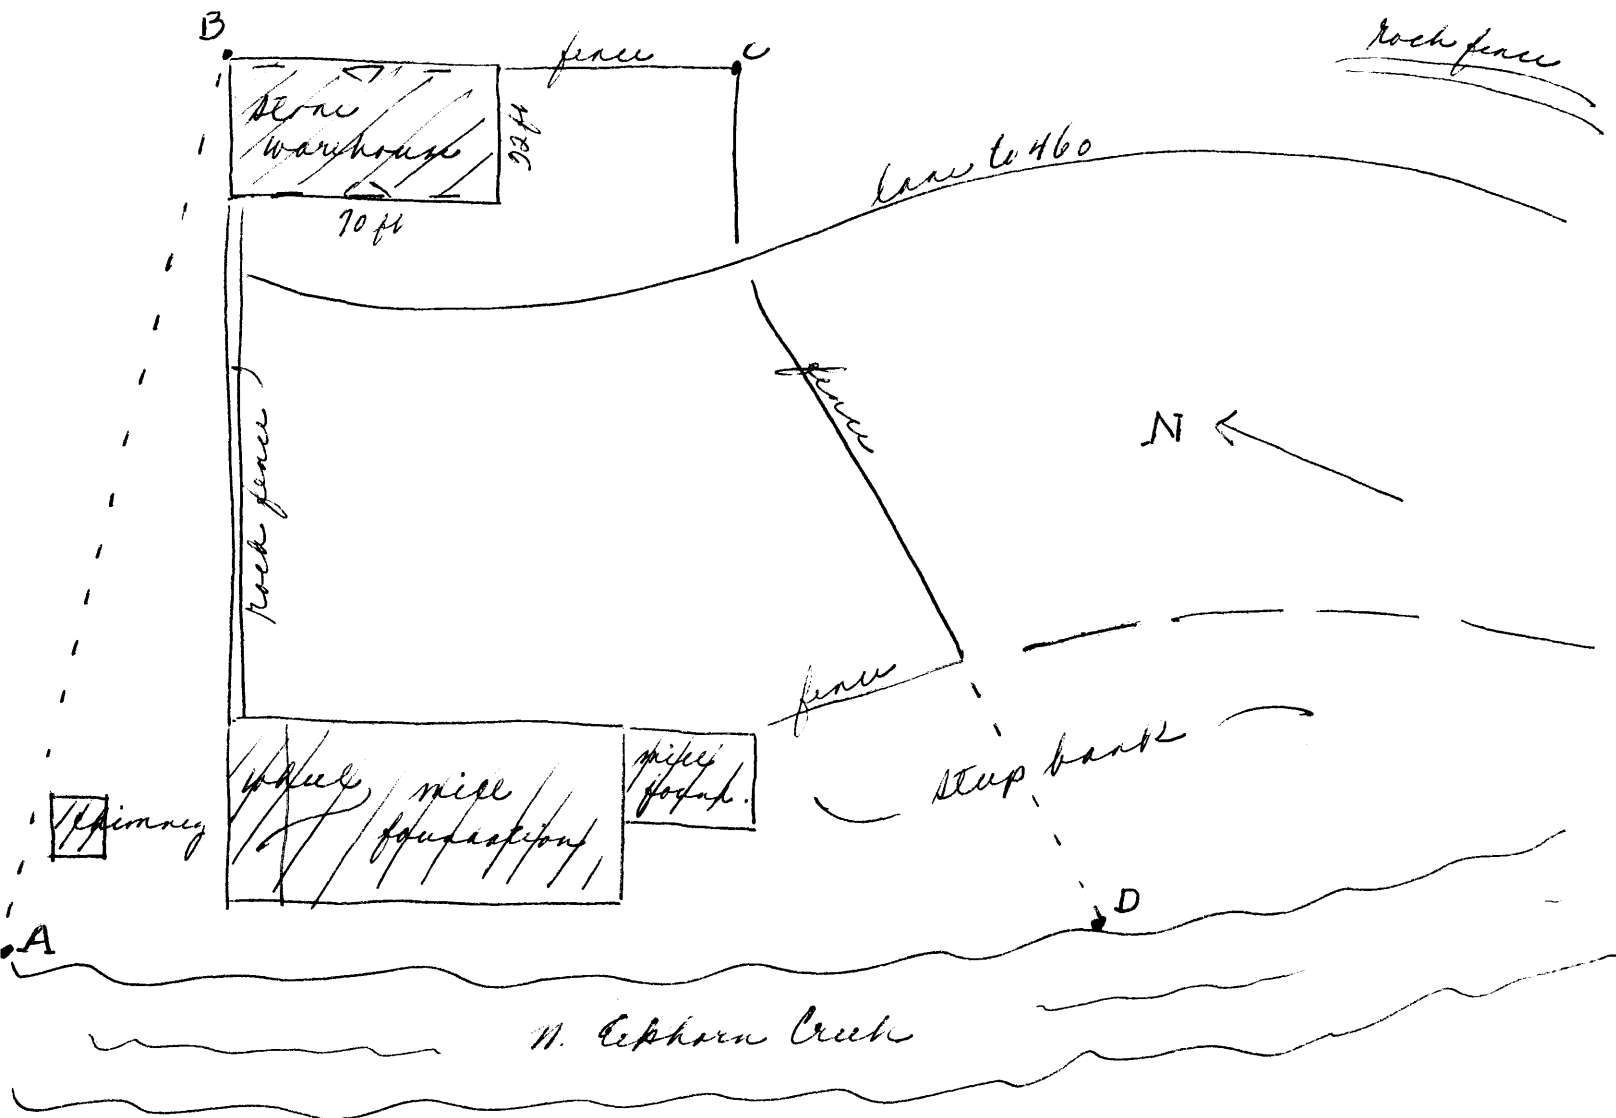
SKETCH MAP OF SITE SHOWING BOUNDARIES AND KEY BUILDINGS AND FEATURES WITH NORTH ARROW.

Beginning at A on the creek bank 15 ft N of the stone chimney, thence E 200 ft to the NE corner of the warehouse, thence along back wall of warehouse and fence 5132 ft to a corner post, thence W and SW 210 ft to the creek, thence W creek NW to the beginning, containing the stone warehouse, mill foundation, and chimney - about 3/4 acre.
