United States Department of the Interior
National Park Service
National Register of Historic Places Registration Form

Historic Name: Sanger Brothers Building (1925)
Other name/site number: Meacham's Department Store
Name of related multiple property listing: N/A

Street & number: 515 Houston Street
City or town: Fort Worth State: Texas County: Tarrant
Not for publication: Vicinity:

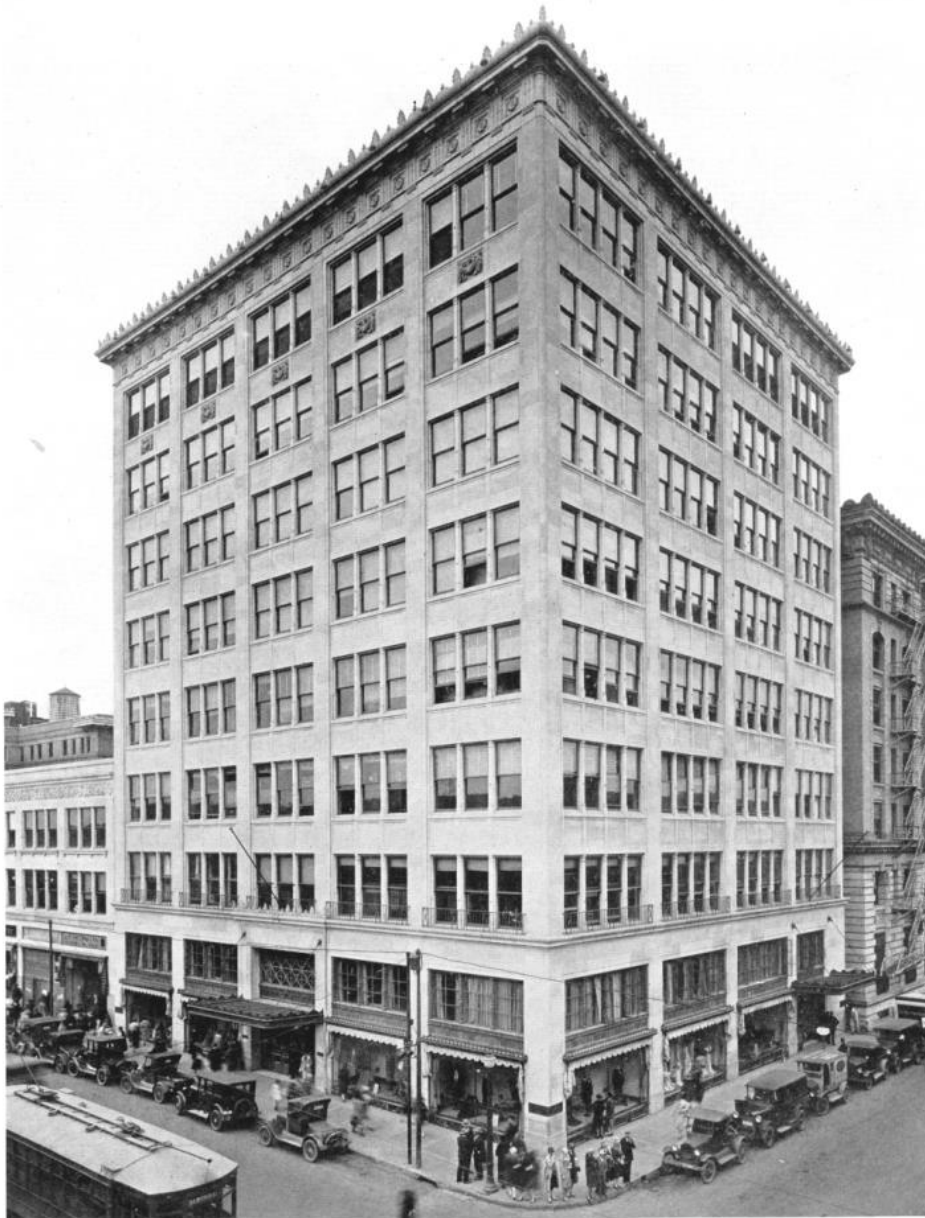
FIGURE 1
HISTORIC PHOTOGRAPH – c. 1925

DEPARTMENT STORE FOR SANGER BROS. COMPANY
Fort Worth

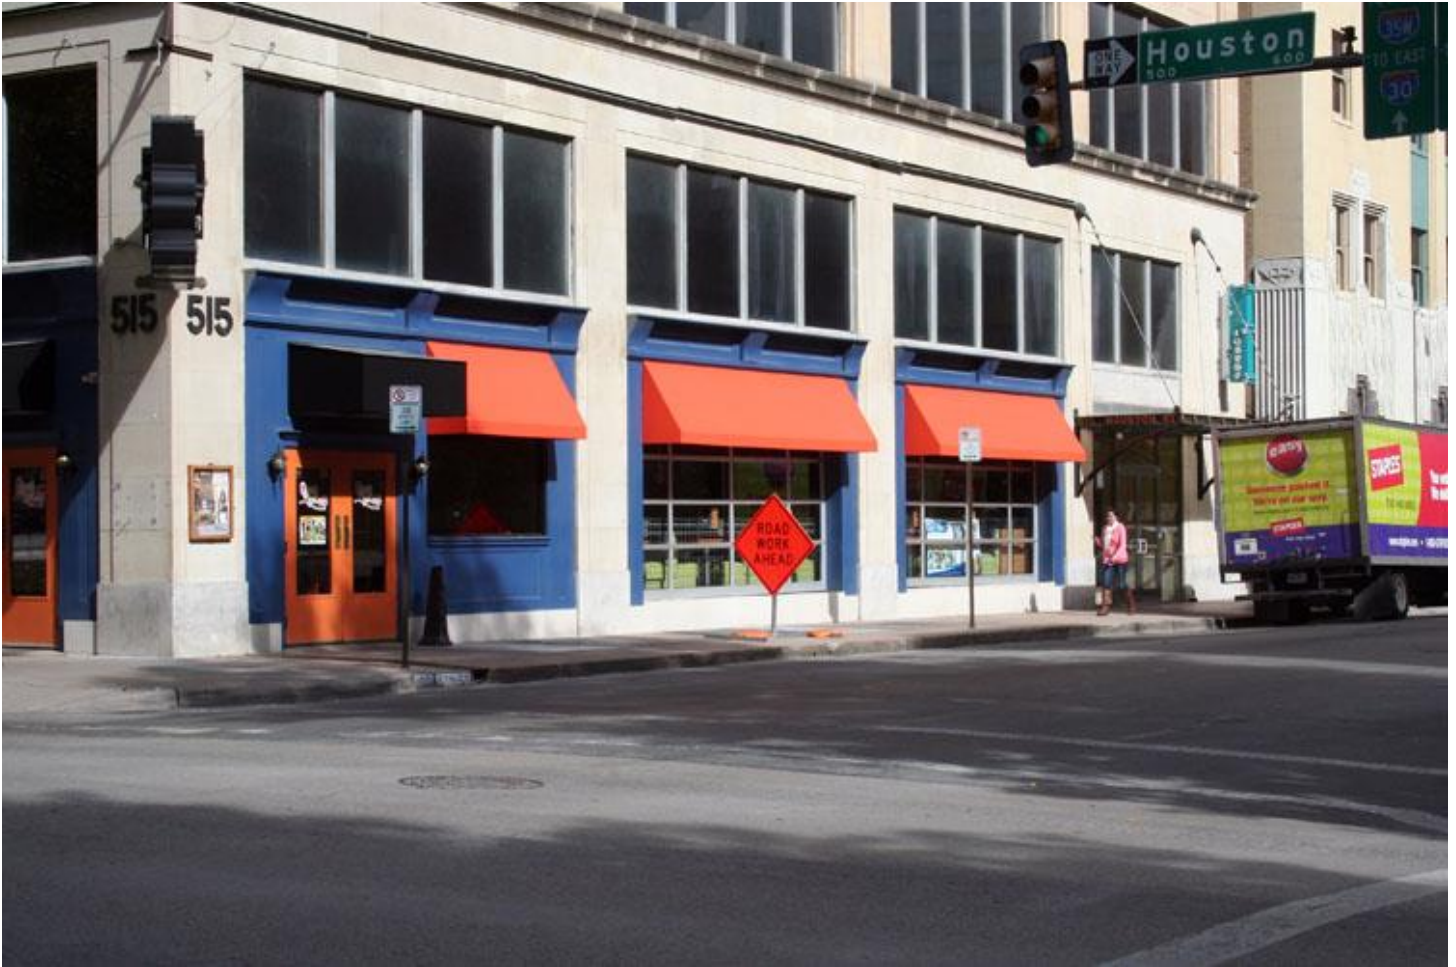
Photo 3: View of south elevation, detail of ground floor storefronts, looking east

The storefronts on the south and west elevations feature modern glazed aluminum overhead doors and painted wood surrounds with paneling and fluting. Most of the storefronts also include a projecting awning. Other fenestration throughout these elevations consists of tripartite aluminum-frame, single-pane windows with unornamented surrounds. A photograph from circa 1980 documents that these windows were in place by that point, but it is believed that they were installed as part of Meacham's mid-century renovations. Some windows include aluminum-frame transoms (with the same opening as the other windows).

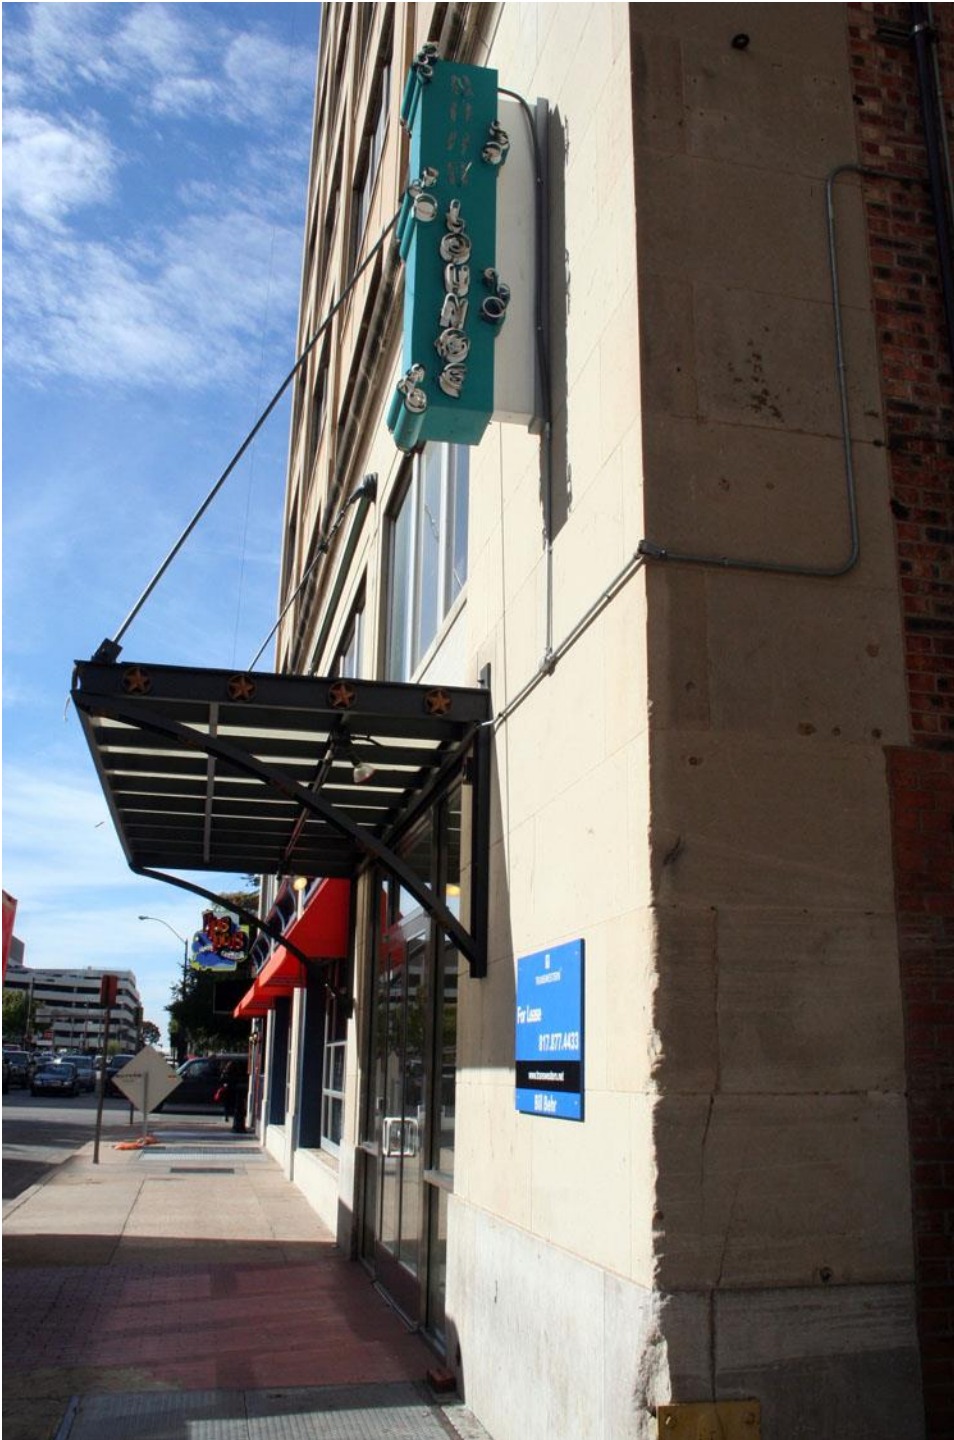
Photo 4: View of south elevation, detail of main entrance, looking west

The primary entrance is located on the south elevation, facing 5th Street, and consists of a modern compatible double-leaf bronze-frame glazed door, with large bronze-frame sidelights and transom. The entrance is demarcated with a suspended, painted metal-frame, glazed canopy which was likely installed in recent decades. At the corner of 5th and Houston Streets, the building also features two entrances to the restaurant space (one entrance on each of the south and west elevations). These secondary entrances each feature a modern compatible double-leaf, glazed, wood-frame door within a wood surround with paneling and fluting, with a projecting fabric awning over each door. A secondary entrance is also located in the northernmost bay on the west elevation and includes a recessed, single-leaf, glazed, metal-frame door and transom; a single-leaf, flush, metal door; and a metal rolling overhead door. These doors are set within a wood paneled surround. An original entrance existed on Houston Street and is denoted by cresting at the beltcourse centered above the mezzanine. The entrance doors were replaced at some point with a modern storefront.

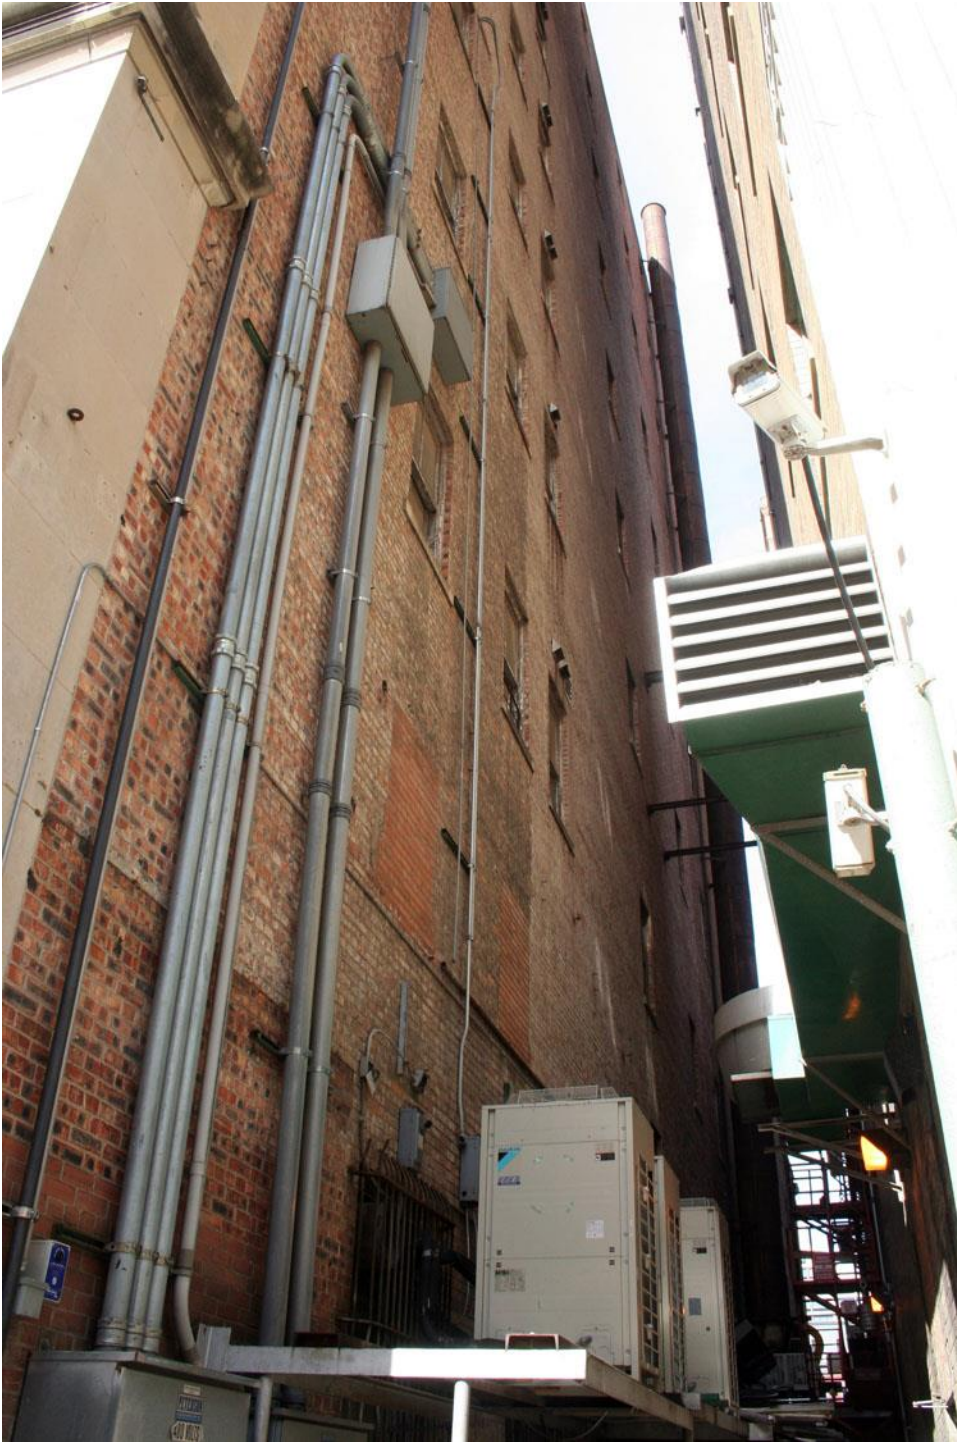
Photo 5: View of east elevation, looking north

The secondary elevations, facing east and north, consist of red brick walls. Both elevations are utilitarian in design with no ornamentation. The east elevation faces a narrow passageway that separates the subject building from the neighboring building at 512 Main Street. This passageway is occupied with mechanical equipment, and the pipes and conduits are exposed on the east elevation. The surviving windows on this elevation are original 2/2 metal framed windows with wired glass. Several window openings on the east

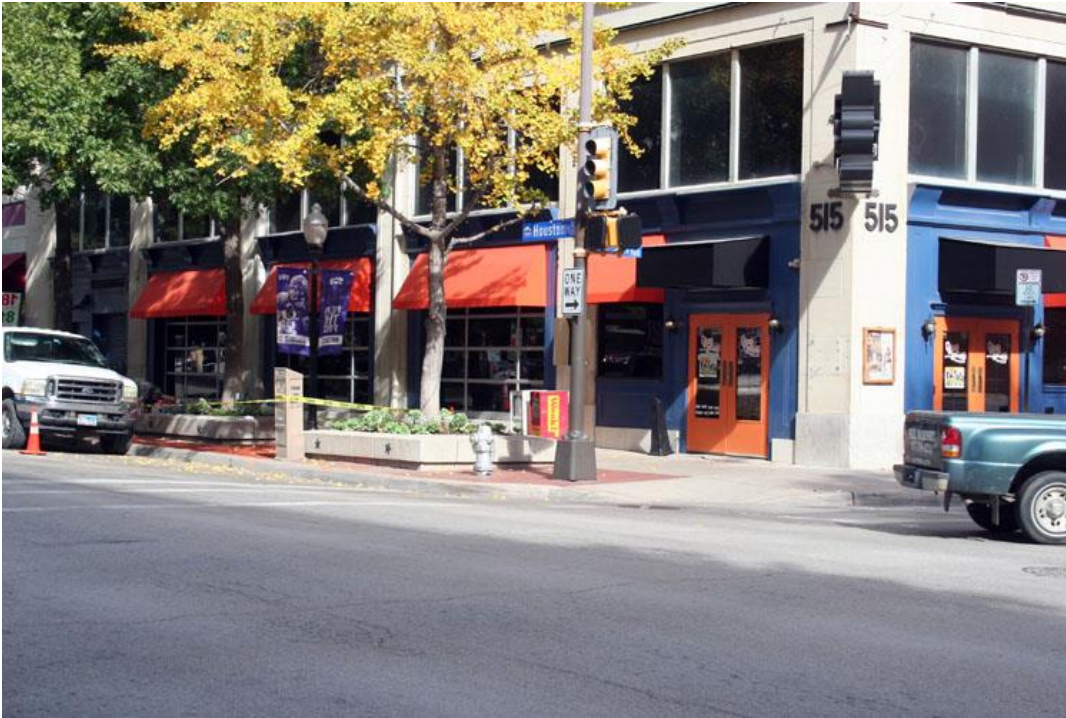
Photo 7: View of west elevation, detail of ground floor storefronts, looking northeast

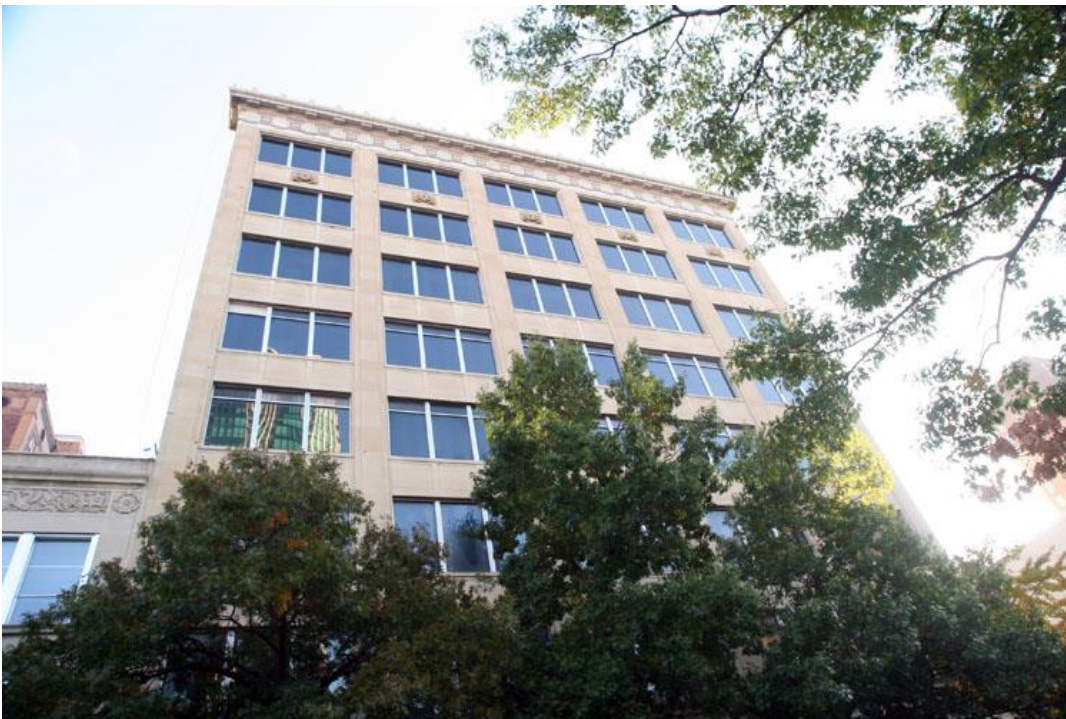
Photo 8: View of west elevation, detail of upper floors, looking east

The primary elevations front Houston Street (west elevation) and 5th Street (south elevation), and the primary entrance is located in the easternmost bay on the south elevation. The west and south elevations share similar configurations, features, and finishes. The south elevation is four bays in width, and the west elevation extends five bays. The elevations have a traditional base-shaft-cornice composition and are adorned with restrained Art Deco ornamentation, which is primarily concentrated between the seventh and eighth floors and at the cornice. The base of the building includes the first floor and mezzanine, and is finished in limestone with aluminum storefront windows in each bay at the first floor that were installed in recent decades. The shaft of the building consists of the second through eighth floors, with shallow articulated limestone piers that separate the bays on the main block of the building. The spandrel between the seventh and eighth floors features a projecting limestone garland in each bay on these elevations. The capital of the configuration comprises the elaborate terra cotta cornice that caps the building at the west and south elevations. The cornice on these elevations features terra cotta triglyphs and painted metopes with terra cotta rosettes. The cornice is topped by a line of terra cotta anthemions.

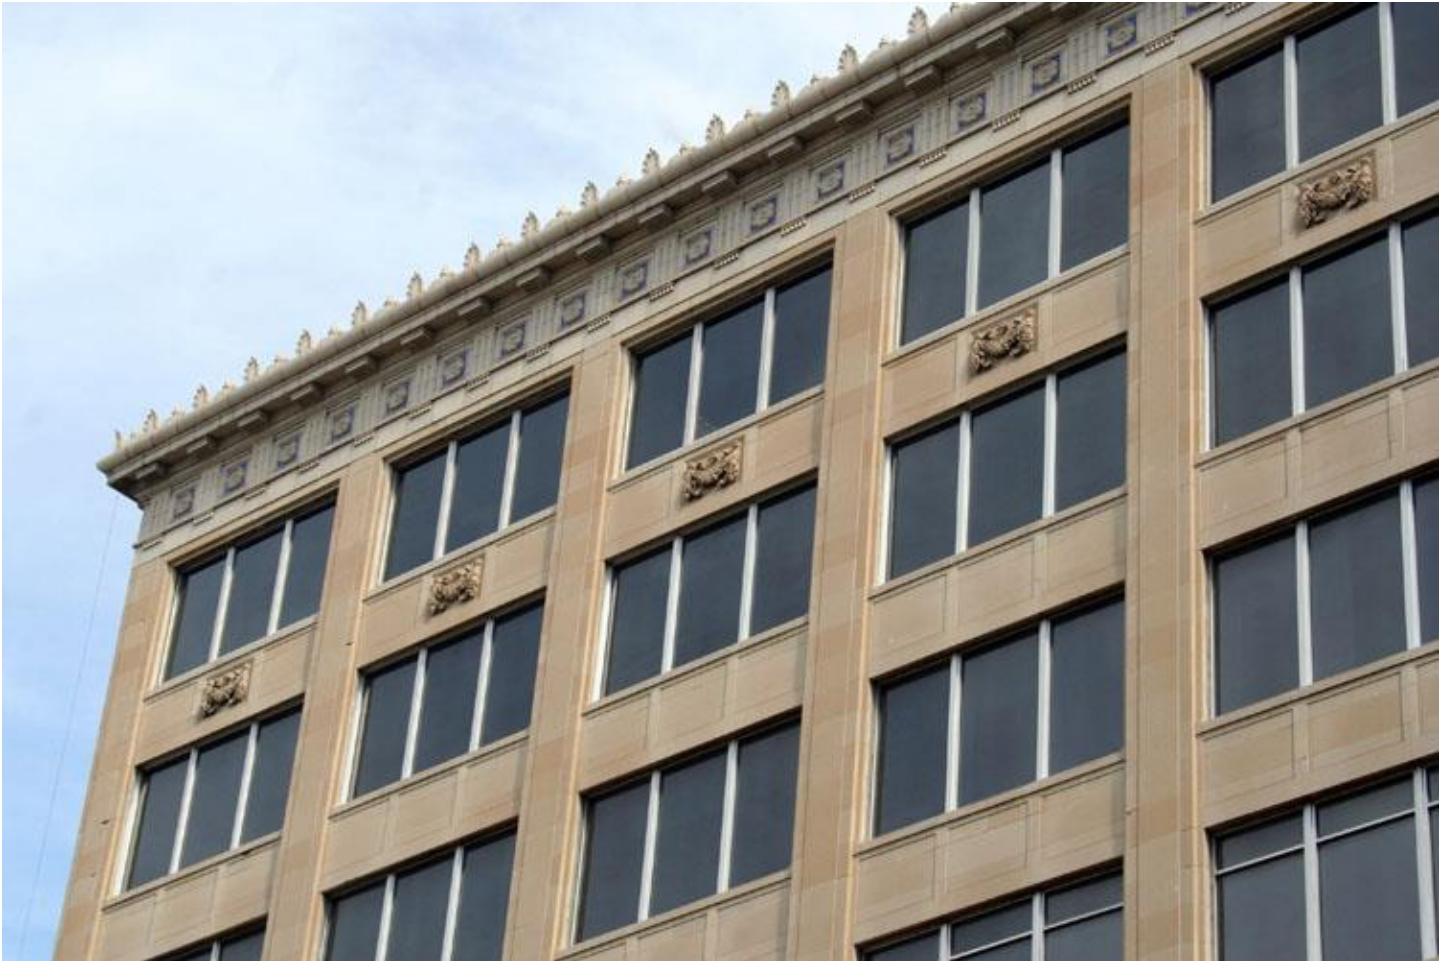
Photo 9: View of west elevation, detail of cornice, looking northeast

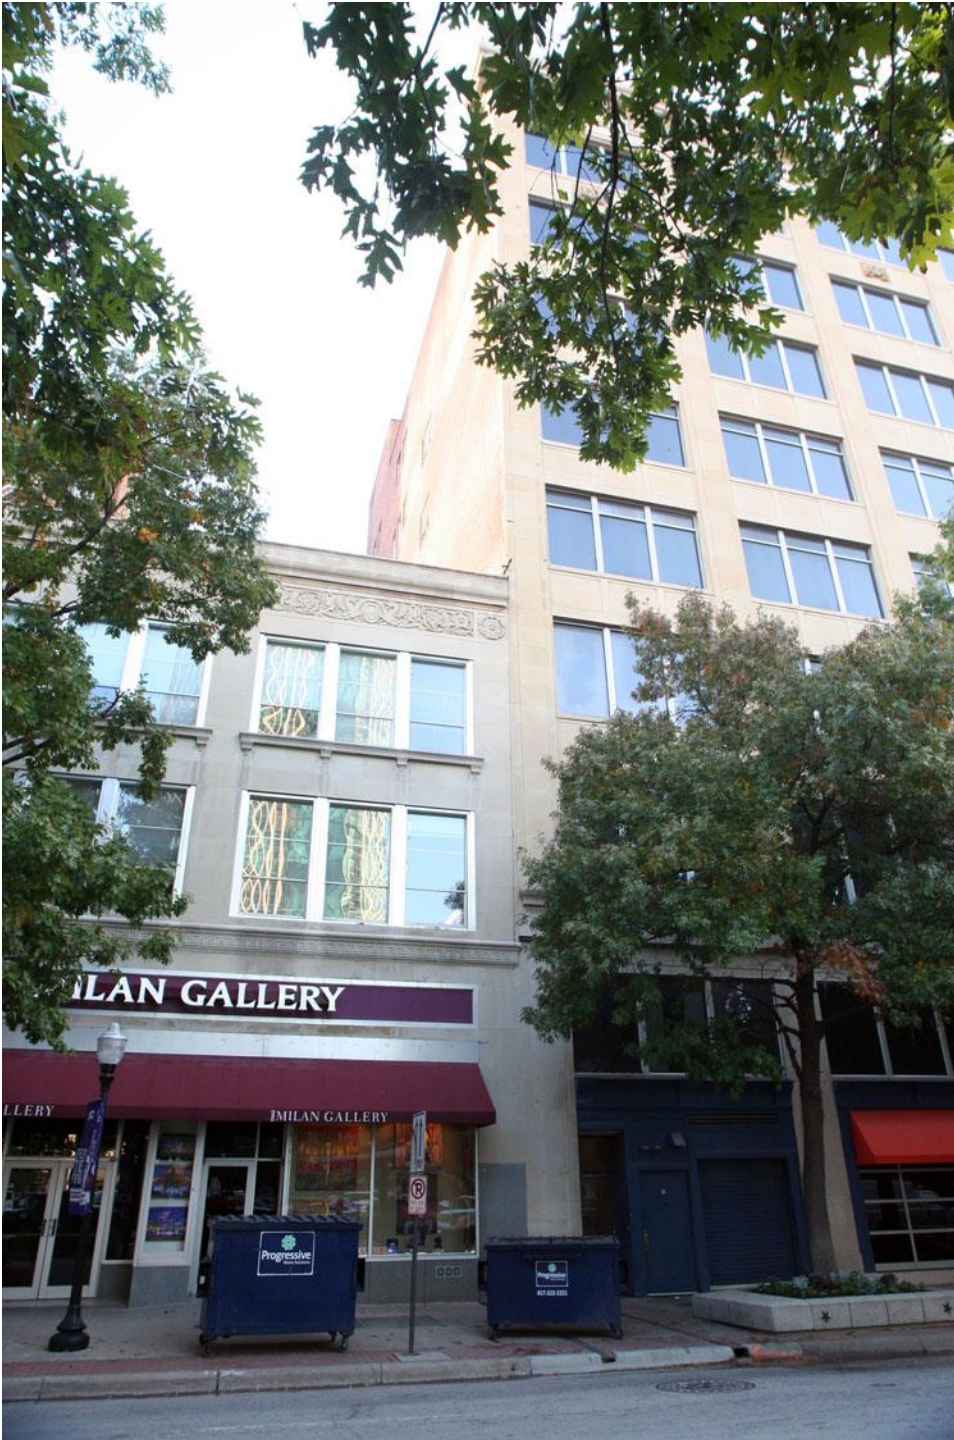
Photo 10: View of west and north elevations, looking east

elevation are infilled. The north elevation of the building also consists of unornamented red brick construction, but its windows are concentrated at the east end of the elevation. Fenestration on this elevation varies and includes both original 2/2 metal framed windows with wire glass and aluminum-frame windows.
