Warsaw Courthouse Square Historic District Kosciusko IN  
Property Name: County: State:

historic name Warsaw Courthouse Square Historic District (name change and boundary increase)

Warsaw Courthouse Square Historic District

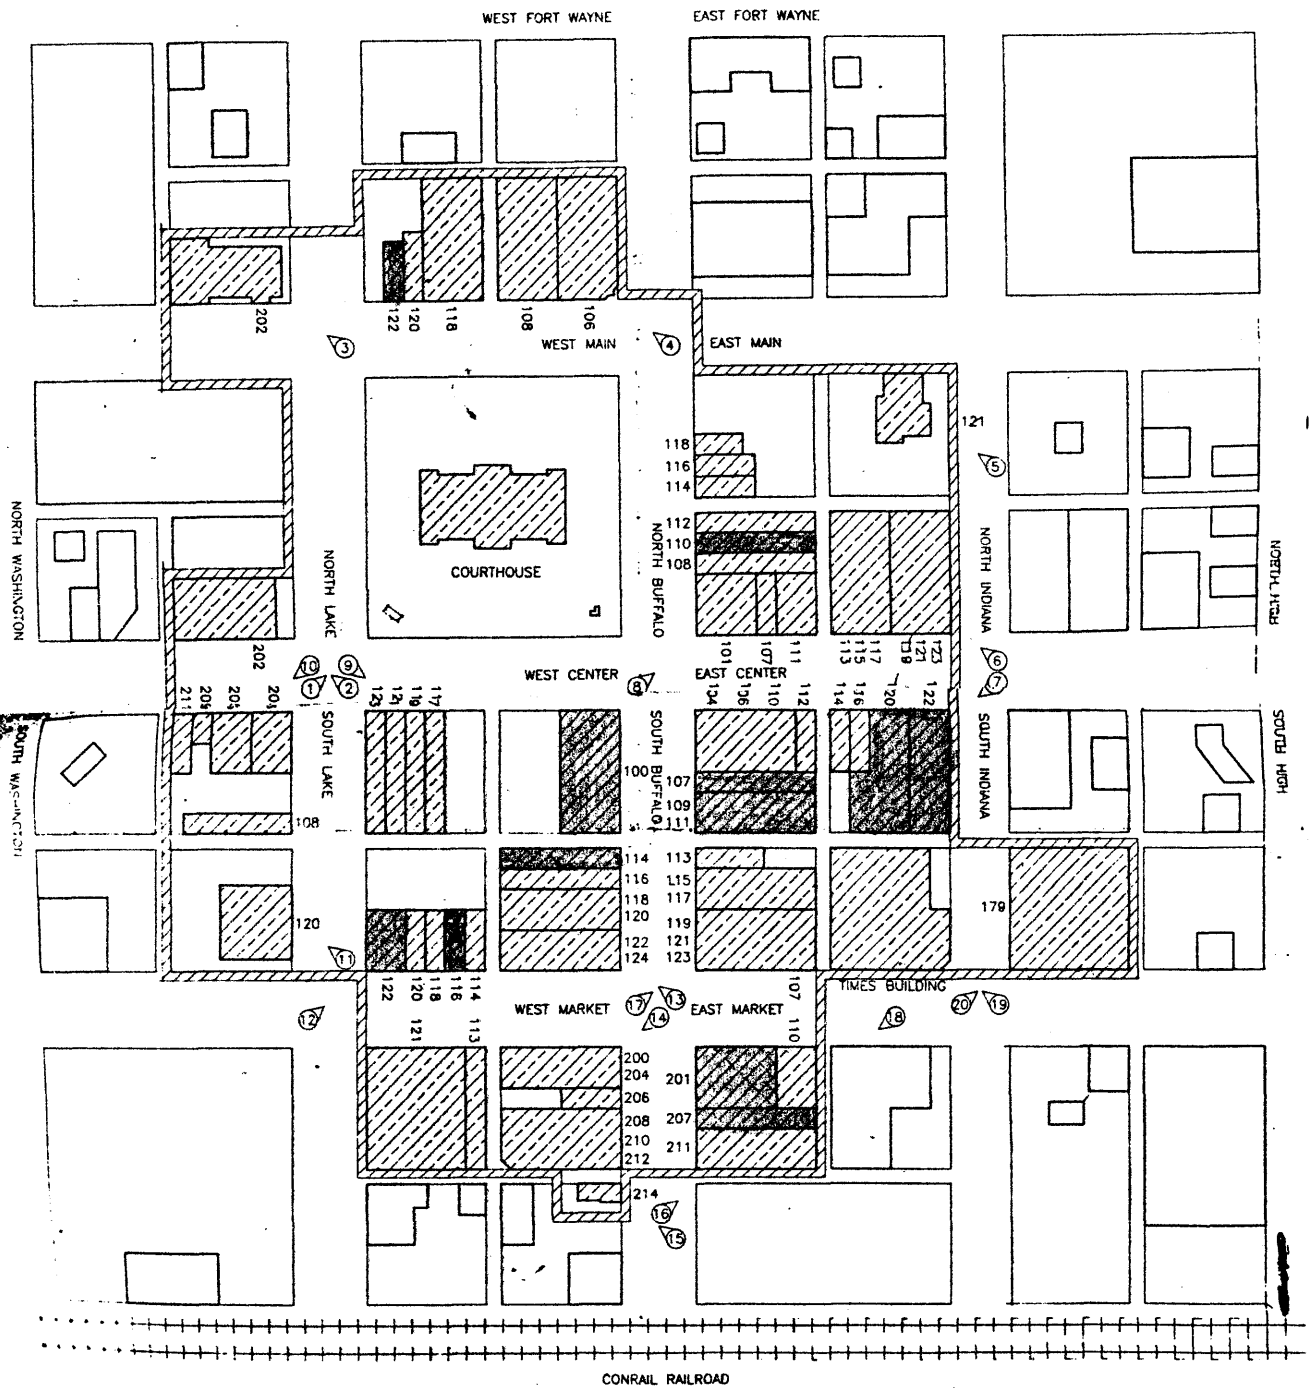
# WARSAW COURTHOUSE SQUARE HISTORIC DISTRICT

1" = 100'-0"
