## **KENTUCKY HISTORIC RESOURCES** Individual Inventory Form

Resource # Me-156 Mercer County

1.	Name of Resource: Burris House	16.	Date:	,
			Original Building ca. 1870 [6	1
<b>Z</b> .	Original Owner:		Addition ell enclosure c.1960	
	Burris	17.	Style:

Continuation Sheet: Me-156 Burris House

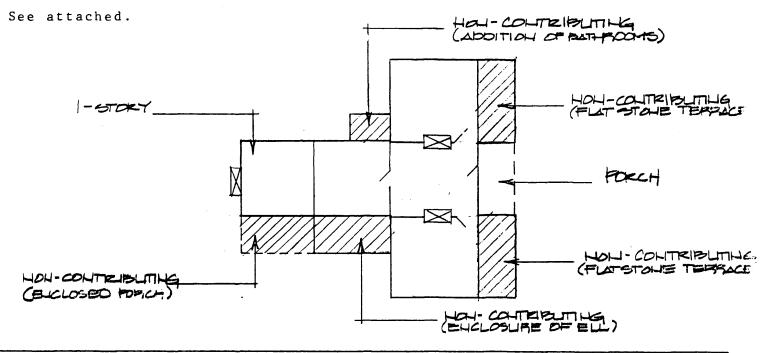
44. Site Plan (and boundary description and justification for N.R. sites):

The residence is a two-story, three-bay frame structure with interior brick chimneys. Windows are double with 1/1 glazing. The floor plan is one room deep, each side of a central hall. The eaves of the hip roof overhang the cornice which is ornamented with brackets. A wooden pilaster defines the corner of the residence. A two-story portico covers the central entry bay. Double-leaf front doors are framed by transom and sidelights. A two-story frame ell extends to the rear joining the main floors of the house to a one-story frame and log kitchen which has an exterior stone and brick chimney.

Modern modifications to the house include stone terraces on either side of the front front porch, enclosure of part of the ell, and an addition of bathrooms as noted in the floorplan in #44. These modifications do not, however, detract from the sense of place or integrity of the building.

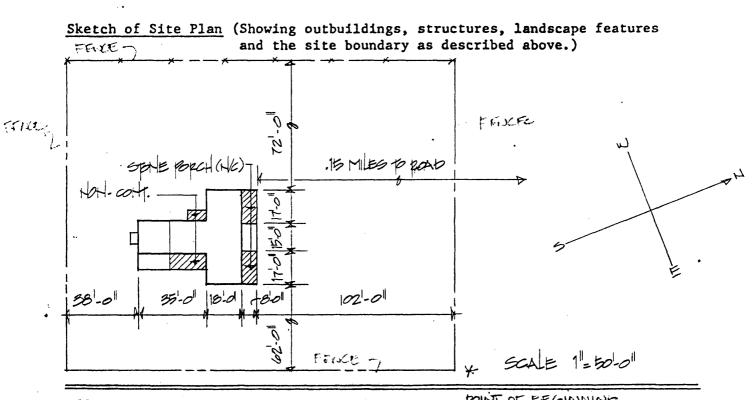
Historic Property Name Burris Hou	iseSite #56
Multiple Resource/Thematic Nomination	
U.T.M. Coordinates - List multiple UTM	s if property is ten or more acres.
A	D
B	E
C	F
Verbal Boundary Description	Acreage84
the northeast corner of the bu to a point; then west 183 feet	eet east and 102 feet north of ilding; then south 201 feet to a point; then north 201 feet to the point of beginning.

POINT OF FEGINNING

The yard-fence was chosen as the boundary because it encloses the only contributing element within the nomination and provides a strong visual demarcation of a setting for the house.
