KENTUCKY HISTORIC RESOURCES
Individual Inventory Form

Resource # BE-110
BOONE County

1. Name of Resource:
Abe Souther House

34. Prepared by: Carolyn Murray-Wooley

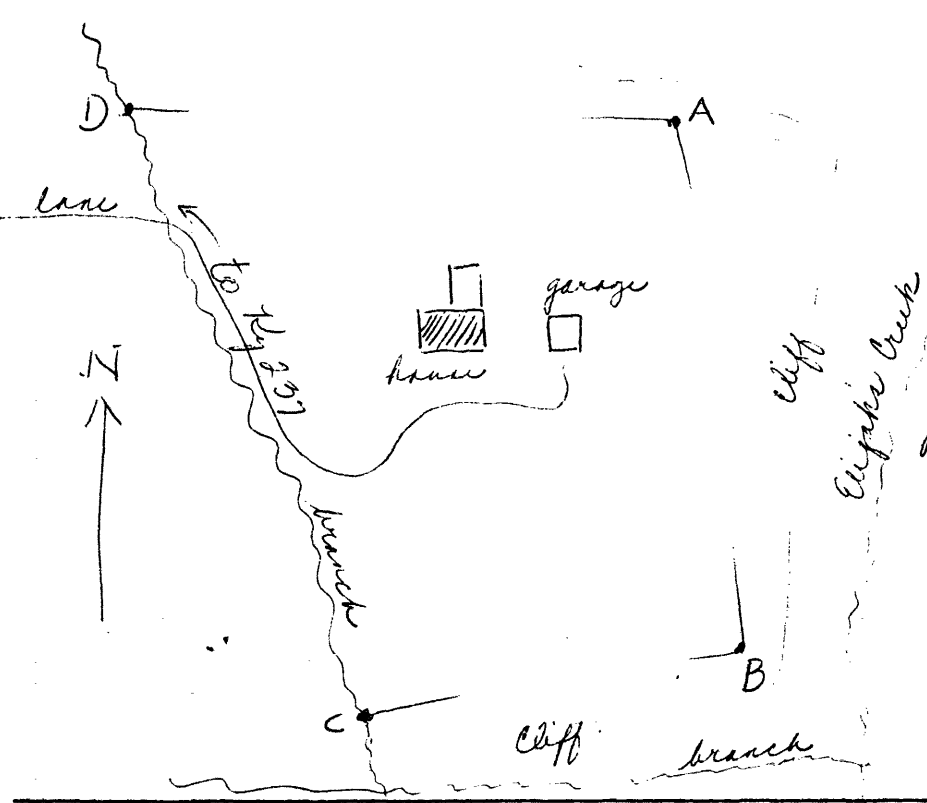
43. Site Plan (and boundary description and justification for N.R. sites):

Site enclosed by A-B-C-D.
A-B and B-C are located at the top of a cliff descending to Elijah's Creek and a tributary. C-D is located on a branch. The boundary was drawn to include the hilltop on which the house is located, which is part of the present and original acreage. Garage is non-contributing.
, contributing building

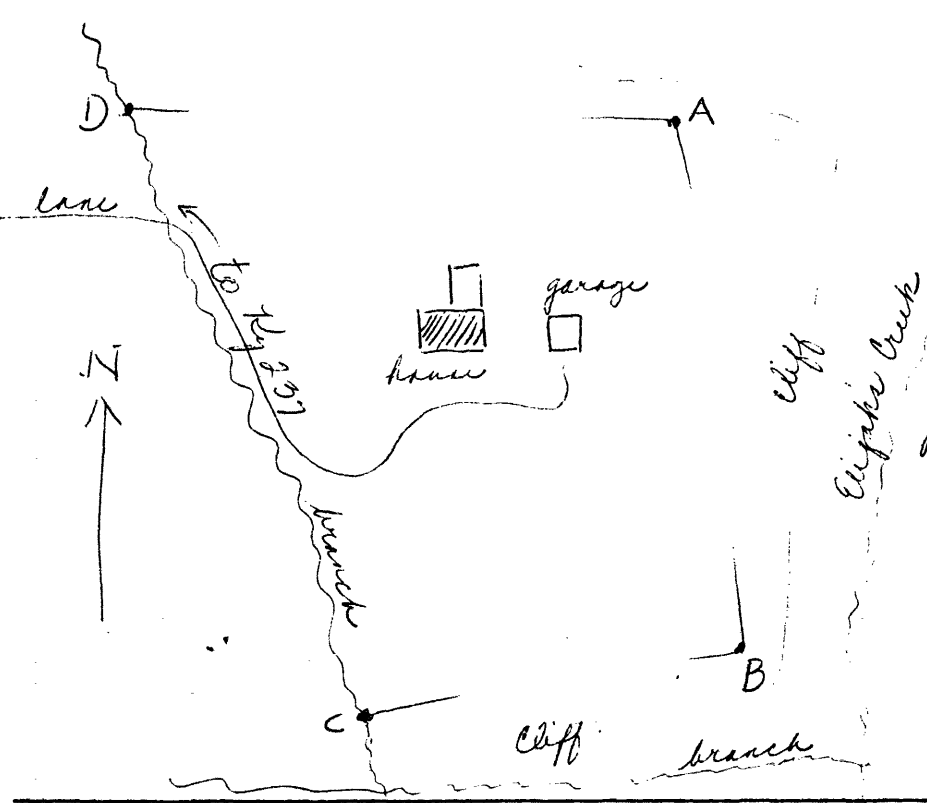
43. Site Plan (and boundary description and justification for N.R. sites):

Site enclosed by A-B-C-D.
A-B and B-C are located at the top of a cliff descending to Elijah's Creek and a tributary. C-D is located on a branch. The boundary was drawn to include the hilltop on which the house is located, which is part of the present and original acreage. Garage is non-contributing.
, contributing building
