Property Name: Deception Pass State Park-Cornet Bay Fire Circle
(Historic Park Landscapes in National and State Parks MPS)

National Register of Historic Places Registration Form

Deception Pass State Park - Cornet Bay Fire Circle
Name of Property

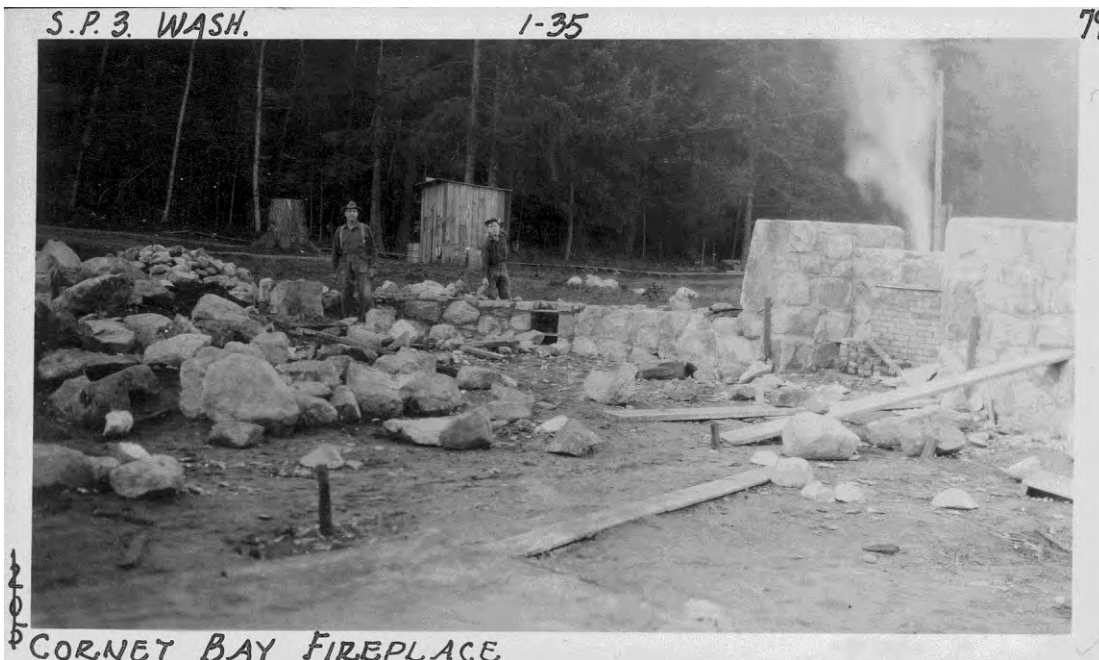
CORNET BAY FIREPLACE
Fire Circle under construction, January 1935. View to north.

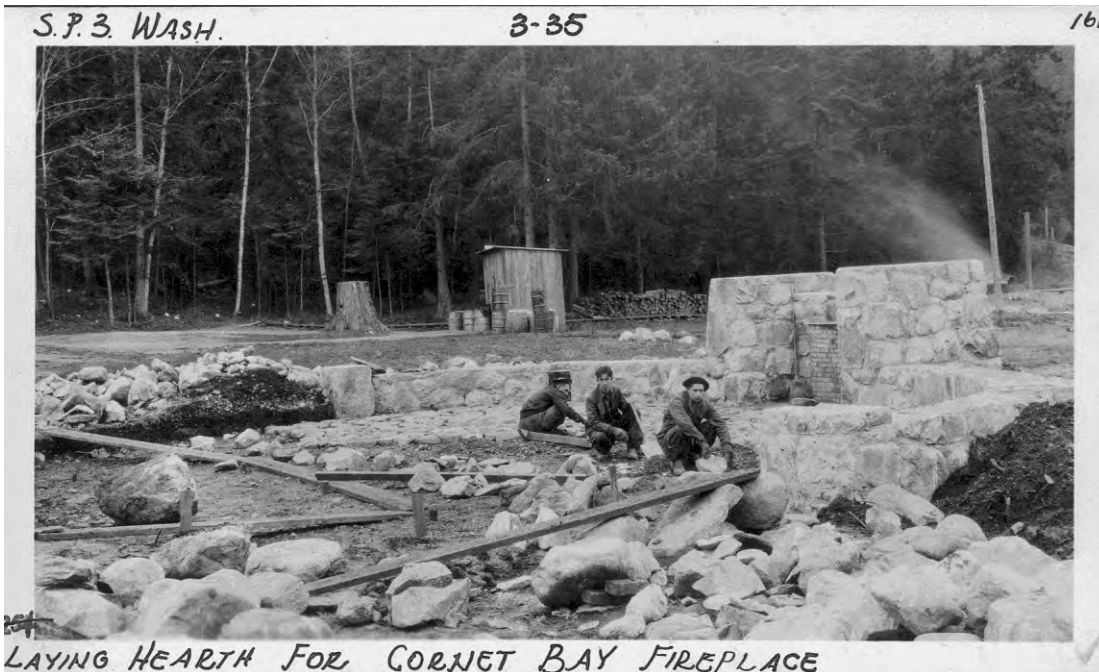
LAYING HEARTH FOR CORNET BAY FIREPLACE
Fire Circle flagstone paver installation, March 1935. View to north.

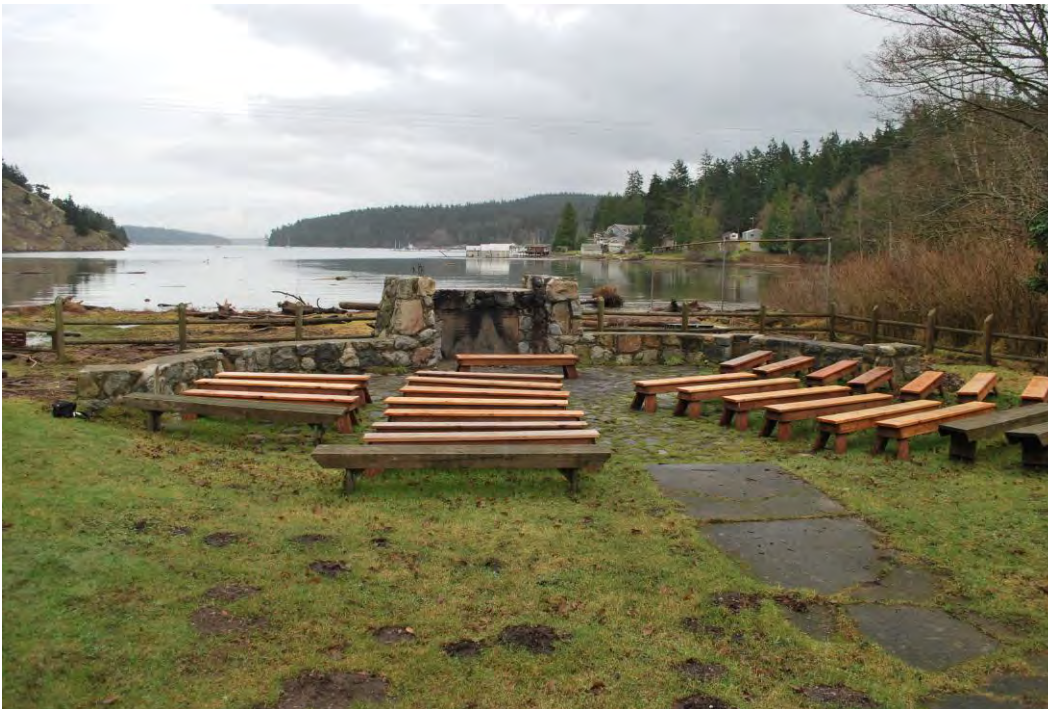
Photo 1 of 4: Cornet Bay Fire Circle, view to north taken 12/22/2014.

Alterations to this resource are minimal. In 2013, the fire brick in the reflector and side niches was replaced in-kind due to deterioration, and repairs were made to the granite walls themselves. The concrete topping on the walls was also repaired. The resource appears largely as it did originally.

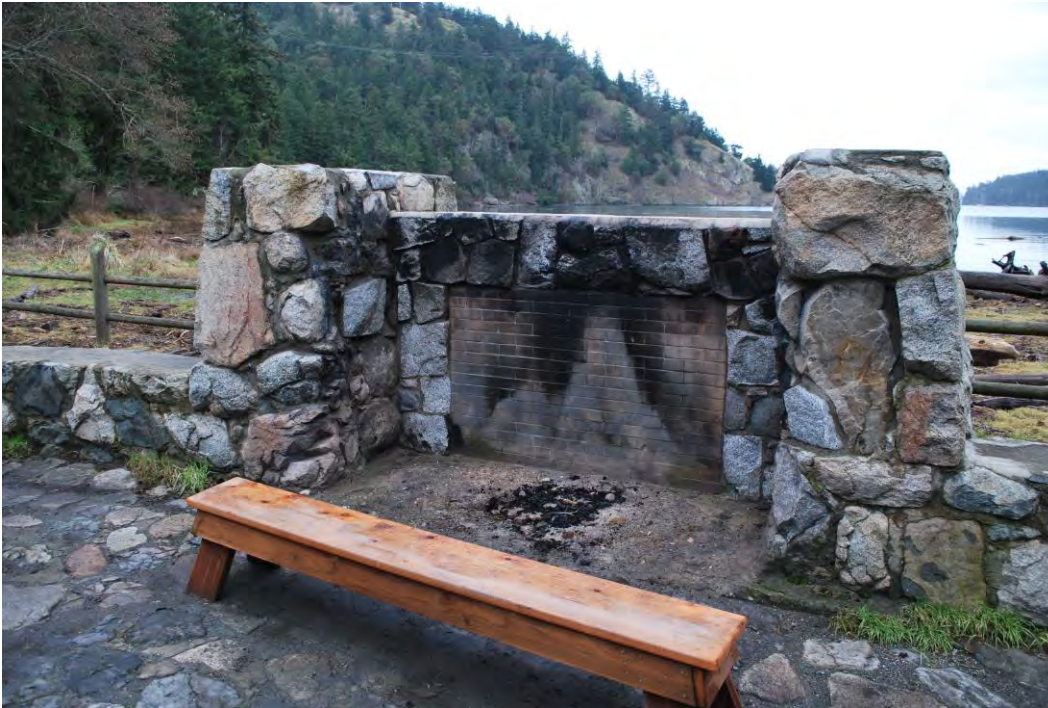
Photo 4 of 4: Cornet Bay Fire Circle, detail view of reflector taken 12/22/2014
