MASSACHUSETTS HISTORICAL COMMISSION
80 BOYLSTON STREET
BOSTON, MA 02116

Address 273 Maple St.

Historic Name Prince Osborne House

Community: DANVERS	Form No: 79
Property Name: Prince-Osborn House

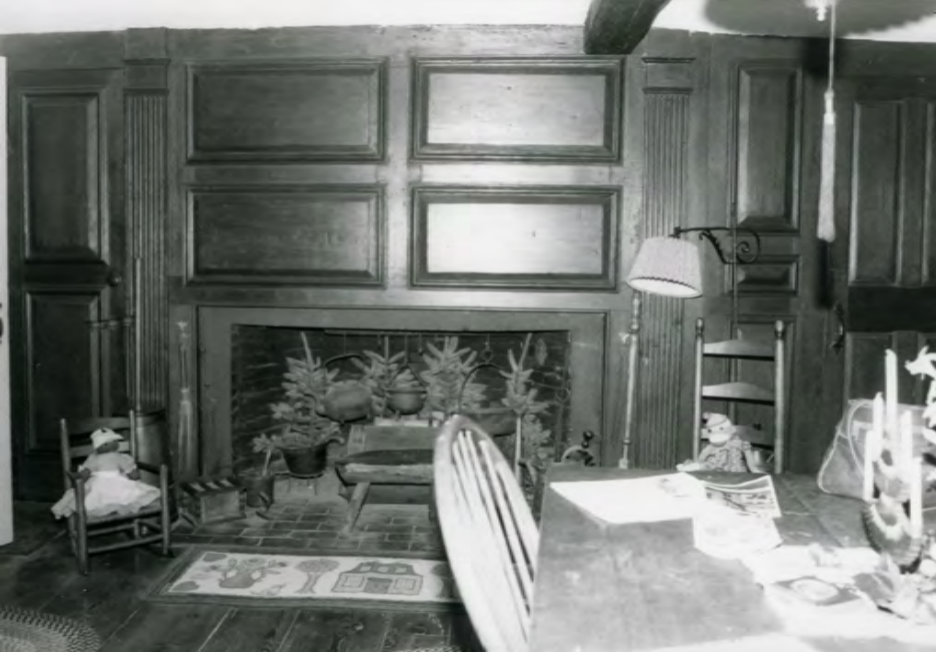
30:21

Right-hand room, near wall

In the right hand room, the only exposed original framing member is the front post supporting the transverse summer beam. The post, a simplified version of the molded post head, has a broad bevel at the lower edge of the head and inch wide flat chamfers on the upright corners. The summer beam, replaced in 1944, was given inch wide flat chamfers replicating those on the original beam. The room retains fine transitional super-raised field paneling on the rear wall, very likely relocated from an original position on the inner wall. Four panels, in which the central field projects above the surrounding bolection, and feather edges are more than two inches wide, are currently mounted horizontally over the rear fireplace. A two panel door with the same super-raised panels is at the right of the fireplace (similar paneling to the left of the fireplace was created in 1944). Pilasters of 18th century construction flank the fireplace. (See significance section for further comment on the paneling and its relocation).

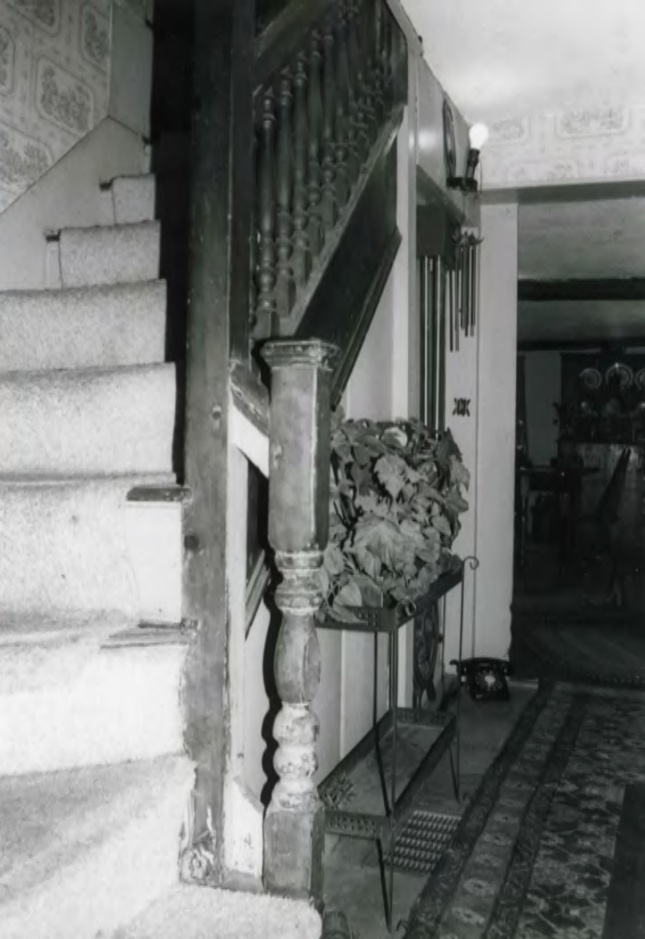
30:22

Danvers
Prince Osborne House
273 Maple Street
Staircase, first floor
1985

The lobby retains a finely crafted staircase of transitional style. Closely spaced turned balusters are set between a molded closed stringer. The newel post is also turned.

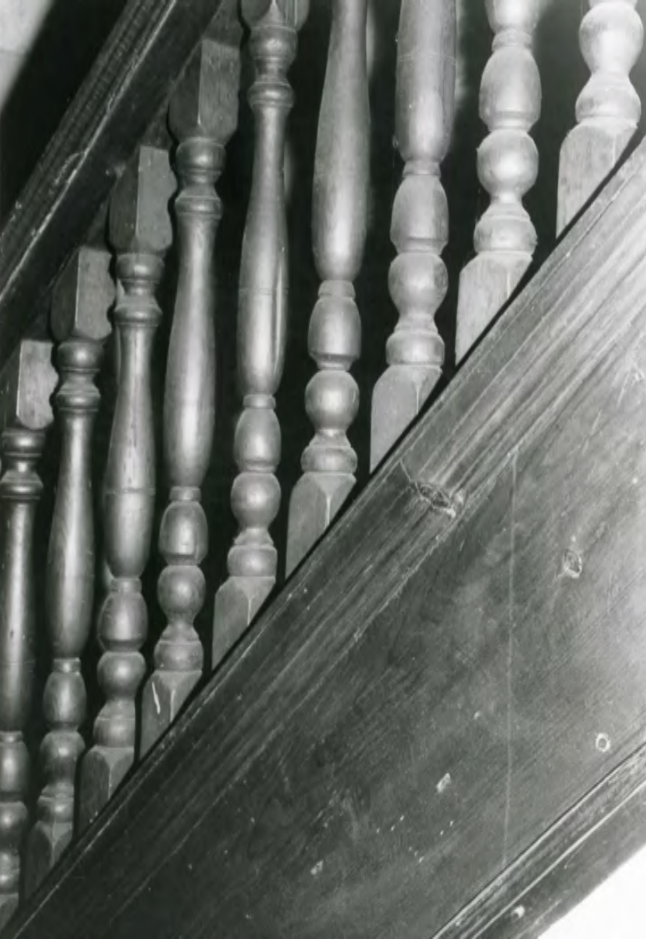
30:26

Staircase detail - 1st floor

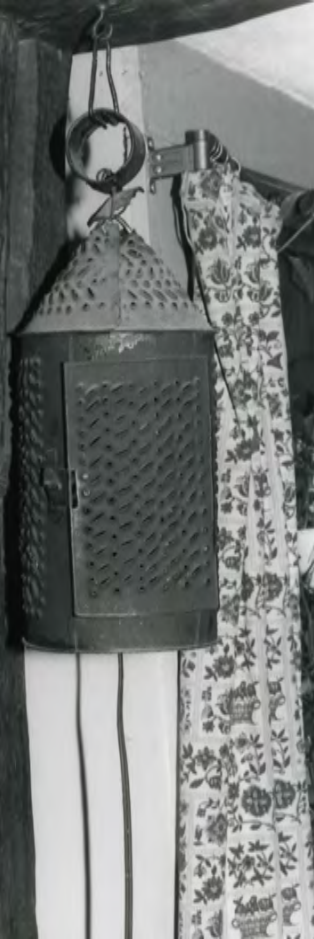
30:30

Danvers
Prince Osborne House
273 Maple Street
Transverse Summer Beam
+ Post
1985

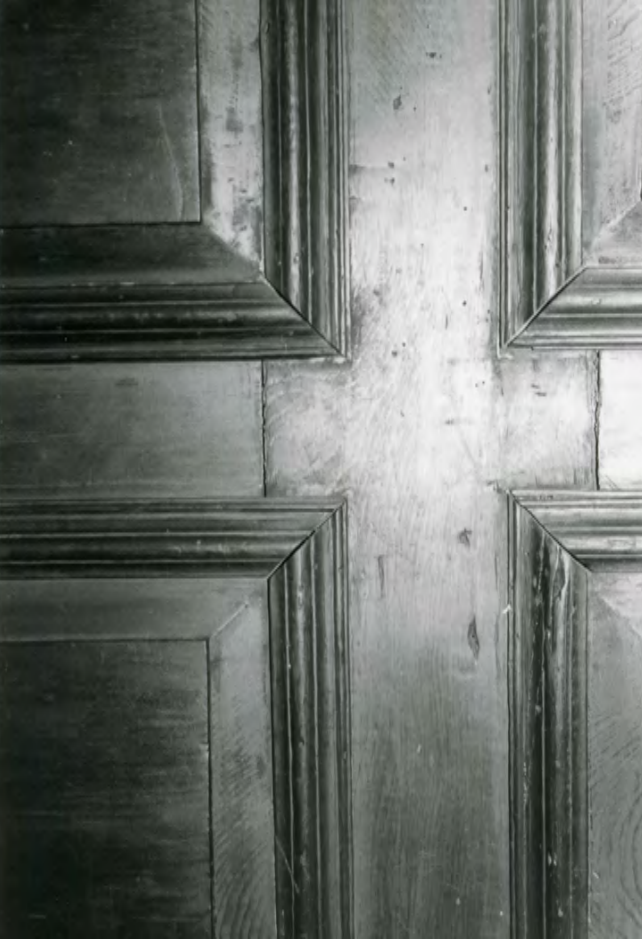
30:32

Detail - Panelling

The staircase and the paneling in the right hand room are significant transitional elements dating to c. 1720. The paneling is particularly noteworthy. True paneling, held together by stiles and rails, it goes a step beyond the finish of the Parson Barnard House in the correct rendering of Renaissance-inspired interior panelling in New England. The extreme width of the feathered edges mark the paneling as one of the earliest examples of its type. (See doors in the White-Ellery House of 1711 and fireplace wall paneling of the Paul Revere House for comparable elements). The building also meets criterion D, for the structure is likely to yield more information about the construction and enlargement of First Period buildings if the framing of the left hand rooms and the junction of the two frames is ever available for examination.

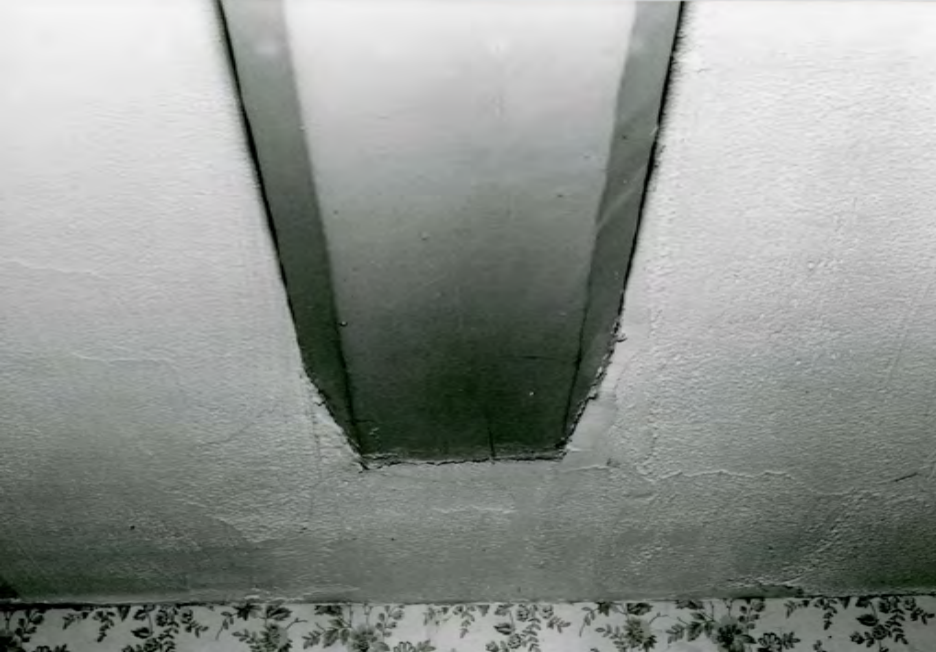
Summer the beam

In the left hand room, believed to be the earlier side, the longitudinal summer beam is 12 inches wide and has 1 1/2 inch flat chamfers and triangular curved stops. The chimney post is finished with a flat chamfer and taper stop. Joist spacing is relatively narrow, in the 17-18" range. In the left hand chamber, the summer tie beam has 1 3/4" to 2" flat chamfers (stops, if present, are buried in plaster).

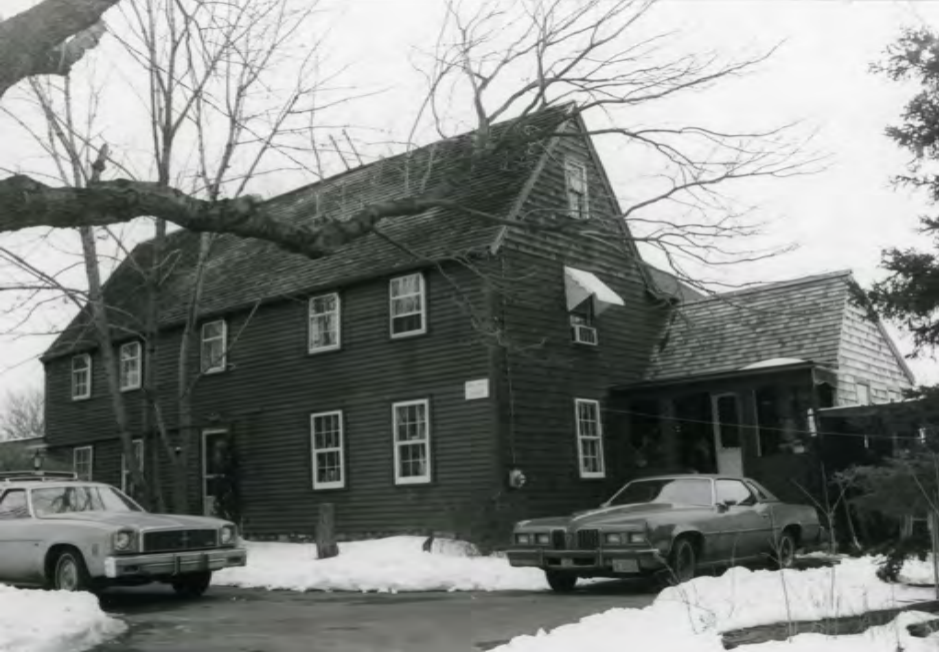
30:36A

Main View

The Prince-Osborne House is a two and one half story building with steeply pitched roof. The main body of the structure, five bays wide and one room deep, incorporates two distinct First Period frames which together make a symmetrical plan. Atypically, the chimney bay appears to be part of the later, right hand frame. There are additions to the sides and rear: a mid 19th century ell to the right rear, a mid 20th century car shed to the left, a lean-to to the left rear, and a small wing to the right. The whole is enveloped in simple finishes with clapboards on the facade and shingles elsewhere. Fenestration, evenly spaced on the facade, is of simply framed sash windows throughout. The central doorway is unornamented. A small hewn overhang extends across the facade to the left of the doorway, indicating the location of the earlier frame within. The two chimneys which pierce the rear roof slope are 1915 reproductions of earlier chimneys removed before the house was relocated from its earlier site on Summer Street in Danvers. The location of those chimneys represents a reorientation probably in the late 18th century of the fireplaces in the principal rooms from inner wall served by central chimney to rear wall.
