National Register of Historic Places Registration Form

historic name Chenoweth-Coulter Farm

**Chenoweth-Coulter Farm
Huntington County, Indiana**

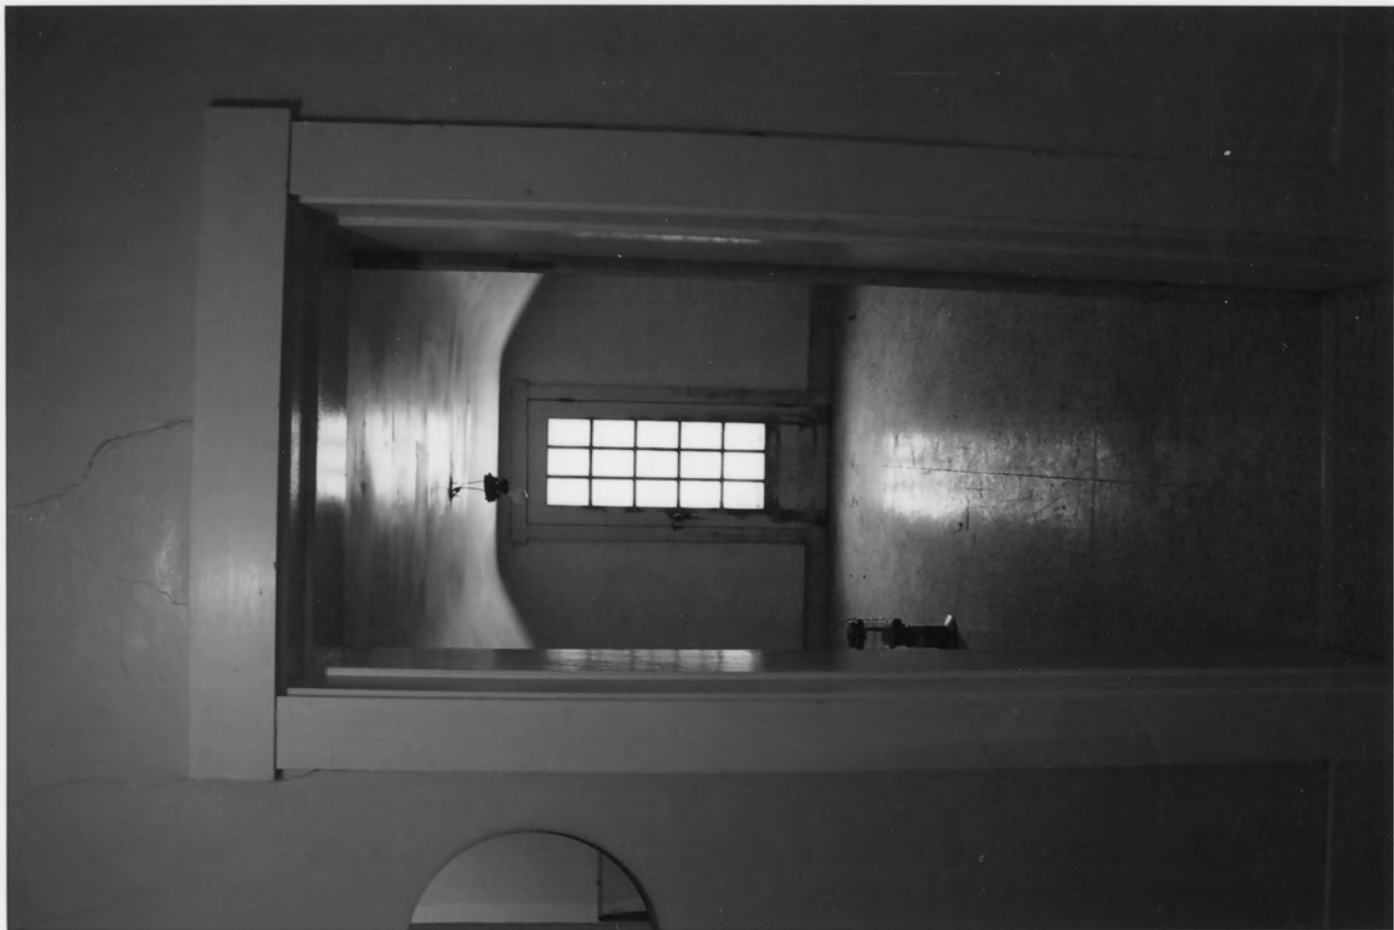
Chenoweth-Coulter Farm, Huntington Co., IN #19

1. Chenoweth-Coulter Farm
2. Huntington County, Indiana
3. Catherine R. Wright
4. December 10, 2007
5. Indiana Department of Natural Resources, DHPA
6. Bedroom over wing, camera facing east
7. 19

the porch. Small doors lead to storage behind the knee walls on both the north and south elevations. The flooring in this bedroom is c.1940s linoleum and the walls and ceiling are plaster.

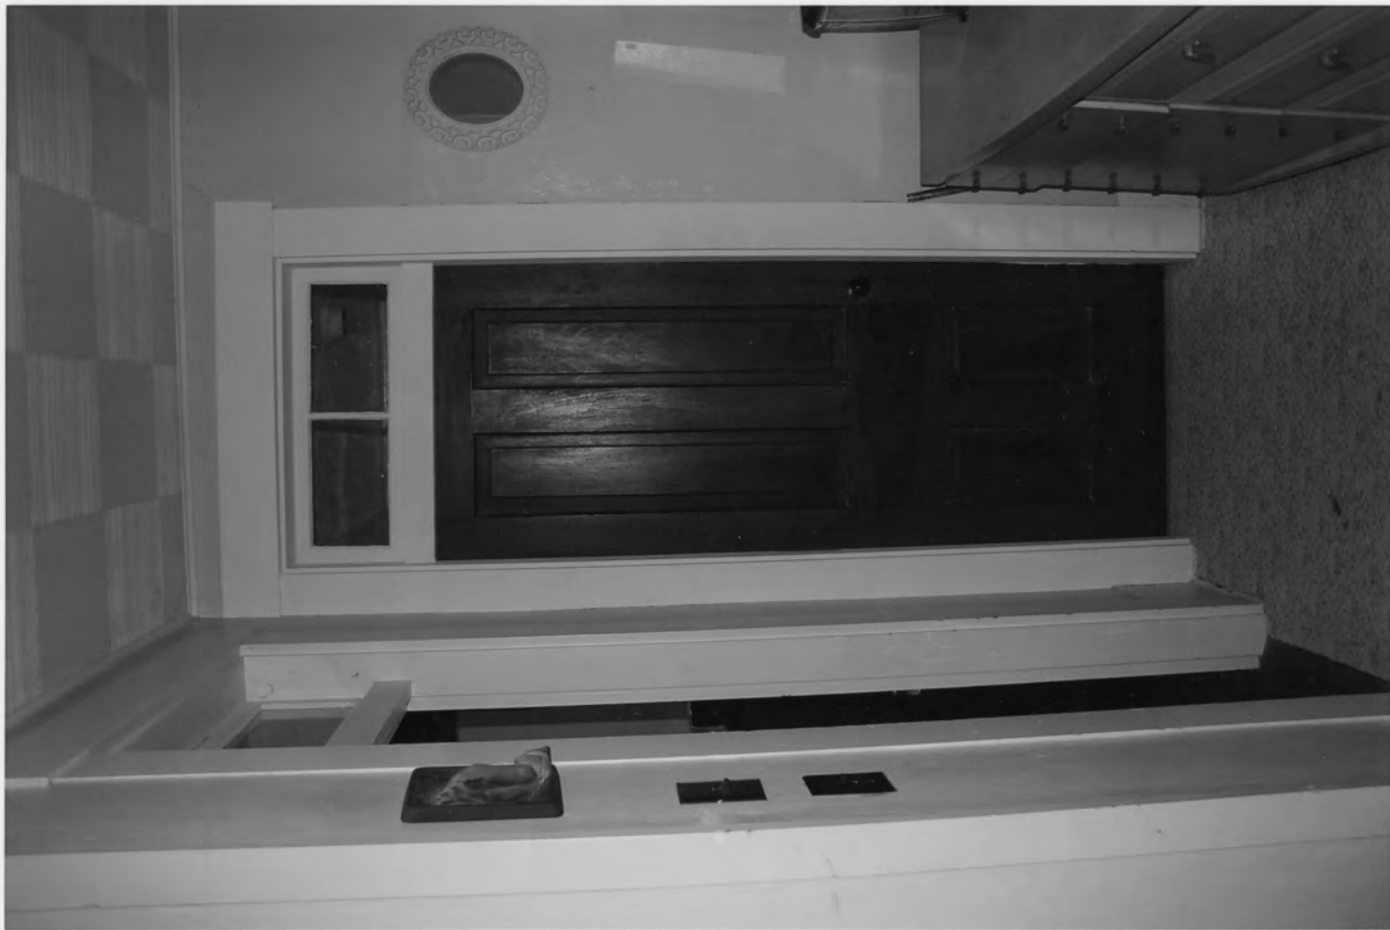
Chenoweth-Coulter Farm, Huntington Co., IN #20

1. Chenoweth-Coulter Farm
2. Huntington County, Indiana
3. Catherine R. Wright
4. June 19, 2007
5. Indiana Department of Natural Resources,
DHPA
6. Second Floor Hall, camera facing west
7. 20
