National Register of Historic Places Registration Form

Historic name: Jordan's Point Historic District

Other names/site number: VDHR File No. 117-5027

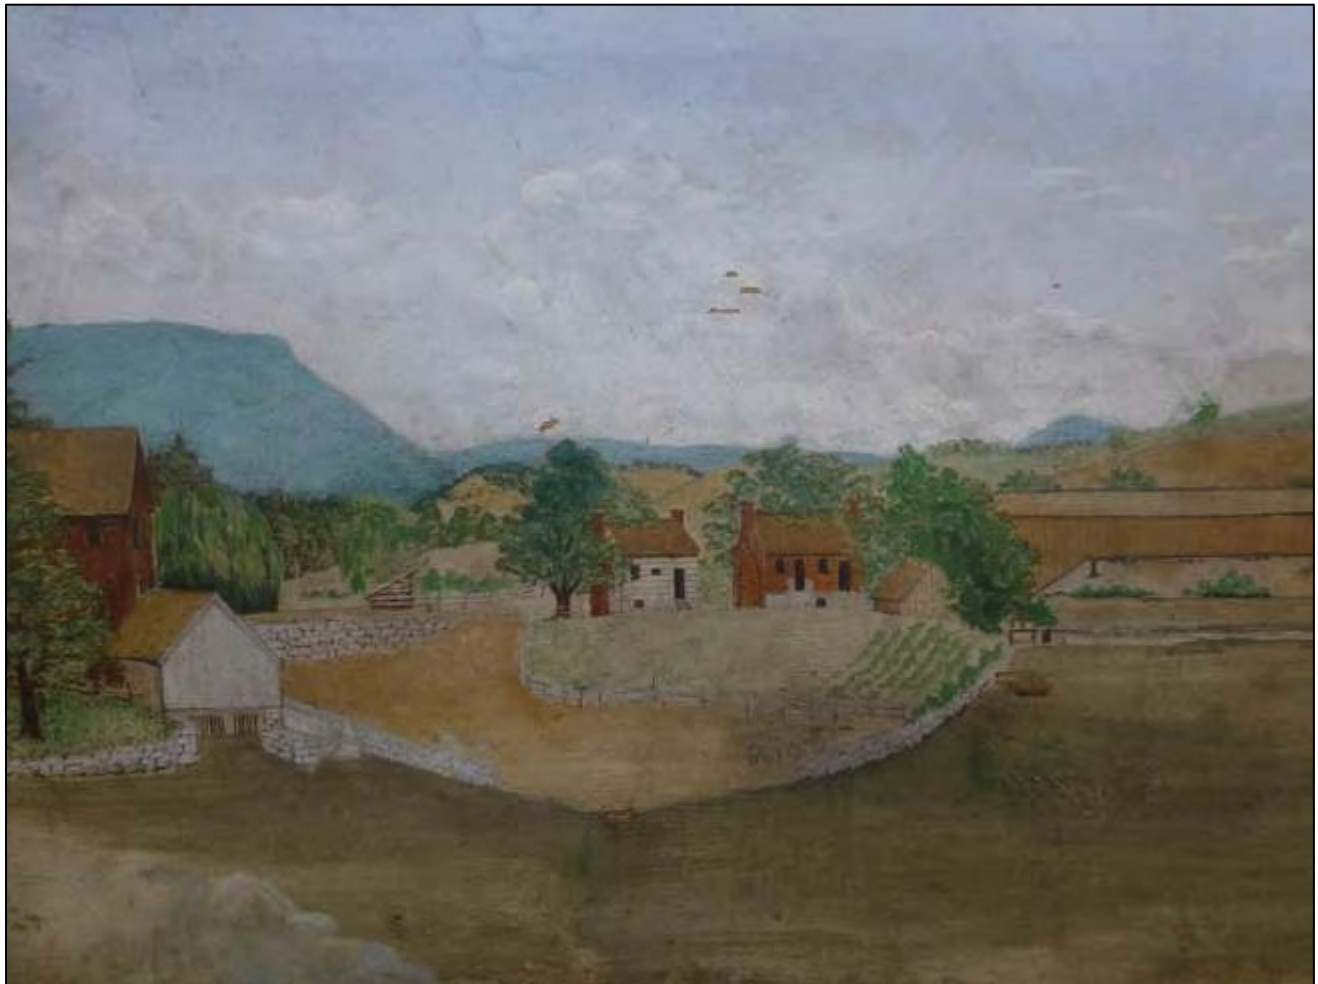
Historic Figure 2. Painting of Jordan's Point by James H. Waddell. The painting probably dates to the 1861-1864 period but an 1870s date is also possible. Courtesy of the Rockbridge Historical Society, Lexington, Va.
