United States Department of the Interior
National Park Service
National Register of Historic Places Registration Form

Historic Name: Jennings-Vickery Historic District
Other name/site number: NA
Name of related multiple property listing: NA

Street & number: Roughly bounded by W. Vickery Blvd, St. Louis Ave, W. Daggett Ave, and Hemphill St., plus
Jennings Avenue Underpass
City or town: Fort Worth State: Texas County: Tarrant
Not for publication: Vicinity:

Jennings-Vickery Historic District, Fort Worth, Tarrant County, Texas

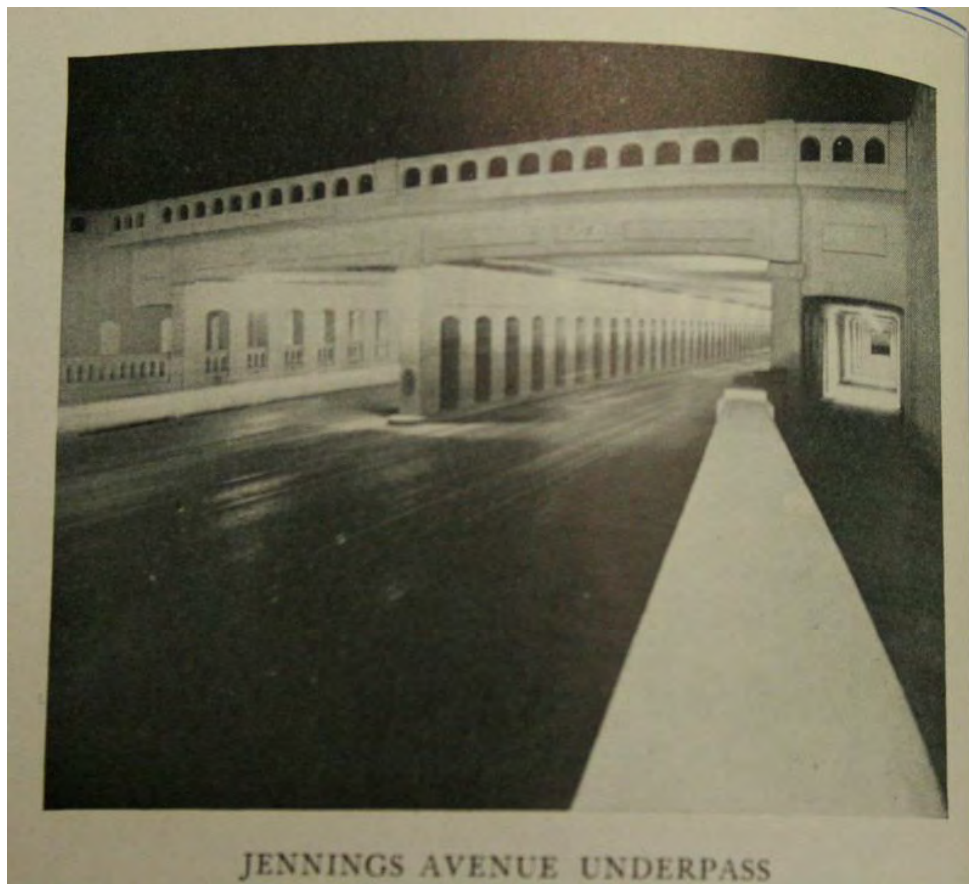
Figure 1: Night view of the Jennings Avenue Underpass, looking south down Jennings Avenue. The underpass was said to be the largest underpass in Texas when it was completed in 1931. From *Five Years of Progress: A Final Report of the Five-Year Work Program of the Fort Worth Chamber of Commerce and a Pictorial Record of Growth and Development of Fort Worth in the Last Five Years, 1928-1932* [Fort Worth Chamber of Commerce, 1932]. Courtesy Fort Worth Library.

In the early twentieth century, travel across the T&P tracks to the Southside was eased with the construction of the Jennings Avenue Viaduct, although its actual construction brought frustration to city leaders and the public. It was initially thought that the project would be completed in February 1902 at a cost of \$70,000. But design changes, difficulty securing steel from the supplier in Roanoke, Virginia, and weather conditions delayed the project's completion until early 1903 and drove its cost to an estimated \$100,000. When completed, the *Fort Worth Telegram* proclaimed the structure to be the finest in the South and that it rivaled similar public improvements in "Greater New York." The newspaper expressed the opinion that the project was a "conspicuous example" of the type of enterprise that added to Fort Worth's fame. The viaduct carried the Jennings Avenue streetcars and other modes of transportation from downtown to the Southside.⁵

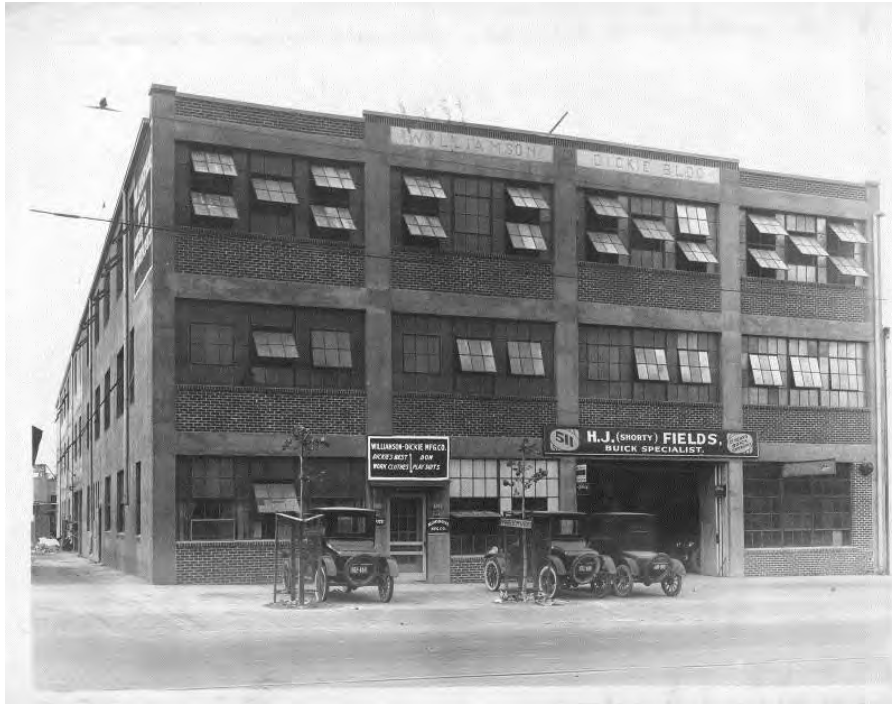
Figure 3: Williamson-Dickie Company Building before the addition of the fourth floor. 10004152, 2004-9, Charles M. Davis Photographs, Special Collections, The University of Texas at Arlington Library, Arlington, Texas [UTA].

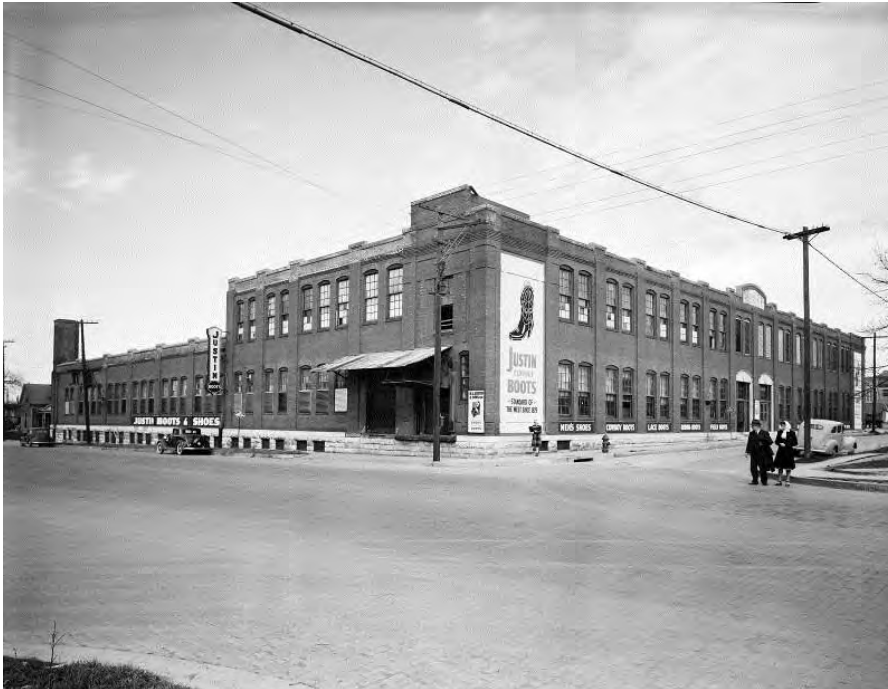
Figure 5: Justin Boot Company Building, 610 W. Daggett Avenue. AR 430452471, March 7, 1945, W.D. Smith Commercial Photography, Courtesy Special Collections, UTA.

23. Justin Boot Company Building, 610 W. Daggett Avenue, c. 1911. This is a two-story brick warehouse with a one-story wing on the north side. It is notable for its massive size, limestone foundation, numerous segmental arched window openings, and decorative brick corbelling on the west and south elevations. The symmetrical façade is organized into fourteen bays divided by brick pilasters. The end bays are blank walls with no window or door openings. The other bays each have paired segmental arched window openings on each floor with the exception of entrances located on the first floor of the center two bays (these entrances consist of modern aluminum-framed storefront style doors that are covered by a shed roof awning of corrugated metal). The center two bays also share a shaped parapet that contains a sign reading “Justin Boot Co./Since 1879.” Brick pilasters also divide the west elevation into bays that feature paired segmental arched windows. Satellite photos indicate that the building retains its rooftop skylights. It is an excellent example of an early twentieth century manufacturing/industrial building—one constructed with wood columns instead of a reinforced concrete structural system. It was originally constructed for the Exline-Reimers Company, a printing and lithograph firm. It later housed several relief programs during the Great Depression. In 1939, it was leased to, and later purchased by, H. J. Justin & Sons, manufacturer of boots and shoes (photos 15 and 16 and Figure 5).

Historic photos reveal that the 1911 portion had double hung multiple-light windows at the time it was occupied by Justin Boots. Although its historic windows have been replaced with 1/1 metal units with tinted glass, the building retains a high degree of integrity on the exterior. It is also significant for its association with a prominent industry that has occupied it for more than 75 years. The Justin Boot Company Building is a contributing building in the proposed Jennings-Vickery Historic District.
