1. Historic Name (s)		22. ADD/County JF. OGS
Hook & Ladde	r #3m	JF-L÷E-GC
Original Owner		23. Zoning Classification
Present Name Hook & Ladde	r #3	Magisterial District

A. A. STOI, L HOOK AND LADDER No. 3.

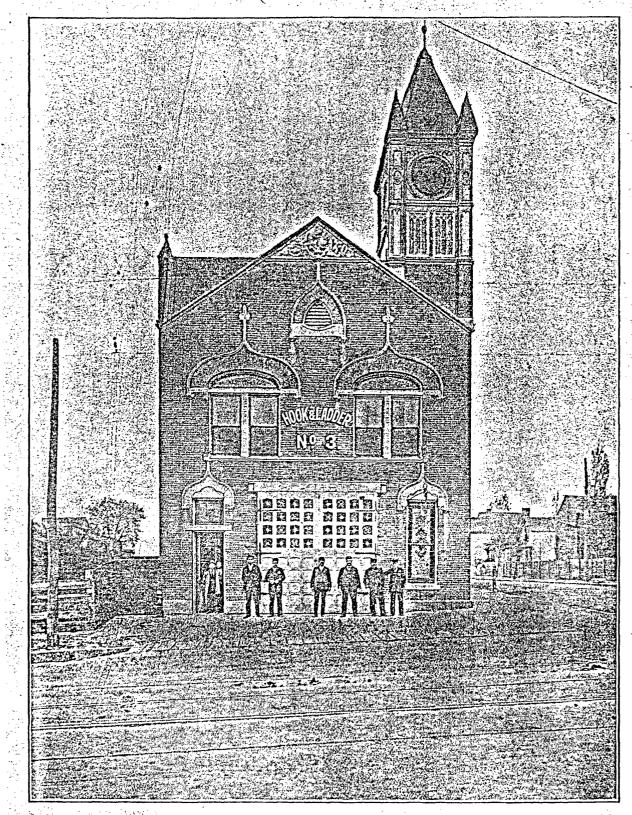
18. in an ogee-arched shape. The structure is capped by a gable with parapet walls extending from the sides. The top of the gable is filled with rinceau decoration. Below this is a louvered opening also with a stone ogee-arched band.
