National Register of Historic Places Registration Form

Historic name: Sugden, Roberta, House

Street & number: 1810 East Orchard Drive

MODERN MOVEMENT: International
Style/Miesian

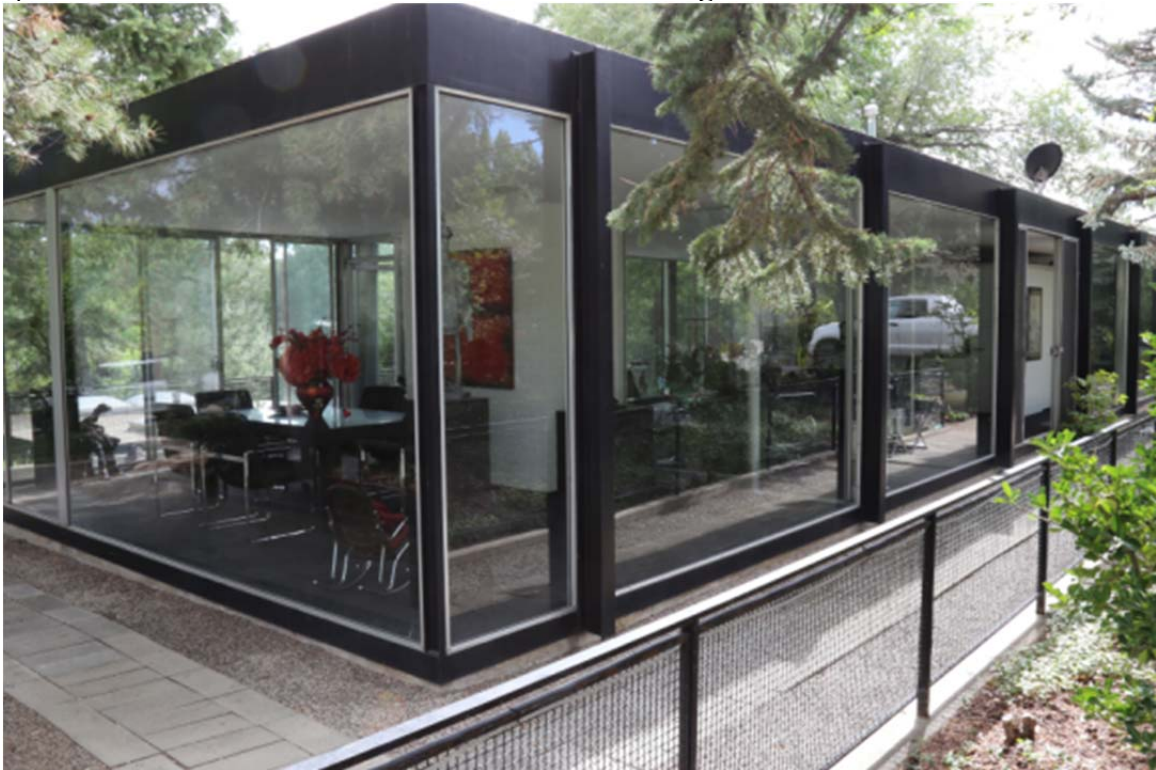
Photograph 1 of 20. View of Northeast elevation. Camera facing southwest.

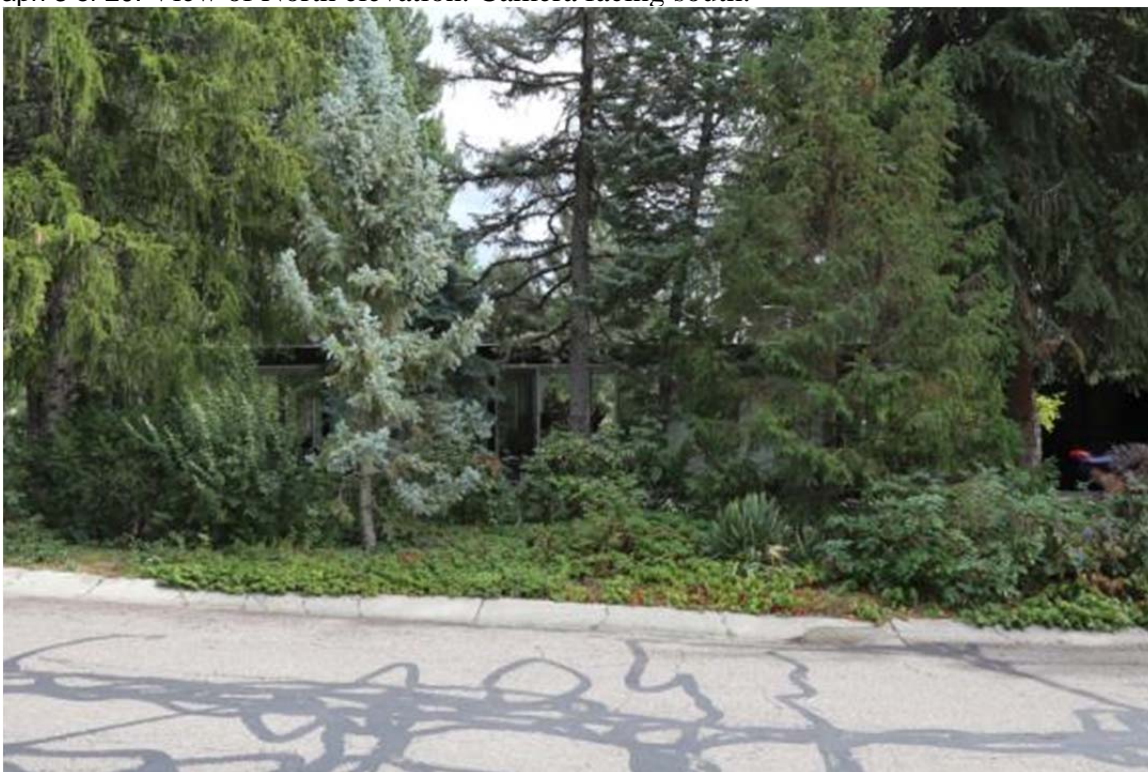
Photograph 3 of 20. View of North elevation. Camera facing south.

The front (north) elevation is six bays wide and faces Orchard Drive. The Sugden House, in keeping with modern ideas and disregarding traditional design elements, does not have a strongly dominant façade or entry. The main views from the street are the horizontal floor and ceiling beams and narrow columns. The entry is combined with the carport and is not directly visible until one proceeds almost completely down the driveway. From east to west are five bays created by vertical columns. Glazing was added to the east bay by John Sugden shortly after original construction.⁵ A second owner also removed the solid glass of the third bay and installed floor-to-ceiling operable sliding glass doors with screens.⁶ The entry door is located directly behind the column separating the living space from the carport and in-line with the east brick carport wall. Atypically, the entry opens into the bedroom which allows the entry to be invisible from all three main facades, removing another traditional element from view. Originally a glass door with narrow transom window, the door is now metal.

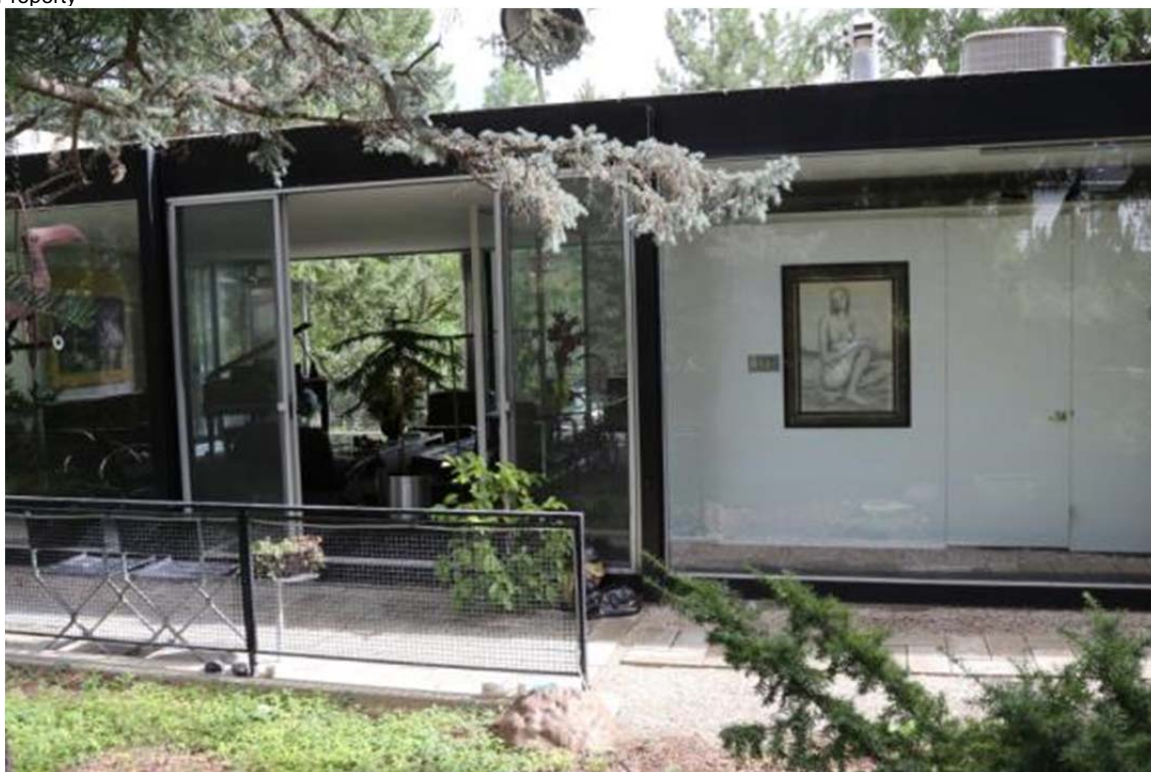
Photograph 4 of 20. View of North elevation. Camera facing south.

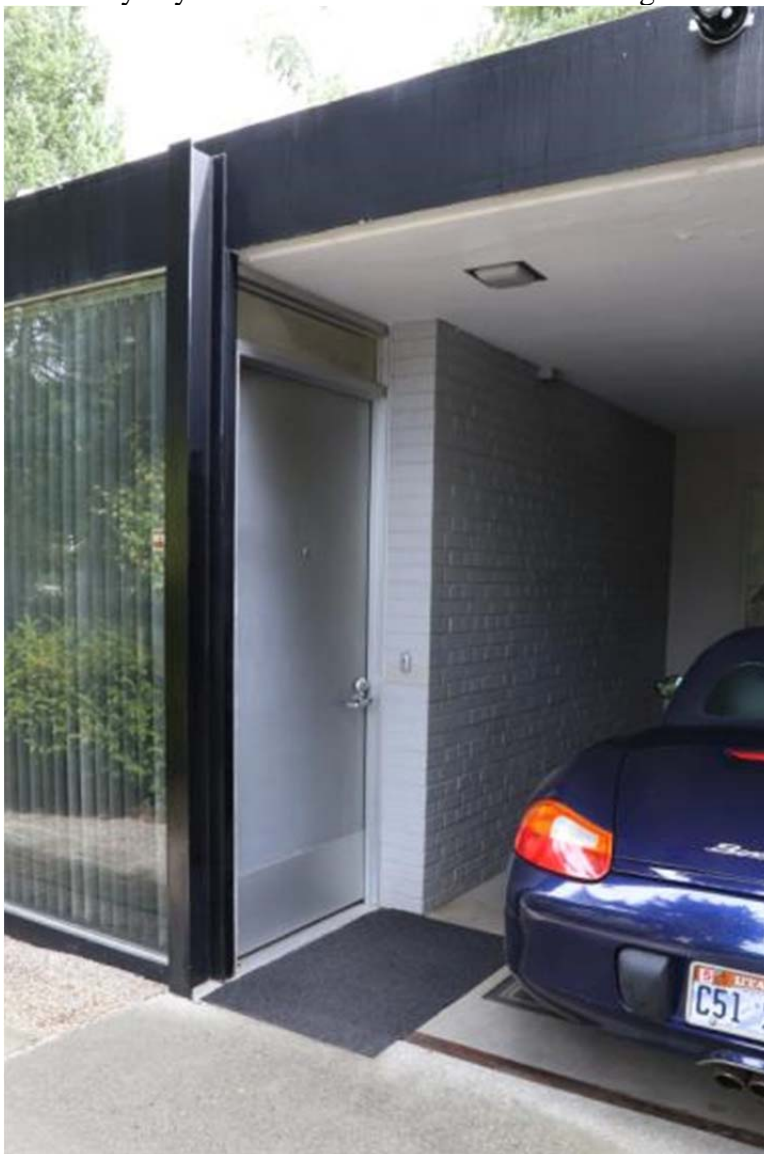
Photograph 5 of 20. View of Entryway and North elevation. Camera facing south.

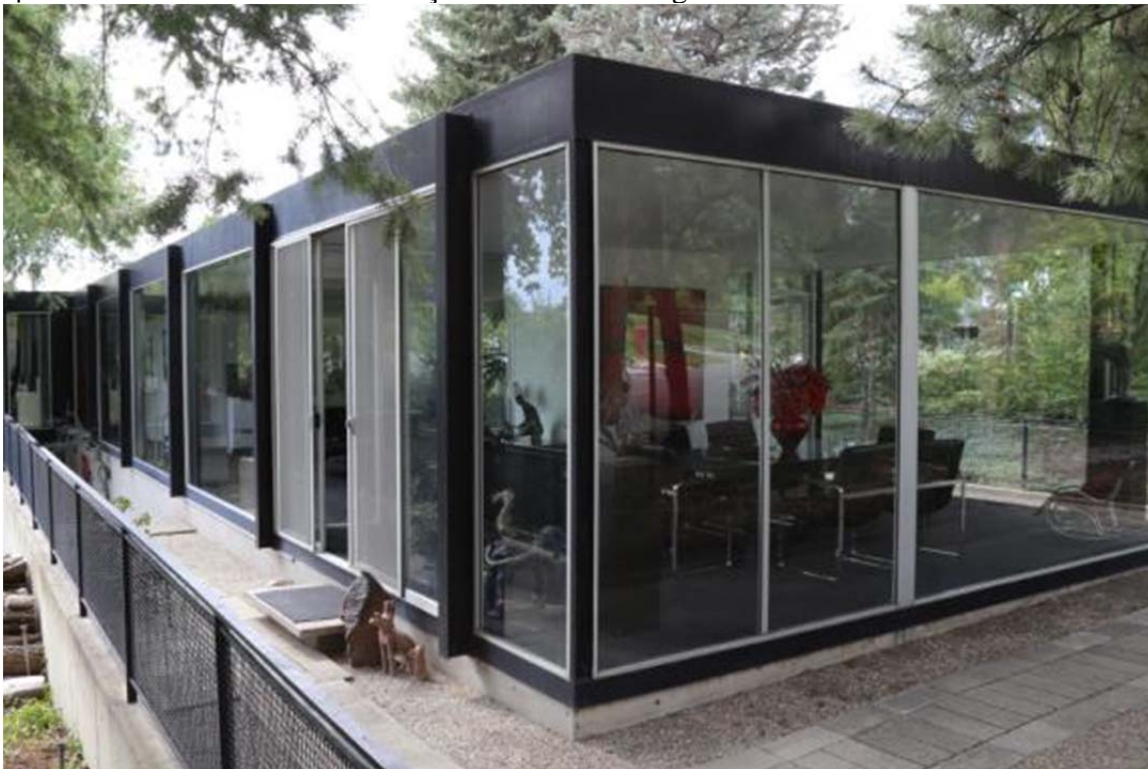
Photograph 6 of 20. View of Southeast Façade. Camera facing northwest.

The south elevation contains six bays and faces Mount Olympus, the larger part of the lot and wooded gully. This elevation has floor-to-ceiling sliding glass doors on the eastern most bay, which mirror the doors in the center of the north façade. The lot slopes strongly away from the structure and the staircase and retaining wall are visible below the next four bays. The rear of the carport has been modified and a two-story square addition matching the width of the carport bay has been added.

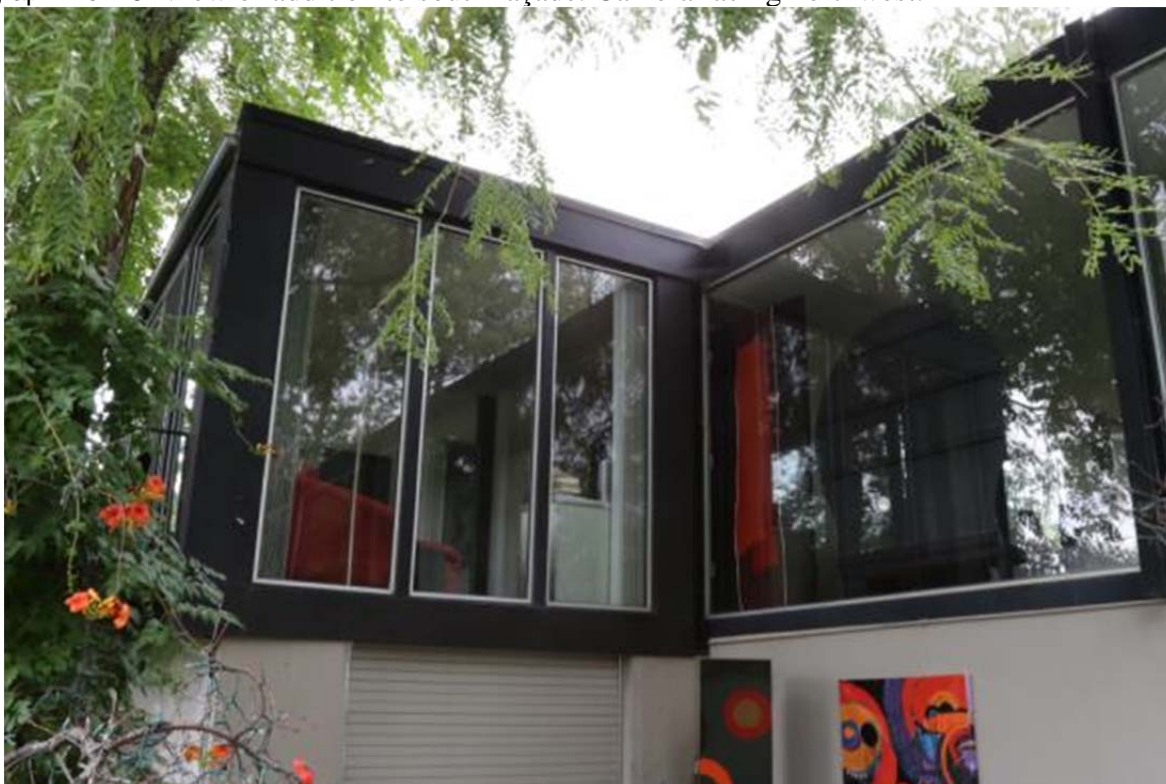
Photograph 7 of 20. View of addition to south façade. Camera facing northwest.

Since its completion in 1955, the Sugden House has been modified three times. John Sugden enclosed most of the open porch in 1963 and added air conditioning in 1964. The enclosure of the carport, room addition to the south façade, operable sliding glass doors and final enclosure of the open porch were completed at an unknown date between 1978 and 1994.⁸ In 2000, the addition to the south façade was modified to recreate the carport, add a second bathroom and install large windows which are similar in height and frame profile to the original glazing walls. The metal columns and beams were also repaired and painted black and the house restored to much of its original design by owner Mollie Kimball with the collaboration of prominent local modern architect Dee Wilson, who practiced with John Sugden.

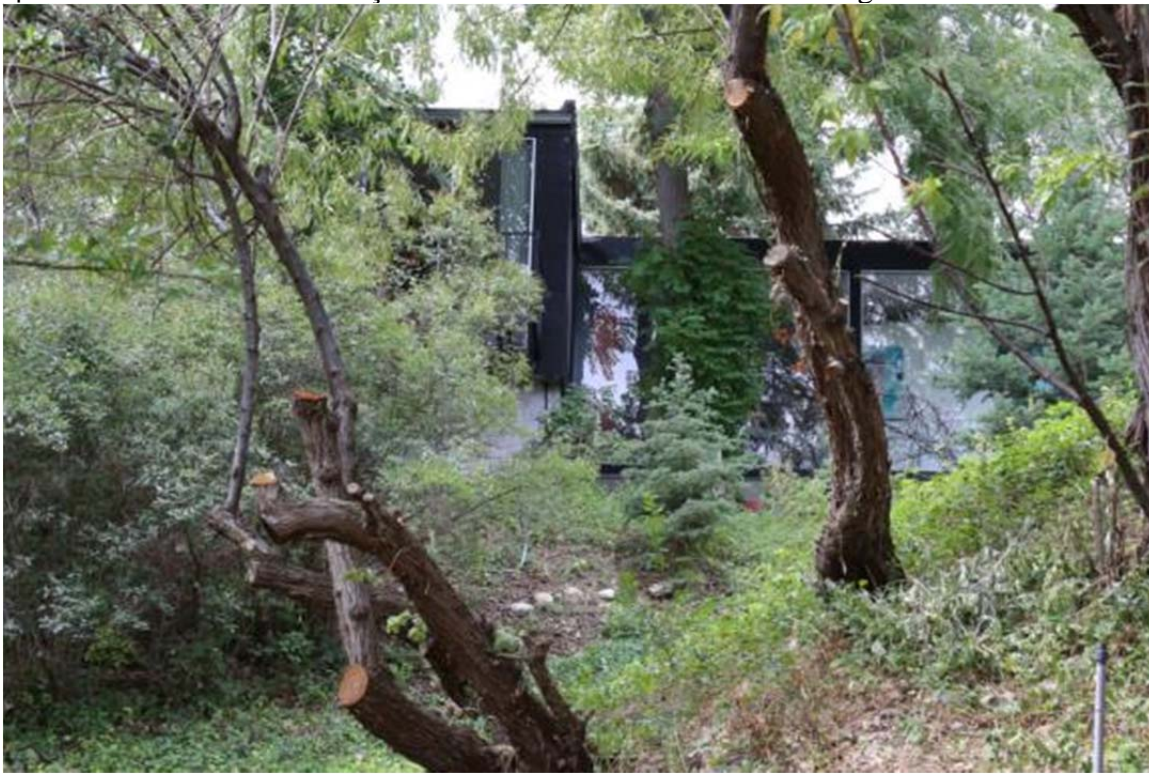
Photograph 8 of 20. View of South façade with site elevation. Camera facing north.

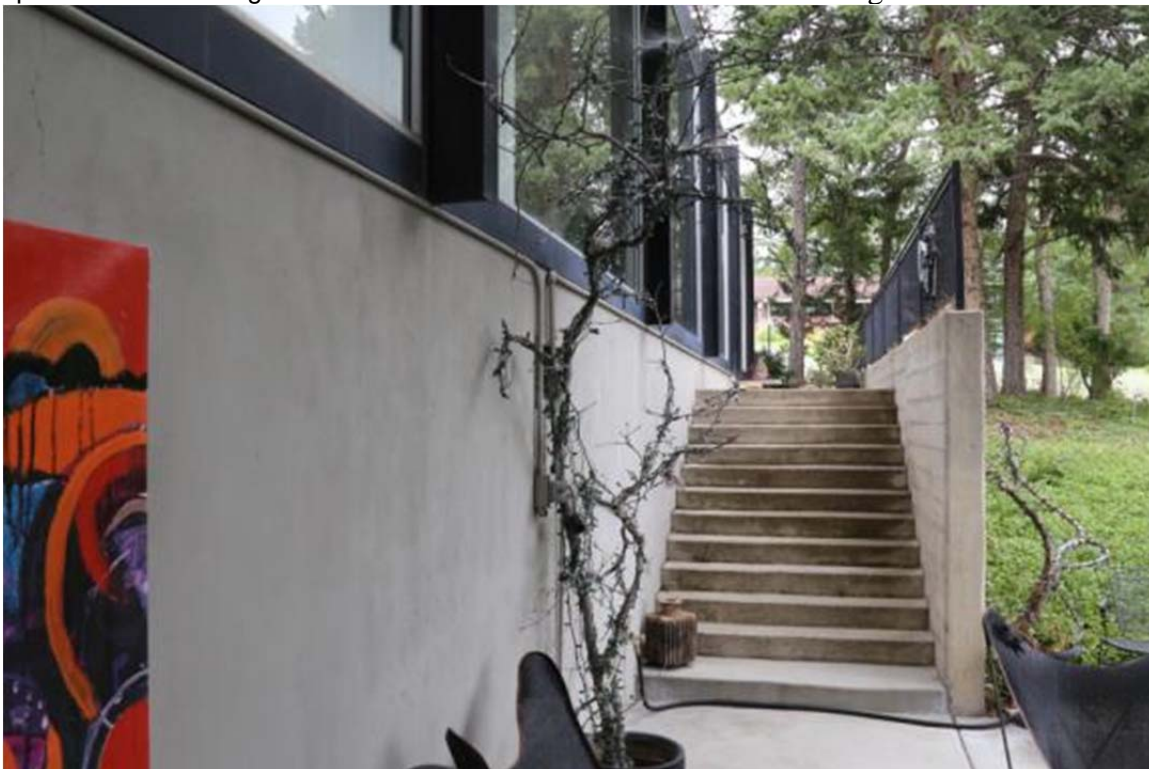
Photograph 9 of 20. Retaining wall and concrete staircase detail. Camera facing east.

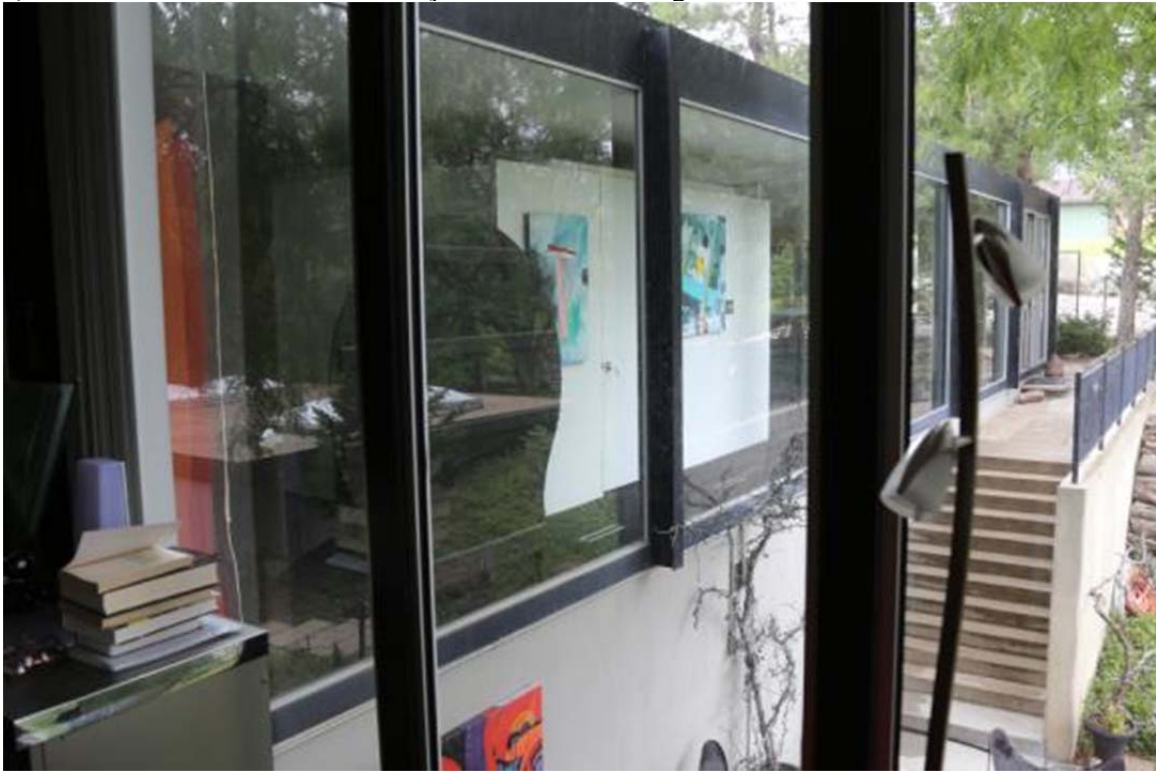
Photograph 10 of 20. View of Southwest façade. Camera facing northeast.

The west elevation was originally two bays wide, but has been increased 11 feet by the addition to the south elevation. The west elevation is composed of an original brick wall which comprises the side of the carport and a solid wood framed wall along the addition.

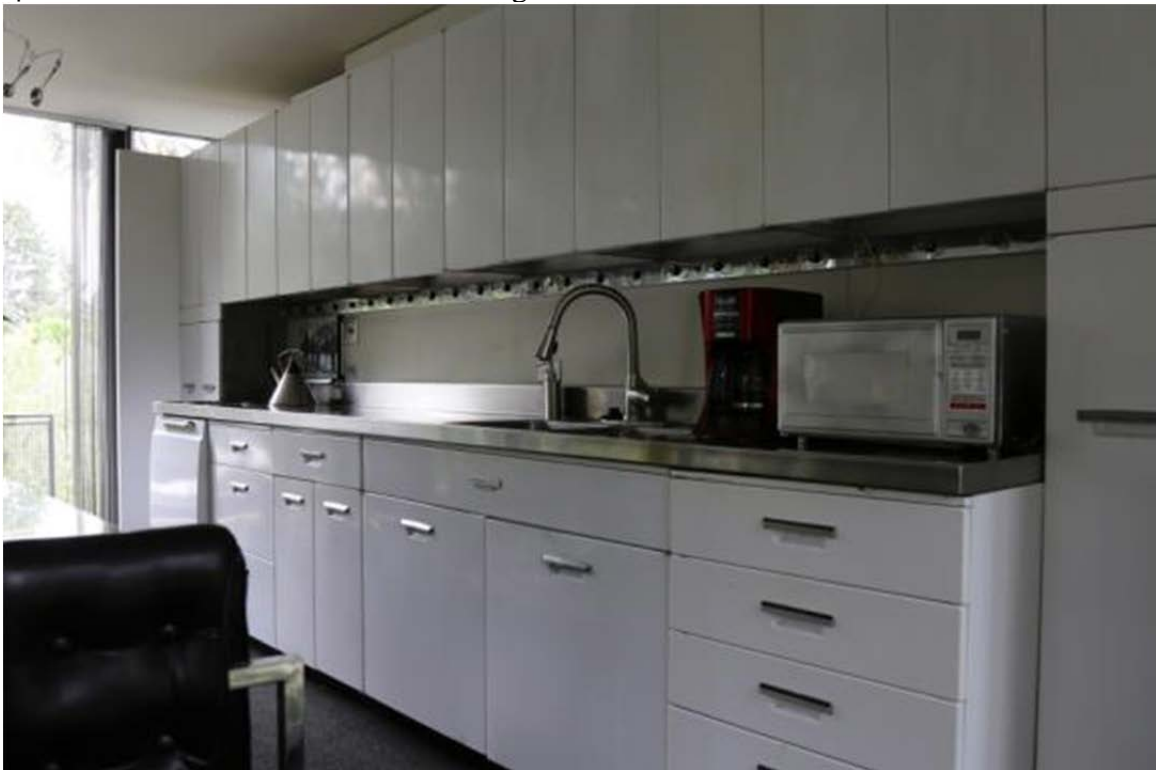
Photograph 11 of 20. Kitchen detail. Camera facing southwest.

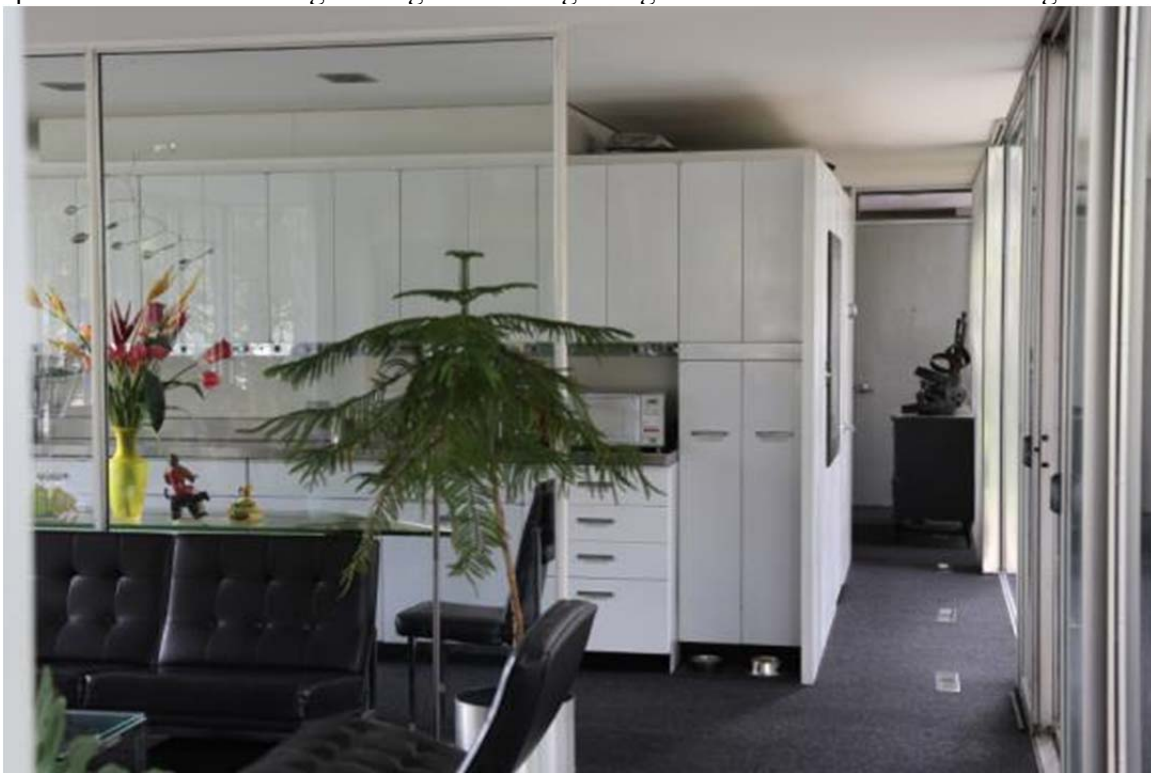
Photograph 12 of 20. View through living room and glazing wall to kitchen. Camera facing west.

The interior of the house continues the spatial themes of the exterior by confining interior walls to the center and leaving the perimeter glazing entirely free of obstruction. Most of the interior walls occur around the service core, which contain the kitchen, bathroom, utilities and storage. This rectangular core, which lies perpendicular to the large rectangle exterior side of the house, is near the west side of the house and separates the bedroom from the rest of the house. Except at its center, the walls of the service core do not reach the ceiling plane, creating the illusion of the core as an independent object. A floor-to-ceiling glazing wall separates the kitchen from the living room. This wall is transparent unless curtains are drawn closed. The living area was originally separated from external bays by perpendicular brick elements with narrow profiles invisible from the large rectangular exterior main façade. The free standing brick fireplace near the east side of the house created a visual barrier from the nearby road to the living room and kitchen. The carport bay on the west side of the house had brick walls on both sides, but nothing on the rear, creating the ability to see through the entire structure.⁷ The brick wall on the east-side of the carport provided privacy to the bedroom and contained the glass entry door. The brick on the west was thicker and allowed for a small amount of storage. All of the visible brick has been painted white, interior and exterior.

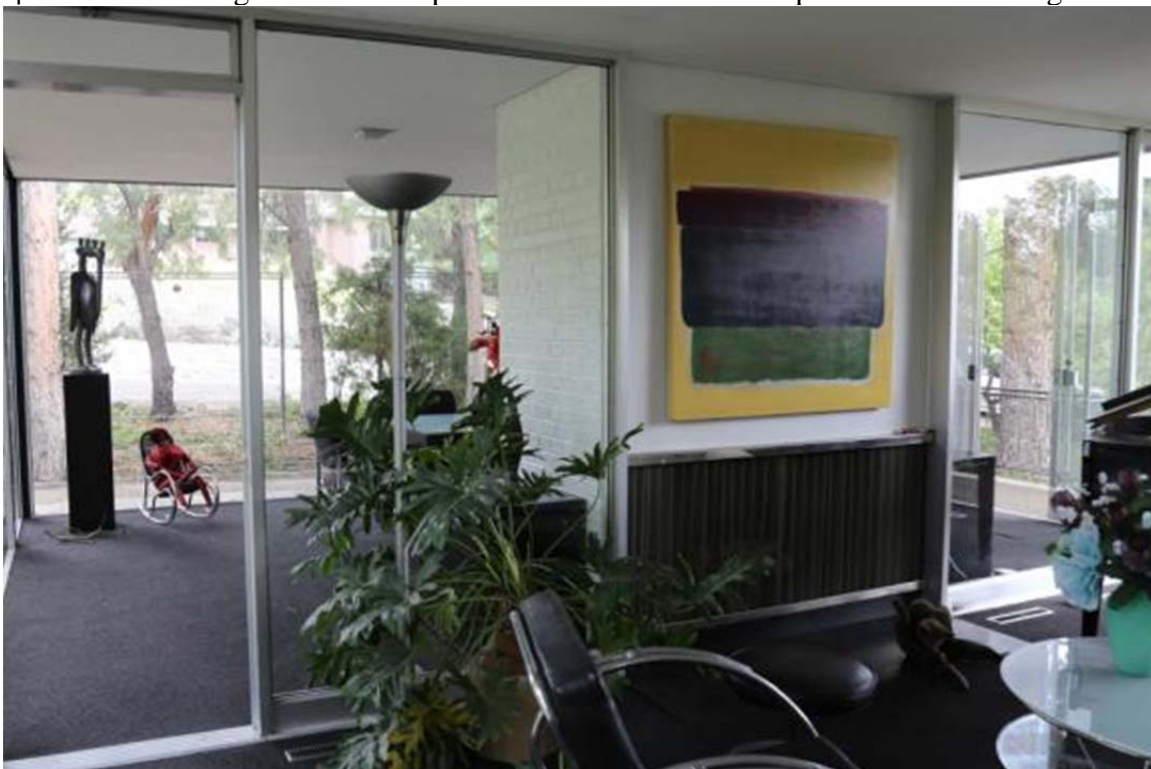
Photograph 13 of 20. Living room and fireplace with view to enclosed patio. Camera facing southeast.

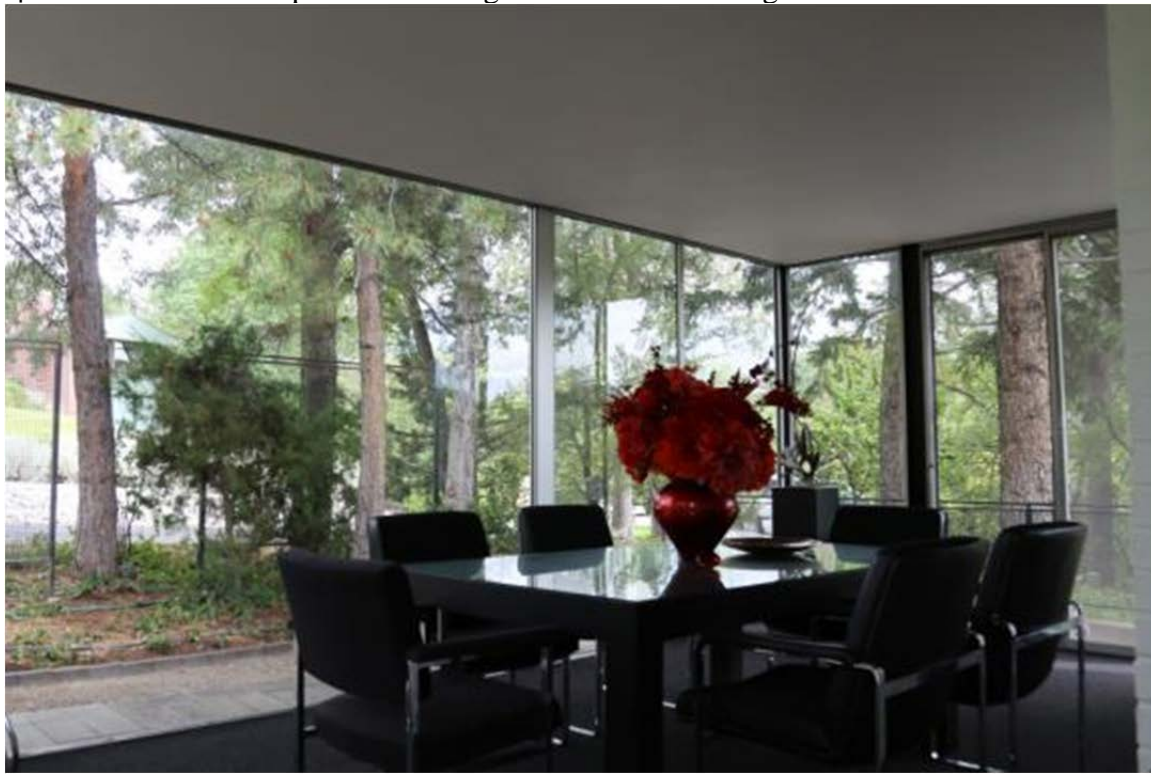
Photograph 14 of 20. Enclosed patio and dining room. Camera facing southeast.

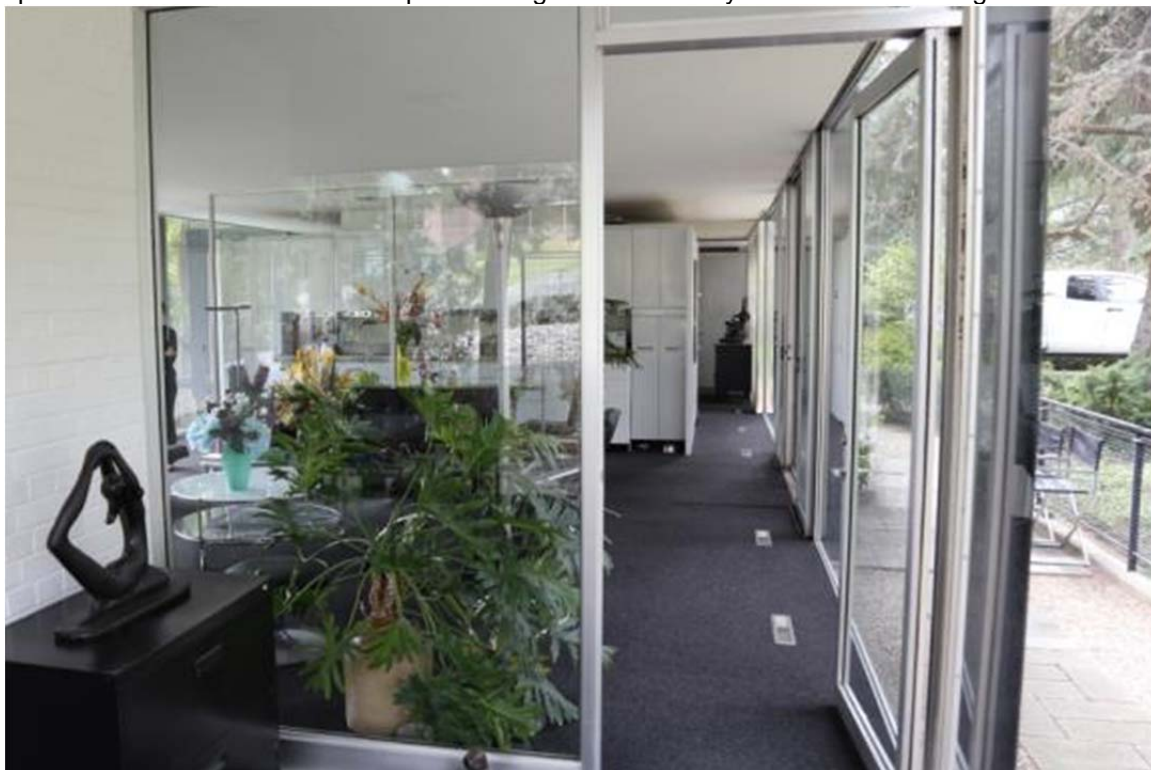
Photograph 15 of 20. View from enclosed patio through house to entry door. Camera facing west.

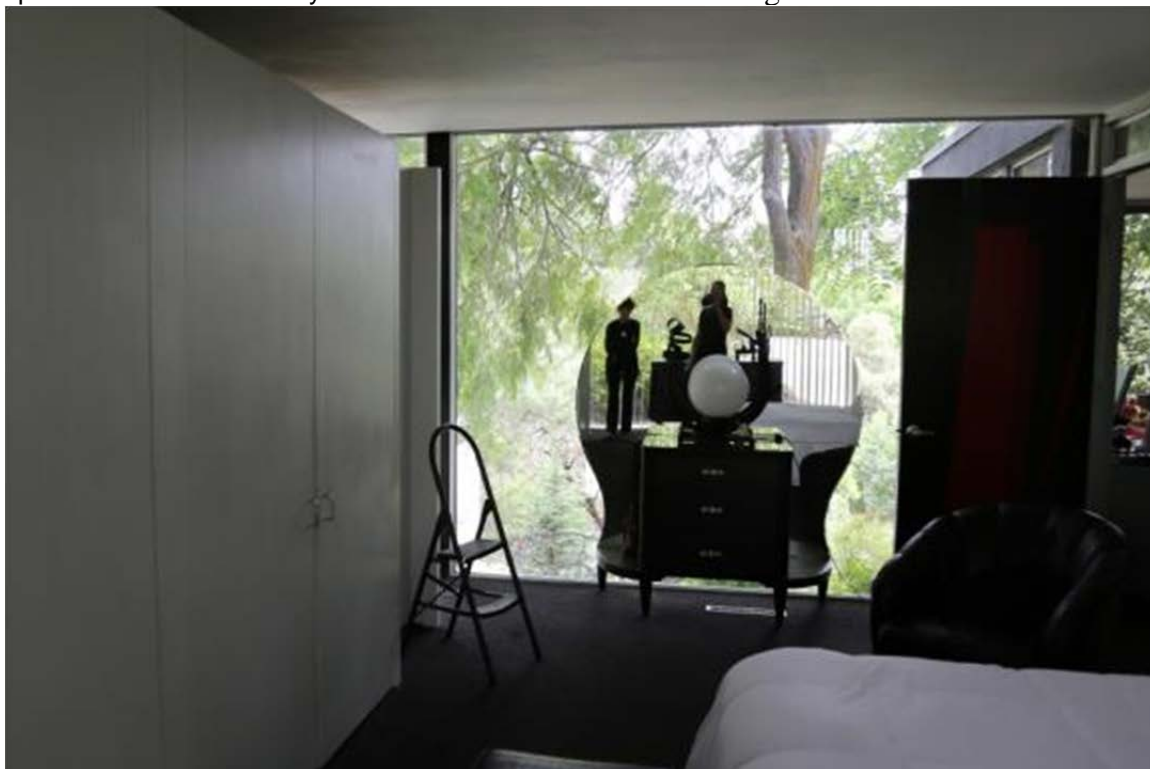
Photograph 16 of 20. View of utility closets and bedroom. Camera facing south.

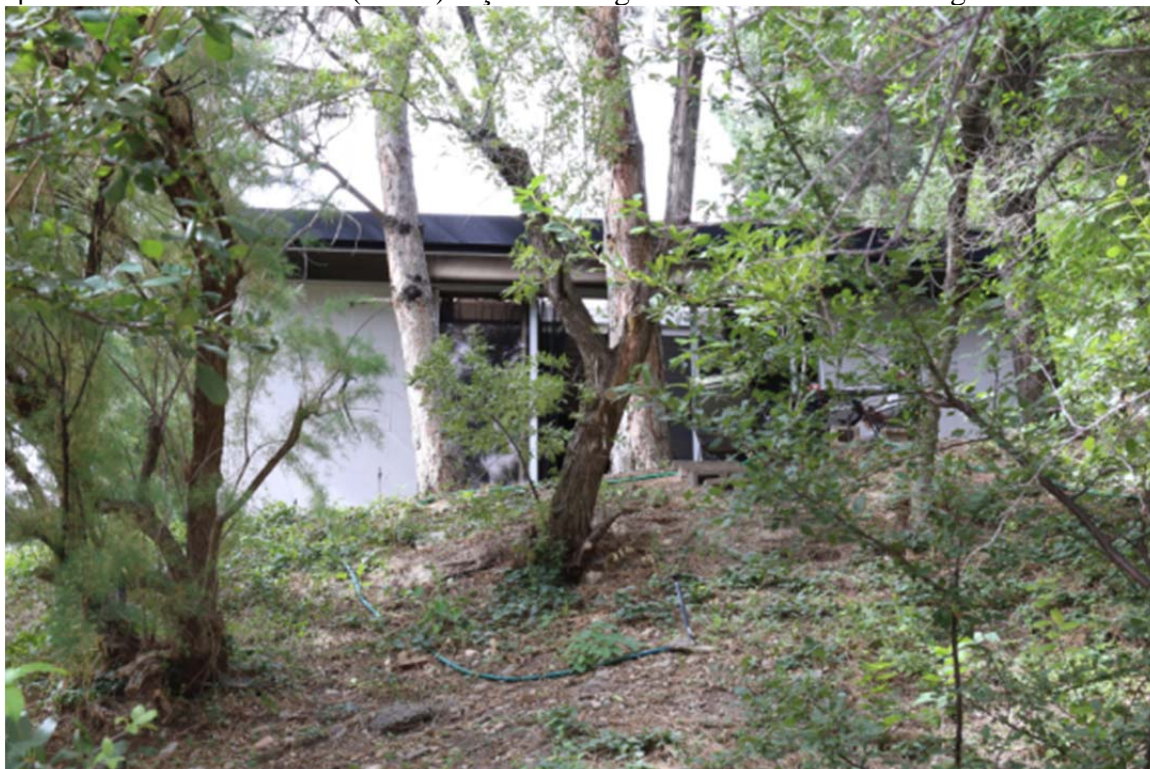
Photograph 17 of 20. View of main (South) façade of Sugden studio. Camera facing north.

Also located on the property is a 24' x 26' concrete and steel studio designed by John Sugden and constructed in 1964.⁹ He used the building as an architectural studio and apartment between 1964 and 1969.¹⁰ The studio is located to the south of the main house and is significantly lower in elevation than the house, allowing the house to remain surrounded by the views and vegetation.¹¹ John Sugden's architecture is also reflected in the concrete, steel and glass studio. The high concrete walls mirror the form pattern and attention to detailing of the Sugden House concrete retaining wall. The concrete walls allow the studio interior to be completely open with steel beams supporting the built-up low-slope membrane roof structure. The interior living space is minimalized, with similar interior fixtures to the main house. The only penetrations to the structure are skylights and a full-height double door-width glazing entryway providing southern light and views. The studio is also a contributing building.

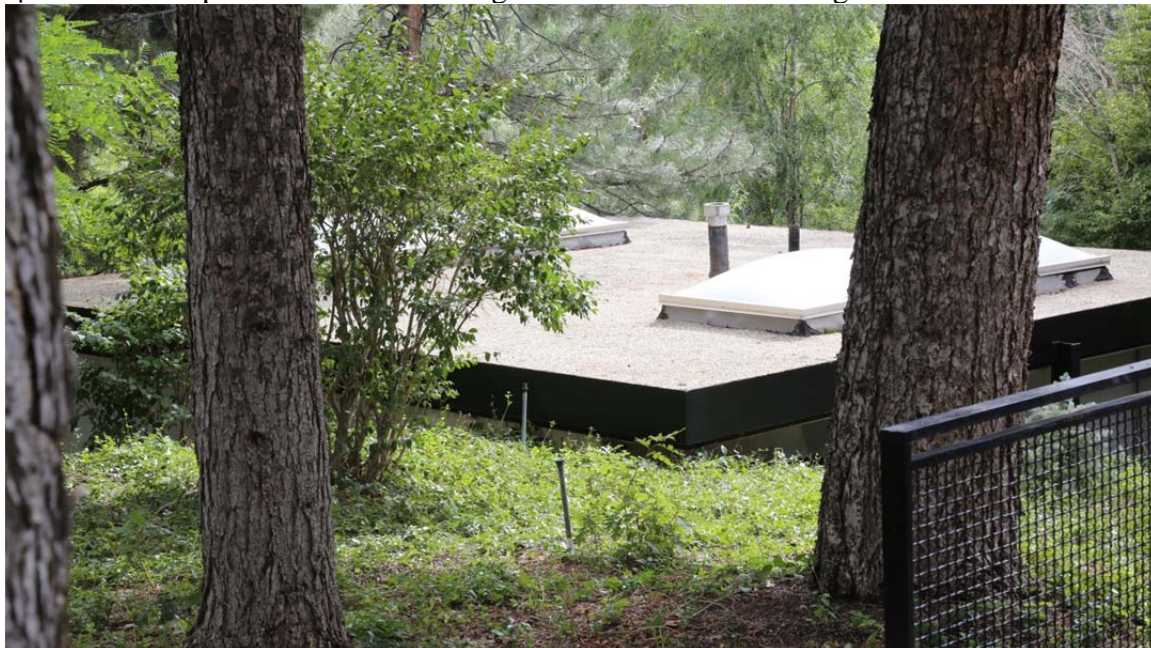
Photograph 19 of 20. Exposed view of John Sugden Studio. Camera facing southwest.

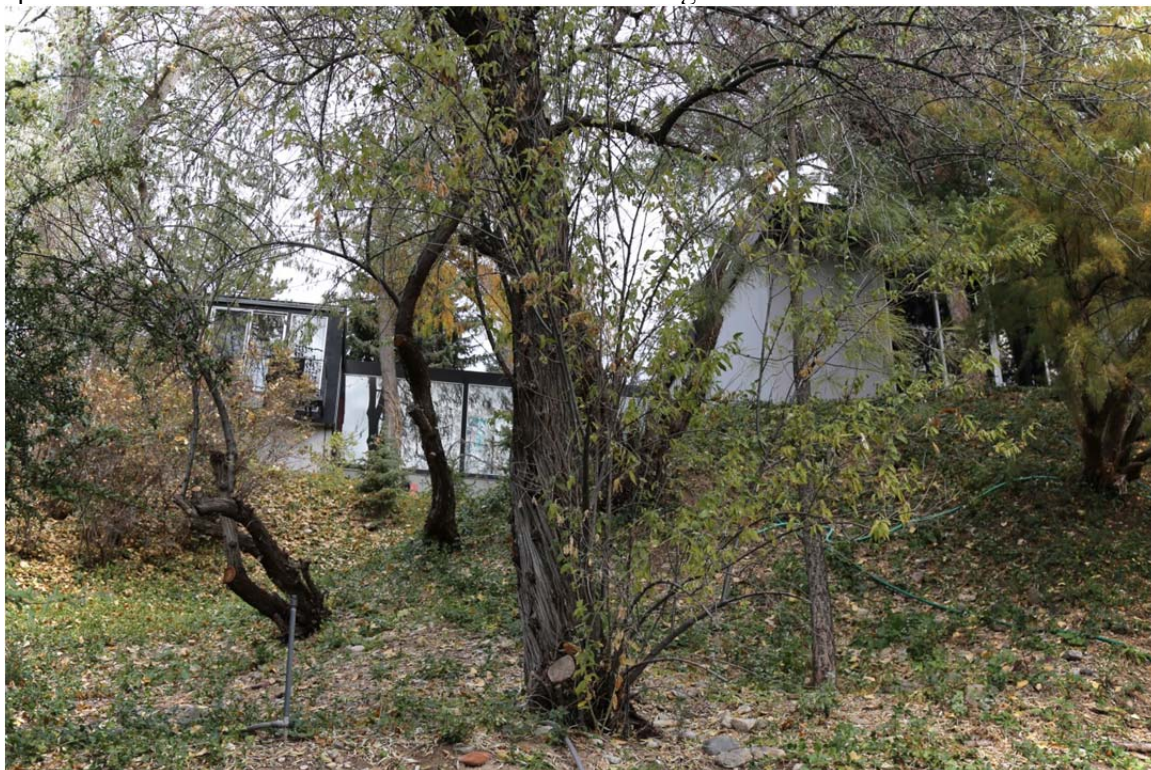
Photograph 20 of 20. View of house and studio. Camera facing north.

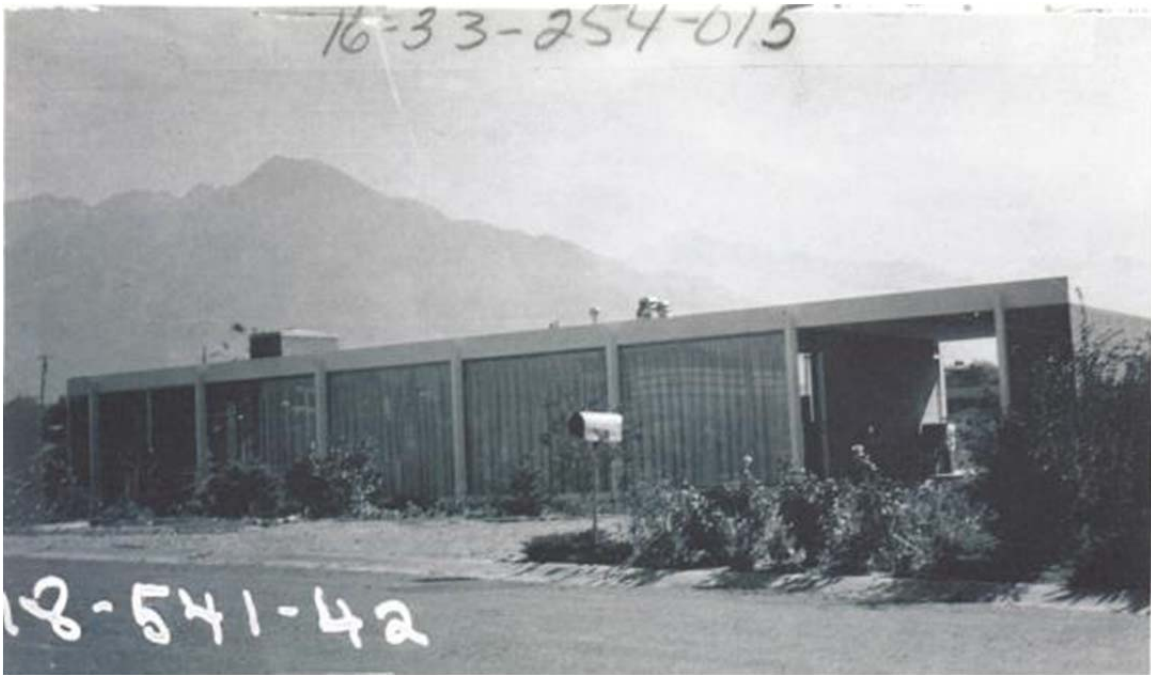
Figure 1. Tax Assessment Photograph circa 1956. Camera facing south.

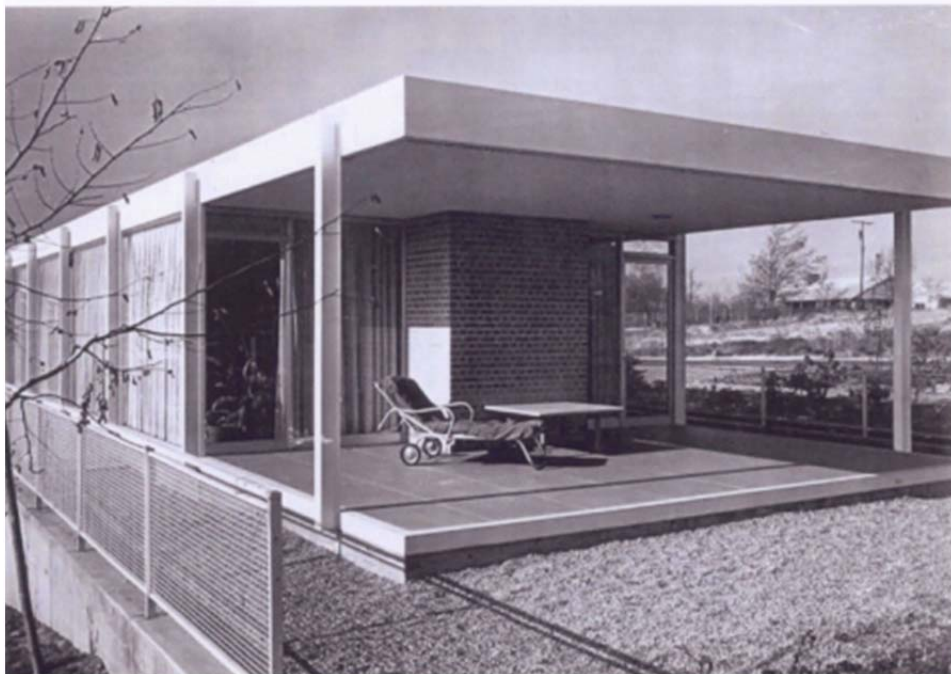
Figure 2. Original East façade Photograph circa 1956. Camera facing west.
