KING COUNTY HISTORIC SITES SURVEY
Inventory Sheet

NAME
Historic Dr. Trueblood House (Kirkland Land Improvement Co. TR)
Common _____ Site No. _____

LOCATION
Number & Street 127-7th Avenue Not for Publication _____
City or Town Kirkland Zip 98033
Incorporated Unincorporated Community name Kirkland
Congressional District 2 Community Planning District Nor Kirk
State Legislative District 45 Zoning Single Fam. Res. 7.2
County Council District 3 Shoreline Environment _____

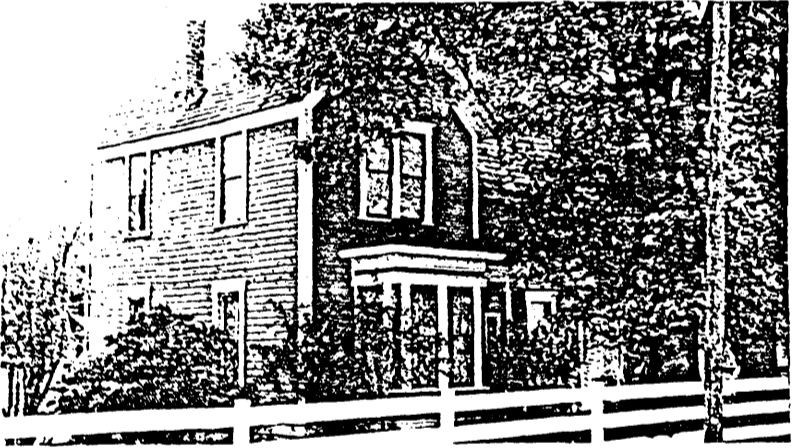
PRESENT & ORIG. PHYSICAL APPEARANCE
The house is Victorian farm house in style; it is basically square, approximately 31' x 33', two full stories with attic. The foundation is concrete block and wood pier. There is a crawl space and a small "root cellar" at the southwest corner.
The roof is a high offset gable with wood shakes. The house is wood frame; the exterior covering is shiplap siding with corner boards. There is a single chimney offset on the east slope of the roof. The roof has projecting eaves with boxed cornice and sloped soffit, verges are projecting with cornice boxed and plain. There is a plain wood frieze running just below the eaves on all sides. All windows are double hung with slip sills, plain surrounds with simple entablatures, except for two second story windows on the east face which have heads formed by a frieze under the eaves and no entablature. There is one bay with four windows on the front 1st floor, double hung windows (approx. 3' x 8') plain surrounds with a continuous frieze above and a hipped shake roof. The main entrance is from a front N.W. corner porch. The porch is wood floored, has a separate roof, one wood support post and gingerbread at three upper corners. The front door is wood with 15 glass panes, a plain surround with a simple entablature.

The house appears very much as it did in the 1890's, no major structural changes have been made.
There is a shed roofed addition added in ca. 1930 to the back of the house approx. 10' x 10' and a large deck off this addition in 1976 approx. 18' x 20'. The lot is level with a slight southerly slope.
