**KENTUCKY HISTORIC RESOURCES** Individual Inventory Form

Resource # ME-H-84 Mercer County

Continuation sheet: U.S. Post Office/Harrodsburg (Me-H-84)

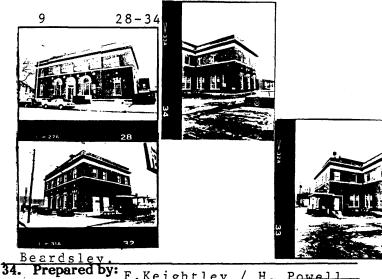
The Harrodsburg Post Office is a two-story brick structure located on one of the most prominent corners in downtown Harrodsburg. It has five bay facades on both Main and Lexington Streets. The central section of the Main Street facade projects forward approximately one foot from the main plane of the building. The projecting section contains the central entrance flanked on either side by a single window. The doorway itself has an arched door surround with both a fanlight and a transom. The windows to either side suggest a Palladian motif through their tripartite configuration. The windows nearest the corners of the building are rectangular in shape, but recessed within a brick arch similar in shape and size to the windows closest to the door. The rectangular windows are accented by jack arches of brick and stone as are the windows on the Lexington Street facade of the building. The second floor windows are smaller and simpler that the first story windows. They are accented by brick jack arches and a stone keystone. The roofline meets the facade with a wide stone cornice and overhanging bracketed eaves. There are gabled dormers in the low hip roof.

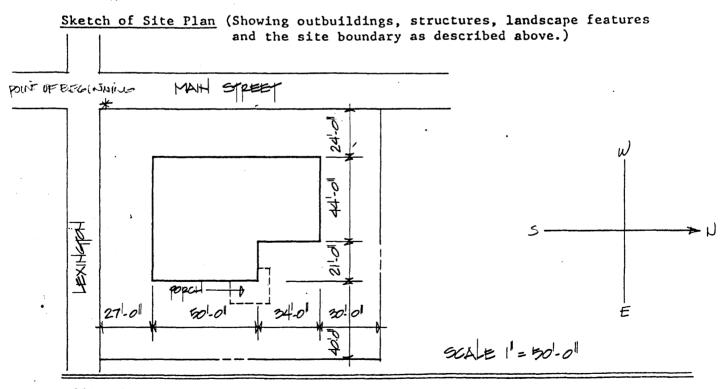
From a point of beginning 24 feet west and 27 feet south of the southwest corner of the building; then north 141 feet to a point; then east 129 feet to a point; then south 141 feet to a point; then west 129 feet to the point of beginning.

The boundary was chosen to follow the property lines historically associated with the Harrodsburg Post Office.
