**NATIONAL REGISTER OF HISTORIC PLACES
INVENTORY -- NOMINATION FORM**

George Stanford Farm

6093 Stanford Road

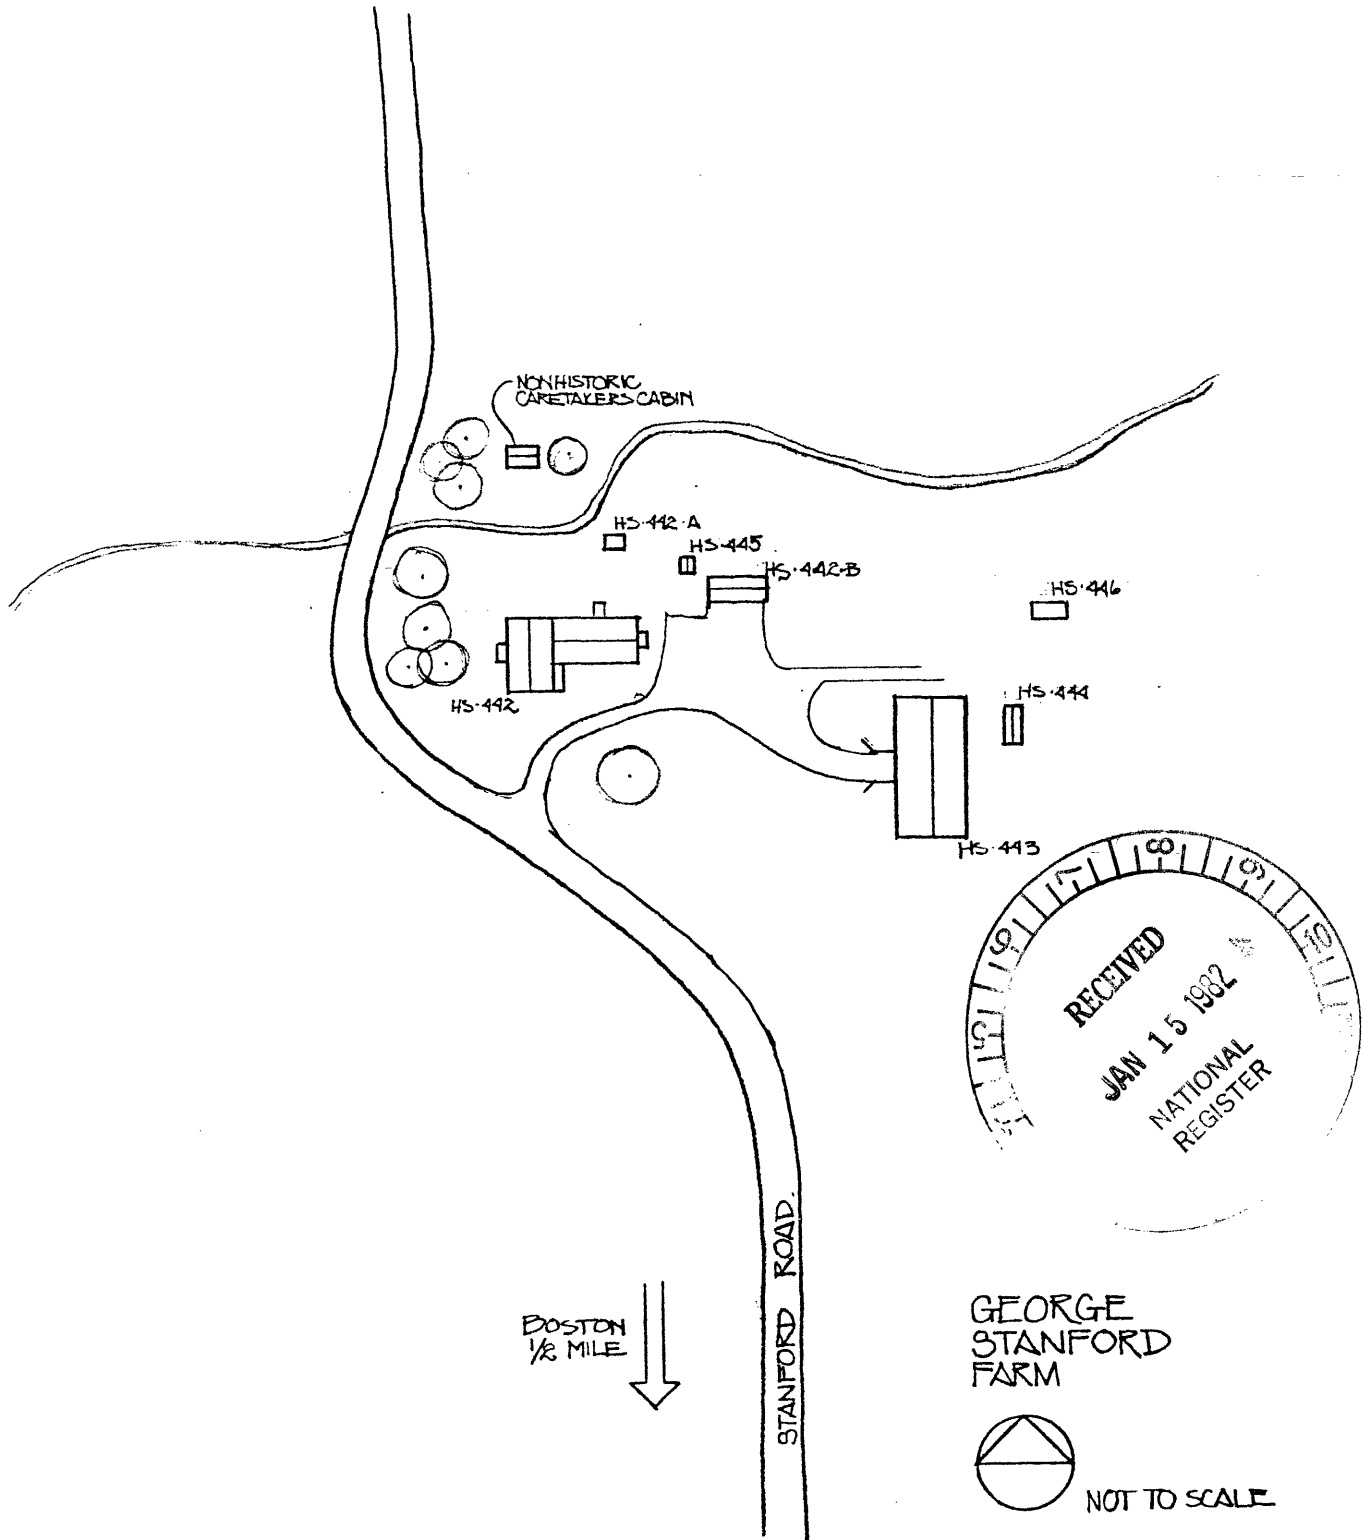
Illustration 2 GEORGE STANFORD FARM

Site Map (sketch, not to scale)
George Stanford Farm complex
Boston Township, Ohio

The George Stanford Farm is located on a rural section of Stanford Road, just north of the small village of Boston. It enjoys a commanding view to the west of the Cuyahoga River and the adjacent Ohio and Erie Canal (see Illustration Nos. 1 and 2). The farm currently consists of a house, a barn, and several outbuildings, all included in the List of Classified Structures (LCS) for the Cuyahoga Valley National Recreation Area as National Park Service Management Category B (Should Be Preserved) historic structures.
