KENTUCKY HISTORIC RESOURCES
 Individual Inventory Form

Resource # HY-NC-71
 Henry County

1. Name of Resource:
 Isham Henderson House

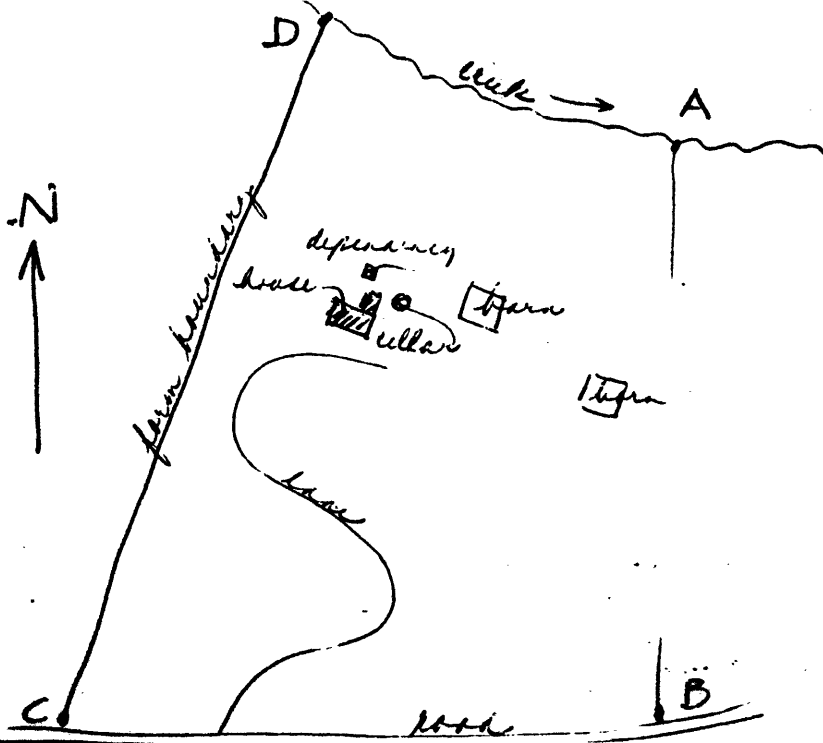
44. Site Plan (and boundary description and justification for N.R. sites):

Site enclosed by A - B - C - D as shown. Includes stone house, frame dependency and root cellar. Barns are not old (N.C.). B - C is with the road. C - D is the present farm boundary. D - A is on a branch of Town Creek.

Boundary drawn to include wildlife preserve on stream and part of road frontage of farm.

House, dependency and root cellar are contributing.
