FORT SHAW

Cascade County, Montana

Fort Shaw Historic District  
Fort Shaw, Montana, Cascade County  
Photo by : Stuart S. White  
Fort Shaw, MT  
Date: April 23, 1979  
View: Northeast Corner

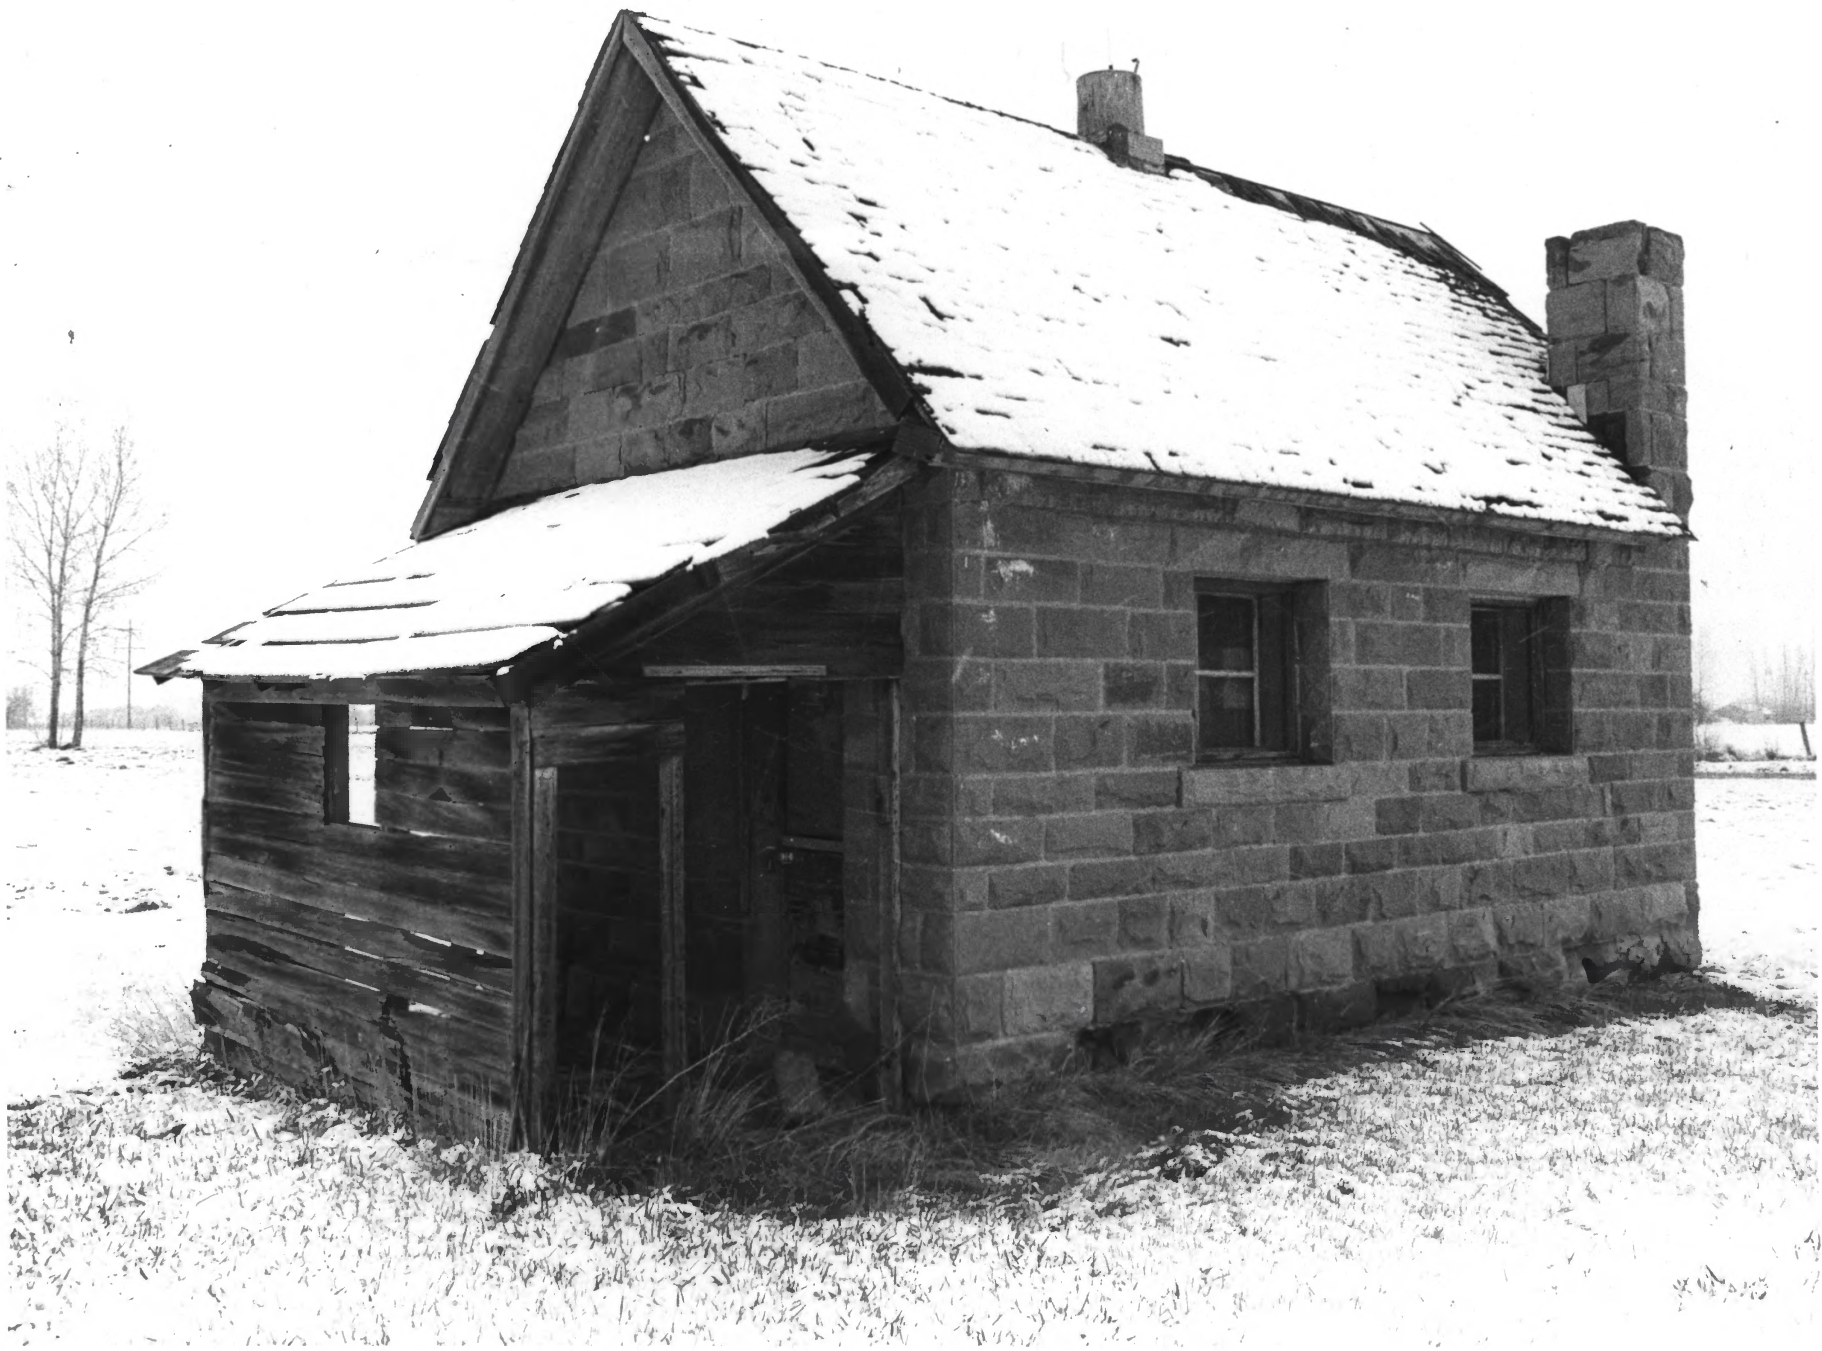
Building #1, Wash House

Northeast View: note poor

condition of foundation

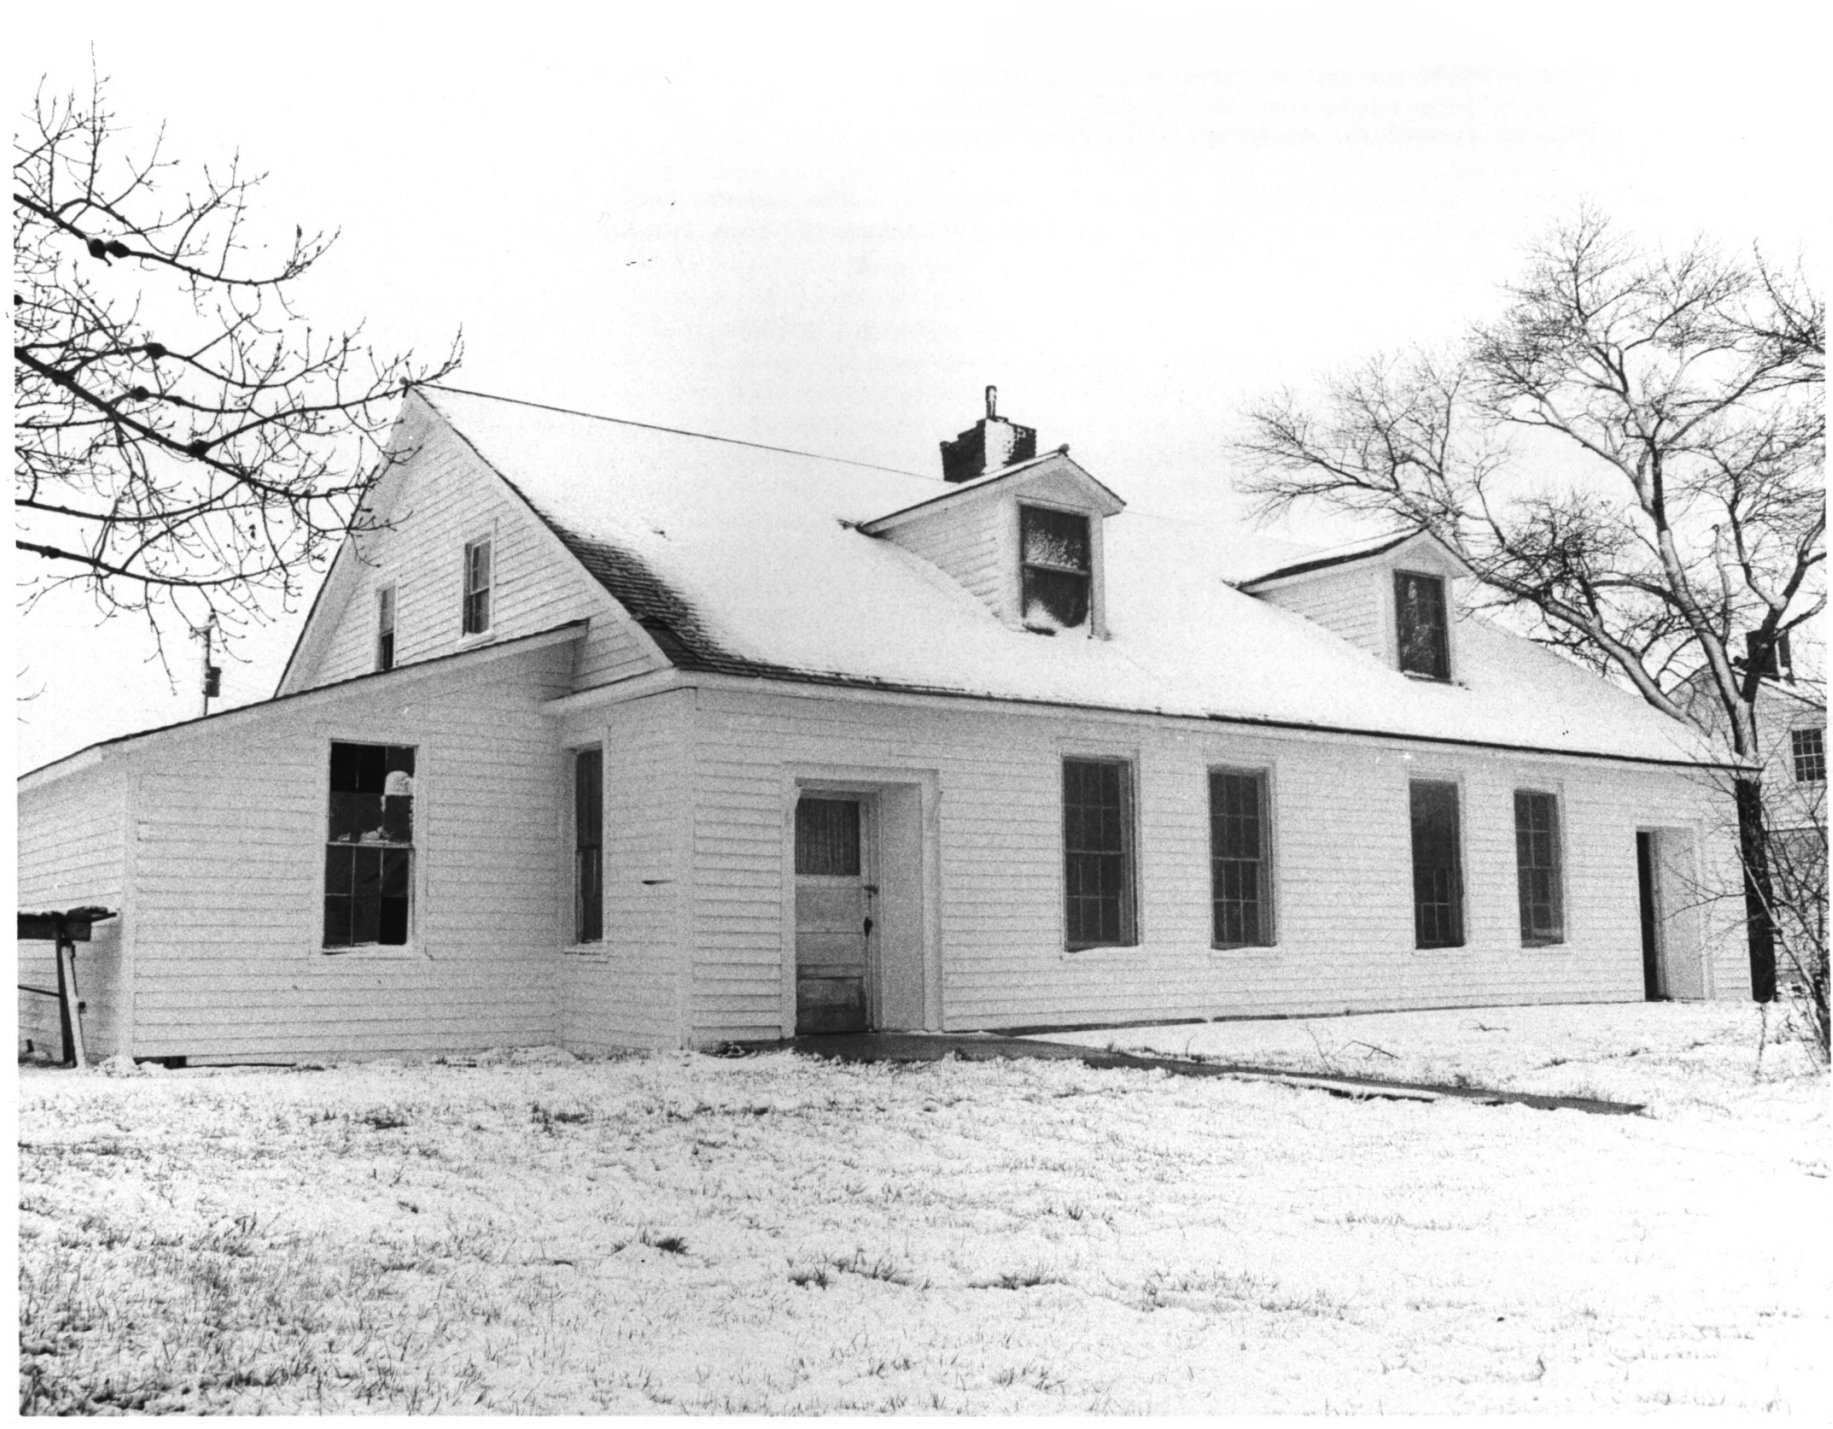
1. Fort Shaw, Montana
2. Photo taken by Stuart S. White on 4/23/79
3. General view of Building #3, the Officer's Quarters. The camera angle is from the northeast. We hope to rebuild the porch that was once on the front of this building and it would be identical to the porch on Building #4.

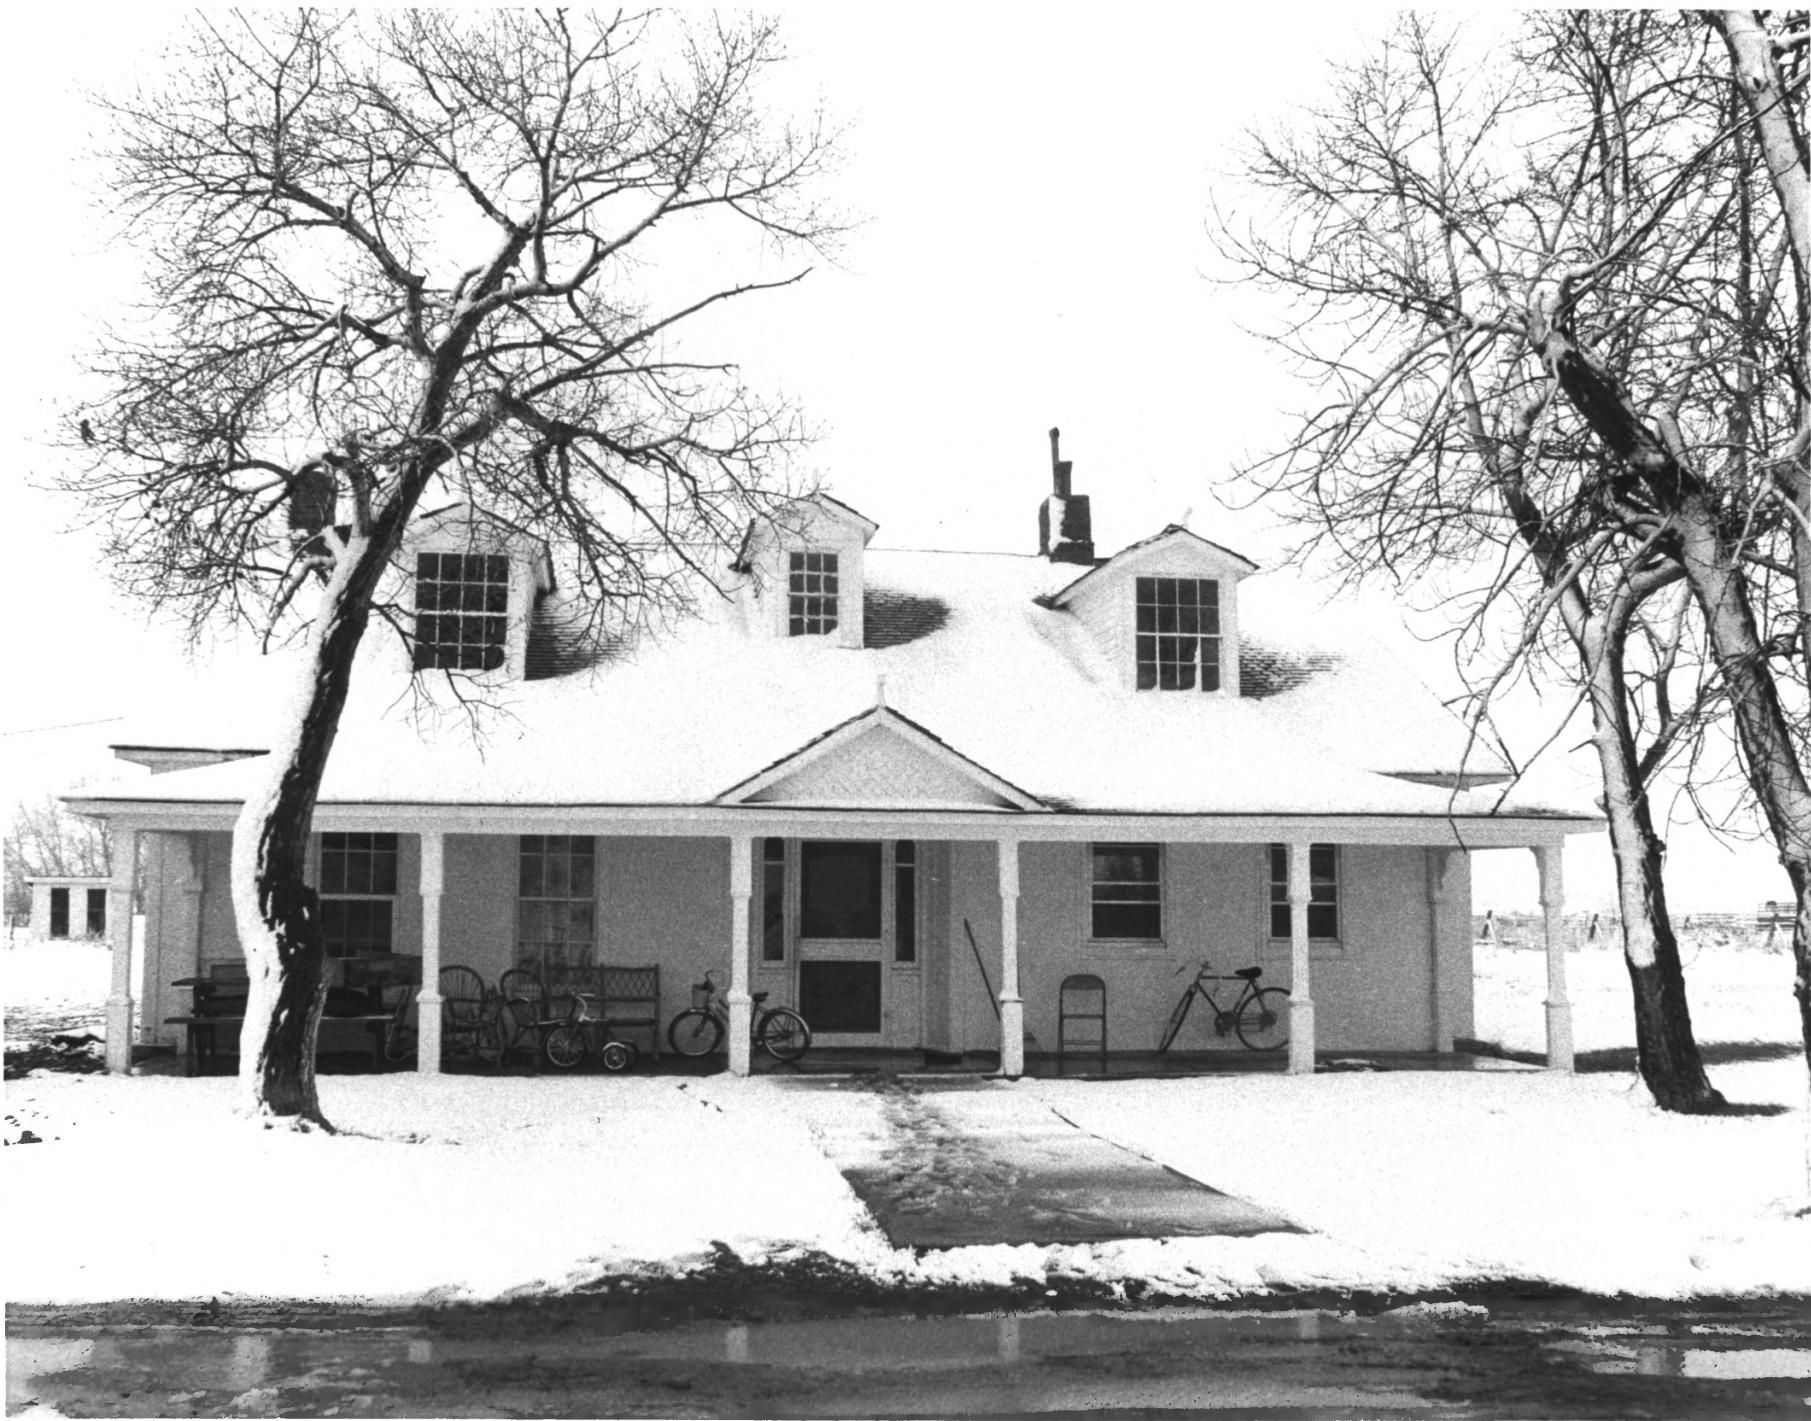
1. **Fort Shaw, Montana**
2. **Photo** taken by Stuart S. White on 4/23/79
3. **The camera angle is from the north and shows the Cammanding Officer's Quarters. This is Building #4 in the report. Note that the porch is still intact and the building has been changed little since the post was abandoned eighty-eight (88) years ago.**

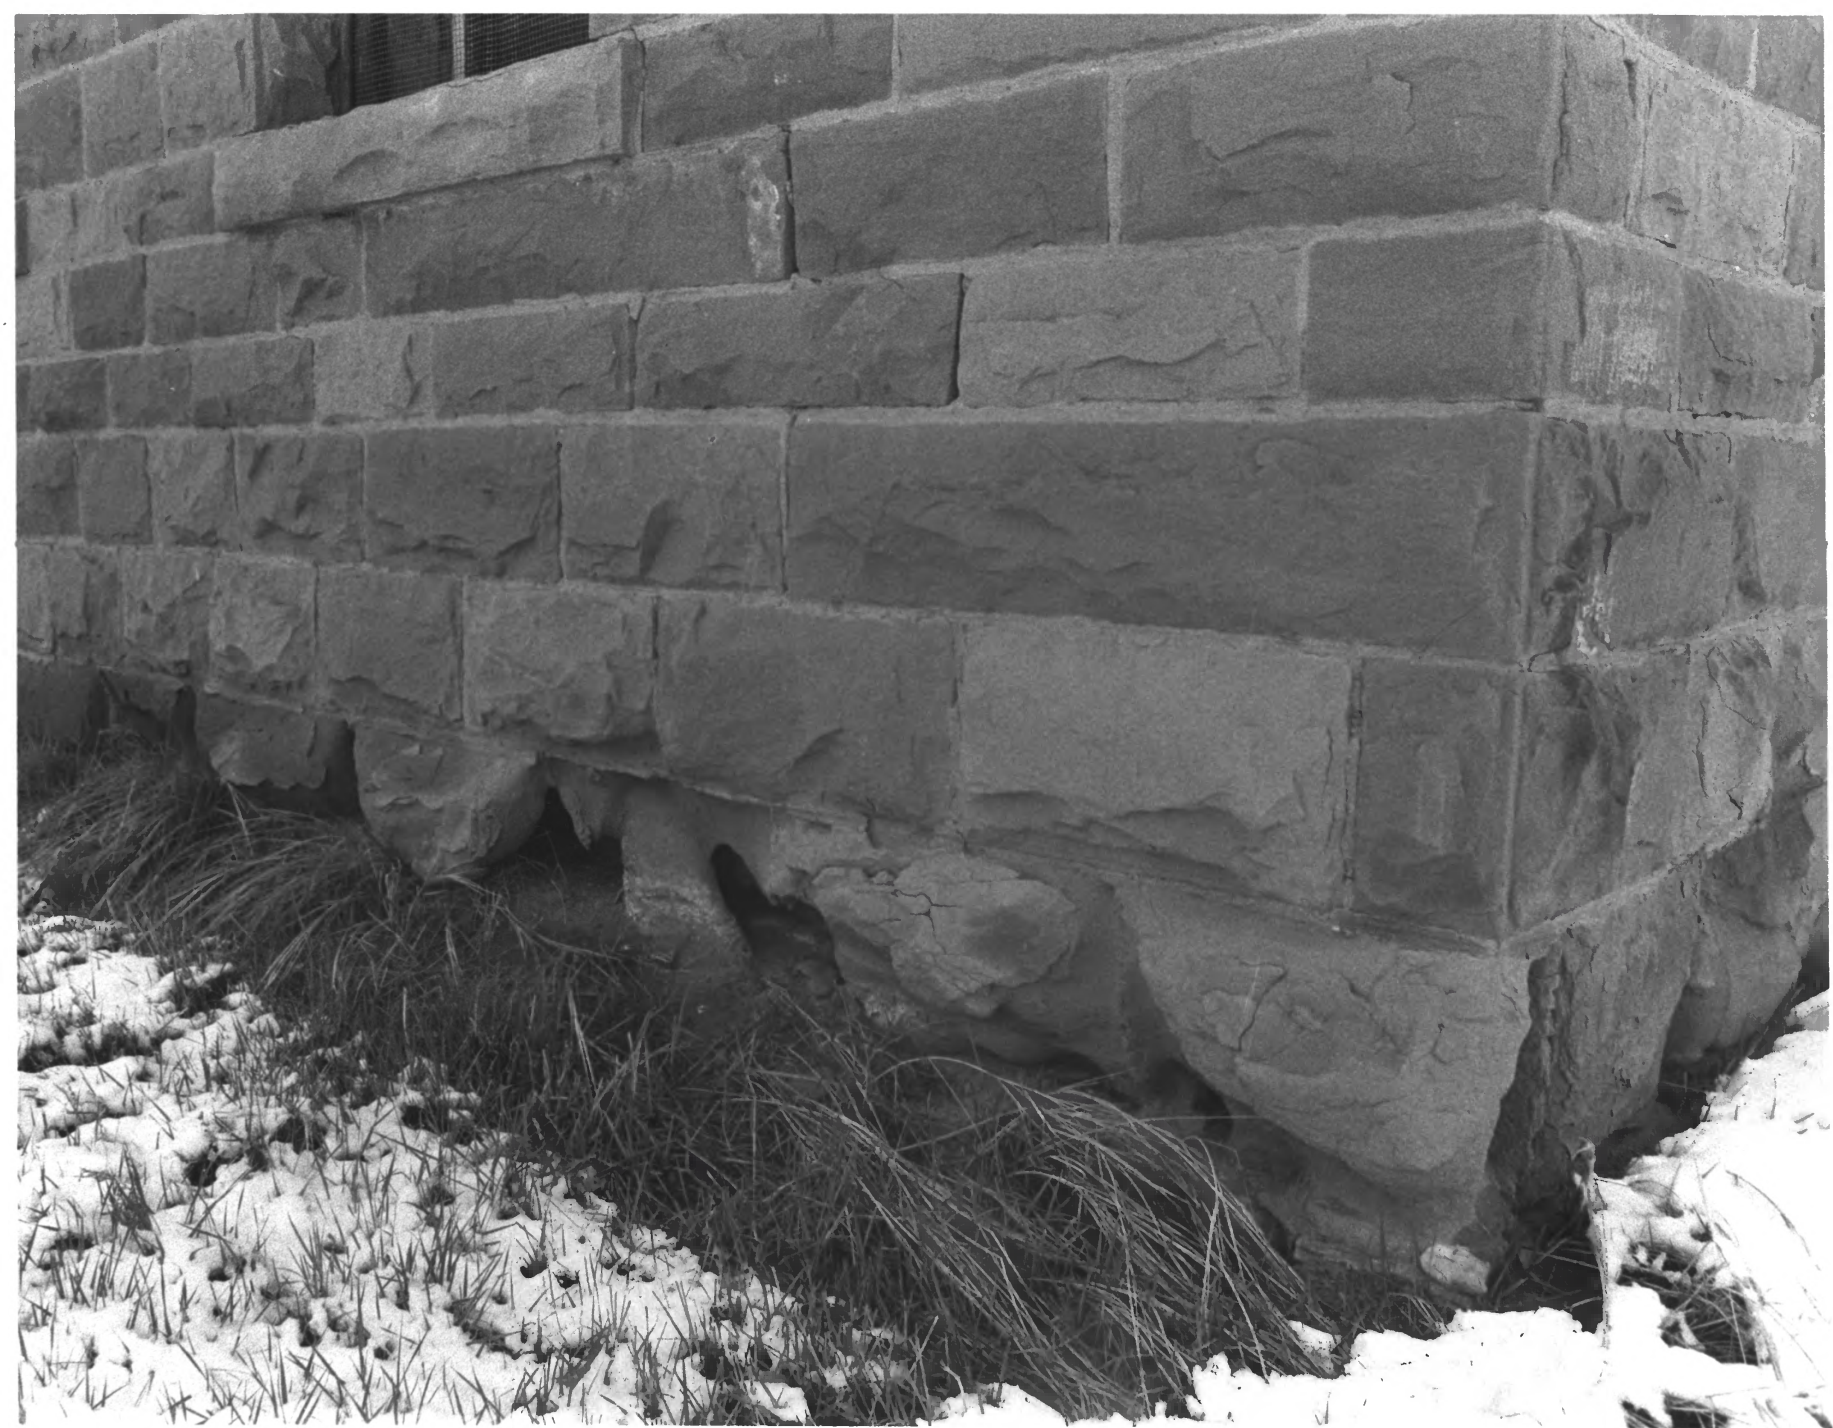
1. Fort Shaw, Montana
2. Photo taken by Stuart S. White on 4/23/79
3. The photo is taken from the southeast, showing the deterioration of the foundation of the wash house. As can be seen, the base of the foundation is eroding away and this represents the greatest structural problem for Buildings 1 & 2.

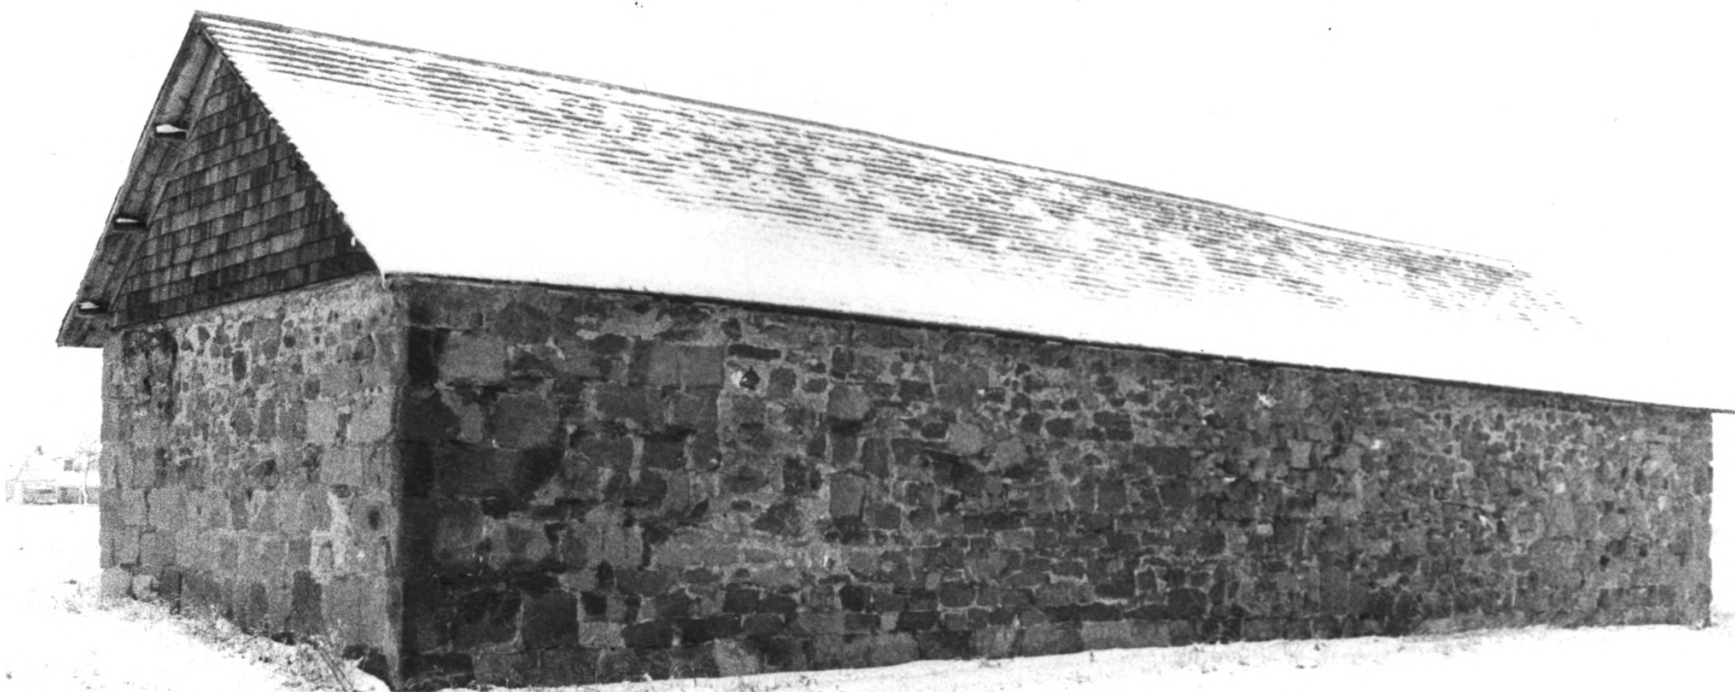
# 5

1. Fort Shaw, Montana
2. Photo taken by Stuart S. White on 4/23/79.
3. Photo is of the stable with the camera angle from the northeast, viewing towards the southwest.

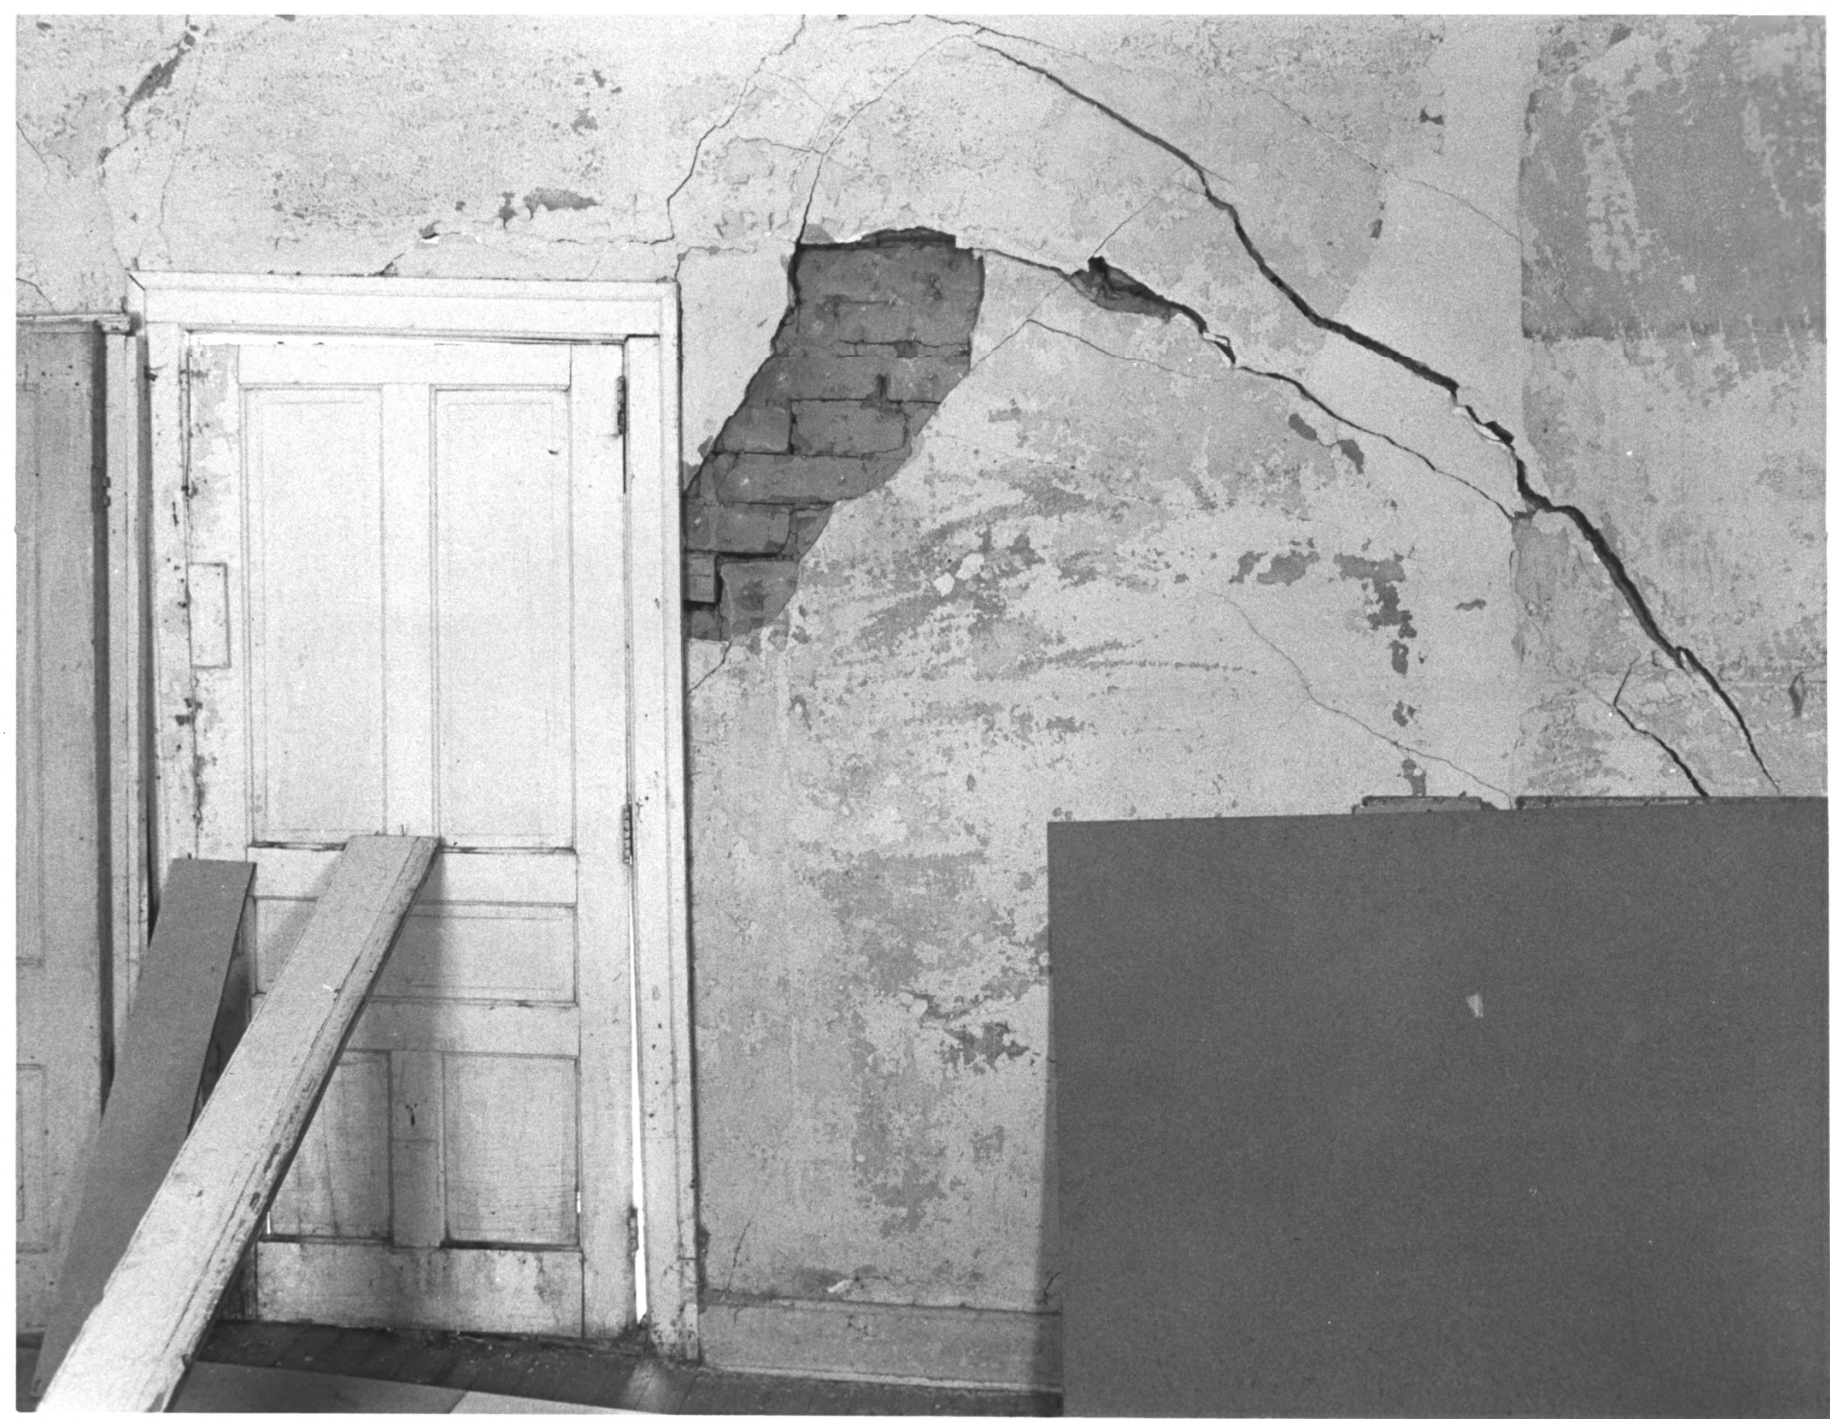
View: inside Building #3

1. Fort Shaw, Montana
2. Photo taken by Stuart S. White on 4/23/79
3. Photo is taken inside Building #3, Officer's Quarters. The picture clearly indicates a severe crack in the east wall. You can also see the adobe bricks with the nails driven in to support the plaster.

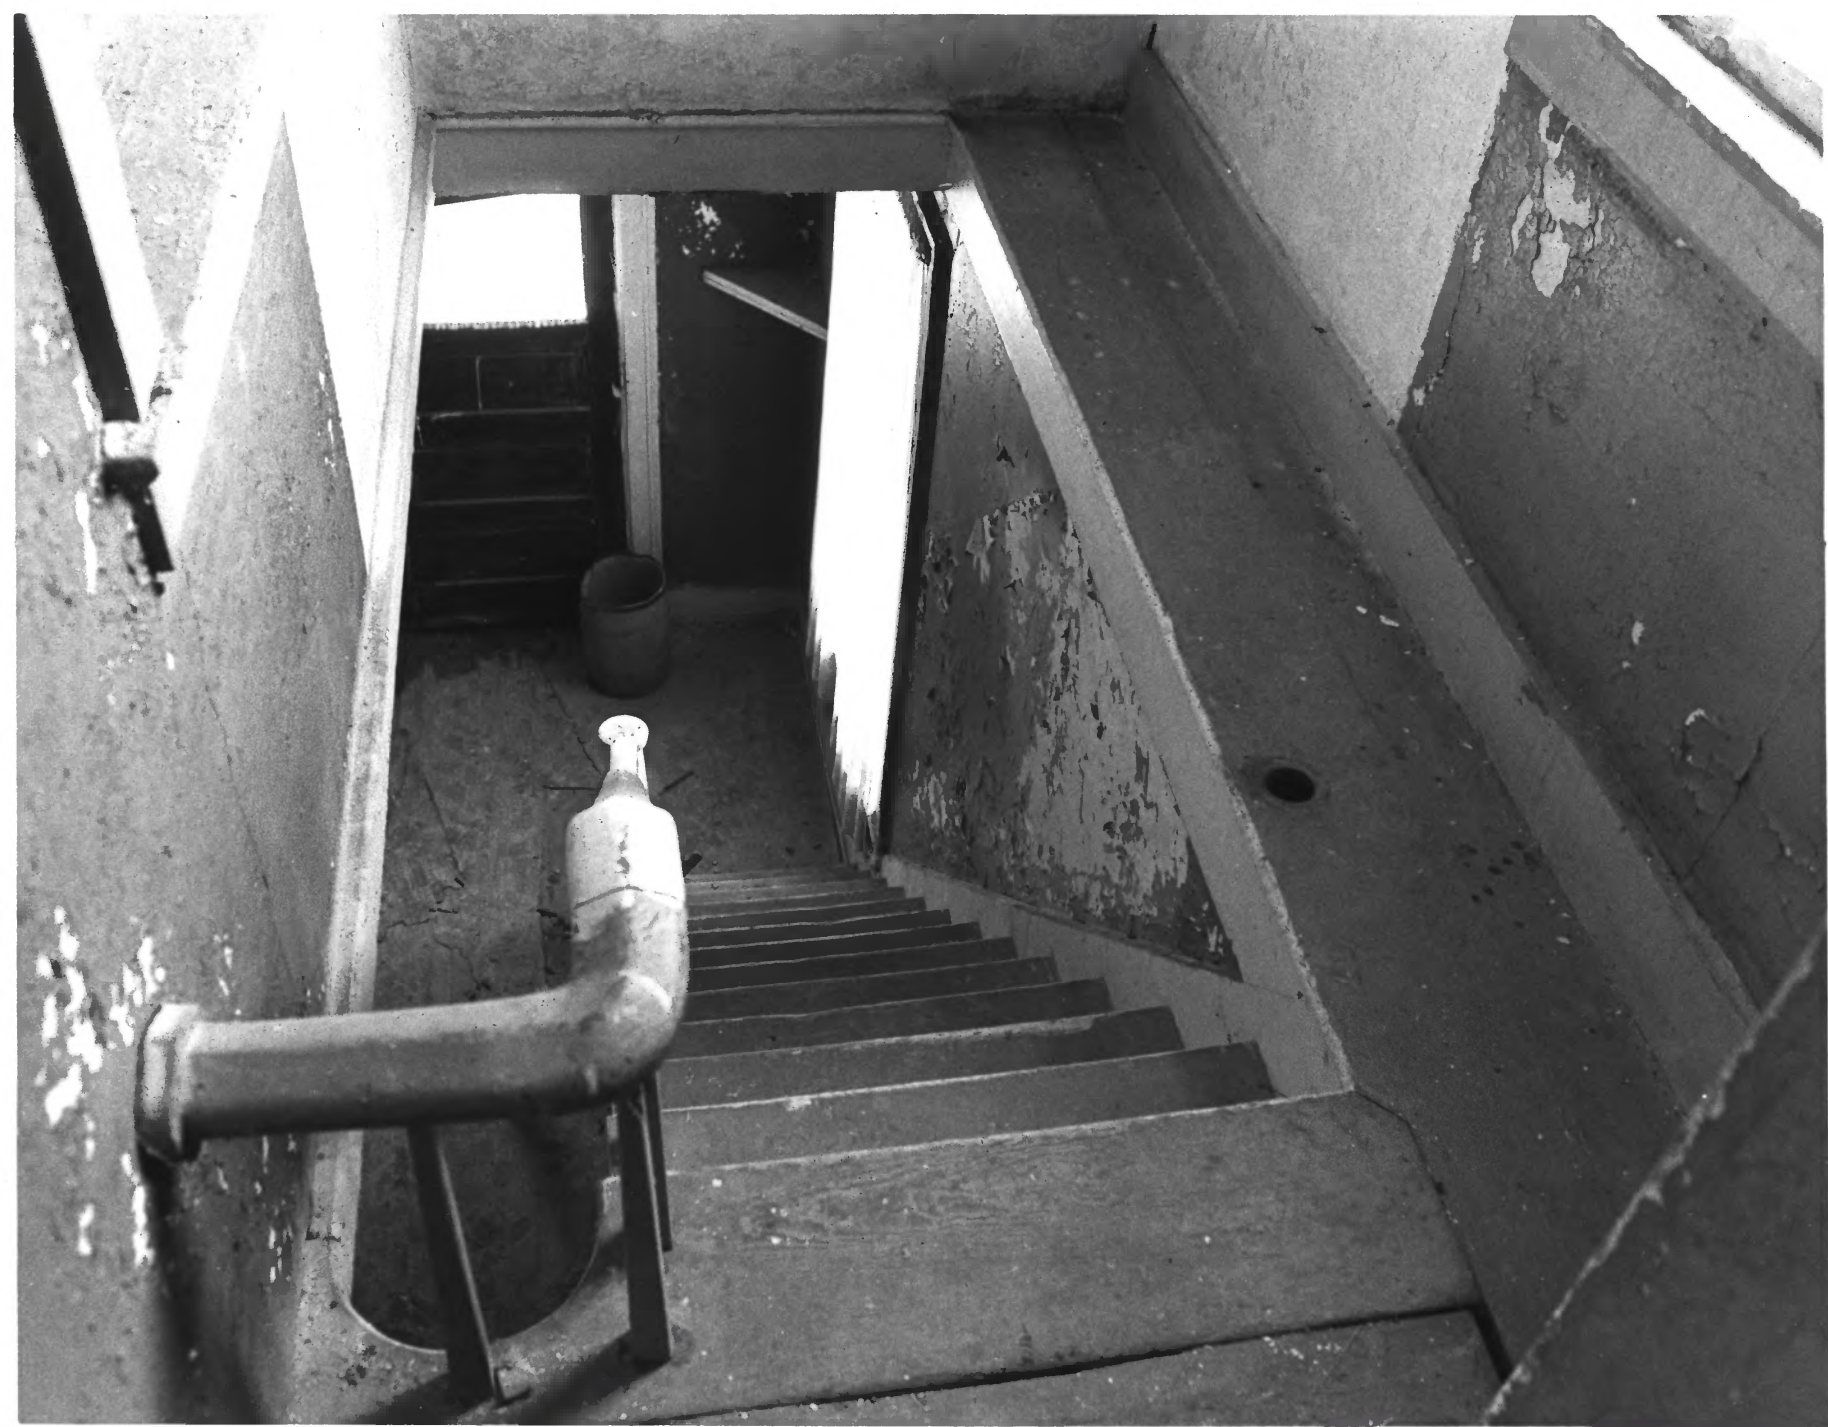
View: east stairway

1. Fort Shaw, Montana
2. Photo taken by Stuart S. White on 4/23/79
3. Photo indicates east stairway in Officer's Quarters.

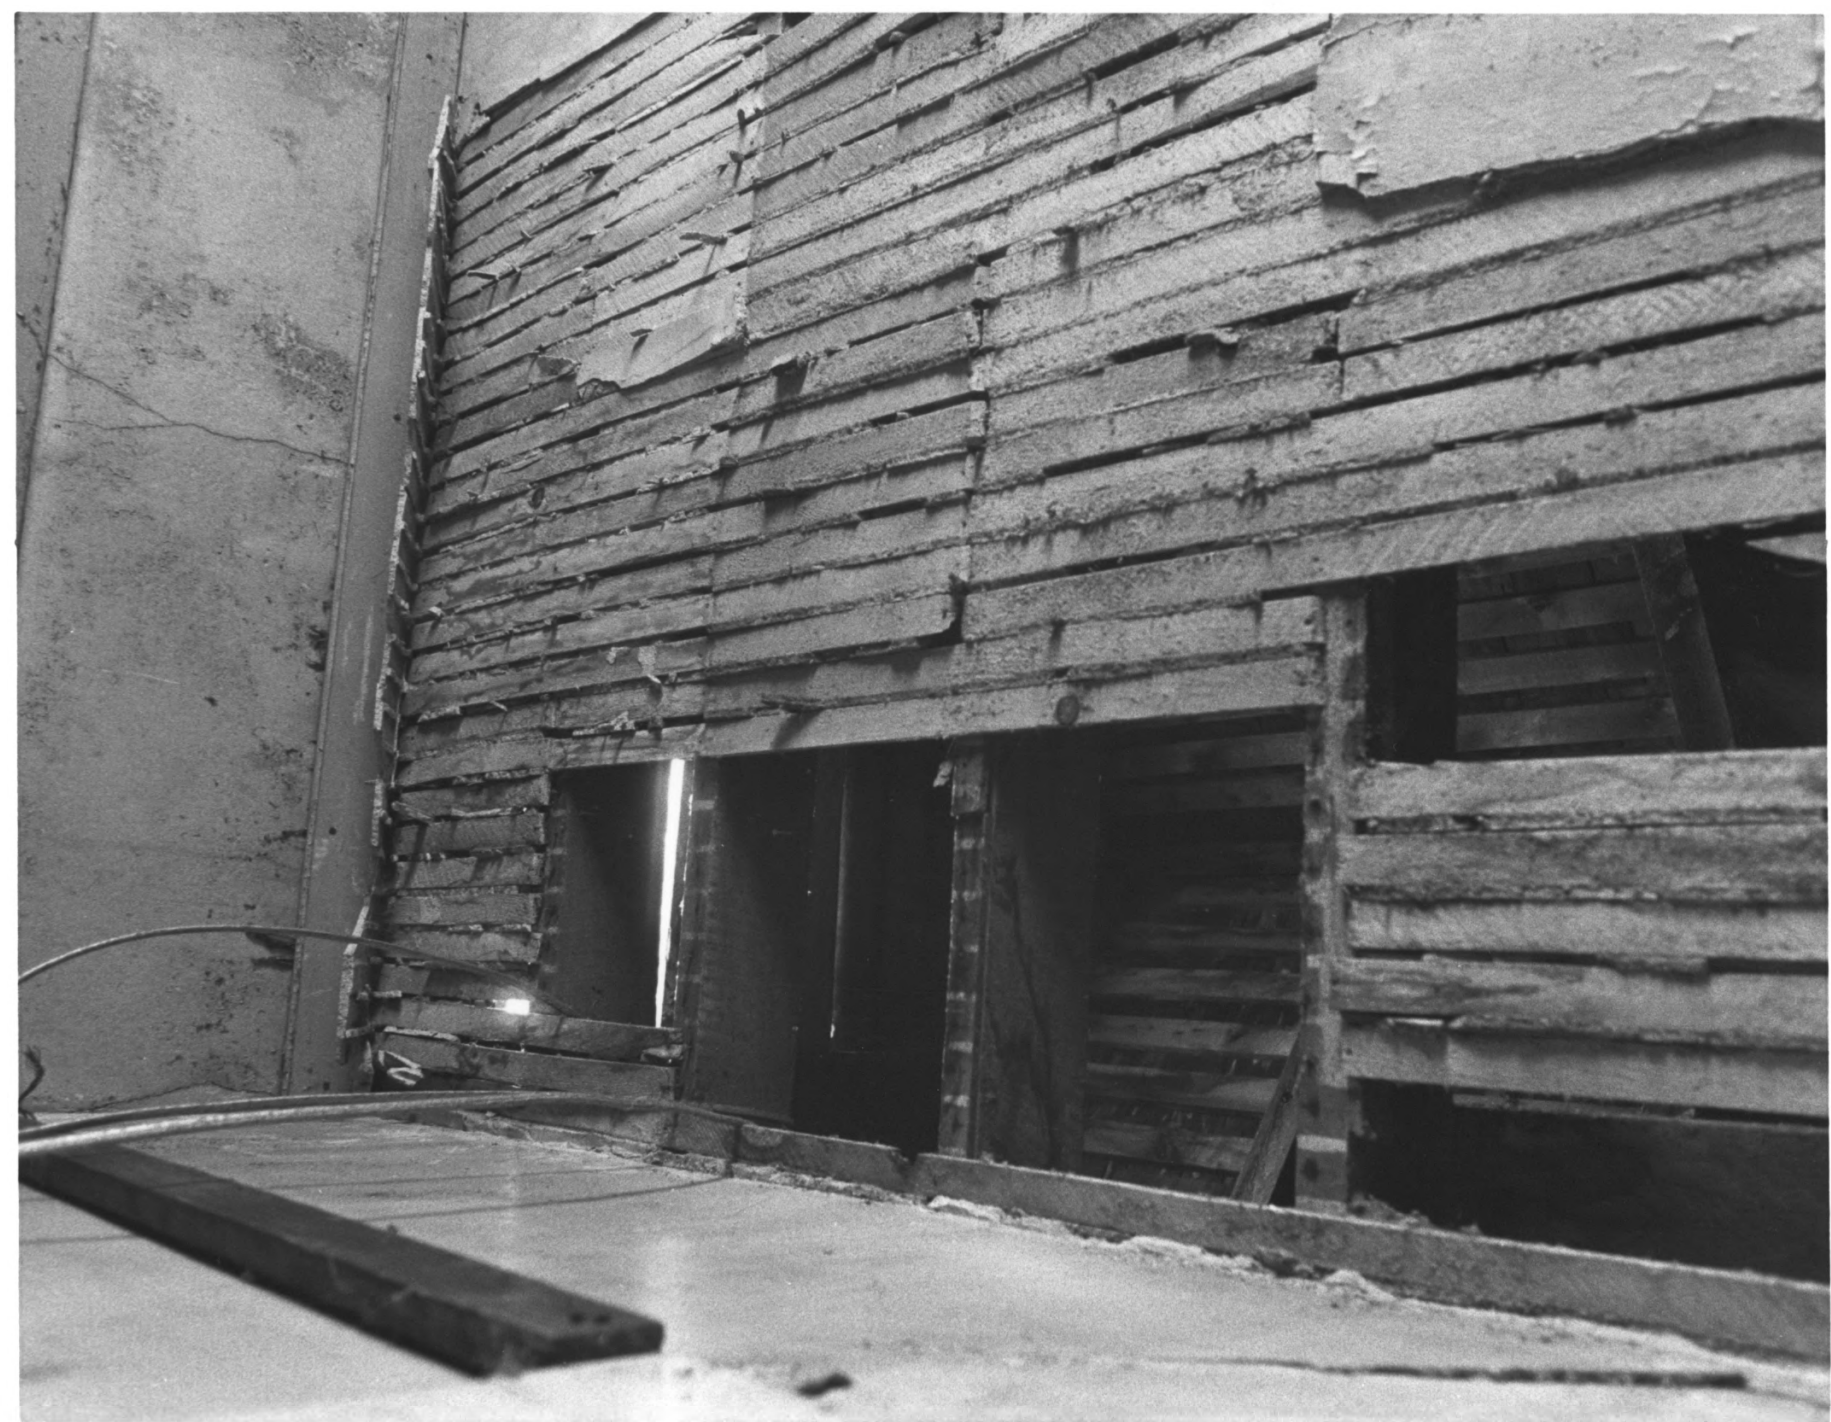
Fort Shaw Historic District  
Fort Shaw, Montana, Cascade County  
Photo by : Stuart S. White  
Fort Shaw, MT  
Date: April 23, 1979  
View: Upstairs Building #3

1. Fort Shaw, Montana
2. Photo taken by Stuart S. White on 4/23/79
3. Photo taken in upstairs area of Building #3 and indicates that the plaster has fallen from the walls over a large area in the interior.

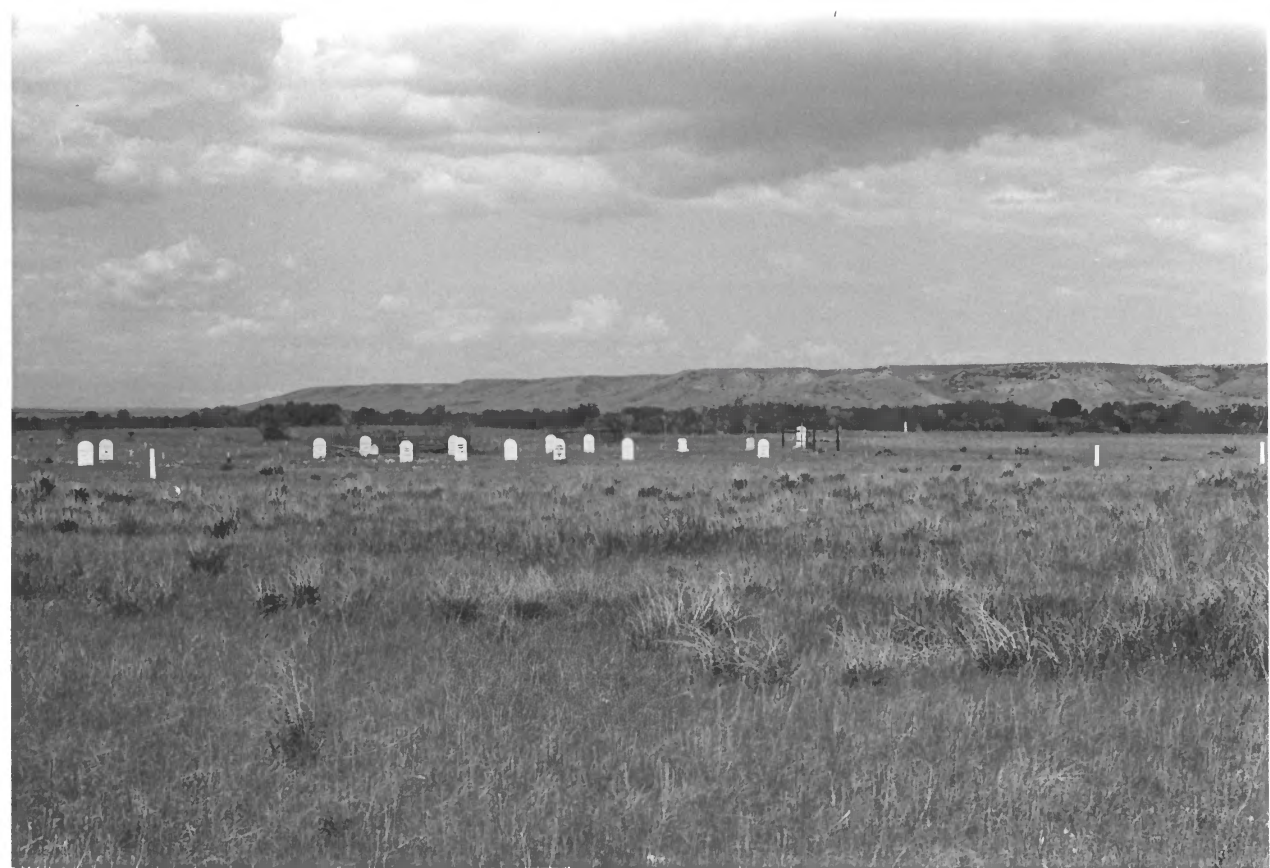
A general view of the military section of the cemetery taken from the southeast corner. It shows the new wooden markers that have recently been erected.

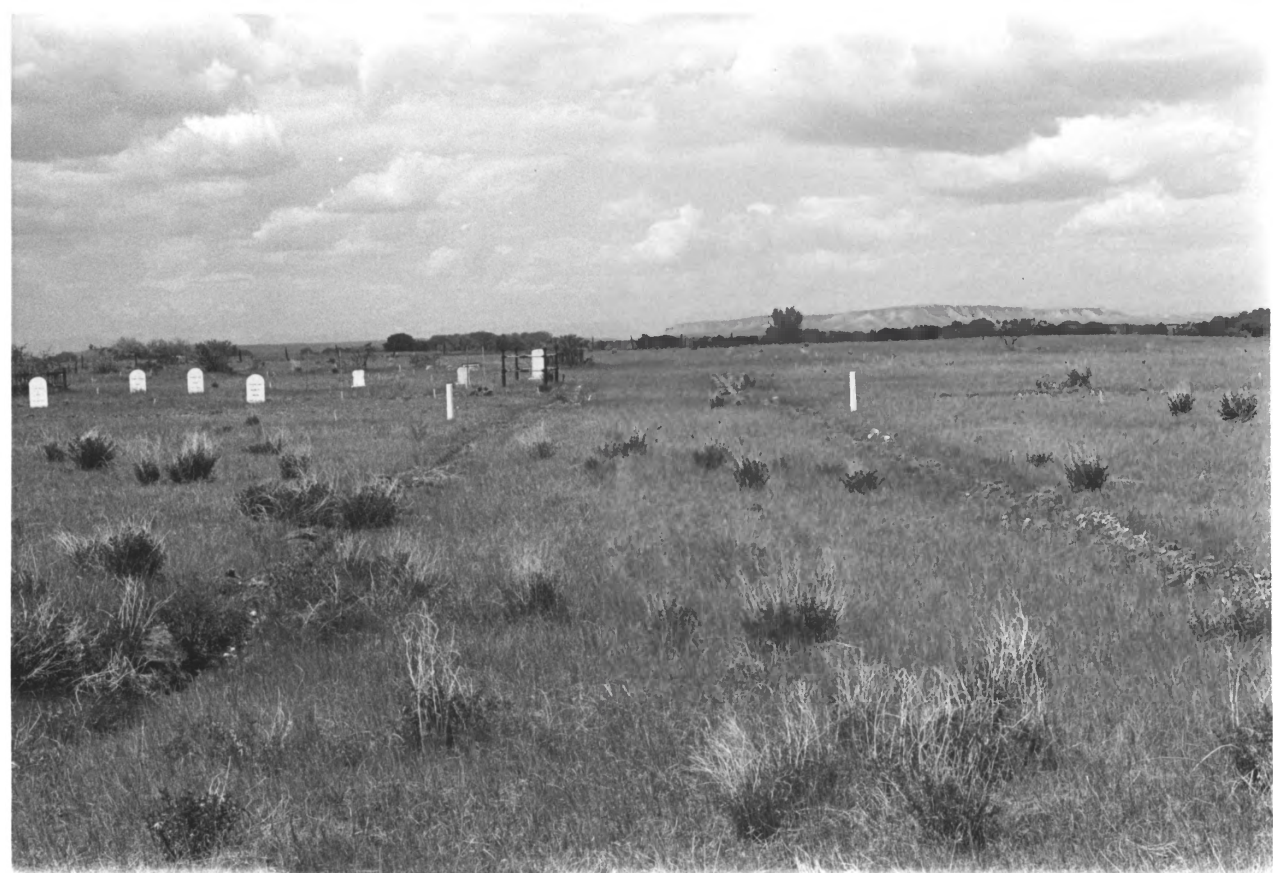
Phototaken from the center  
of the original military road  
that ran from Fort Shaw to the  
Cemetery. Note the irrigation  
ditches that were originally  
constructed by the Army.

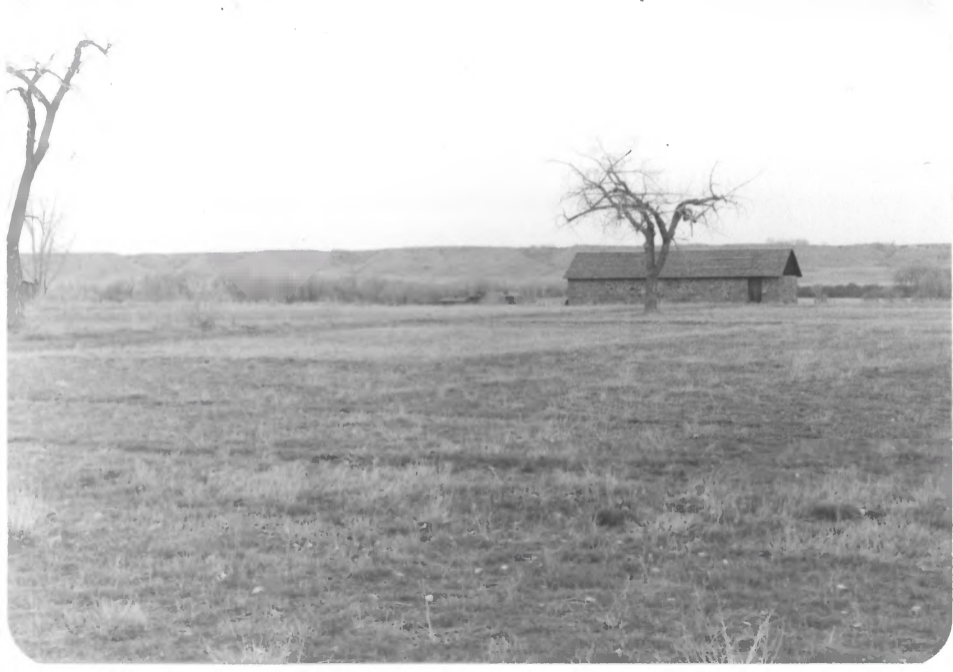
Stone building that was a part of the stable complex. This building has been re-roofed. Note the outline of foundations in the foreground.
