FORT SHAW

Cascade County, Montana

Fort Shaw Historic District  
Fort Shaw, Montana, Cascade County  
Photo by : Stuart S. White  
Fort Shaw, MT  
Date: April 23, 1979  
View: Northeast Corner

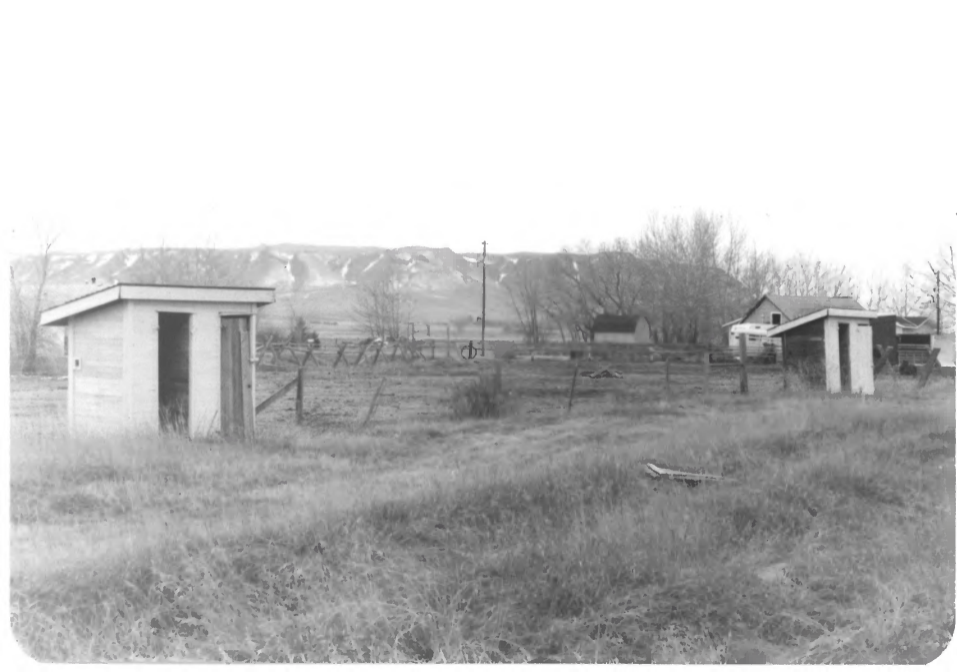
Latrines standing behind the  
building on Officer's Row.  
Numerous foundations in this  
area.

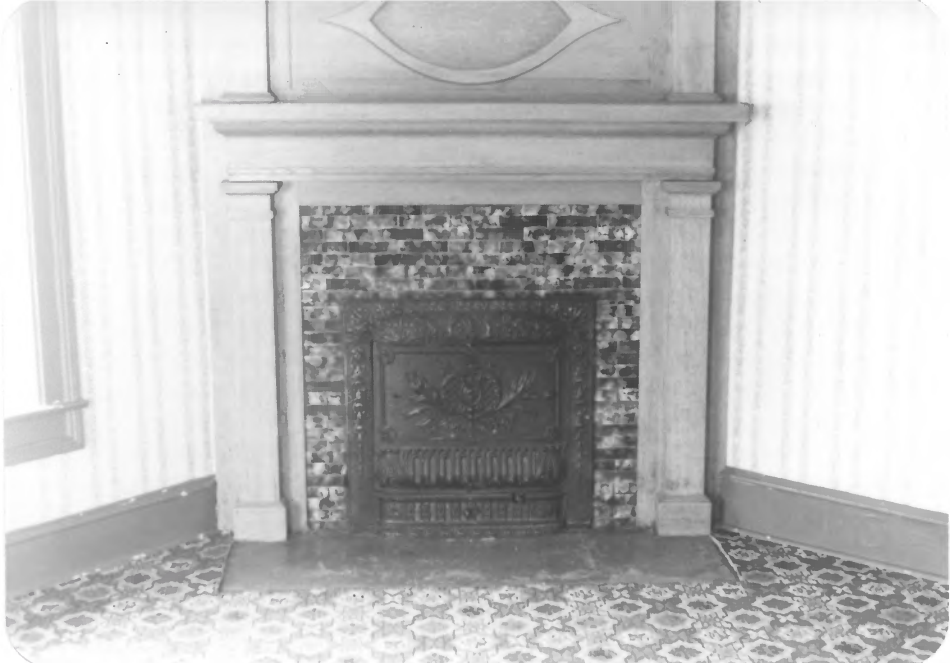
This is a view of the fire place  
that is in the CO's Quarters.

It was shipped to Fort Shaw via  
Fort Benton from St. Louis, in  
1867. Original hardwood floor  
is under the rug and in good  
condition

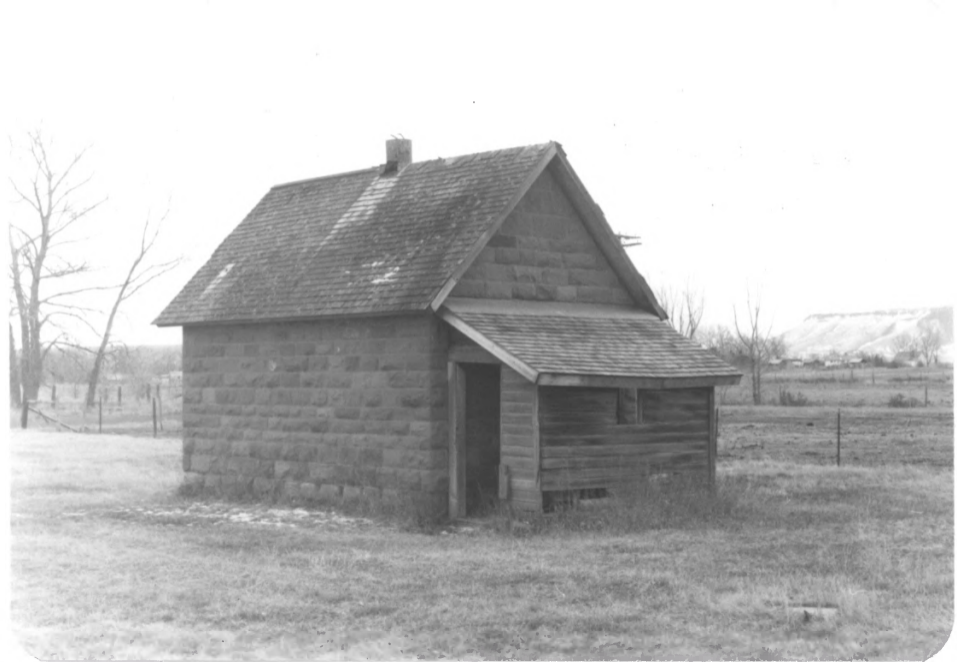
Wash house in southeast corner.  
Because of the sandstone foundation, it is in bad shape and we have plans to repair it this summer.

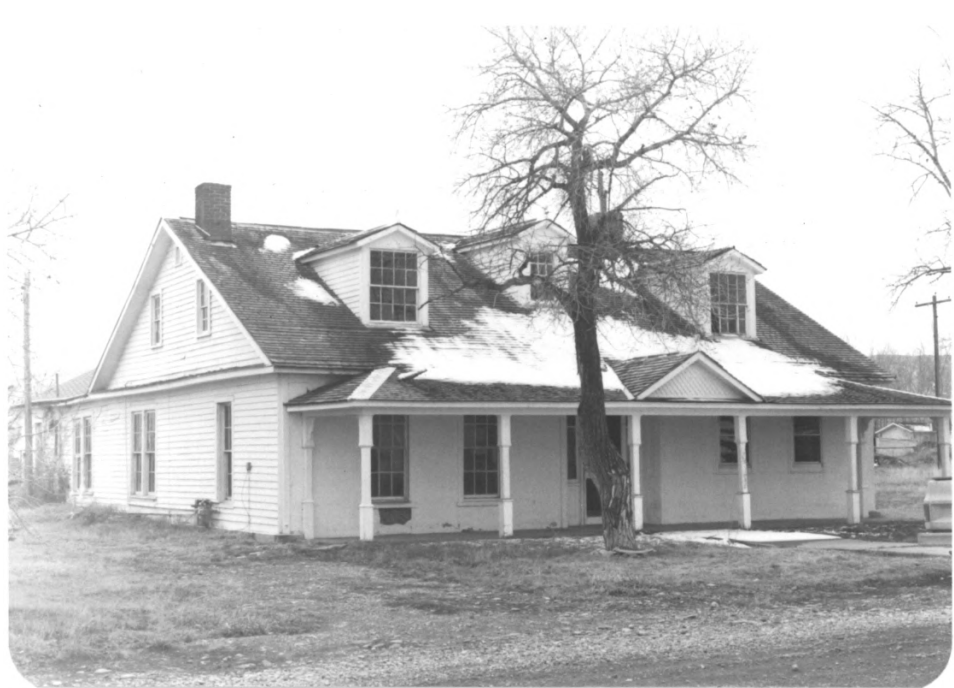
General view of Cammanding Officer's Quarters. The porch is original. Note deterioratoin below the window at left. We will take care of this, this summer.

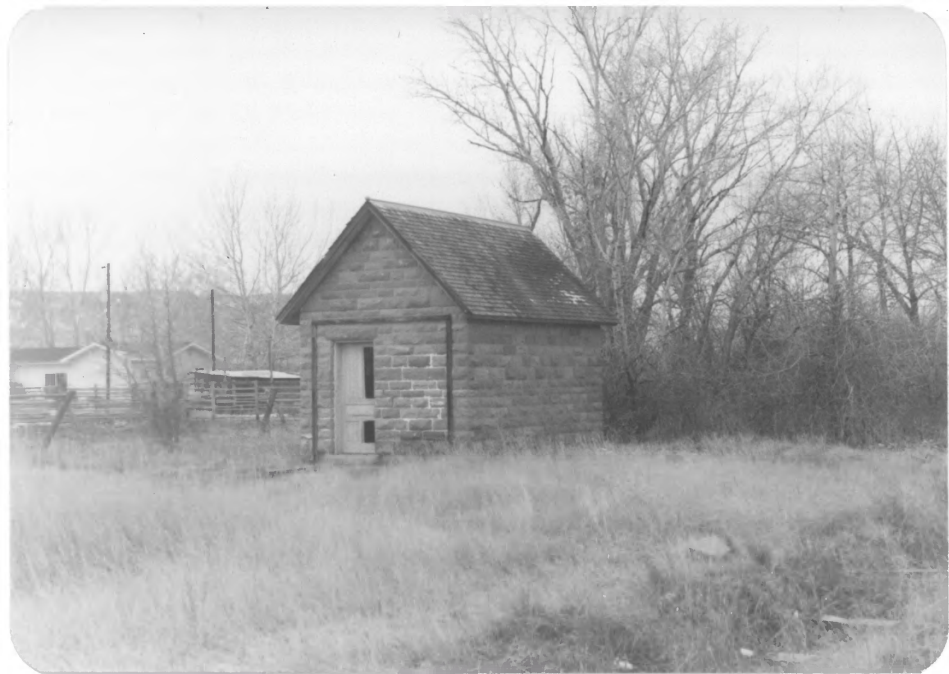
Wash house in southwest corner.  
Wooden entrway was removed due to  
cave in of roof. Foundation in  
bad condition.

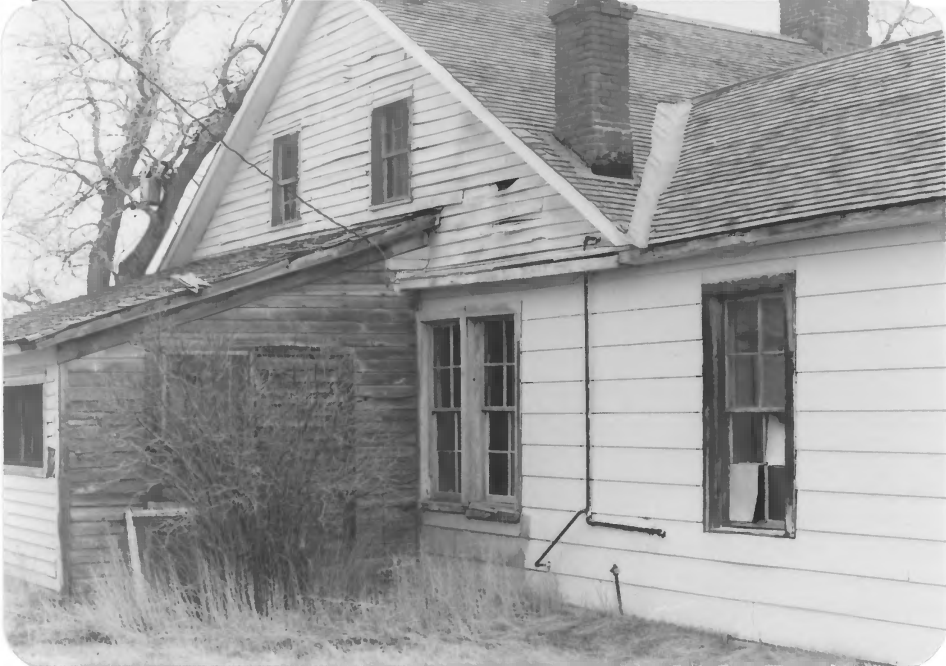
A detail of Officer's Quarters.  
Note portion was resided. Tents  
of 13th Inf. were used for in-  
sulation and are still visible.

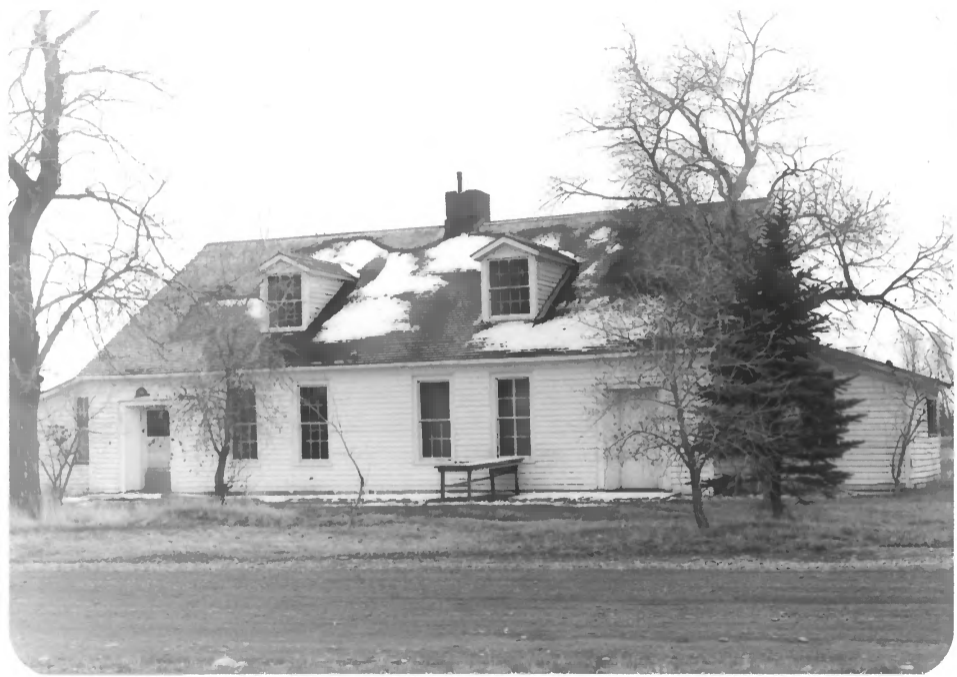
Officers's Quarters to the east of the CO's building. Porch was removed and interior has been altered. We would like to restore it to original appearance as we have copies of building plan.
