National Register of Historic Places Registration Form

historic name Benson Historic Barrio

street & number 307-572 Fifth Street, between San Pedro Street and Route 80

city or town Benson

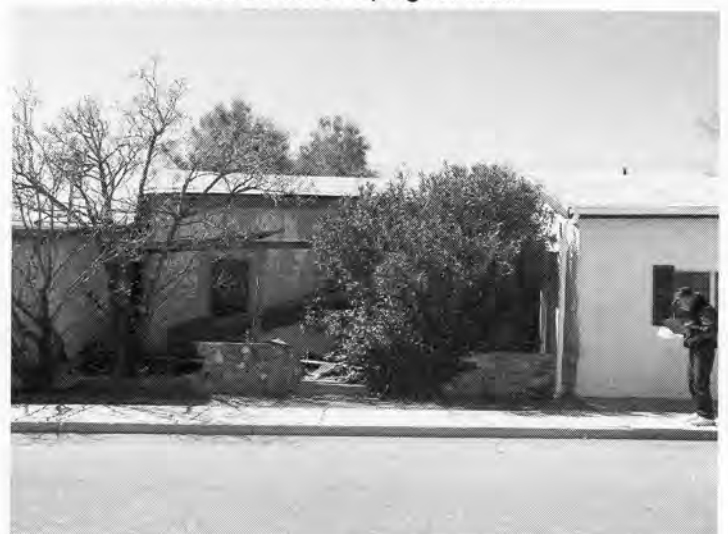
Photo 4. 478 E. Fifth Street. This transitional, side-gabled massed-plan dwelling is placed so that its walls abut those of its neighbor, a Mexican settlement trait. 464 E. Fifth Street, next door, is placed very close to the front property line.

Another very old, side gabled, linear-plan dwelling of the "transitional tradition" is 478 E. Fifth Street on Block 24 (Photo 4). Built around 1905, it abuts its neighbors on either side. The vacant dwelling is in very poor condition today and its full-width frame porch (showing on the 1931 Sanborn Map) has completely collapsed. It is not known whether the dwelling originally had a flat roof. Currently it has a side-gabled roof with roll composition roofing.

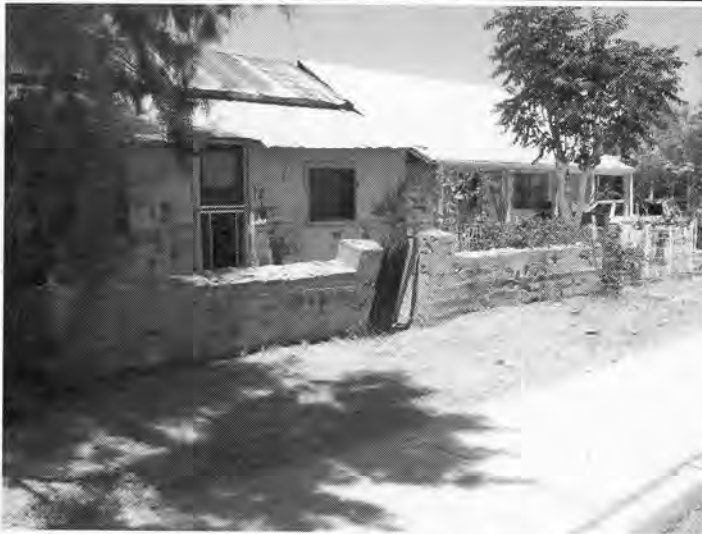
Photo 5. Unique, hand-poured wall marking the front property line of 371 E. Fifth Street. Note also the green painted house walls. Both the garden wall and the pastel color of the house walls are Mexican cultural traits.

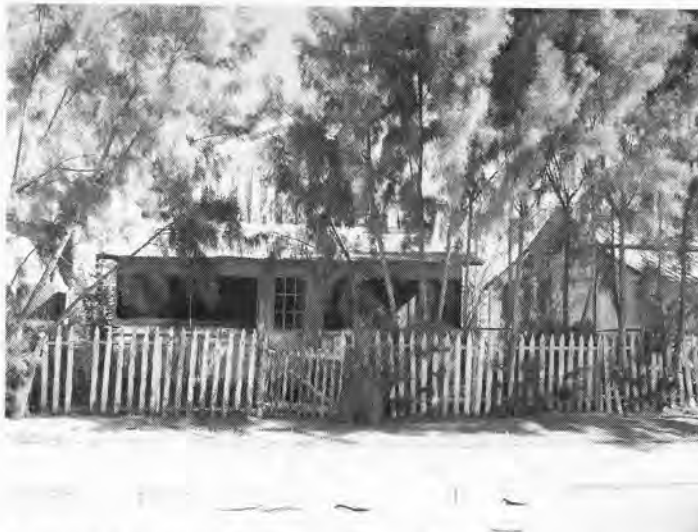
Photo 7. 369 E. Fifth Street. A 1900 "railroad house" west of Gila Street. This is a gable-front, massed-plan dwelling, a Euroamerican vernacular type. Built of frame, it may be an example of "box construction."

In the Barrio, the earliest contributing dwellings of this type are found side-by-side on Block 19 at 351 and 369 E. Fifth Street (Photo 7). These "railroad houses" were built in 1900 to accommodate employees of the Southern Pacific Railroad. They are Greek-Revival influenced due to their temple-front shape and gable cornice returns. Both houses have wood, double-hung windows and full-width, drop-shed, front porches on wood posts.

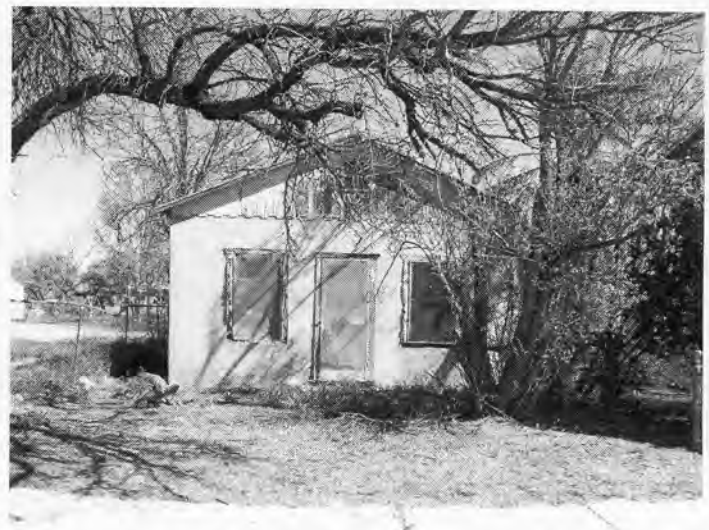
Photo 8. 419 E. Fifth Street. A second-generation, front-gabled, tan colored, stuccoed dwelling built in 1928 by Joaquin and Ana Figueroa Meza. The dwelling has only two rooms.

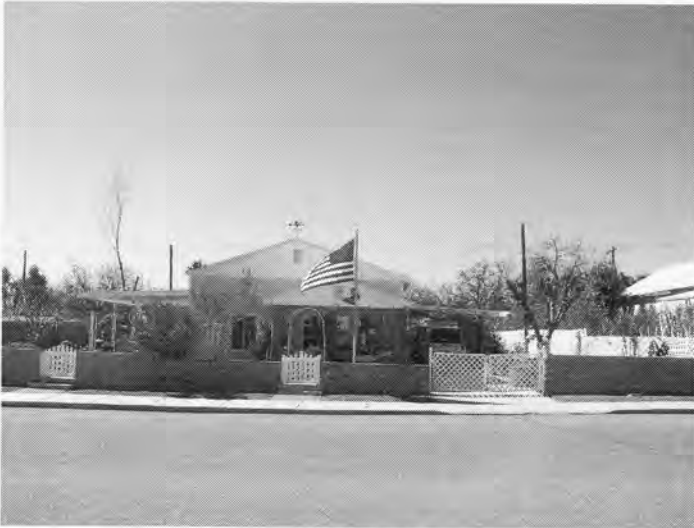
Photo 9. 418 E. Fifth Street, the Ellsworth House. This gable-front, massed-plan dwelling acquired its current form and front porch through a 1950s remodel of the original ca. 1900 adobe walls. The siding is painted a vibrant mint green color.

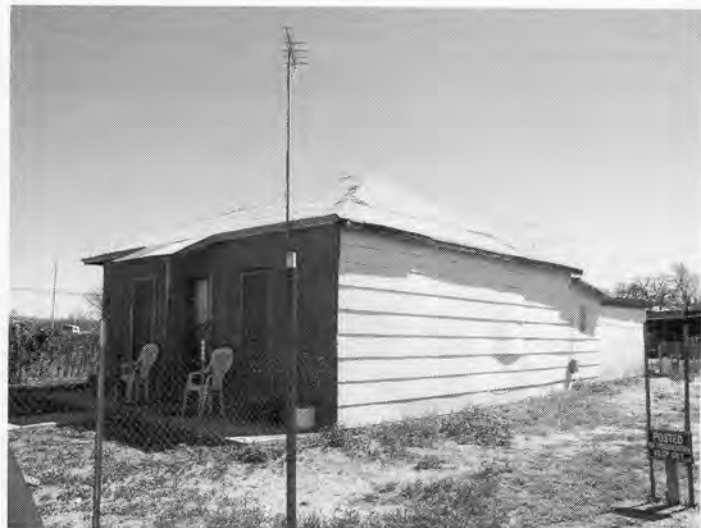
Photo 10. 550 E. Fifth Street. This is a classic pyramidal cottage built in 1930 of stuccoed adobe. The west wall has blue, horizontal, composition siding.

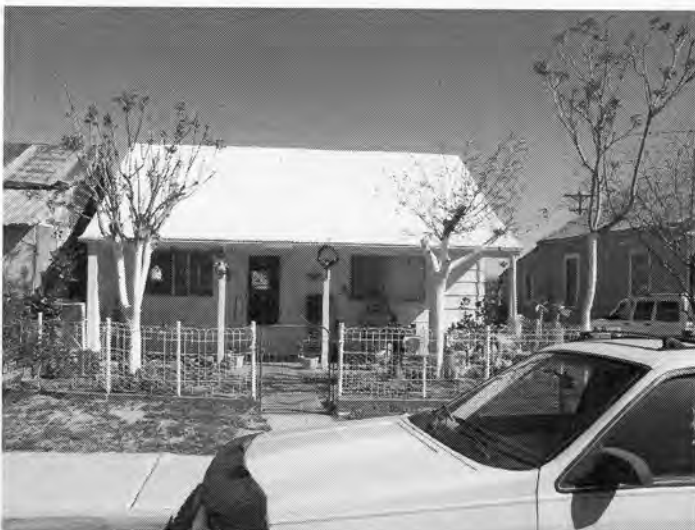
Photo 11. 387 E. Fifth Street. A second generation "railroad house" built in 1925. This is a side-gabled linear-plan type with shed additions to the rear.

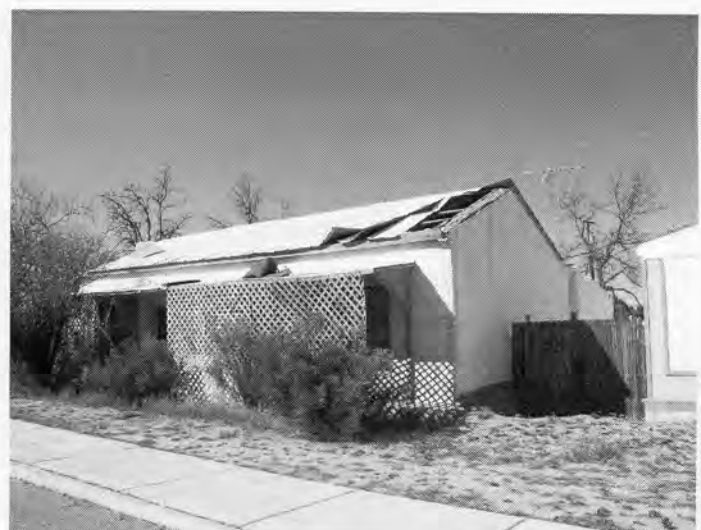
Photo 12. 463 E. 5th Street. The 1900 Genaro Figueroa house was originally a Sonoran, parapet-walled, flat-roofed dwelling. It was later transformed by the addition of a pitched roof, exemplifying the "transitional" tradition.

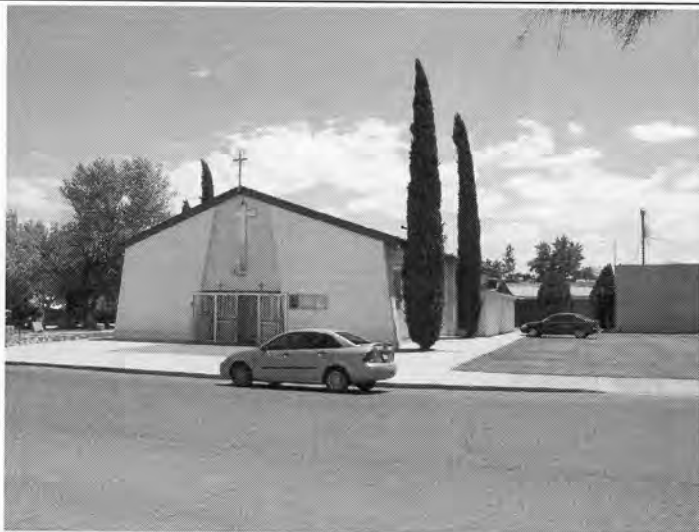
Photo 13. Our Lady of Lourdes Catholic Church. Located near the center, it is the "heart" of the Barrio.

The sanctuary has a low-pitched, slightly overhanging, gabled roof. The front façade has heavy, masonry walls with battered ends and a central, entry panel with glazed, cut, bronzed, sheet metal doors below and a large metal cross mounted on stucco above. Each door is marked with the name of one of the four gospel saints, Matthew, Mark, Luke and John. The side facades have stained glass windows and spaced masonry piers to support the wood trusses. The masonry is concrete brick (Cal-Clay block) sprayed with Tuff Tex, a white textured masonry coating.

The current or second church (Photo 13) was built just west of the original 1895 church. Construction was completed in January 1949 under the leadership of Fr. Thomas Doyle. The architect was Terry Atkinson of Tucson and the builders were Shorty Martinez and Vern Bell. Volunteer labor from the community was used in the construction, especially during foundation work when the 5 ft. x 5 ft. concrete footings were built. The congregation's perception of the church was that it was designed in a "modified Spanish style" and that the exposed beam and truss ceiling represented the stable in Bethlehem.

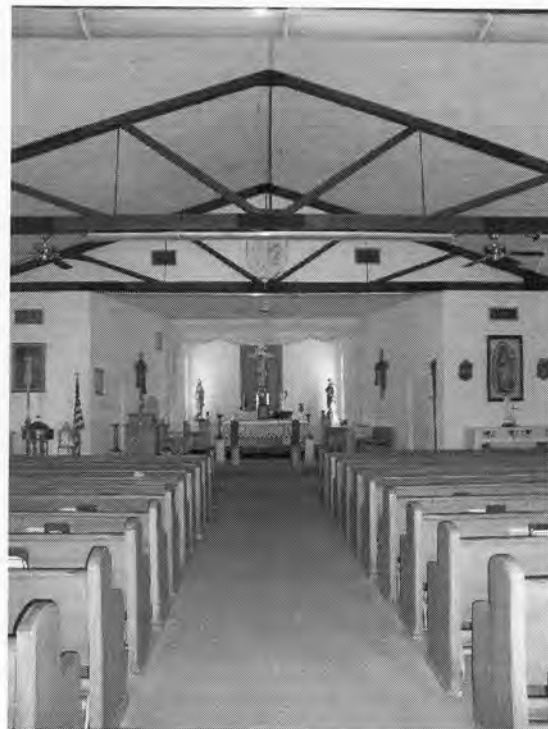
Photo 14. Interior of Our Lady of Lourdes Catholic Church. View towards altar showing trusses and oak pews.

The interior of the sanctuary is simple and noteworthy for its dark stained wood trusses and simple stained glass windows individually donated. The pews are of oak (Photo 14).

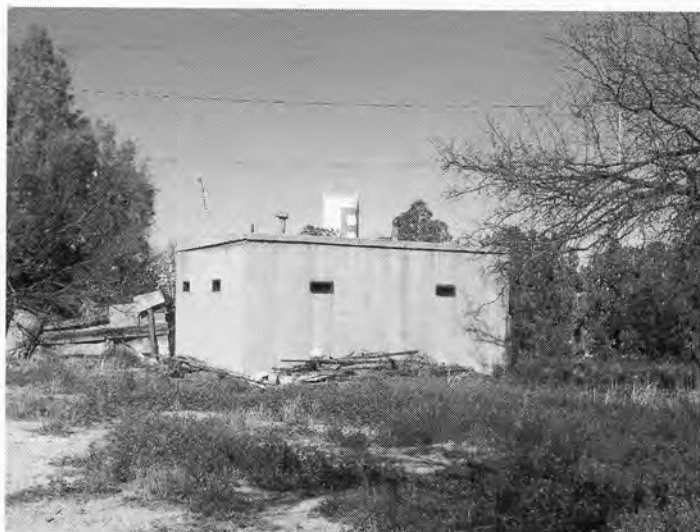
Photo 15. The Old Jail House. Built in 1915, it is located on what was for many years the Mejia property. Constructed of concrete, it has a trapezoidal plan and an overhanging, slightly gabled, concrete roof.

Dating back to 1915 the old Jail is a 314 square-foot building with a trapezoidal plan. Built of reinforced concrete, it has a slightly gabled, overhanging, concrete roof. Typical of a jail, the single window has small, steel-frame window ports with bars and a rusted metal door (Photo 15). There is a ghost sign on the east façade advertising "RUIZ'S MEXICAN AMERICAN – CARNE – STEAK" plus two other illegible words.

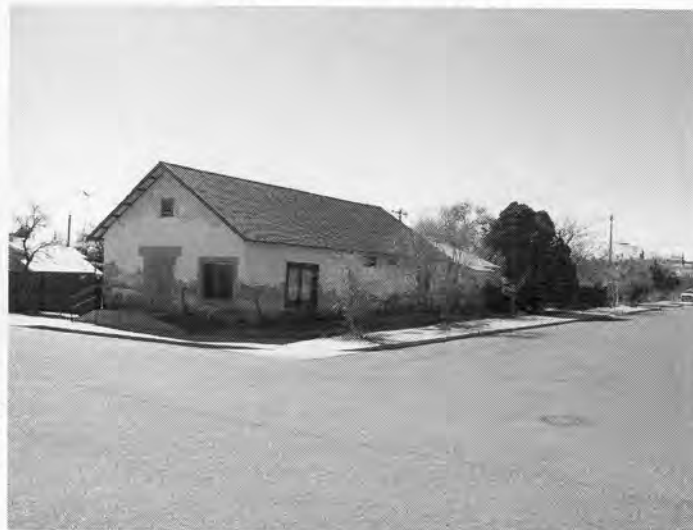
Photo 16. Original Quihuiz Grocery Store, built in 1925. Owned and operated by the Quihuiz family who resided in back. Unusual for a corner commercial building is its elongated, gabled form.

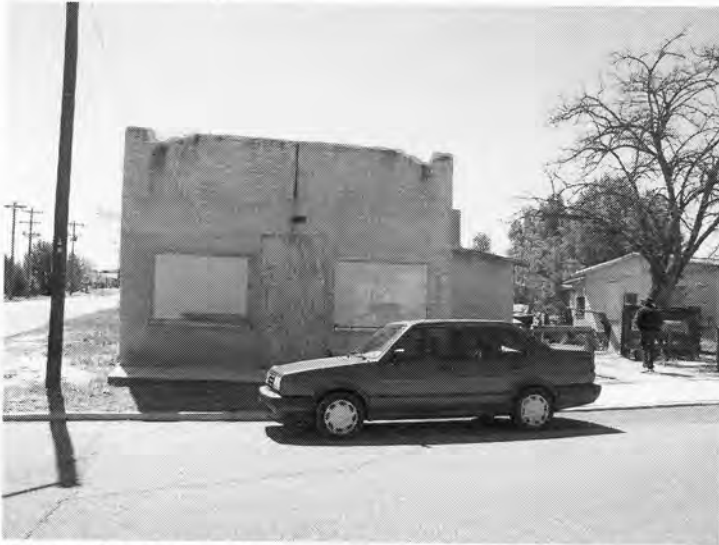
Photo 17. Former Deliciosa Café, now vacant, built around 1936. Owners Diego and Angelita Guitierrez ran a restaurant and package liquor store from the premises. Built of stuccoed adobe, this corner store has large storefront windows, a central entry and sculpted parapets.

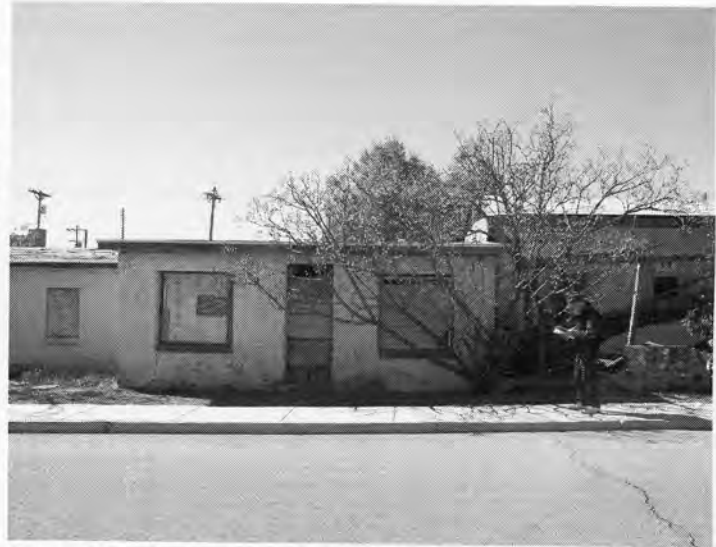
Photo 18. The Pool Hall, built around 1936 by Jose Ruiz Lopez. Currently vacant, it has been owned by members of the Lopez family for many decades. Residential in scale and appearance, this side-gabled, vernacular hall of mud adobe is unusual for a commercial building.

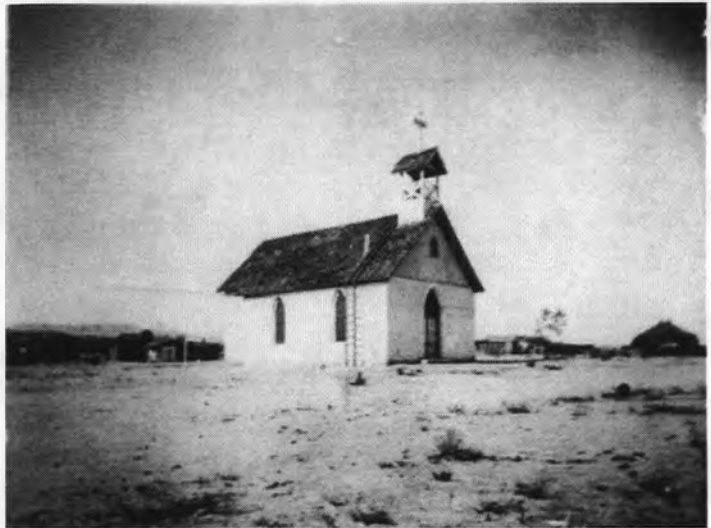
Photo 22. Our Lady of Lourdes Catholic Church, first building. Built on Block 25 in 1895, this modest, Gothic Revival-influenced adobe church served Benson and surrounds and as the heart of the Barrio, probably around 1895.
